**An Archaeological Evaluation in the Ha-  
ha at Launde Abbey, Launde Road,  
Leicestershire LE7 9XB**

**NGR: SK 79706 04375**

ULAS Report No 2017-085  
©2017

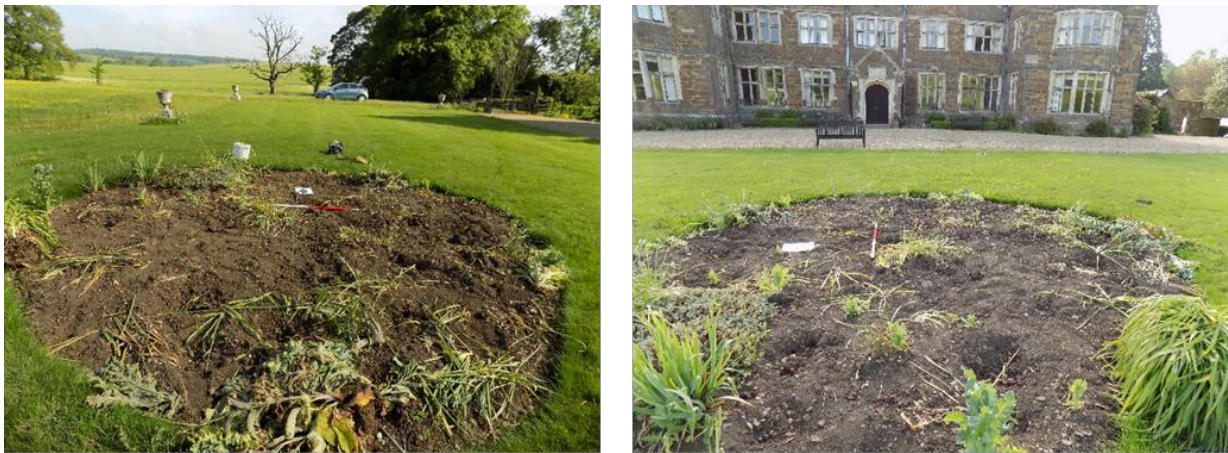
Figure 5. Location of the flower bed within the Ha-ha (1m scale)

General photographs of the area were taken prior the commencement of the excavation of the test pit. The 1mx1m test pit represented a sample of the 2.5m<sup>2</sup> hole that will be required for the concrete foundation supporting the statue. The location of the test pit was discussed in advance with the client and its position within the ha-ha established through triangulation of measured distances from the house (Fig. 5).

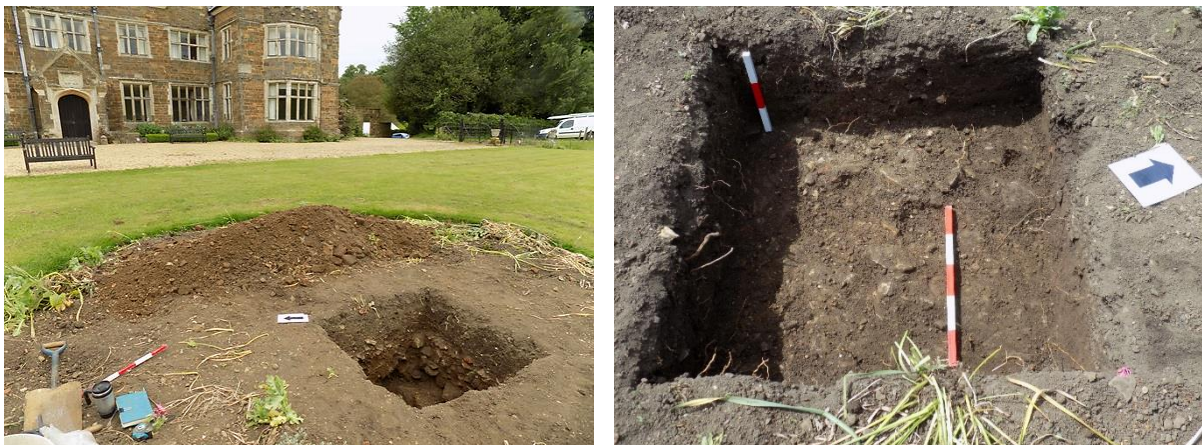
Figure 7. Location of excavated test pit (left) and pre-excitation of rubble layer (3) (right)

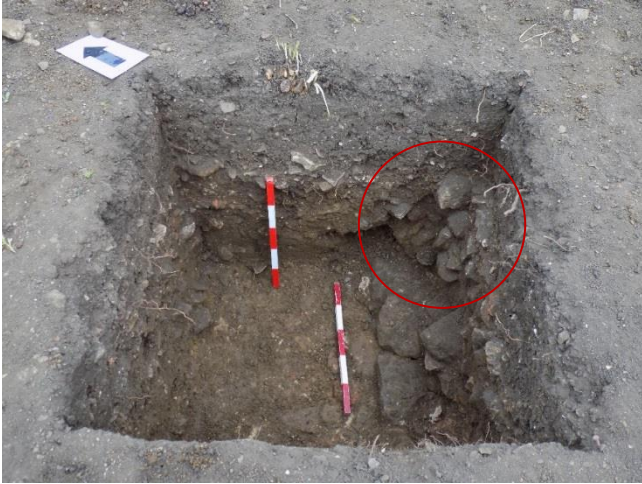
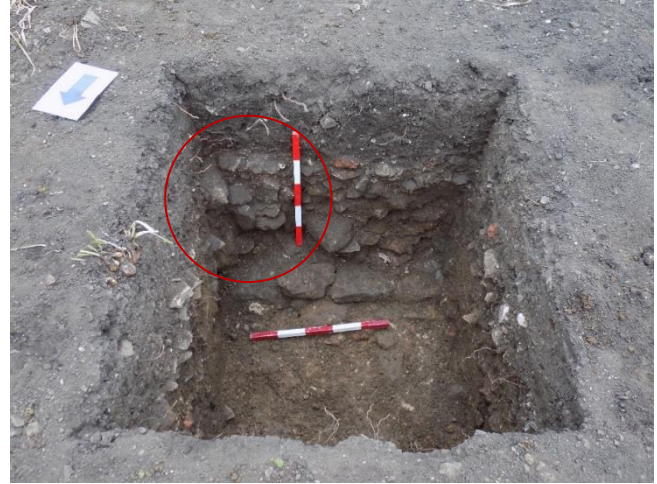
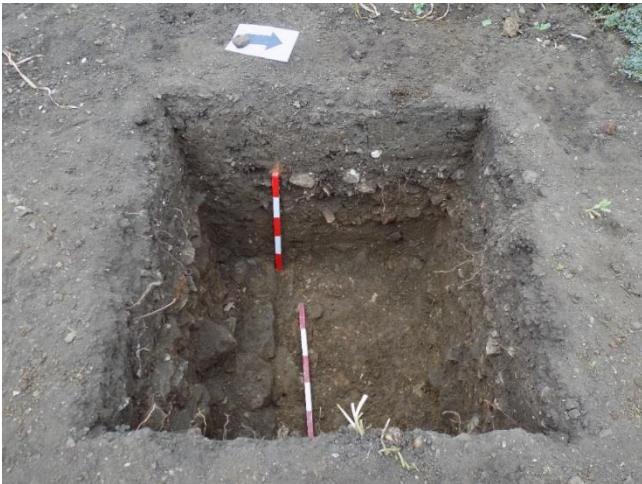
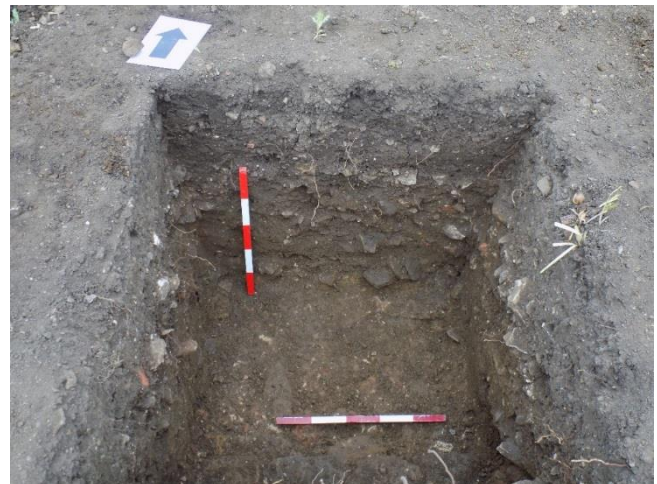
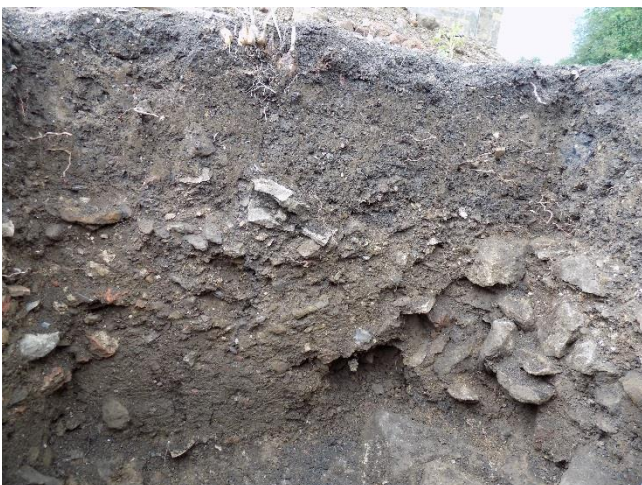
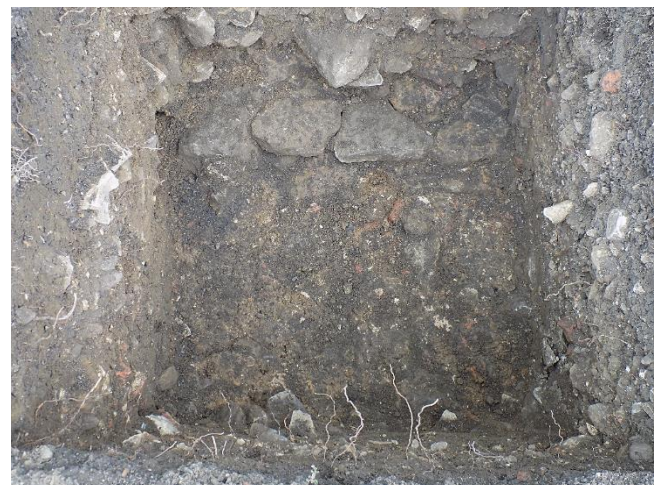
a. West-facing section of test pit (0.5m scales)

b. North-facing section of test pit (0.5m scales)

c. East-facing section of test pit (0.5m scales)

d. South-facing section of test pit (0.5m scales)

e. South-east corner showing concentration of stone above wall)

f. Post excavation of test pit

Figure 8. Post excavation photographs of test pit showing rubble layer (3) and East-West wall (5)

The garden soil, approximately 0.18m in depth, was a mixed dark brown-grey clayey silt (1), under which was a mixed layer of silty clay (2), between 0.17m and 0.22m in depth, containing fragments of ironstone, sandstone and fragments of brick. The layer below, 0.22-35m thick, consisted of mixed rubble containing broken brick, ironstone and sandstone (Fig. 7). This layer was consistent across the pit, however, larger concentrations of brick were encountered on the northern end, while the southern side was much more compacted with a significant number of stone accumulated on the southeast corner (Fig. 8e). A mid grey-brown clayey silt with rare fragments of brick and charcoal flecks laid below the rubble measuring approximately 0.20m. Immediately below this layer, located to the south of the pit was an earth bonded wall (5) consisting of a band of horizontally laid limestone on an east-west alignment (Fig. 8 and 9). Due to the limitations of the excavation area, it is not possible to ascertain the

dimensions of the wall, nor its character or its relationship to known archaeology, the priory or the manor house without further exploration. The line of this wall it is not indicated in the postulated reconstruction of Liddle and O'Brien (1995). It is however possible for the wall to be an internal partition related to the cloistral complex of the priory, or alternatively to be linked to its conversion into a country house in the second half of the 16th century.

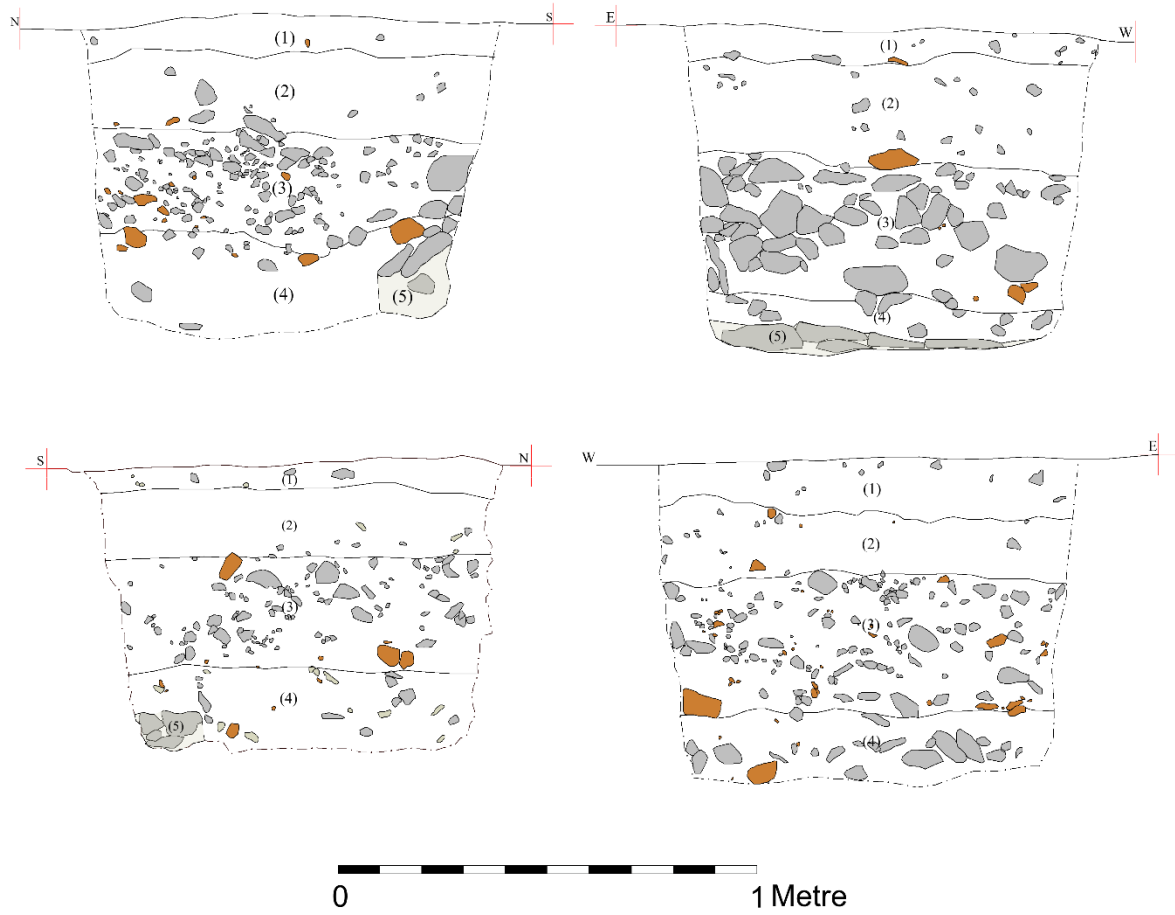
Figure 9. Section drawings of test pit in Ha-ha

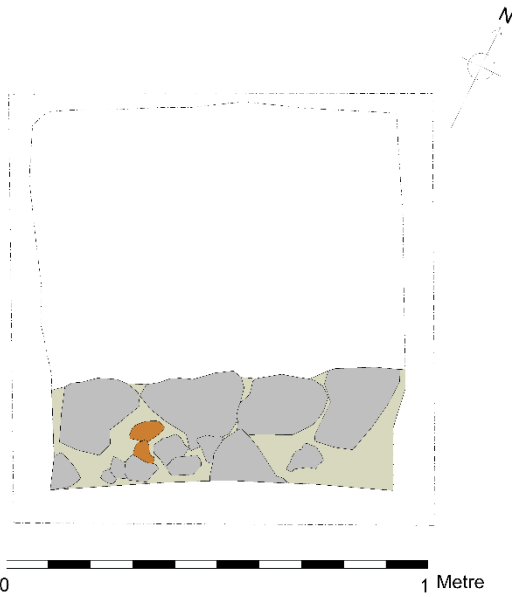
Figure 10. Plan of test pit
