**An Archaeological Evaluation on Land  
at Hall Farm, Hall Lane, Packington**

**ULAS Report No 2018-028**

**For: Lychgate Homes Ltd**

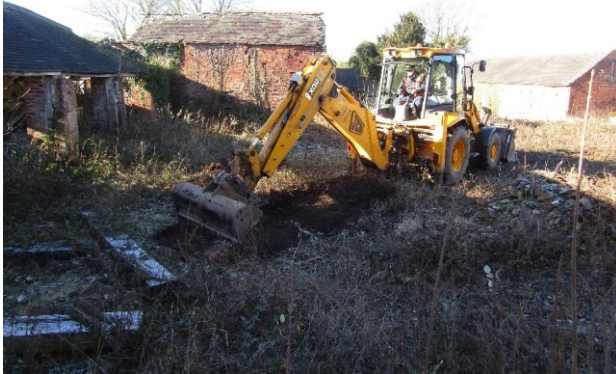
Figure 4: Maching Trench 03, looking west

7.1 Five trenches were excavated across the development area (Figure 4) using a JCB fitted with a 1.60m wide toothless ditching bucket. Three trenches of 15 x 1.60m were located in the farmyards, two in the west and one in the east in front of the farmhouse, the latter relocated due to an extant modern foul waste service. A trench of 10 x 1.6m was located between mature trees to the south of the farmhouse and another of 24 x 1.6m to the south of the ancillary buildings.

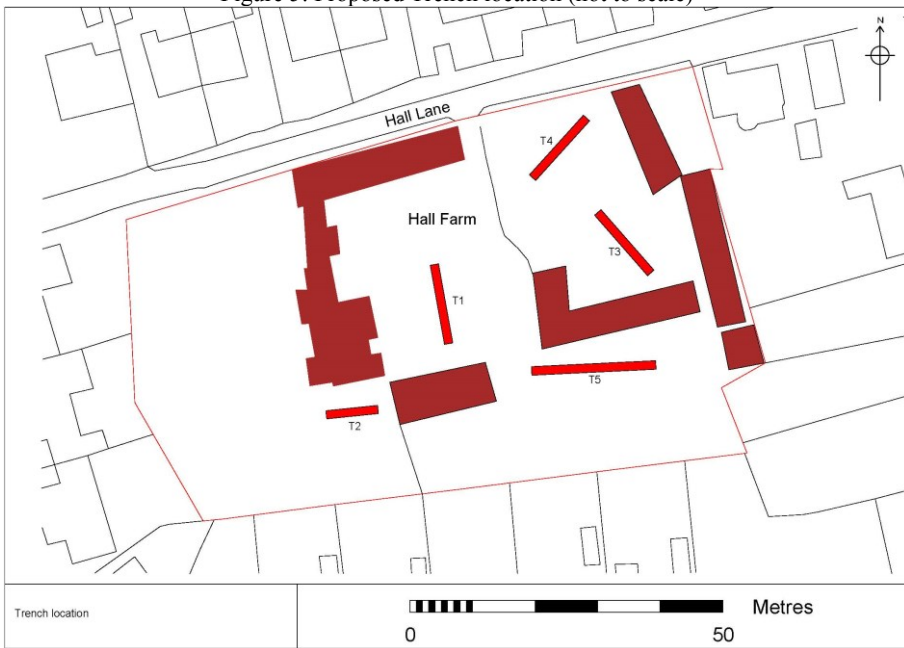
Figure 6: Actual Trench location

Some alterations were made to the proposed trench locations in the field. Trench 01 was relocated approximately 6m to the south to avoid an existing foul drainage service. The orientation of Trench 02 was limited by the presence of mature trees behind the farmhouse and Trench 05 was shortened from 30m to 24m due to the presence of mature vegetation in the south east of the development area and the proximity to the dilapidated buildings there.

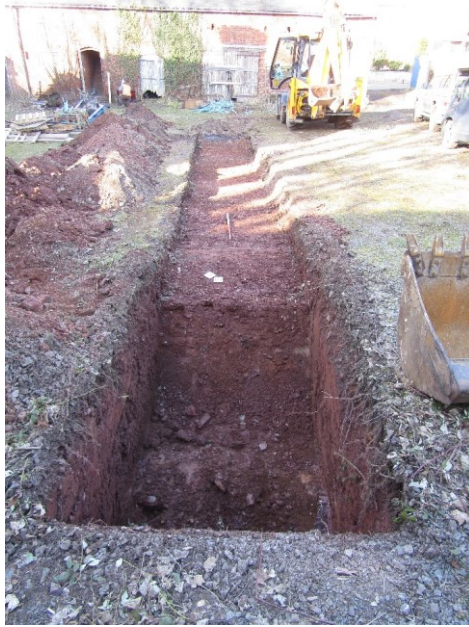
Figure 7: Trench 01, looking north

Trench 01 was located in the lower western farmyard in front of the farmhouse. A mid-light red/brown stony clay natural substratum with frequent sub-angular limestone was recorded along the length of the trench at a notably shallow depth (*c.*0.20m). A test pit, *c.*1.40m deep, was excavated into this at the southern end to determine and clarify levels. Possible plough scars running approximately east-west were recorded *c.*3.0m from the southern end and a drain associated with the farmhouse truncated the trench at its northern extent. No archaeological deposits or residual finds were recovered.

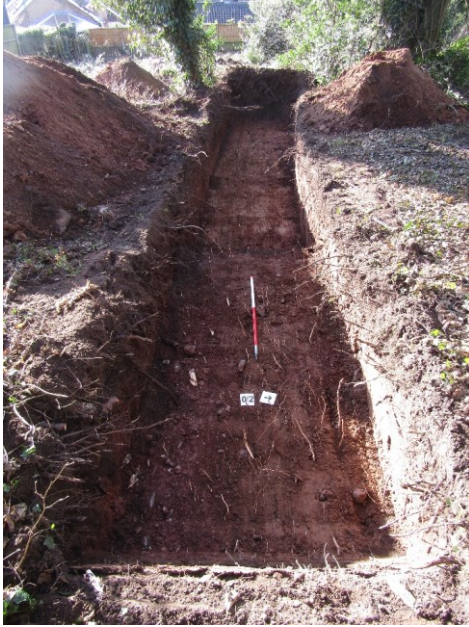
Figure 8: Trench 02, looking west

Trench 02 was located to the south-west of the site behind the farmyard and revealed evidence for a possible furrow, consisting of silty sand with redeposited natural lenses and orientated approximately east-west. A test slot was machine excavated through this to a depth of *c.* 1.15m. A similar substratum to that in Trench 01 was observed. No archaeological deposits were encountered or finds recovered.

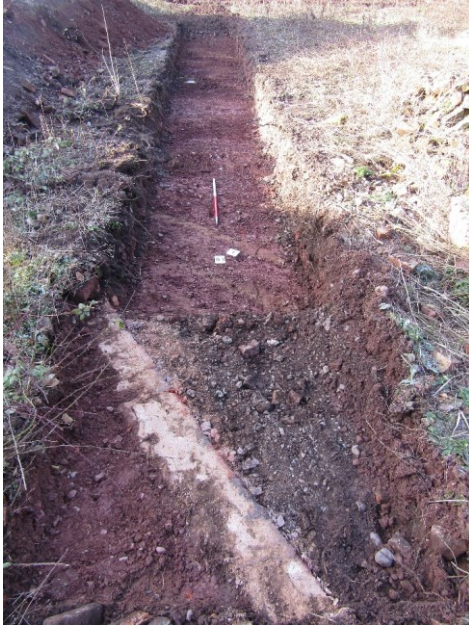
Figure 9: Trench 03, looking north-west

Located in the 'upper' farmyard to the west of the development area, Trench 03 exposed modern walls associated with demolished ancillary farmyard buildings/structure, one of brick at the southern end and another of stone and brick construction traversing the trench, approximately 9.0m to the north. Possible plough scars, some containing fragmentary brick and also orientated east/west, were recorded but no archaeological deposits or finds. A natural drift material of red/brown clay was reached consistently along the length of the trench.

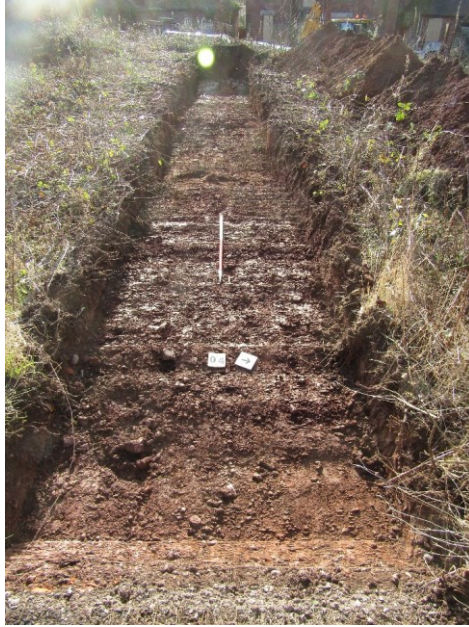
Figure 10: Trench 04, looking west

Also in the 'upper' farmyard, Trench 04 was located towards Hall Lane. A furrow was observed orientated east/west across the trench, *c.* 7m from the western end. The base of the trench was similar natural substratum. No archaeological deposits or finds were recovered.

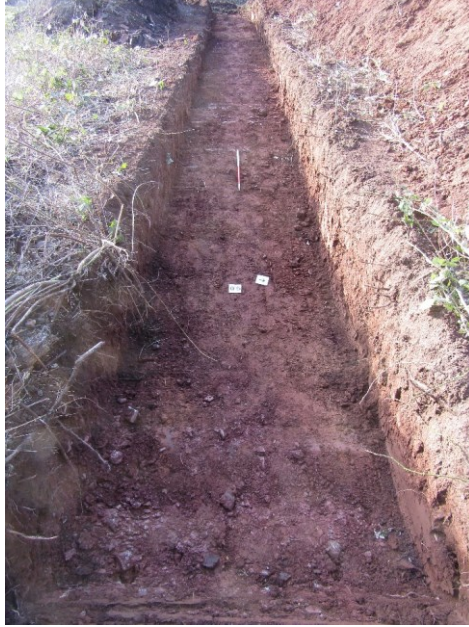
Figure 11: Trench 05, looking west

Located to the south-west of the development area and behind farmyard buildings, Trench 05 linked the 'upper' and 'lower' farmyards. Natural red/brown clay substratum was observed along the length of the trench. No archaeological deposits were observed or finds recovered but there was evidence of north-east/south-west furrows consisting of mixed yellow/brown silty sand with natural clay lenses.
