**A Level 2 and 3 Historic Building  
Survey at the former Towers Hospital,  
Gipsy Lane,  
Leicester.**

**NGR: SK 618 060**

ULAS Report No. 2014-204  
©2015

**For: KRT Associates**

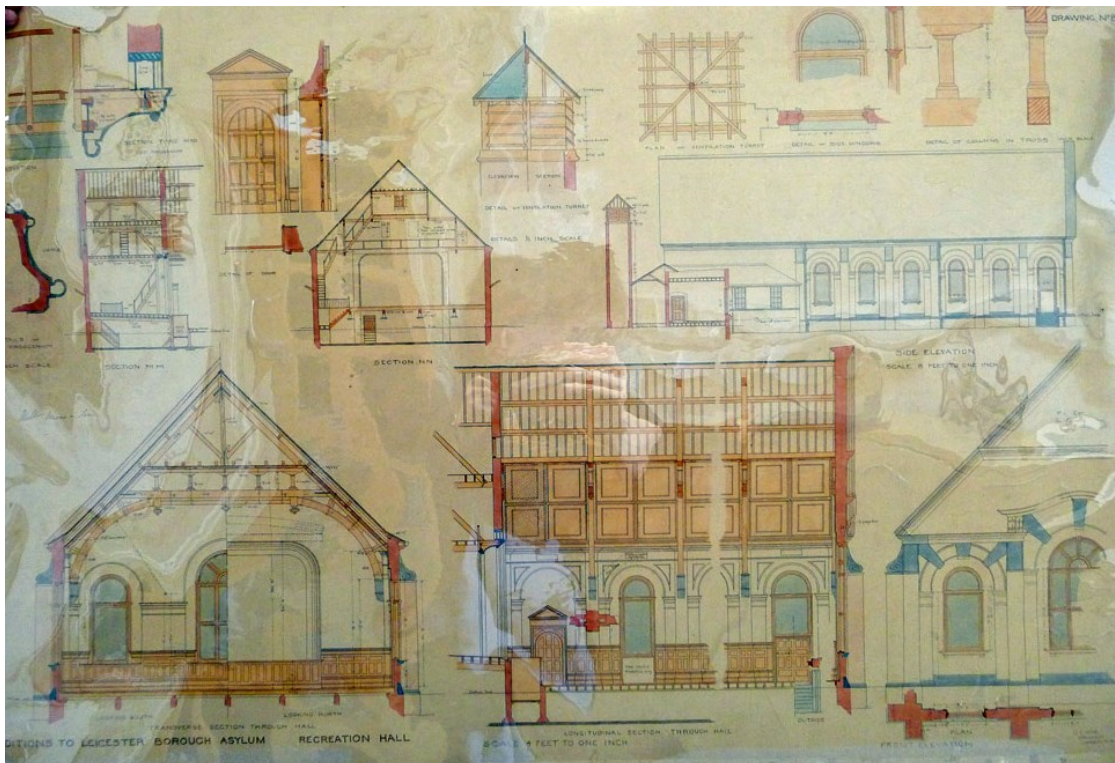
Plan DE5065/2 is a highly detailed and coloured technical drawing for the proposed recreation hall and shows a number of architectural details most of which are still present (Fig. 16).

Figure 16 Elevations and details for proposed recreation hall  
ROLLR reference DE5065/2

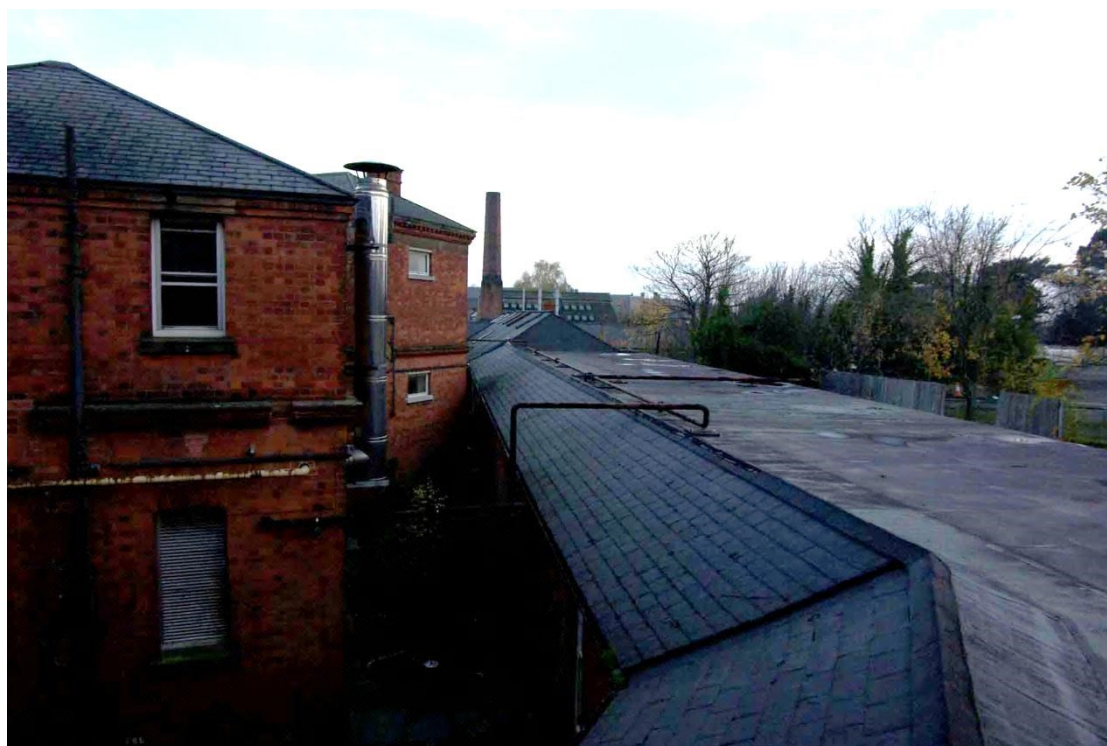
Figure 18 View of corridor roof at eastern end

Looking west. Flat-roofed 1940s extension to right of corridor pitched roof.  
Two-storied toilet blocks attached to Daisy Peake wards on left of picture. Boiler house roof is visible behind chimney

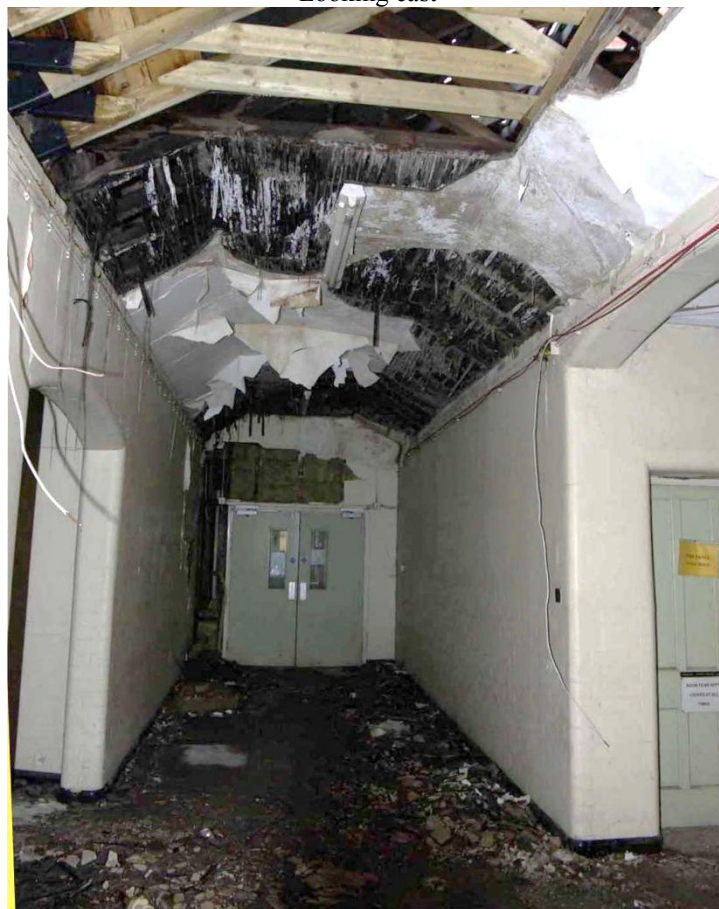
Figure 21 Main corridor to north of recreation hall  
Looking north west. East corridor of food processing area to right of picture

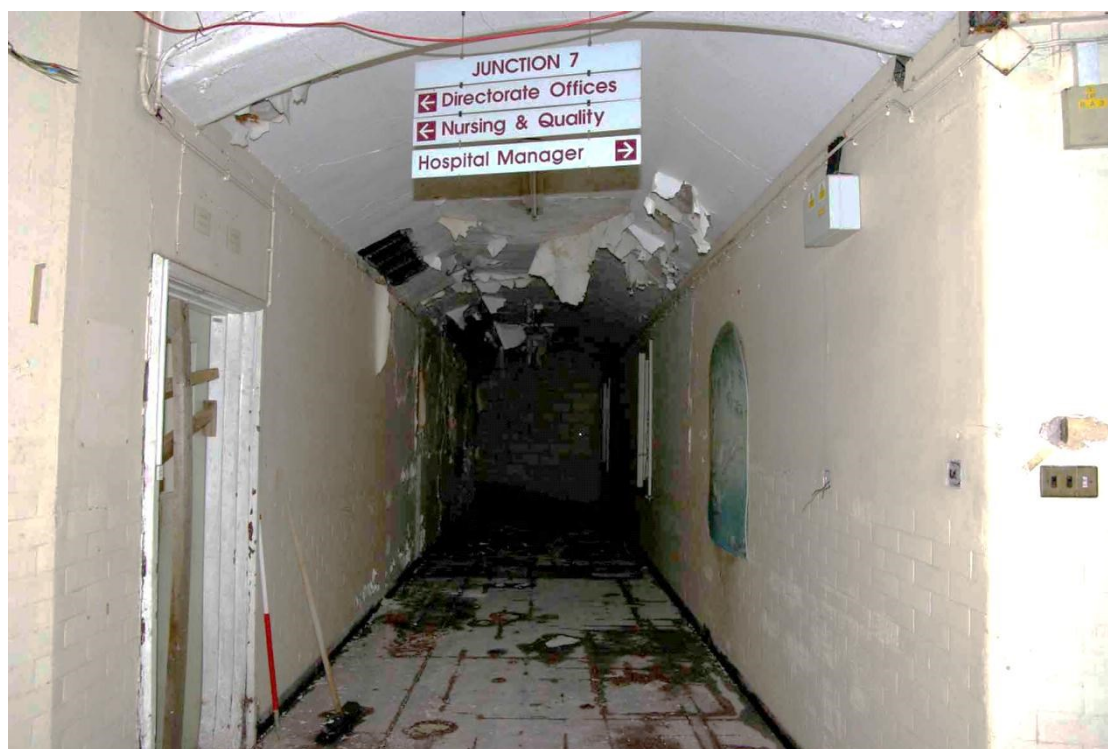
Figure 22 Main corridor at Junction 7

Looking west. Truncated and breeze blocked west end of corridor in centre of picture

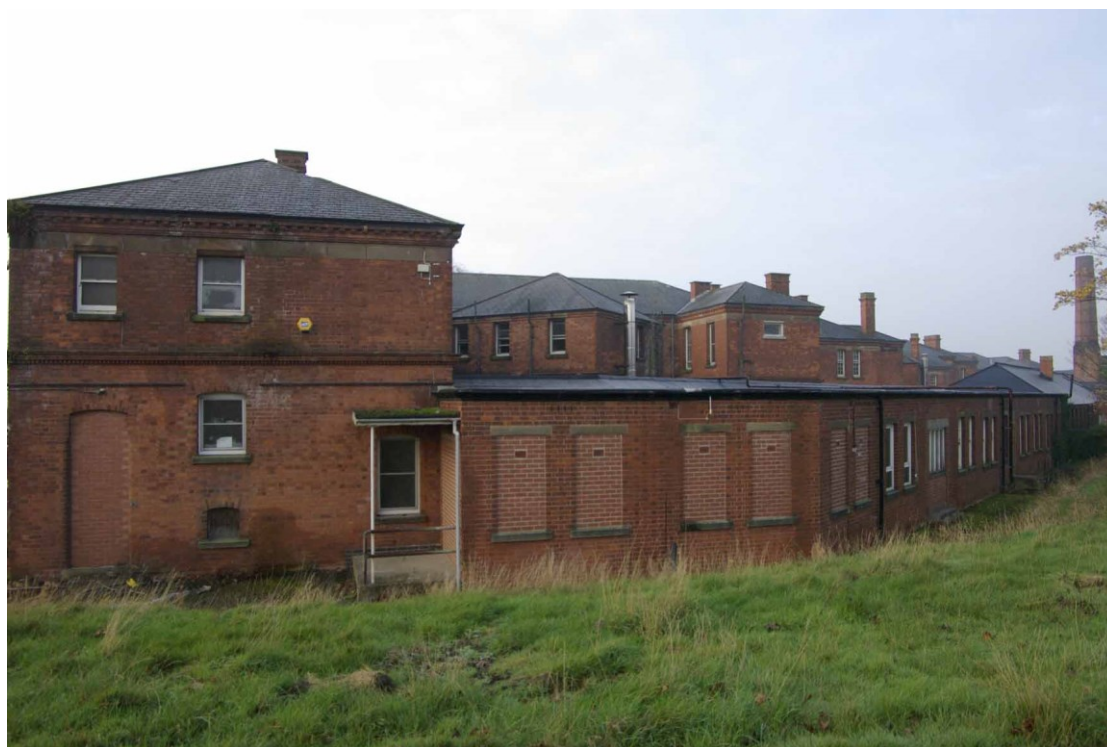
Figure 23 East end of main corridor

Looking south west. Flat-roofed single storey building is the 1940s addition built along the northern wall of the corridor. Daisy Peake wards and toilet block to rear

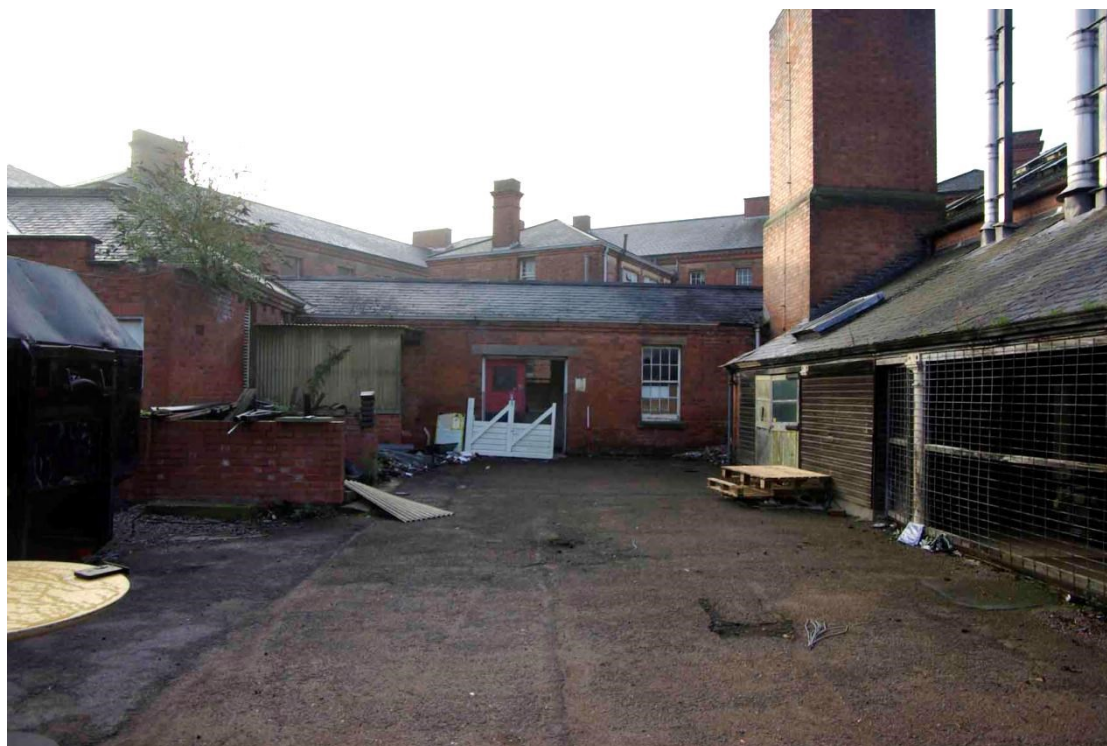
Figure 24 North elevation of main corridor adjacent to boiler house

On the northern side the main corridor is obscured by buildings for most of its length with the exception of a short portion adjacent to the boiler house where a set of double doors and a small sash window can be seen (Figs. 23, and 24). The southern side of the corridor faces out into the oddly shaped courtyards created by the two storey Daisy Peake Building (Figs. 25 to 28). This elevation of the corridor is built of the usual red brick with header/stretcher bond over three courses of blue bricks laid in an English bond for the damp proof course. The wooden-framed sash windows all match each other in style and consist of two sashes holding four by four panes. Many of them have been boarded over on their lower halves but appear to be complete. Each of the internal courtyards is reached by a single panelled door leading from the main corridor. Other doors on the northern side of the Daisy Peake wards also lead out to the courtyard. Four brick-built connecting corridors of similar cross section to the main corridor lead to the Daisy Peake Building. Because of the zig-zag nature of the Daisy Peake Building one of the access corridors runs from the main corridor at an acute angle. To the east of the large entertainment hall the south wall of main corridor has a large multi-paned glass wall and doorway leading out to the south to give access to the front of the Daisy Peake Building. Most of this wall is boarded over but appears to have been an entrance of some importance when first built. To the west of this is a two-storey structure with large and quite spacious offices at ground floor level. Signs on the doors suggest these were for senior nursing staff. These rooms are discussed later as Rooms GF1, 2 and 3. The remainder of the south elevation of the west end of the main corridor is obscured by the recreation hall and another building which was either a small block of offices or nursing accommodation. To the west and beyond this point the corridor has been crudely cut off and blocked with breeze blocks (see Figs. 22 and 29). West of this point the new housing estate road has been built which cuts across the former site. Recent plans of the whole hospital complex show the corridor

Looking south. Boiler house on right, workshops on left

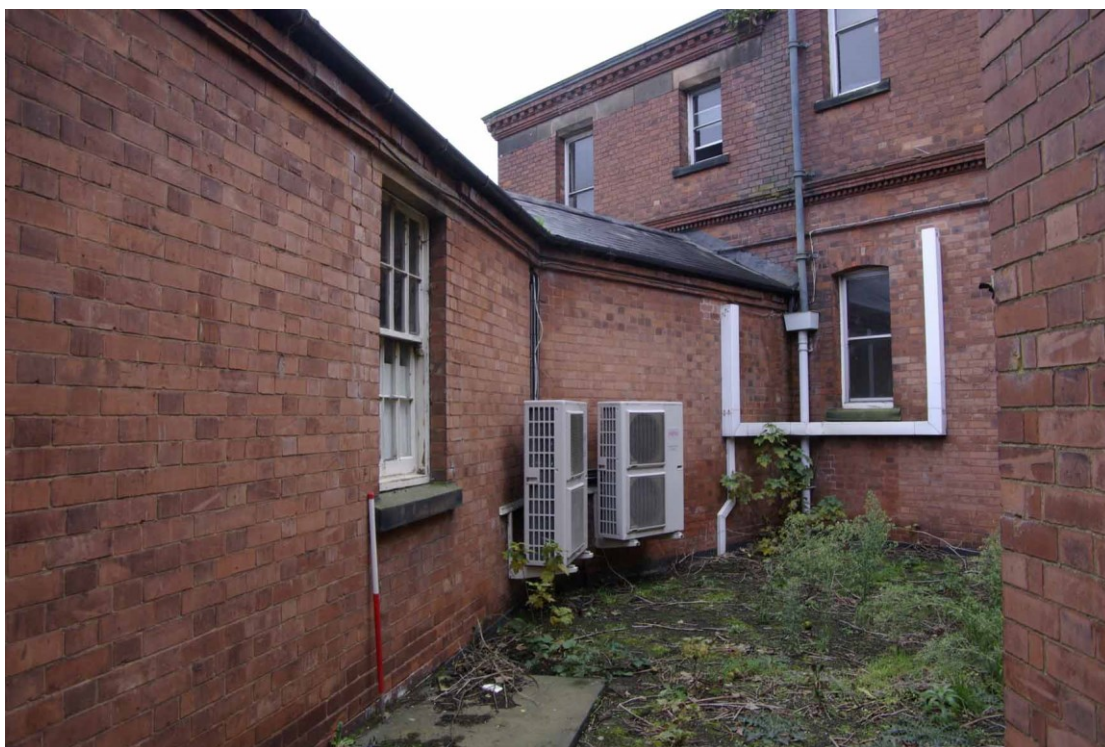
Figure 25 South facing elevation of main corridor at eastern end  
Looking north-east, 1m scale. The two storey building is the east end of the Daisy Peake Building.

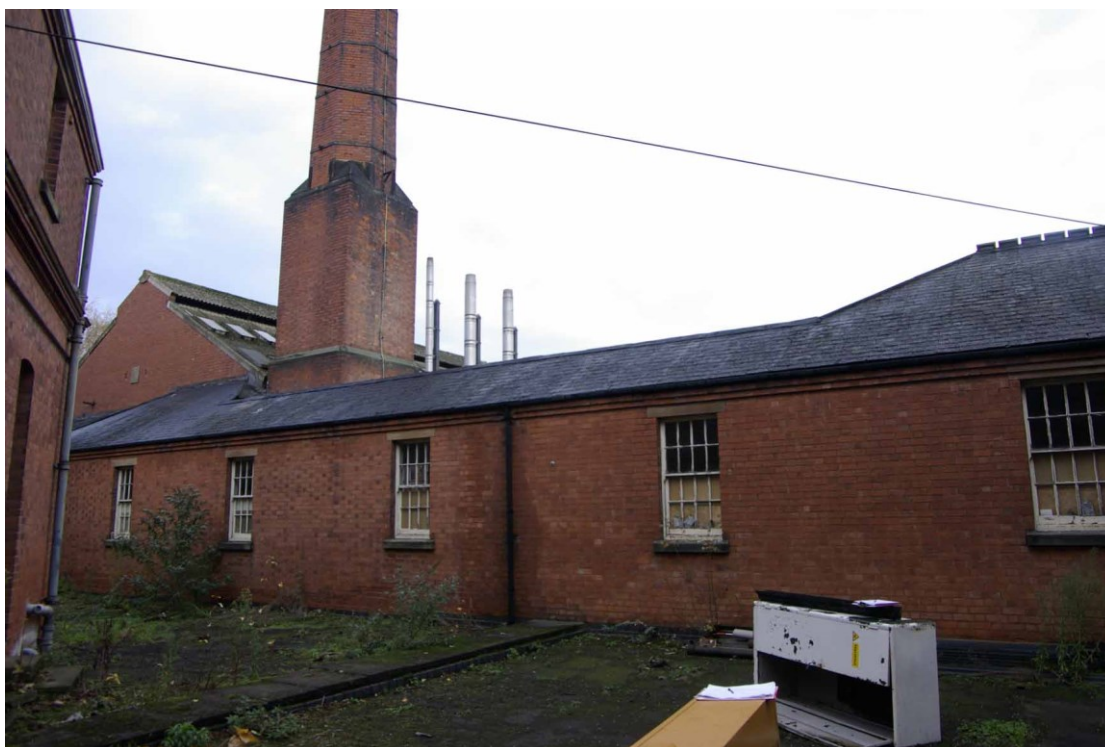
Figure 27 South facing elevation of main corridor east of boiler house  
Looking north-west. Photo taken on opposite side of corridor to Fig. 24

West of the workshops and Rooms GF6 and 7 the main corridor again exists as a separate free-standing corridor before reaching the large boiler house which forms its northern wall (see Figs. 24 and 27). At this point the corridor floor changes from concrete to pink terrazzo with a pale green border. A panelled door on the same style used throughout the main corridor leads into the engineering department and adjacent boiler house (Fig. 38). The boiler house and engineering block are discussed below. On the western side of the boiler house corridor door are two small sets of toilets, presumably reserved for male and female staff. West of the toilet, still on the northern side of the corridor is a large open white-tiled room GF10. This room has a high ceiling with a large lantern roof-light set into the southern side of the pitched roof. When first built the walls had brown glazed tiles to shoulder height and white glazed tiles up to roof height (Figs. 39, 40 and 41). The walls have been covered with plasterboard and a false ceiling added to hide the roof light but much of this has recently been removed. The structural components of the roof match those used in rooms GF6 and 7. Although the western end wall has been removed, and there are no fittings left, this room appears to have been some form of wet wash room or treatment room which would require regular cleaning out. The western wall of GF10 has been removed to create a larger room which now follows the angle of the main corridor which kinks towards the north west at this point. The post 1915 plan is not clear enough to identify what the function of Room GF10 was. On the south side of GF10 is the angled corridor (Junction 6?) junction leading south eastwards to the Daisy Peake Building (Fig. 42).

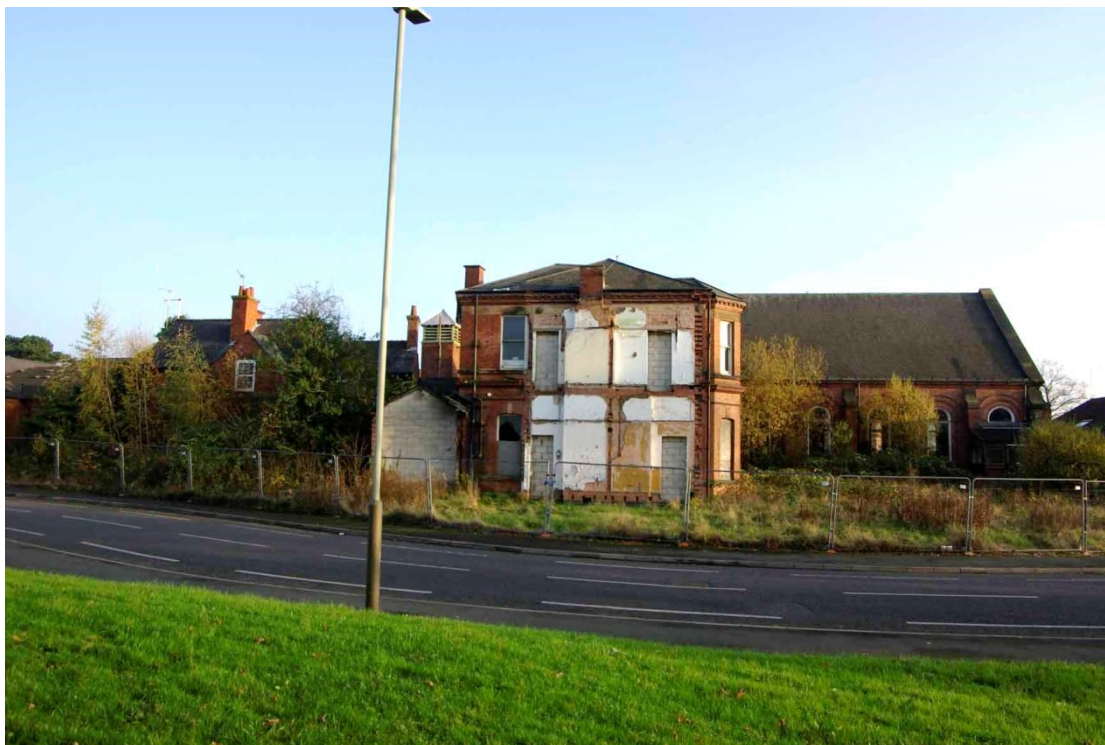
Figure 29 Daisy Peake Buildings seen from the west

Looking west, photograph taken approximately from the site of the 1913 bath house. Truncated and blocked main corridor on right of lamppost (compare with Figure 22). Recreation hall on right

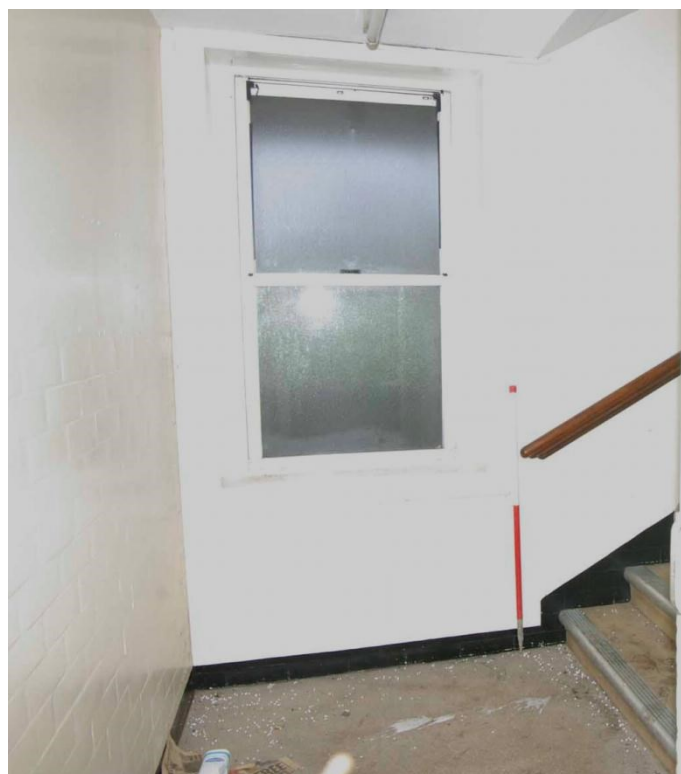
Figure 30 Stairs from east end of main corridor up to Daisy Peake Building  
Looking north, 1m scale. Note painted over wall tiles and modernised sash window

The internal walls of the main corridor, the hall and the stairs are lined with glazed bricks up to shoulder height which have been painted but were once a dark brown. This is one of Hine's trademarks. Painted plaster covers the walls above the glazed bricks. As noted a number of wooden-framed sash windows light the corridor as do flush glazed roof lights set into the southern side of the corridor roof. Very few signs survive along the corridor to show the functions of each area but the individual junction numbers are still present to show that Junction 5 is the small central corridor whilst Junction 6 is the acutely angled corridor.

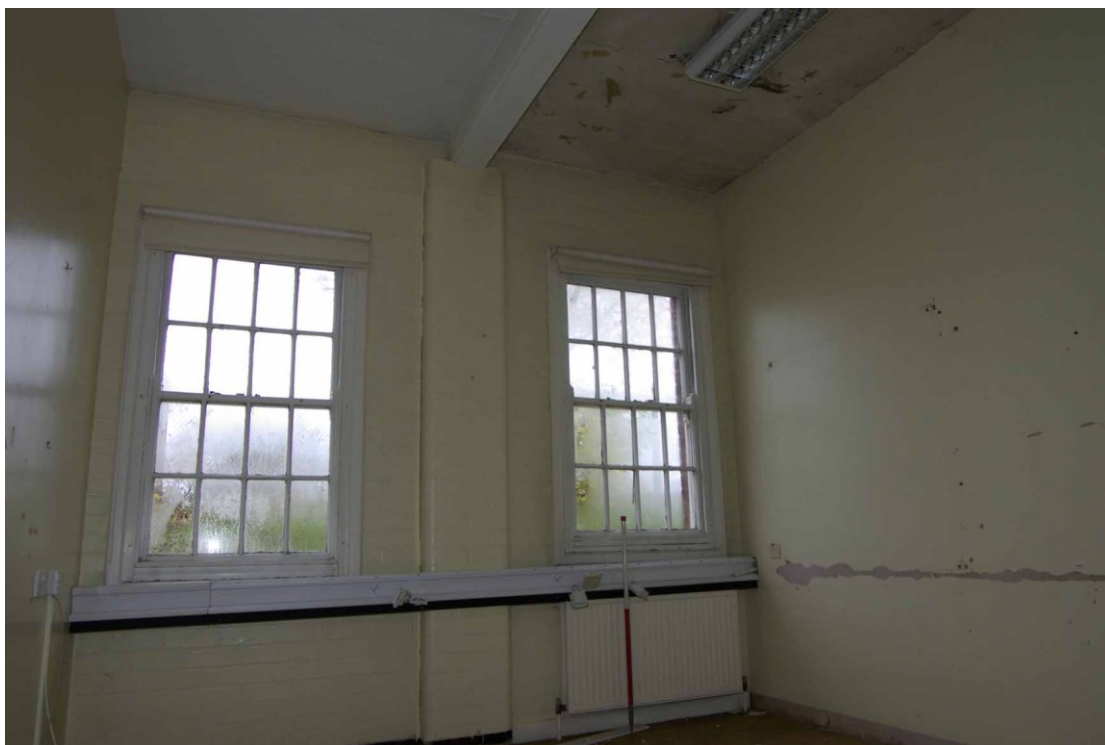
Figure 34 Re-used sash windows in 1940s extension  
Looking north, 1m scale

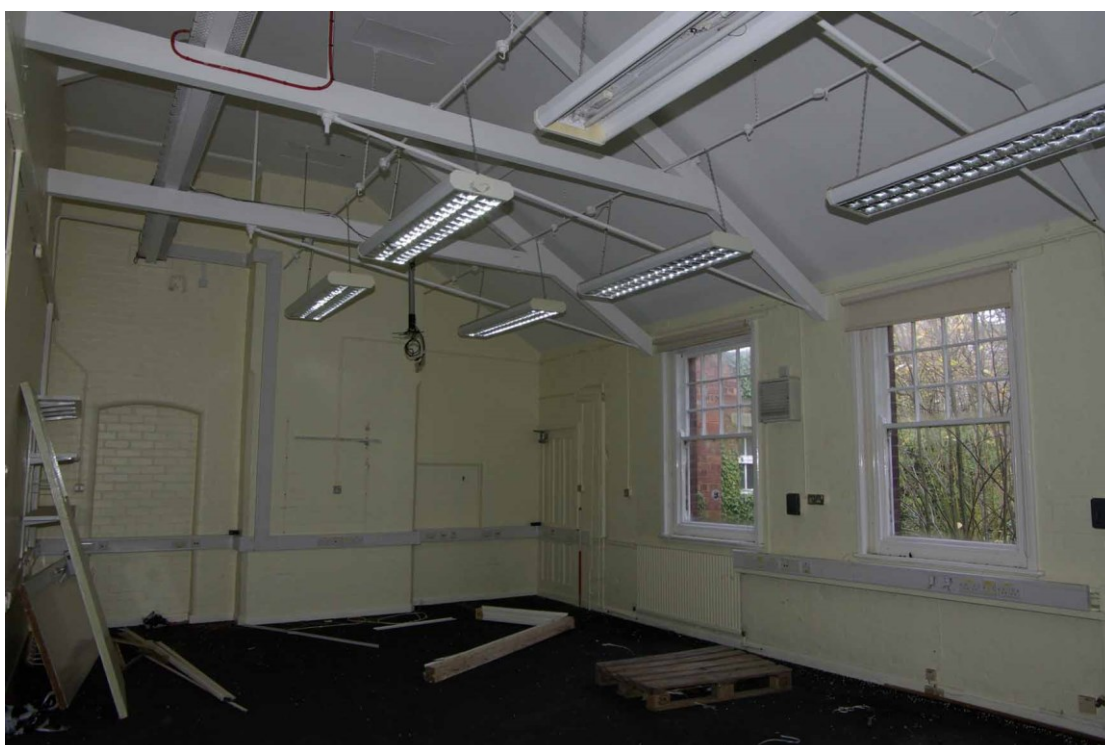
Figure 35 Workshop room GF6  
Looking north-west, 1m scale. Note blocked fireplace and doorway into adjacent workshop

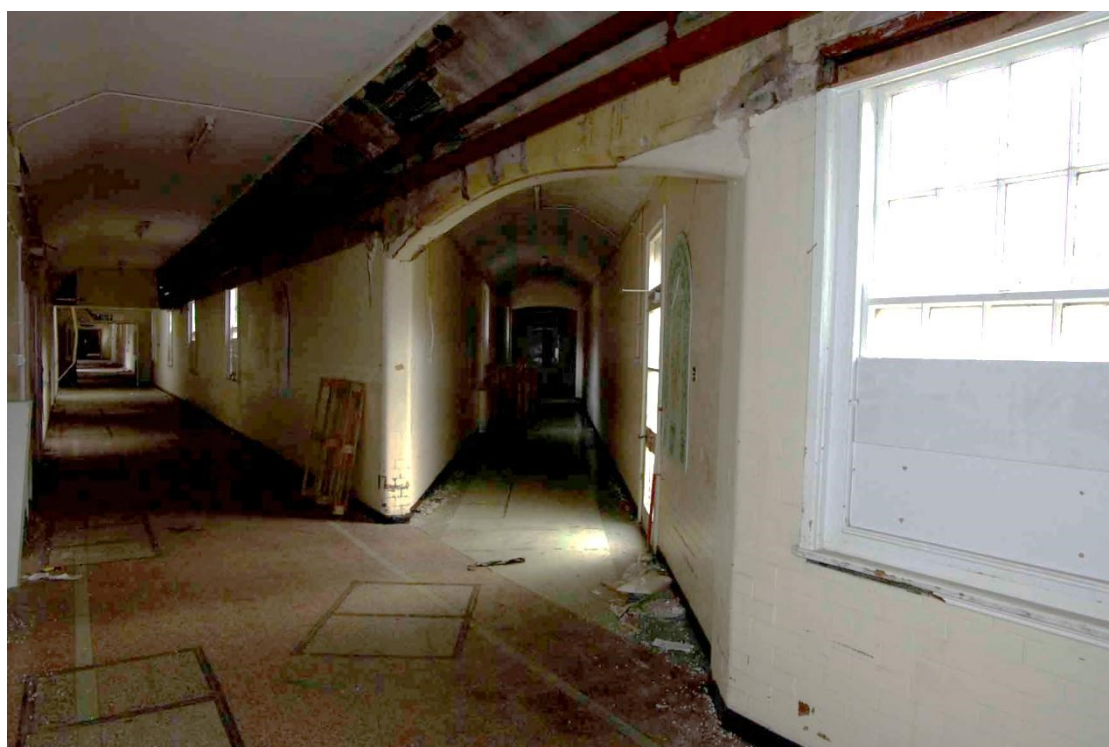
Figure 42 Main corridor and angled junction to the Daisy Peake Building  
Looking south-east. Main corridor on left of picture

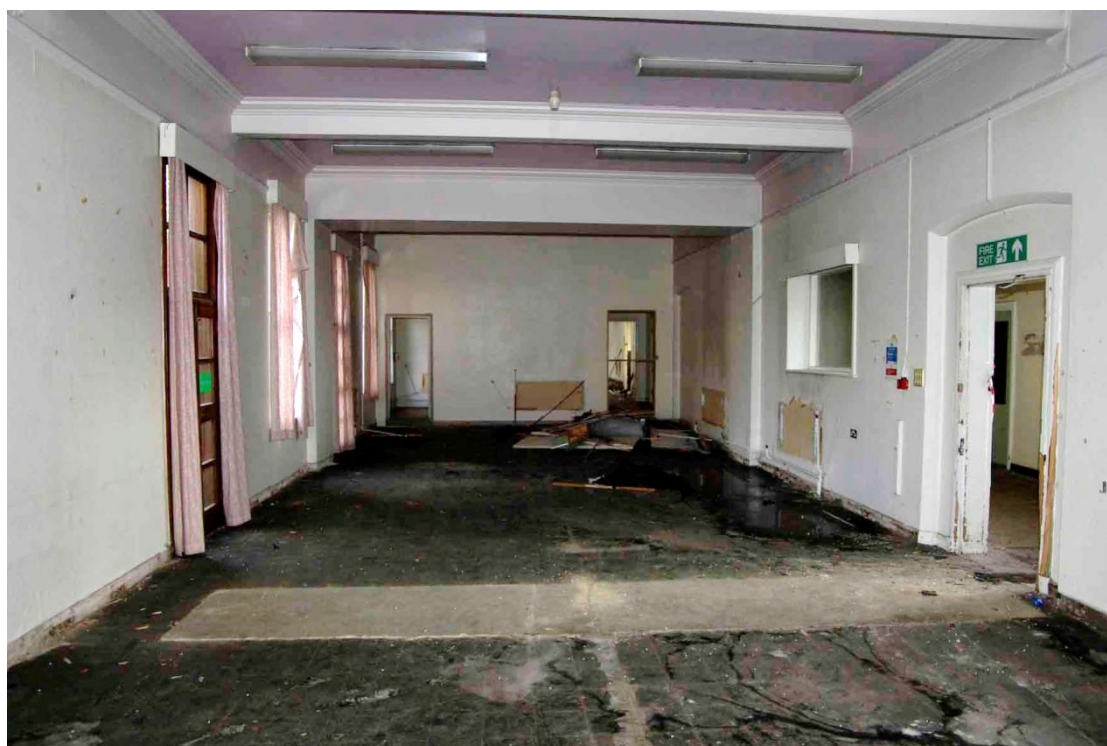
Figure 43 Ward GF12

A larger open ward, GF12, is next along the corridor. This room forms a large open ward looking out into a landscaped courtyard (Fig. 43). The ward has a double-width doorway onto the main corridor. One of the southern windows on the corridor side has been widened and clear glass inserted, possibly to allow observation into the ward rather than needing to enter it. A modified window made into a doorway near to the north west corner leads into a modern glass and timber coffee lounge/conservatory. A second door in the corner of GF12 leads up a step into the staff cafeteria GF14. Both are discussed below. Instead of the multi-paned sash windows seen so far this ward has two sashes consisting of single panes which allow more light in and give a less institutional feel to the room (Fig. 44). The ceiling has north to south masonry beams with moulded plaster coving in between each beam. The east end of the ward has been partitioned off to create a small entranceway into the ward from room GF10 with an adjacent small room with a lowered ceiling (GF11). At the western end of the ward is a small light well in the form of a small open yard with no door access. This is one of a number of such features in this area of the complex where the large number of clustered buildings seriously affect the amount of natural light available. An inserted washroom, GF13, lies to the north of the small light well.

Looking south-east. Note far wall has been inserted to create a small end room. Main corridor on right of photo

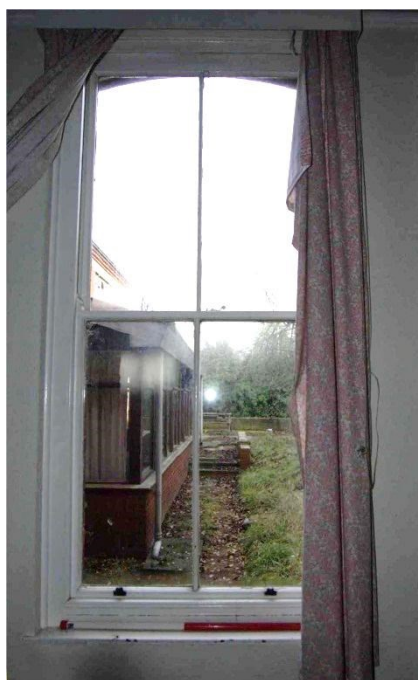
Figure 44 Ward GF 12 north east facing sash window  
Looking north east, 1m scale. Modern coffee lounge is visible in the courtyard

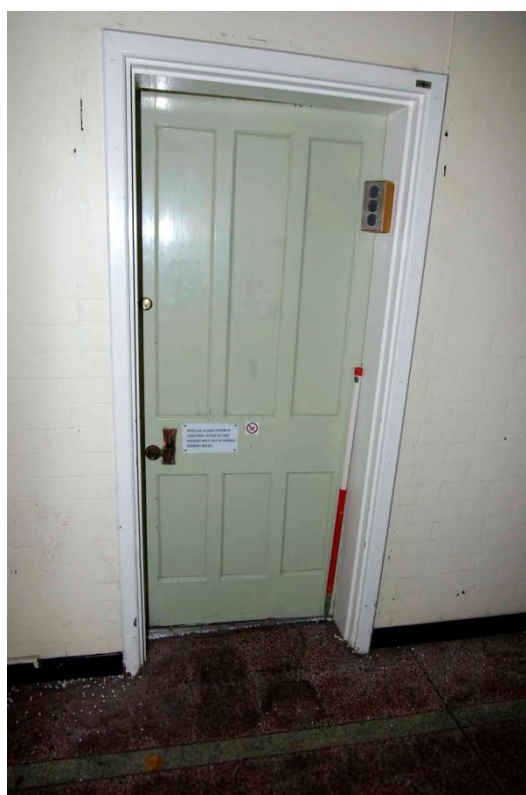
Figure 47 Doorway to Room GF1, Director of Nursing's room  
Looking south-west, 1m scale

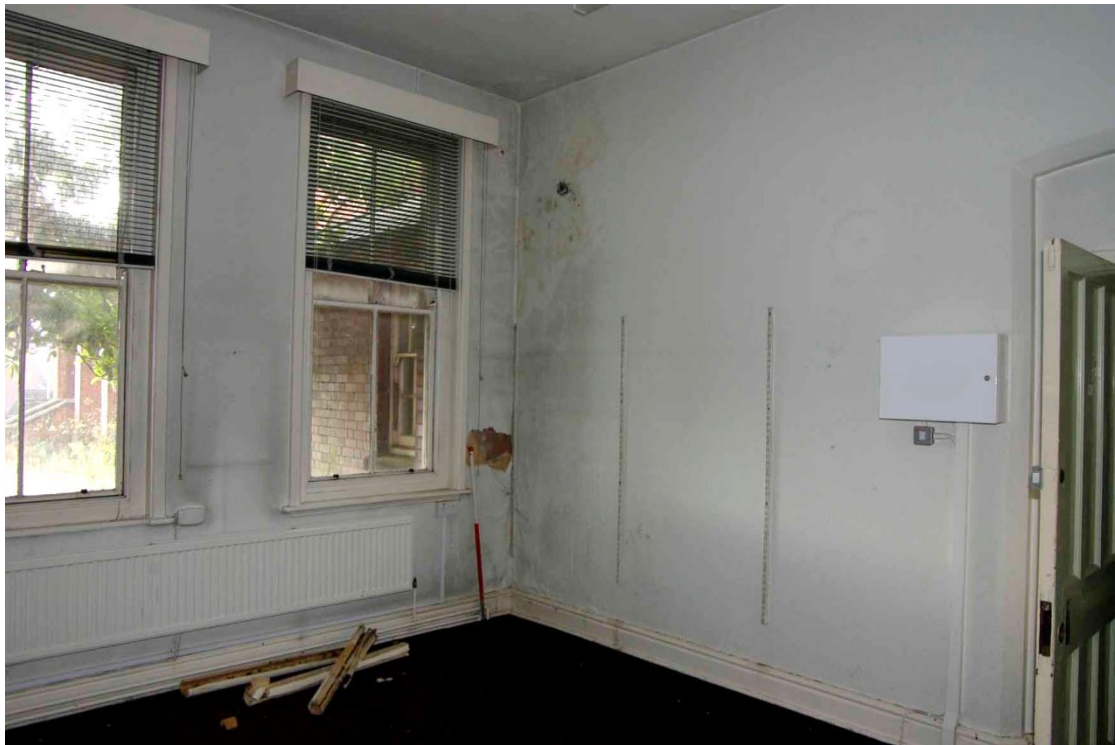
On the west side of the stairs is a single room, GF3, with doors to the stairs and a short corridor leading to the entertainment hall (Fig. 51). This room has a similar skirting board and windows to GF1 and 2 but does not have a picture rail or fireplace. Beyond GF3, to the west, is a short corridor heading towards the south west which runs along the first part of the east side of the recreation hall. The corridor has a doorway to the outside and also two doors going into the hall. One of the doors allows access to the backstage area whilst the other leads into the main hall. The hall is discussed in more detail below. A similar short corridor western runs down the western side of the hall and has access to the sides of the stage and hall. As with GF3 a door leads into the side of another two storey range. This range has two bay windows facing southwards over the hospital grounds. At the time of the survey all of the floors had been removed creating a dangerous environment and the doors sealed shut preventing any form of survey other than that shown in Figure 52. It is probable that these rooms were first built as accommodation for senior staff.

Figure 51 Room GF3  
Looking south-west, 1m scale. Note east elevation of entertainment hall seen through window

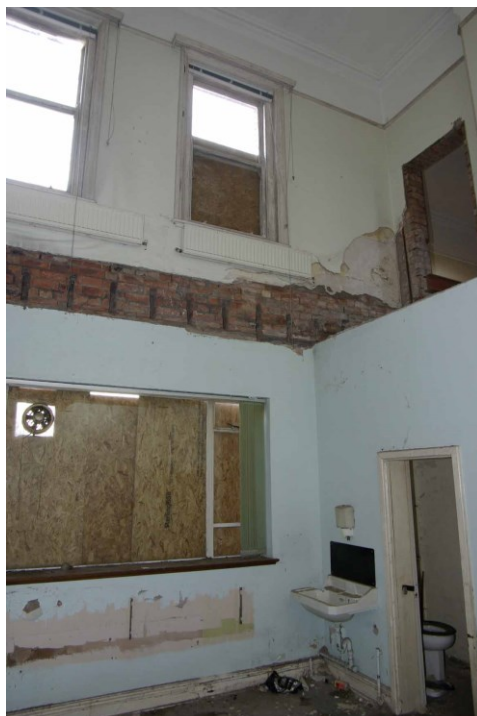
Figure 52 Room GF4 ground and first floors  
Looking south-west through hole in sealed doorway

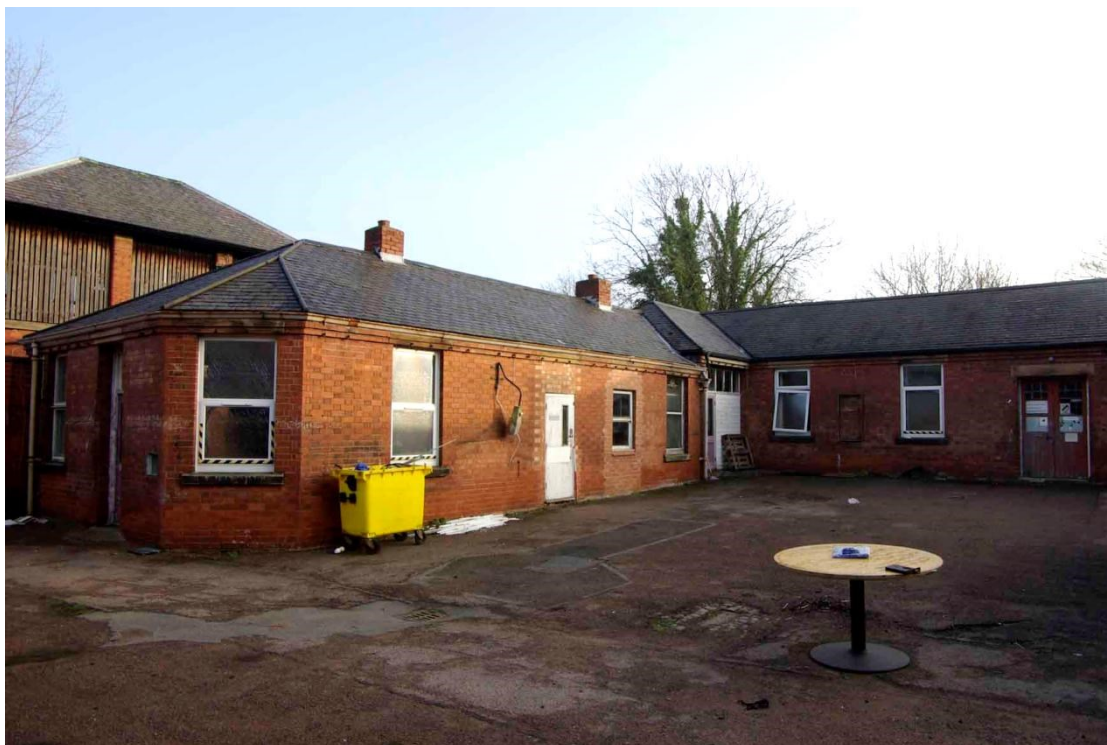
Figure 54 Workshop WS2 and 3  
Looking north-east. Photo taken facing away from boiler house

Workshop WS3 consists of two elements built to accommodate a slight drop down to the west in the ground level (see Fig. 54). The eastern component shares the same roof structure with WS2 although it does not have any tie beams and a modern false ceiling has been inserted (Fig. 60). The south wall of this part contains a single doorway with the rest being part glazed and part wooden boards. The choice of boarding rather than masonry is not clear. The wooden floor is at the same height as WS2 but steps down into the western component of the building. The western component has a lower roof with a simple purlin and rafter structure with small tie-beams rather than full width ones. The principal rafters are joined using metal shoes as often seen in industrial buildings of a similar date (Fig 61). The extreme western end of WS3 has a single thickness brick wall to create two smaller rooms with a central fireplace. The south west corner of the building has been cut off to create an angle which probably assisted vehicles negotiating the turn into and out of the yard.

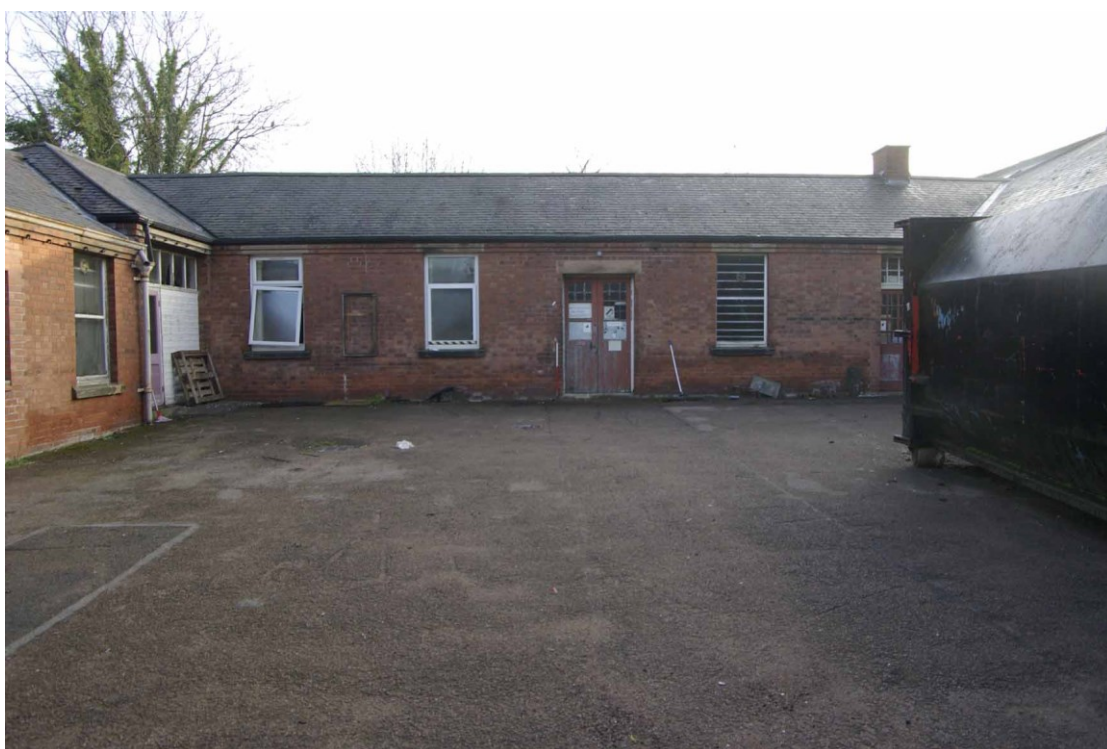
Figure 55 Workshop WS2 west facing elevation  
Looking east, 1m scale. WS1 on right, WS3 on left

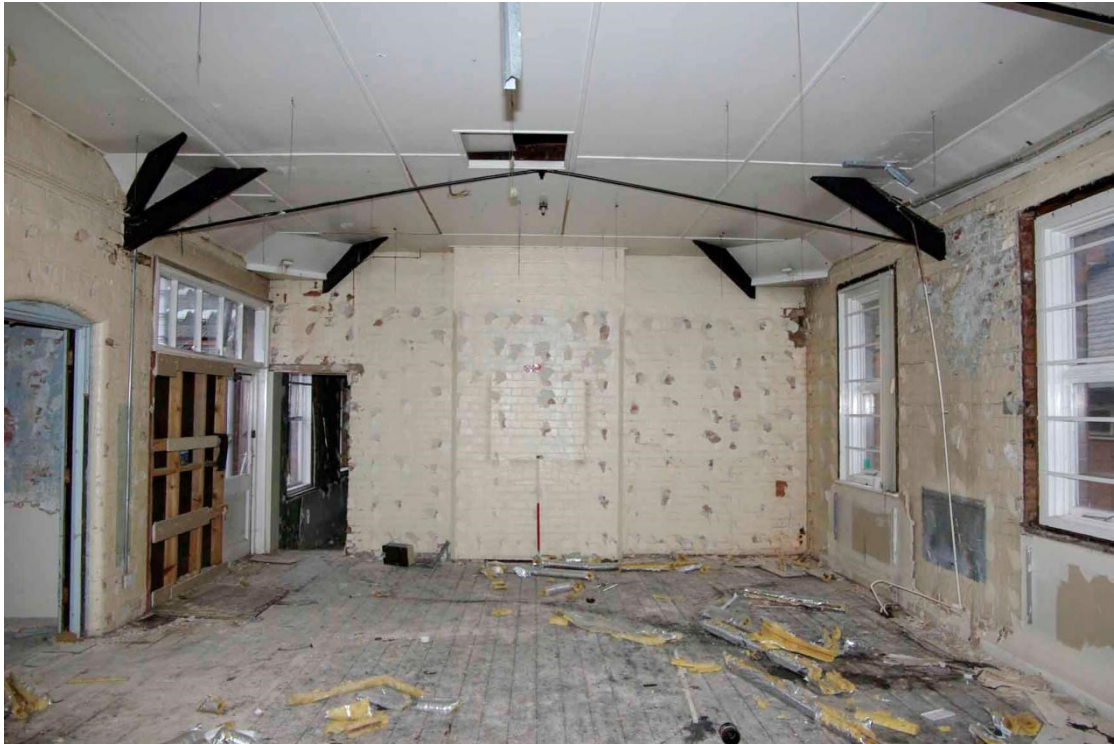
Figure 60 East end of workshop WS3  
Looking west, 1m scale. Doorway to western part of WS3 to left of chimney breast

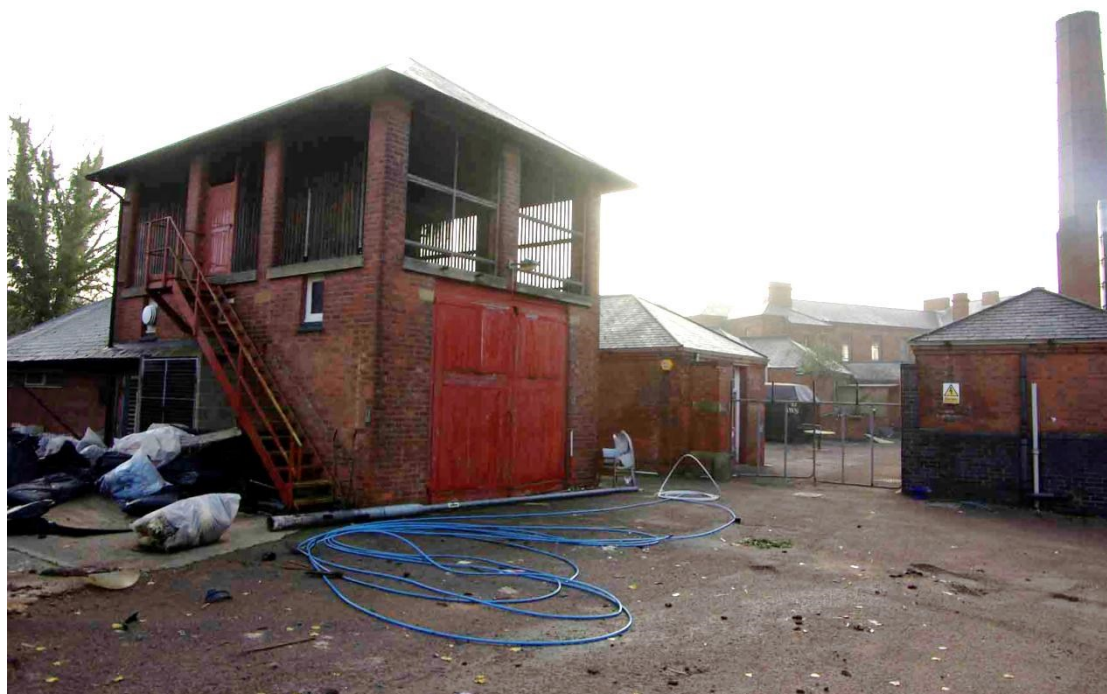
North of the workshops WS1 to 3 is a two storey free-standing structure identified as the timber and engineering stores on the 1989 plan. The building is of red brick with brick piers on the first floor holding up the slate covered roof (Fig. 62). The first floor has an external metal staircase leading to an open slatted timber seasoning store. At

ground floor level the west facing elevation has a large set of double doors suggesting that this was first built as some type of vehicle or carriage store. Two doors on the south side lead into the two halves of the building. The central dividing wall is a modern feature and is made of breeze-blocks. The western half has a vehicle inspection pit running across the floor but appears to have been most recently used to store spare engineering and electrical parts (Fig. 63). The eastern half of this building houses a large generator. Butting up against the eastern end of WS4 is a single storey open office (Fig. 64). The walls are made from modern red brick laid in a stretcher bond (Fig. 65). The roof is of slate. This appears to have been either a common room or possible seminar or teaching room. Inside it can be seen that the room was originally built as an open space supported on cast iron columns. The roof structure is similar to those found in late 19th century agricultural buildings and uses metal stirrups to join the king post and raking struts to the purlins and truss.

Figure 62 WS4 engineering and timber store  
Looking south-east, 1m scale. Workshop and boiler house yard through gate

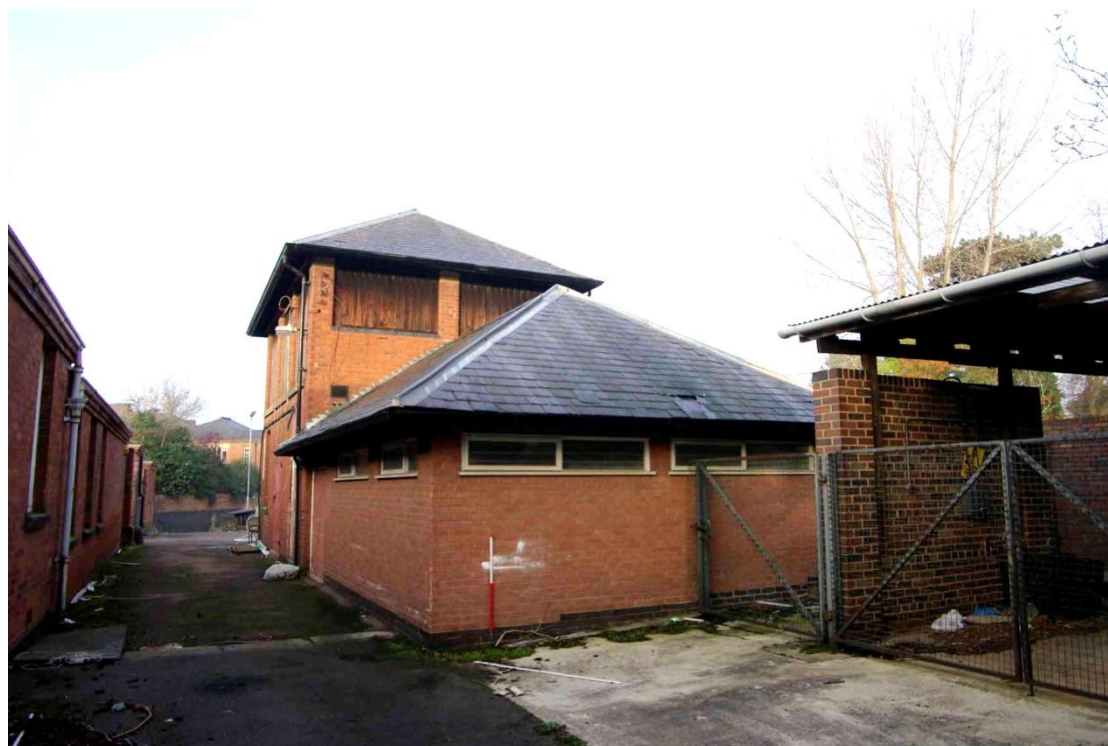
Figure 64 Single storey building attached to eastern side of WS4  
Looking north-west, 1m scale. Workshop WS3 on left of photo

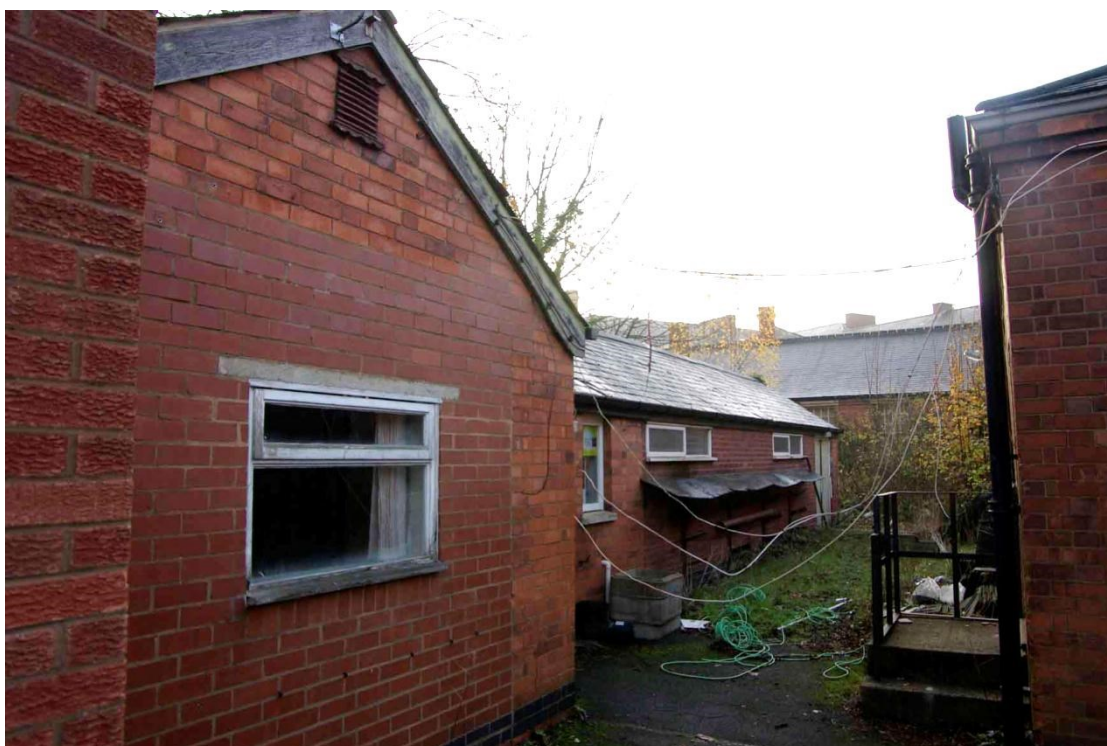
To the east behind the workshops is a long rectangular single storey building (WS5). This building first appears on the 1953 Ordnance Survey map and is built of red brick with a slate roof (Fig. 66). The northern end of the building forms an east to west gable end and has a large entrance blocked with later brick suggesting a blocked garage type doorway. The gable has a decorative vent made from earthenware tiles. To the south of this the building forms a long narrow structure which shows evidence of being built as an open fronted building which has been blocked with later brickwork. Internally the building has been stripped of all fixtures and fittings leaving only a single large room along with a small kitchen area and two small store rooms (Fig. 67).

Figure 66 Workshop WS5  
Looking south-east. Workshop WS3 on right of photo

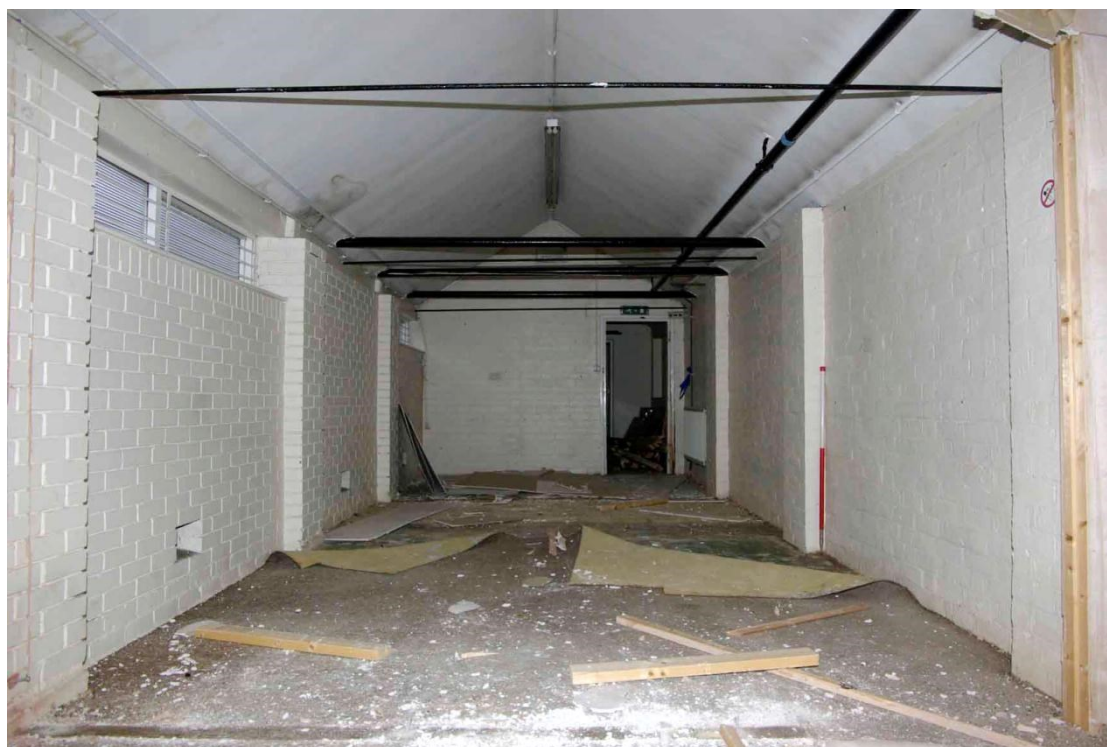
Figure 67 Workshop WS5  
Looking north, 1m scale
