**A Level 2 and 3 Historic Building  
Survey at the former Towers Hospital,  
Gipsy Lane,  
Leicester.**

**NGR: SK 618 060**

ULAS Report No. 2014-204  
©2015

**For: KRT Associates**

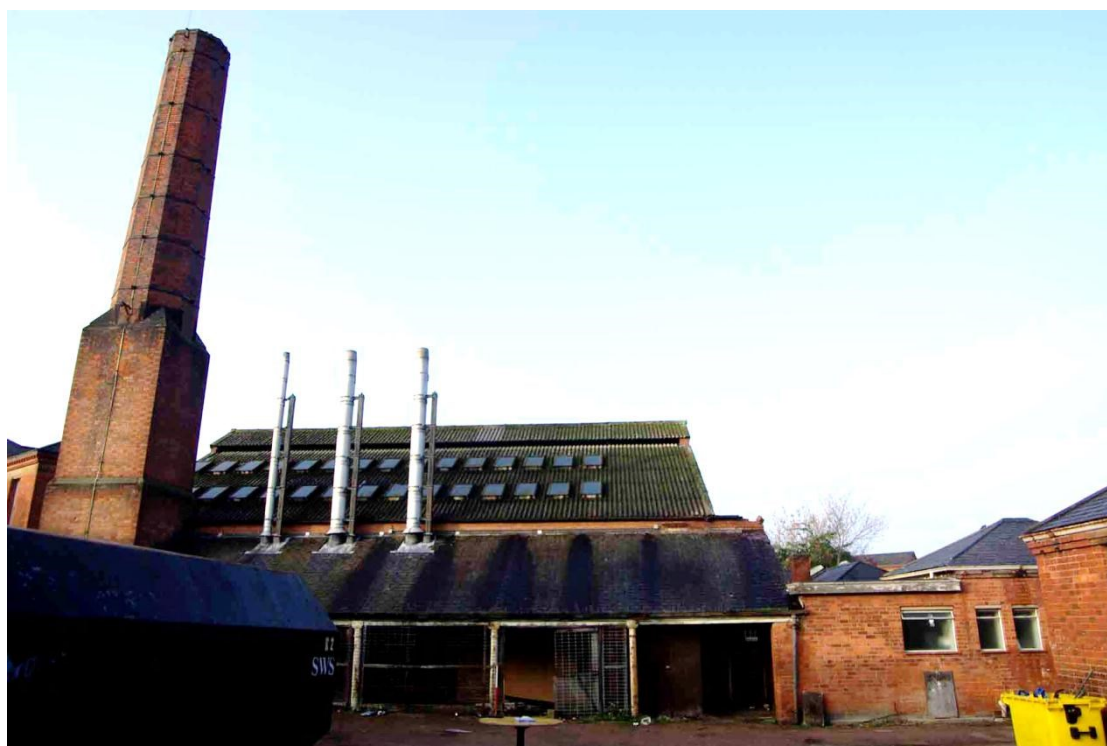
Figure 68 Boiler house east facing elevation  
Looking west, 1m scale. Washroom to right of lean-to. WS3 on extreme right of picture.

Built against the eastern elevation of the boiler house is a slate-roofed lean-to structure which is supported by cast iron columns (Fig. 68). Blocked openings on the east wall of the boiler house suggest that this lean-to was once part of the boiler house. To the north of the lean-to is a brick built toilet and washroom block built from red brick and slate (Fig. 71). The washroom has been repaired on its eastern side but

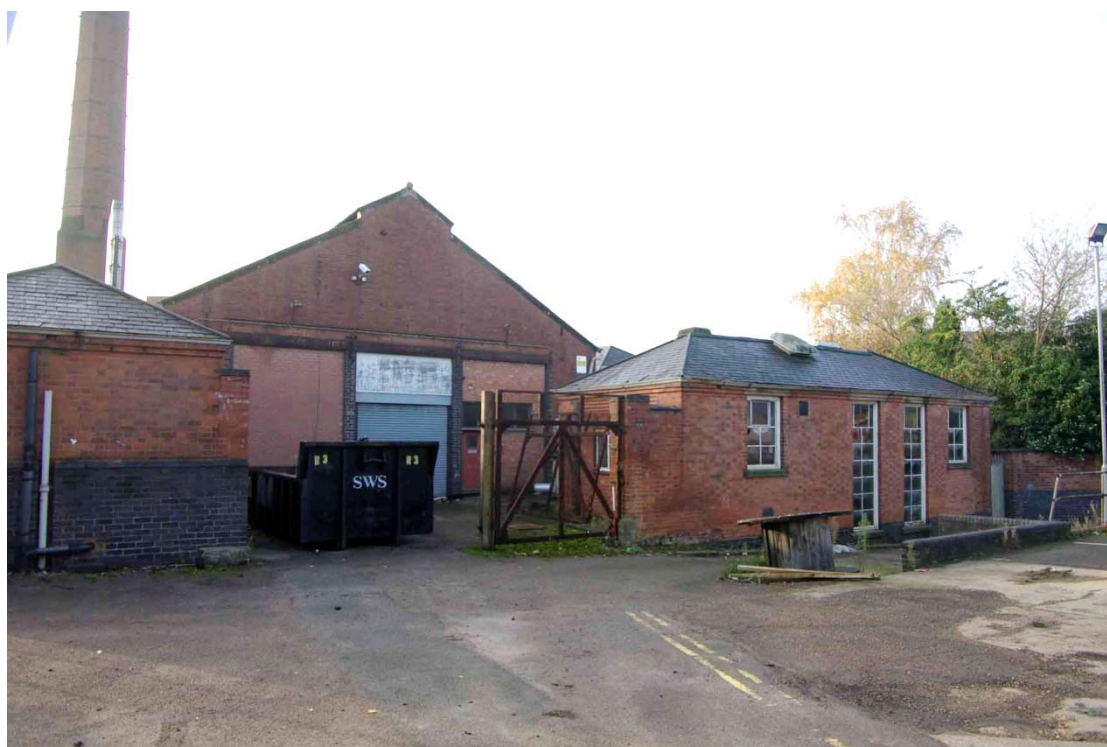
this appears to have been due to damage rather than an alteration. Inside the room has been completely covered in modern white tiles which obscure any earlier details.

Figure 69 Boiler house north facing elevation  
Looking south-west, 1m scale. Note north wall of washroom on left of picture

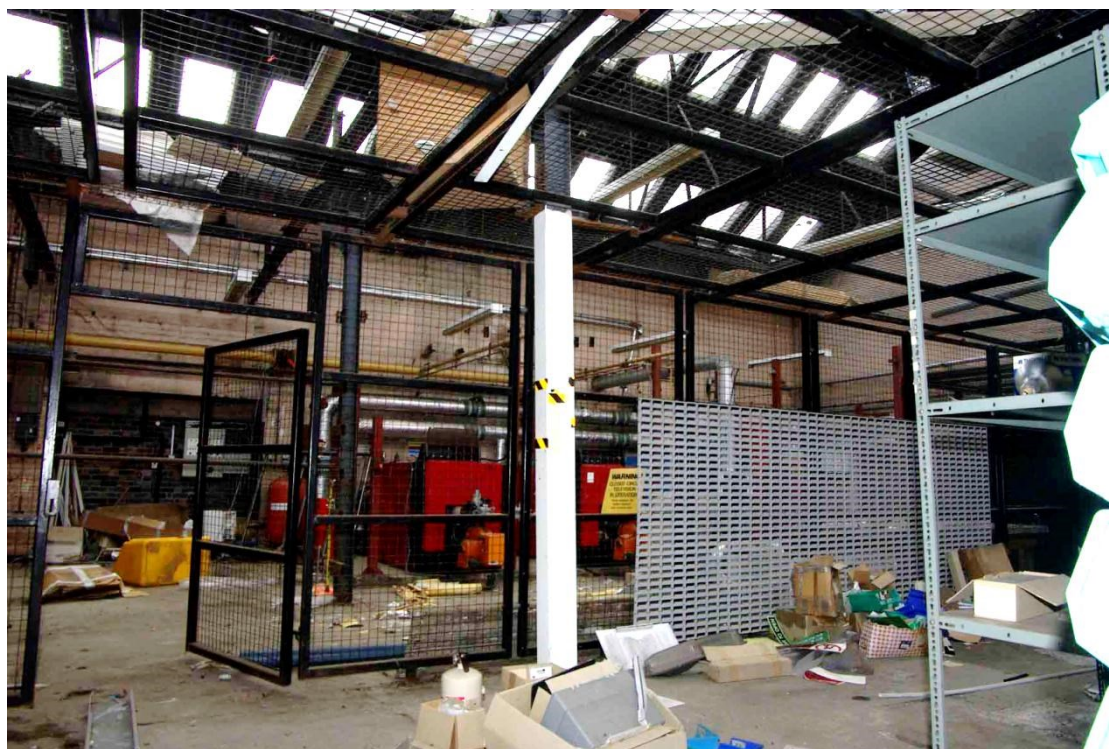
Figure 70 Boiler house interior  
Looking south-east

Inside, the boiler house contains modern replacement gas fired boilers which are considerably smaller than the originals hence the large amount of open space (Fig. 70). Even the 1972 Ordnance Survey map shows a coal yard behind the boiler house suggesting that coal fired boilers were still in use at this time. A warning sign of asbestos risk prevented a detailed survey but it could be seen that the roof structure was supported by fan trusses of angle steel. A flight of stairs in the northwest corner of the boiler house room leads down to a flooded basement below the engineering buildings.

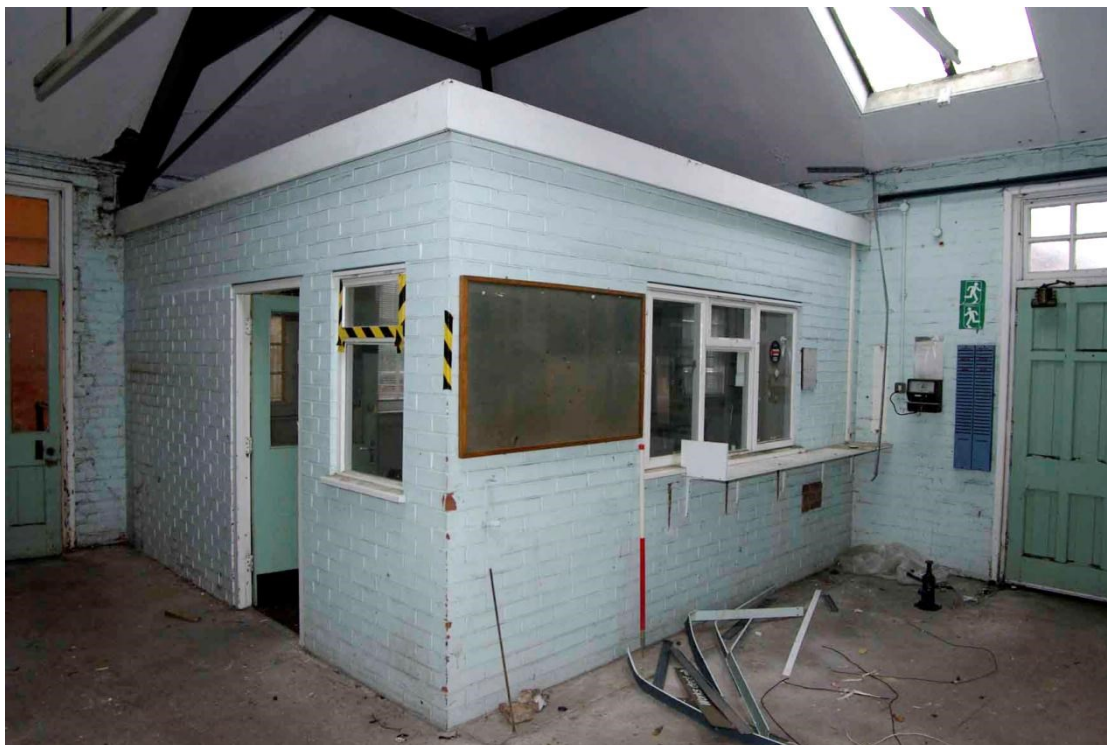
Figure 73 Inserted office at north end of engineering workshop  
Looking north-west, 1m scale. Door to accumulator room on left

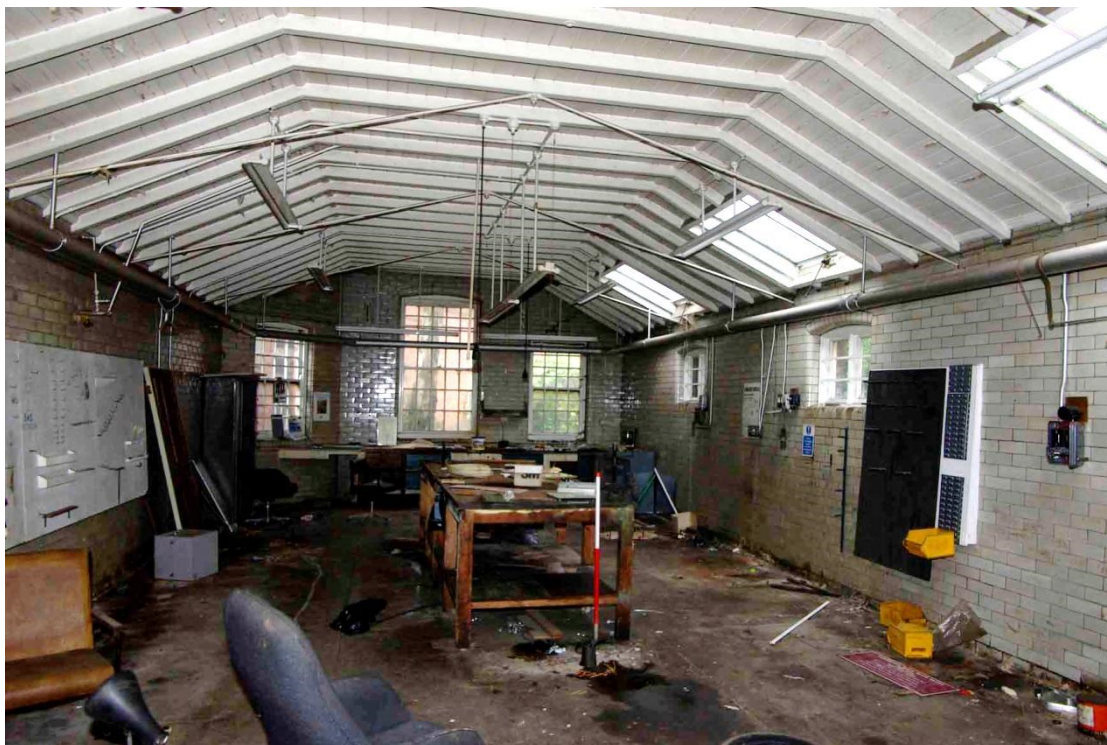
Figure 75 Accumulator room GF9  
Looking west, 1m scale. Note angled corner in south west corner

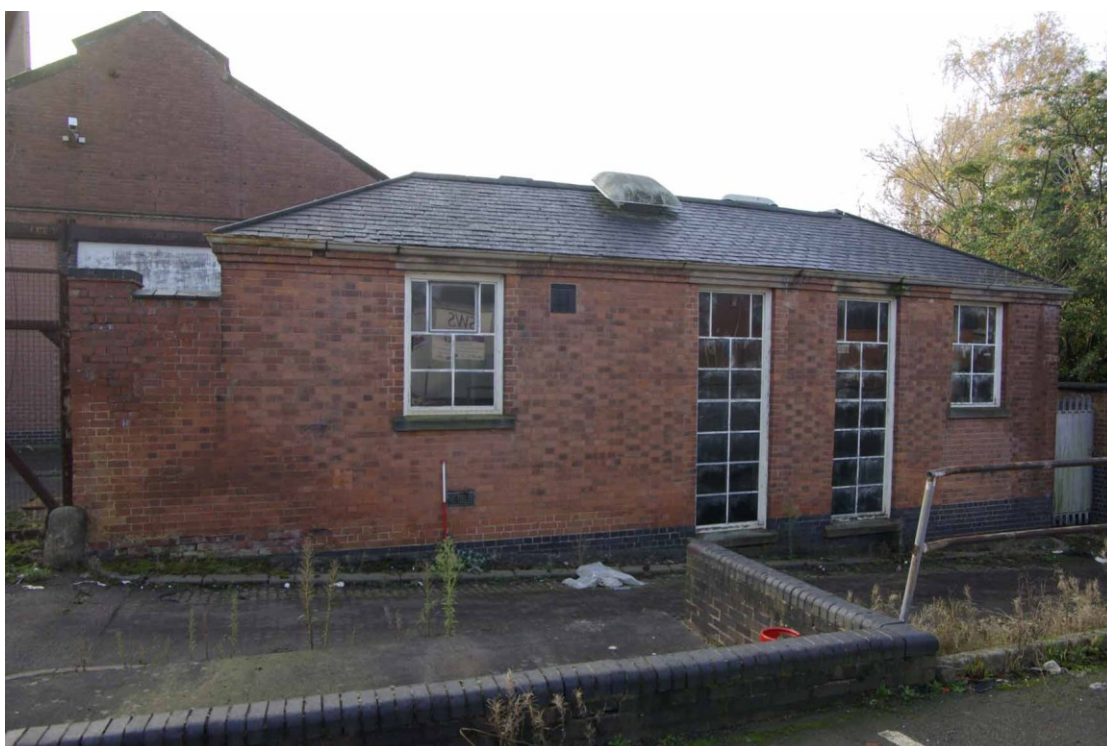
Figure 76 Building (pump room?) at north end of engineering workshop  
Looking south, 1m scale

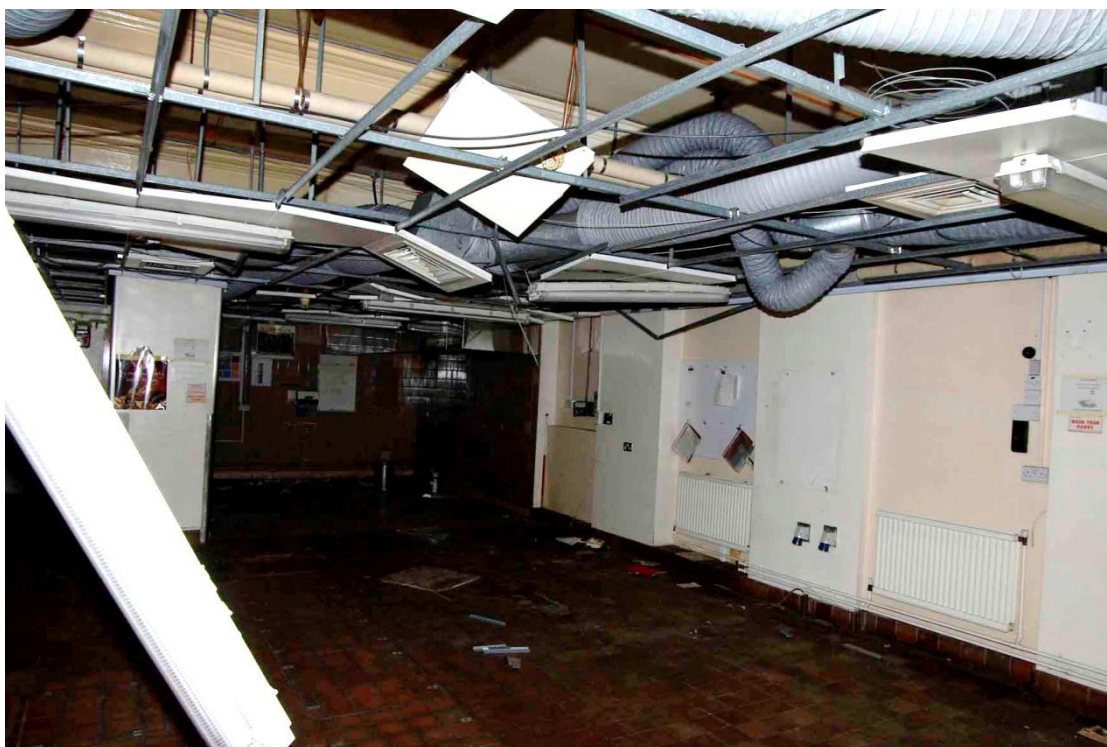
**Figure 78 Staff cafeteria**  
Looking north-east, 1m scale. Note moulded beams above false ceiling

Much of the eastern side of this corridor is taken up with the staff cafeteria (Fig. 78). The cafeteria has no natural light with evidence at least three windows having been blocked on each side. A false ceiling has also been added to hide the slightly higher ceiling which has moulded plaster detailing on each of the beams. The decoration is the same as that seen in nearby ward GF12. There is a blocked fireplace at the southern end of the room. A menu entitled *Towers Hospital Catering Services buffet menu 1998/99* was found among the debris of the collapsed false ceiling which shows that the hospital had a dedicated catering service even as late as 1999. A new addition of a timber and glass conservatory, which is not shown until the publication of the 1991 OS map, has been built against the east wall of the cafeteria (Figs. 79 and 80). Access to the conservatory is either from ward GF 12 or from a large coffee lounge (GF15) to the north. Coffee lounge GF15 is a large open room with a staircase and a wraparound balcony leading up to the first floor of the Daisy Peake range (Fig. 81). The patio doors are 1940s or 1950s style metal Crittall windows as are the first floor balcony windows. A knocked-through doorway at the north end of the room leads to a raised area which in turn leads back out to the George Hine corridor.

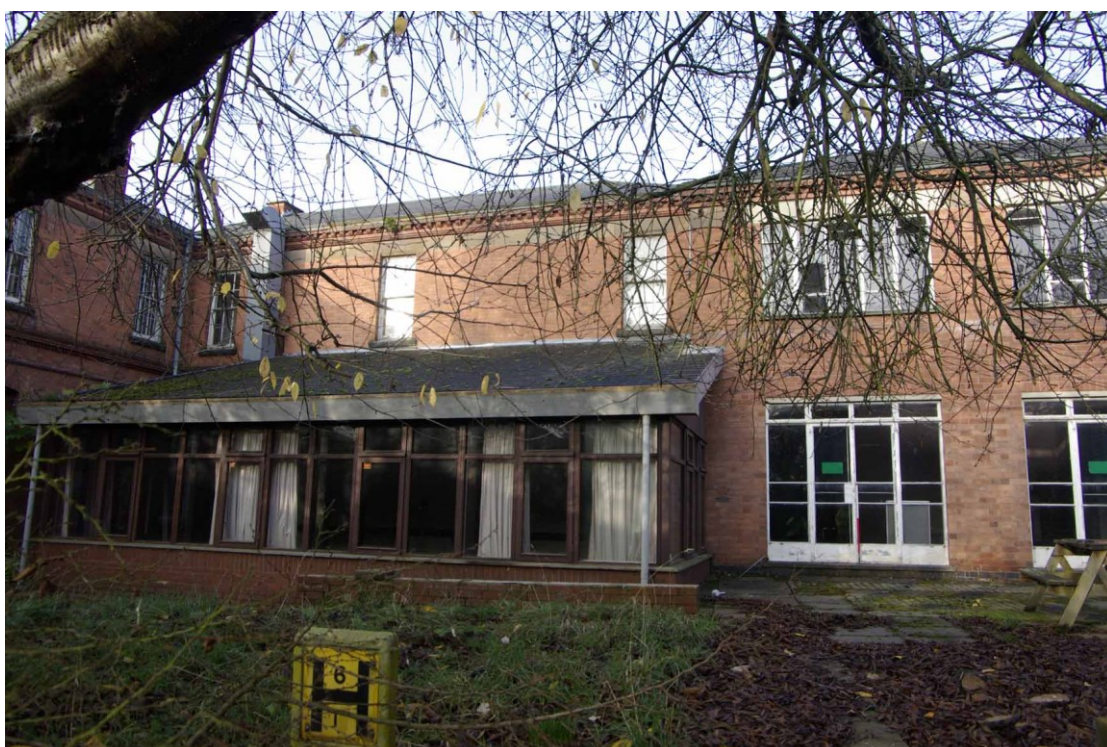
**Figure 79 Staff conservatory**  
Looking south-west. Metal windows of coffee lounge on right

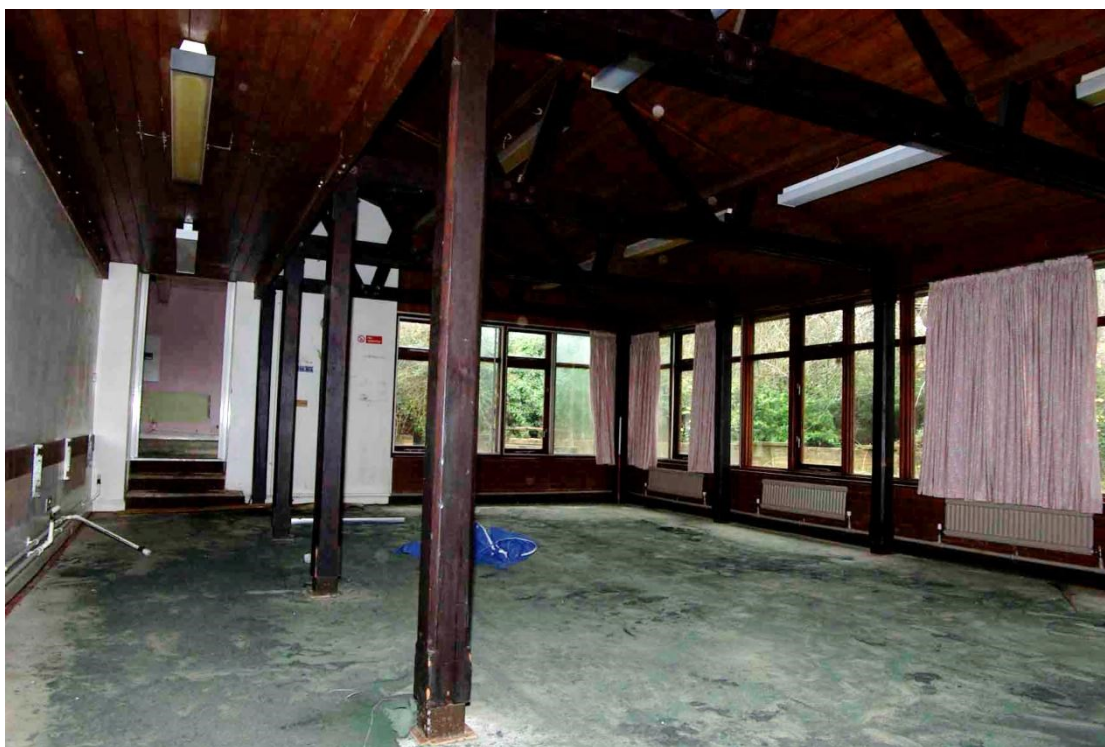
Figure 80 Modern conservatory  
Looking north-east. Doorway to coffee lounge up steps on left of picture

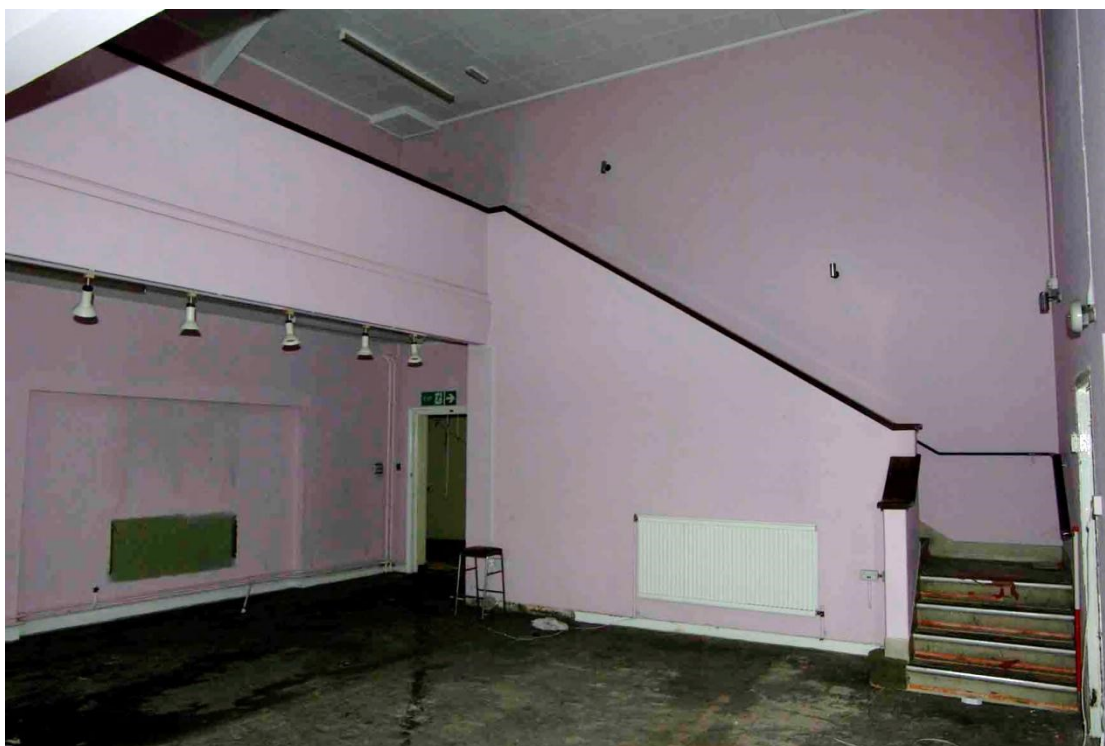
Figure 81 Coffee lounge  
Looking south-west, 1m scale. Stairs lead to balcony and Daisy Peake buildings

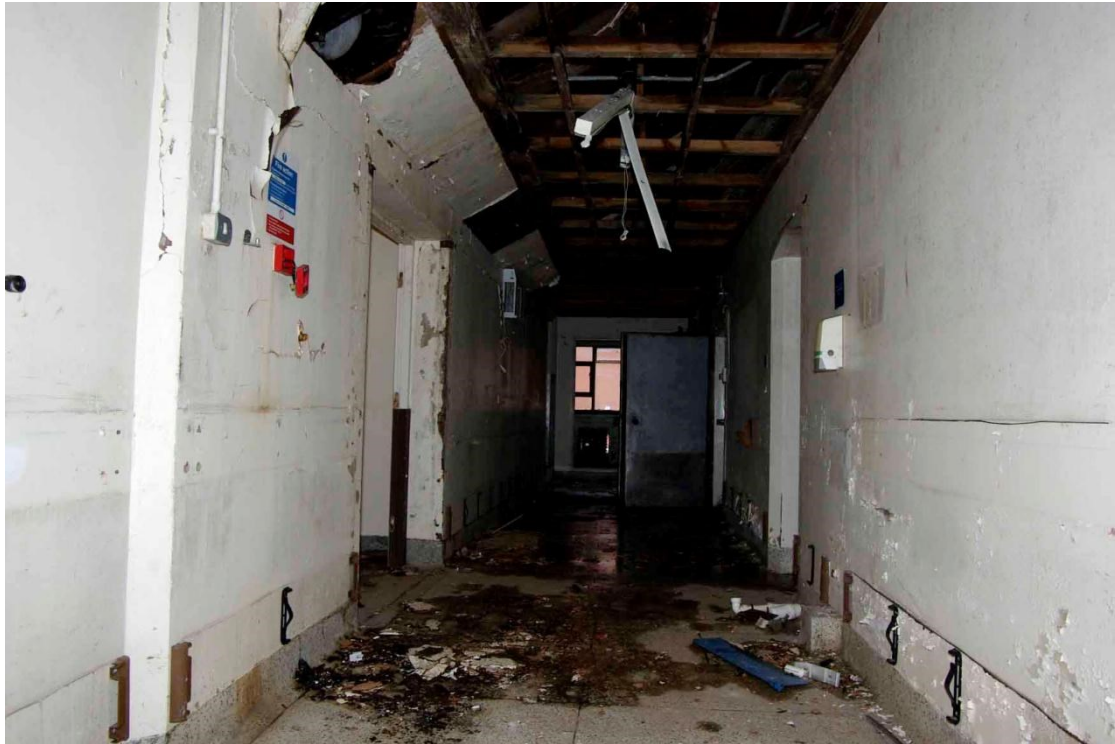
Figure 82 Cold storage area  
Looking north-east

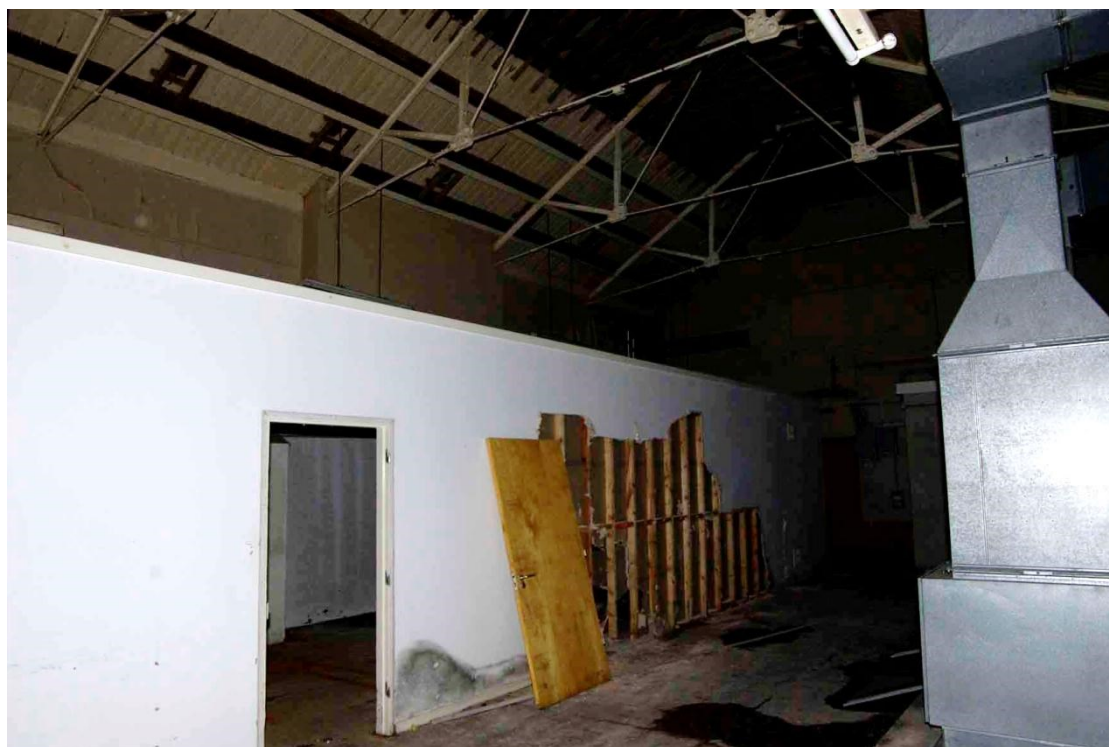
supported by fan trusses of angle iron and steel rod (Fig. 84) and a smaller hall with a lower roof used as a cold food preparation area with cold stores built around the walls (Fig. 85).

Figure 84 Large food preparation hall  
Looking west.

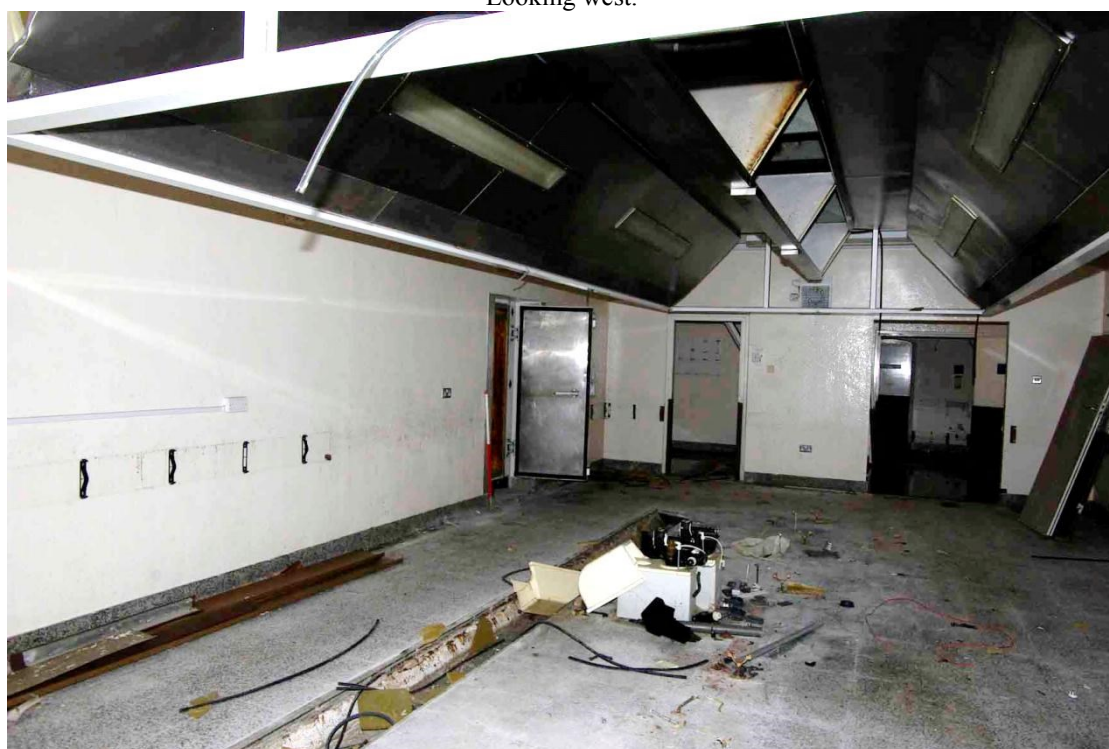
Figure 85 Inserted food preparation hall and cold store rooms  
Looking north-east, 1m scale.

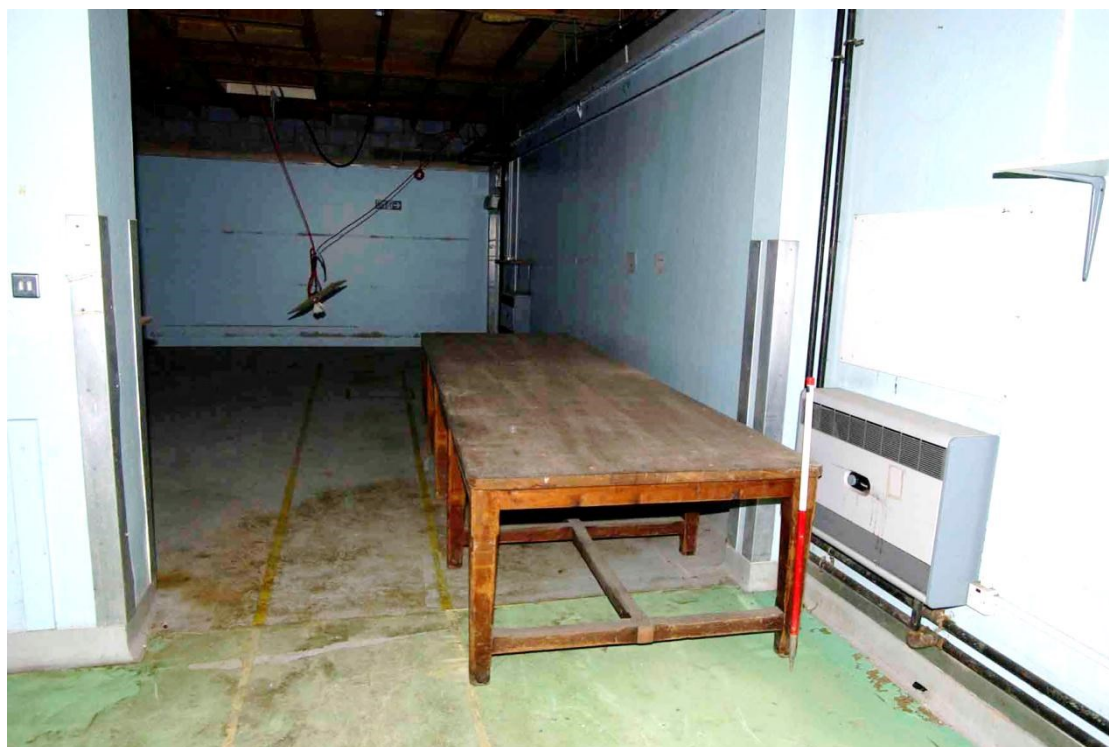
To the west of the inserted halls is a short corridor leading to the lift shaft and a large open room GF18 which has a large wooden table but no other fittings to show what it might have been used for (Fig. 86). The west wall of GF18 has a doorway out to the western corridor leading to the George Hine range (Fig. 87). This corridor has recently been blocked by breeze blocks for no clear reason. Along the walls of the corridor are numerous sockets with the names of wards and rooms across the Daisy Peake buildings. It is possible that these were storage areas for electrically heated trollies to take food to the various parts of the building. There are rubber buffer strips attached to the wall which might also support this idea. To the south of GF18 is another cold food preparation room GF20 (Fig. 88). This room looks out onto another enclosed courtyard designed to bring light into what would otherwise be dark rooms. A tall ventilation tower serving the recreation hall has been built into the corner of this yard and is discussed below.

Figure 86 Food preparation room GF18  
Looking south-west, 1m scale

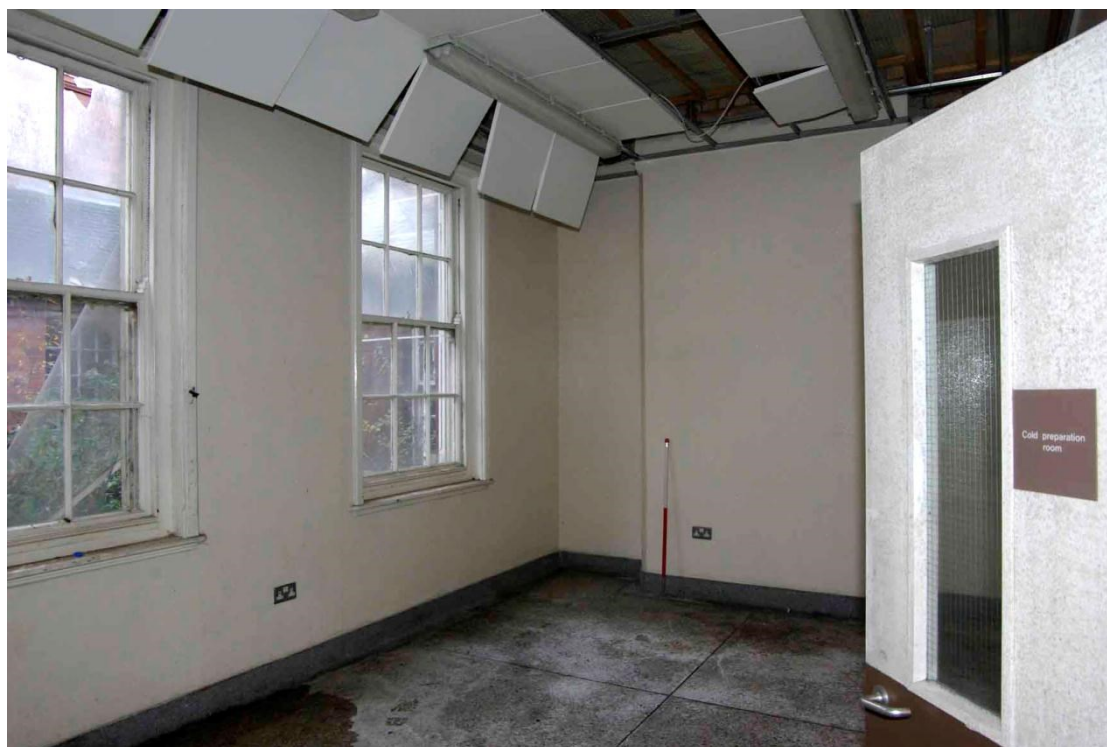
Figure 88 Cold food preparation room GF20  
Looking south-west, 1m scale. Windows look out into enclosed light well courtyard

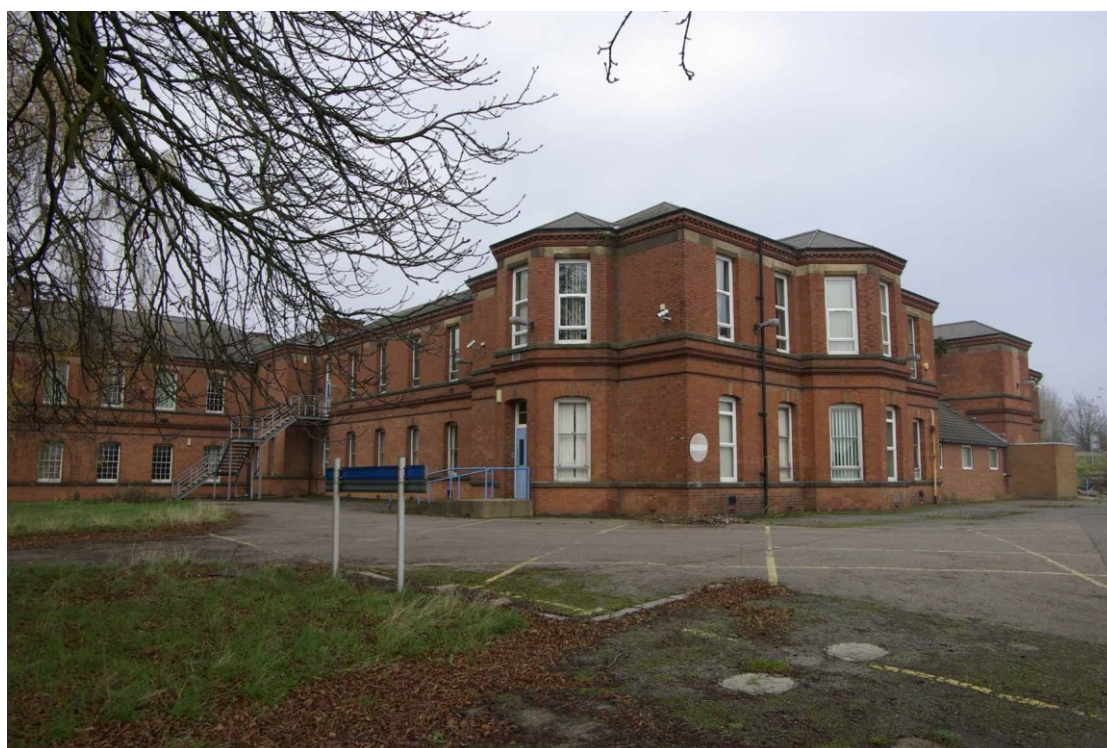
The generally south facing range contains a separate ward in each echelon which in plan can be seen as similar in length but with slightly different widths. The eastern end of the range has a former entrance or conservatory blocked to create a single storey brick and slate extension facing eastwards (Fig. 89). This structure appears as a recessed glazed roofed structure as late as the 1972 OS map. Elsewhere along the façade there are very few significant alterations. Most of the day rooms which are located at each outward facing angle have modern fire escape doors and wheelchair ramps in place of the original steps. There are also first floor fire escape stairs leading to modified windows. Most of the chimney stacks have lost their pots and have been capped. A lift shaft has been added in the angle created by the Fosse and Belgrave wards (Fig. 90). A ground floor veranda on the west side of the Beaumanor ward has been boarded over (Fig. 92). A photograph held by the ROLLR shows this in use in the 1930s when open air wards were popular. At the western end of the Daisy Peake range is the Director of Nursing and administration office as described above. The boarded over entrance can also be seen here (Fig. 94). West of this is the recreation hall which is described below followed by another partially free standing block for staff accommodation (Fig. 95). This is the range containing room GF4 which has been completely gutted as discussed earlier. At the time of the survey a building which was attached to the western side of this range had been demolished (see Fig. 29).

Figure 89 Eastern end of Daisy Peake Building. De Montfort and Newarke wards  
Looking north-west. Note ground floor infilled entrance on right of picture. Fosse and Belgrave wards  
on left of photo. Lift shaft mechanism on extreme right of buildings

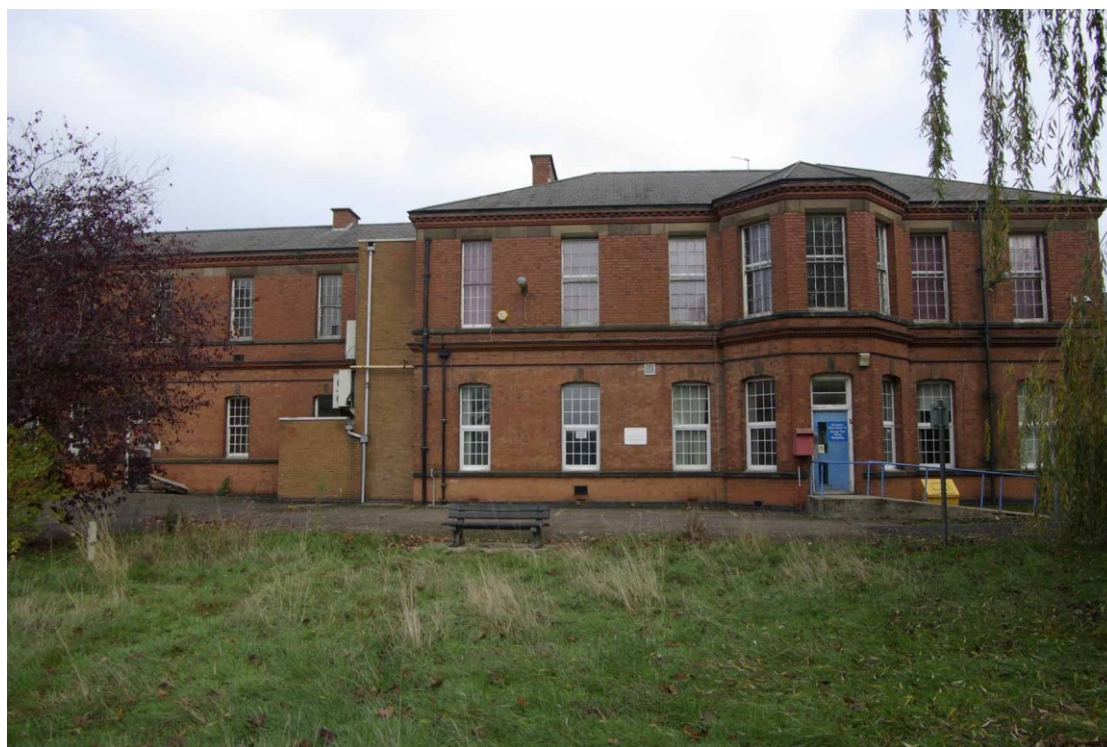
Figure 90 East end of Daisy Peake Building. Fosse and Belgrave wards  
Looking north. Inserted lift shaft centre left

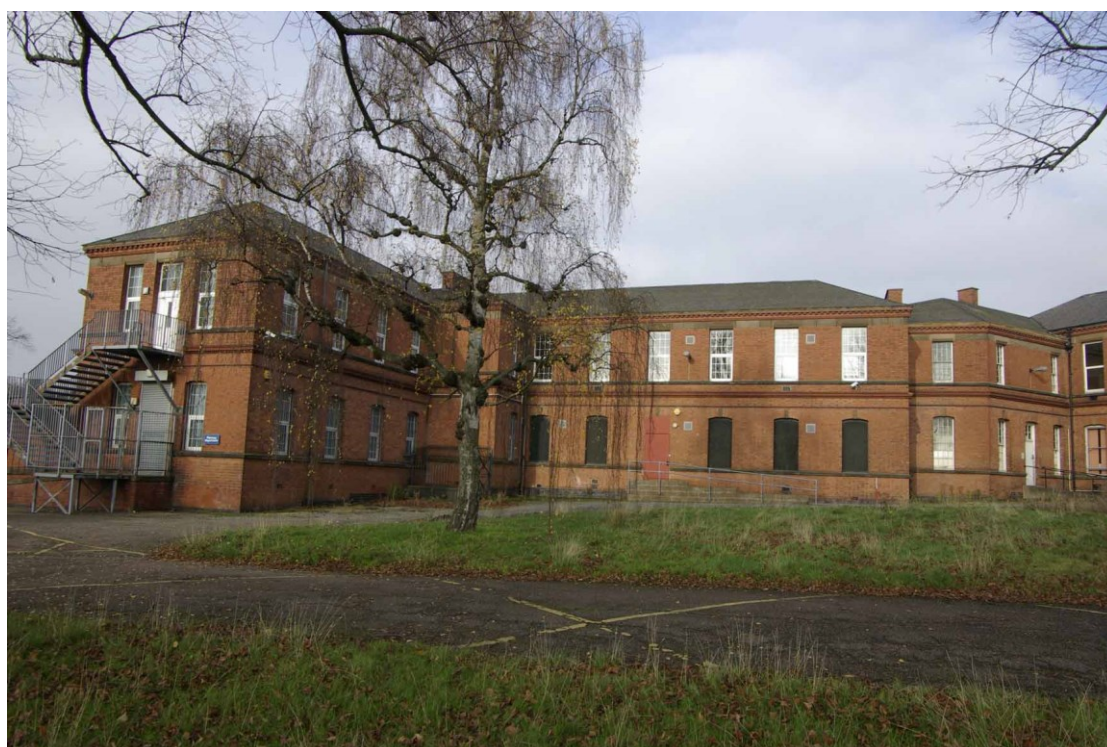
Figure 91 Daisy Peake Building – Beaumanor and Cropston wards  
Looking north-west

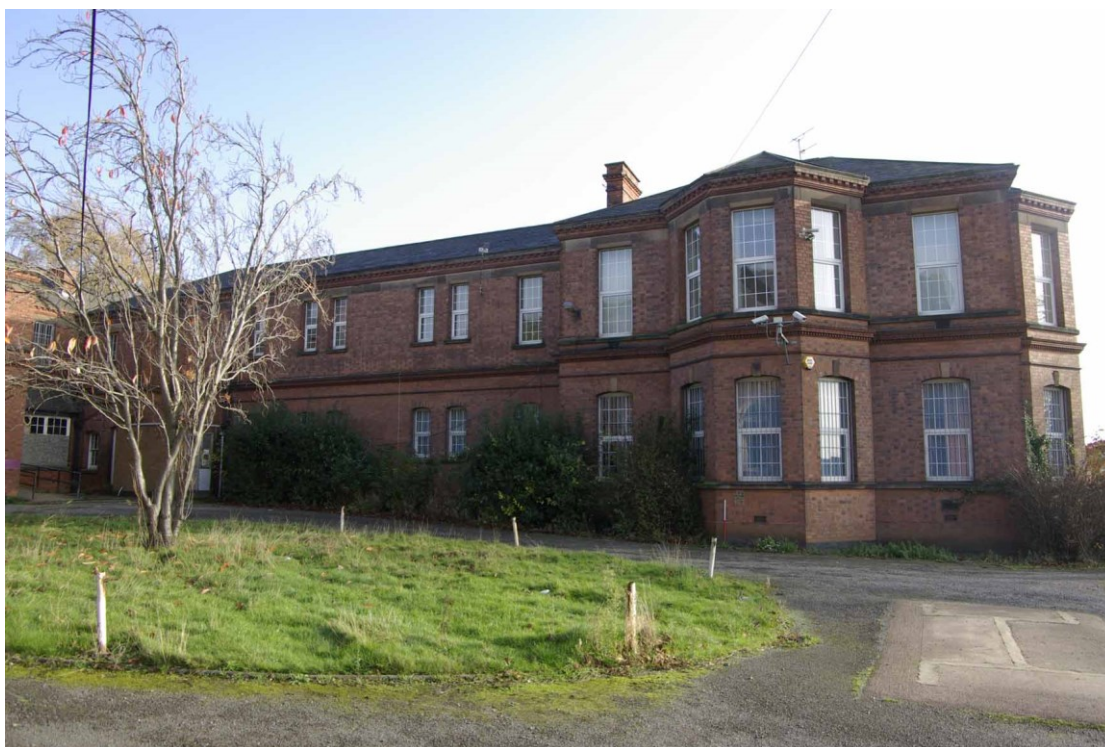
Figure 93 Daisy Peake Building –offices  
Looking east

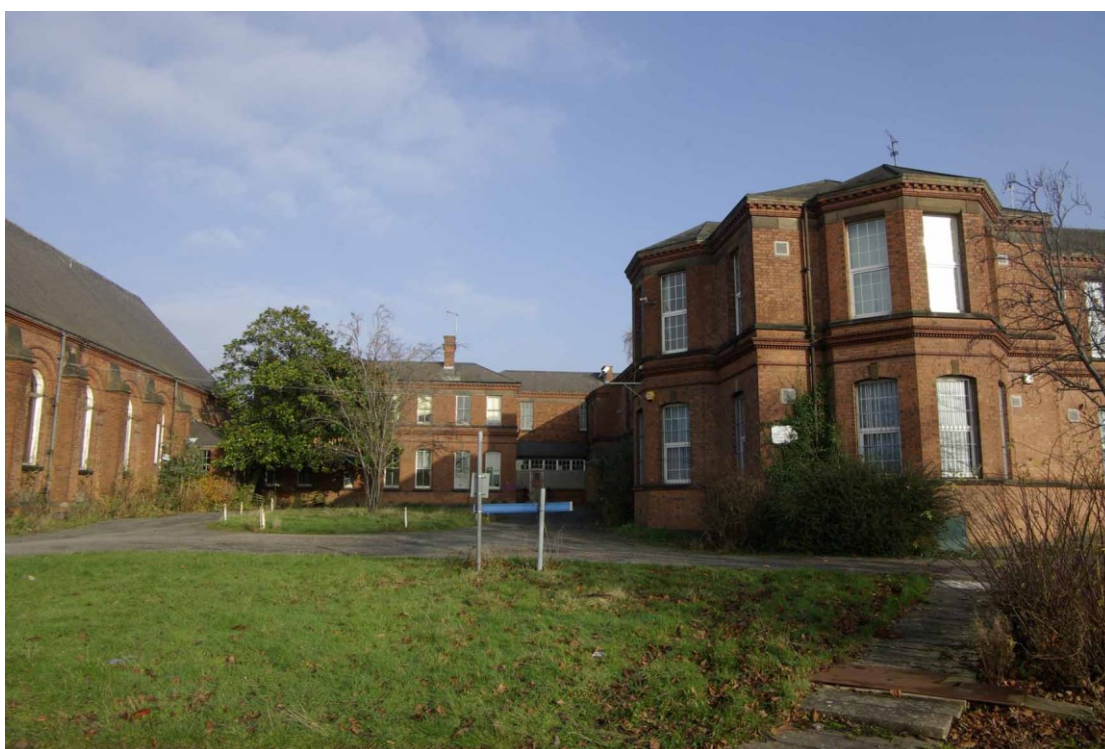
Figure 94 Daisy Peake Buildings – nurse's office and old entrance  
Looking north. Recreation hall on left

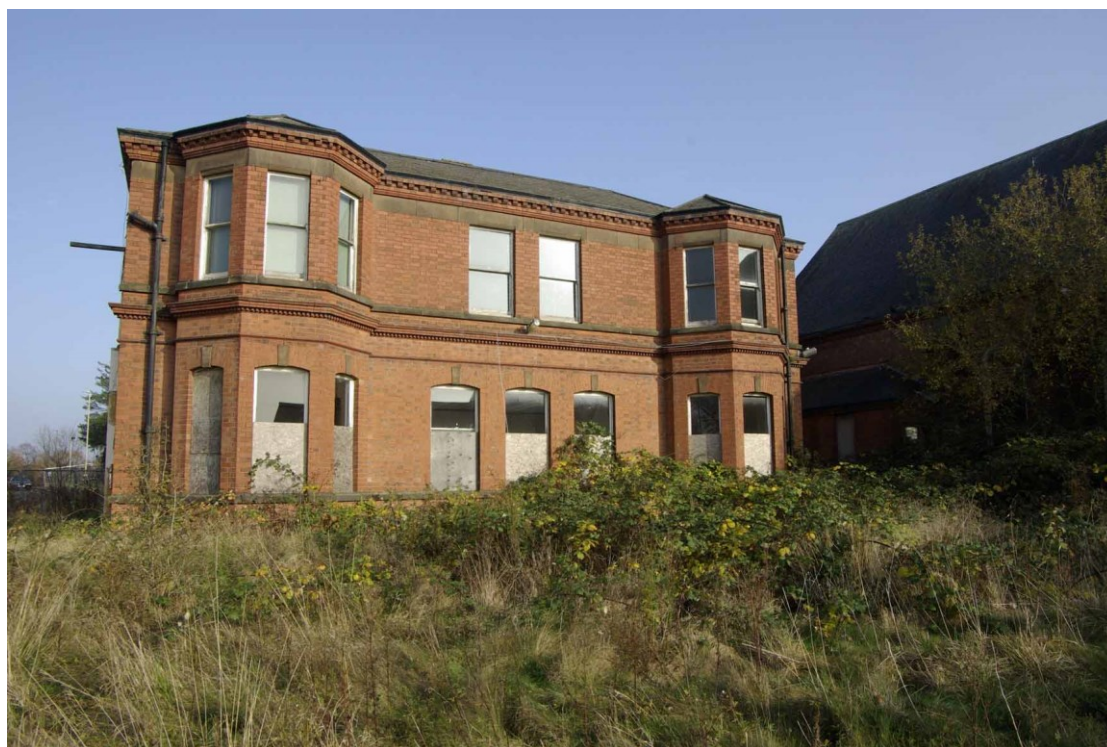
Figure 95 Admin and personnel building to west of recreation hall  
Looking north-east. Note recreation hall on right of picture

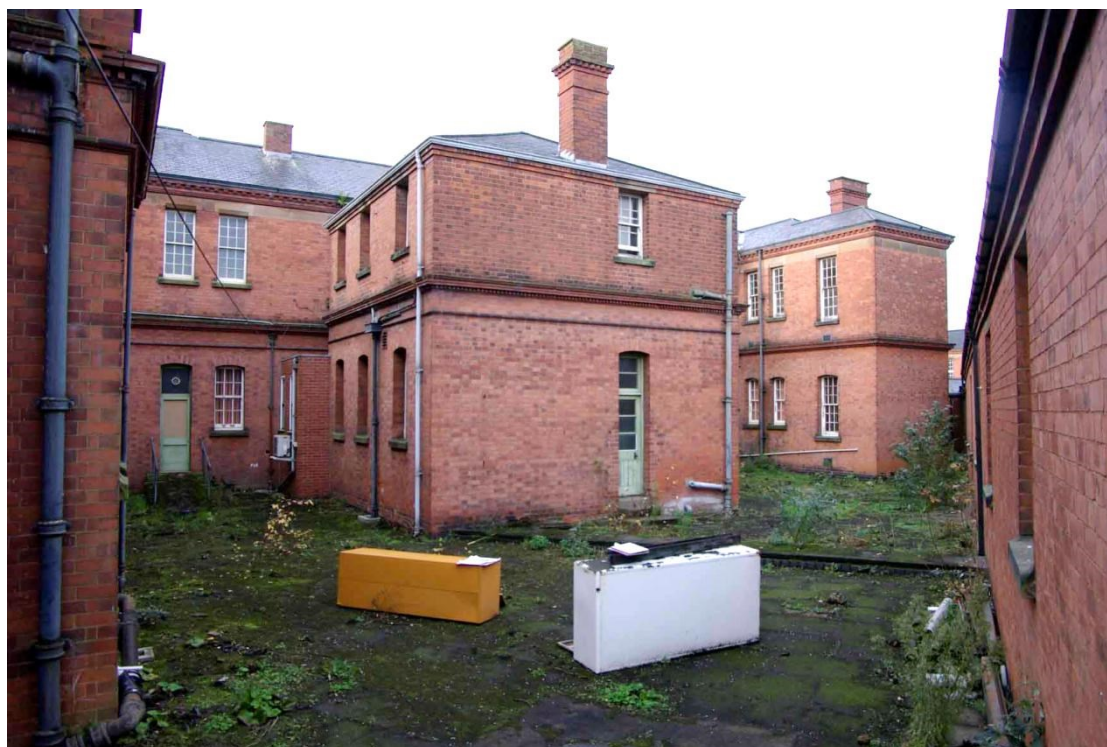
The echelon shape of the Daisy Peake buildings creates six roughly triangular shaped courtyards with the main corridor forming the northern boundary. The toilet blocks serving each ward project out into the courtyards which limits the useable space in all but the largest yard (Figs. 96 to 99). The brick dentiling at the eaves along with a string course seen on the southern elevation are repeated here but with slightly less embellishments. Limestone details can be seen around the windows but does not appear as a decorative band. As with the south facing elevation the windows are a mix of original wooden sashes along with later repairs and replacements. Doors set at irregular places lead out from each ward and, at a few points, from the main corridor. The toilet blocks are connected to the wards by a short linking passage but are otherwise free-standing to maximise the number of windows and ventilation. There is evidence that most of the yards were paved but some has since been removed and many are overgrown. The largest of the yards appears to have been used as a secure space for exercise purposes and a photograph held at the ROLLR shows an exercise class being held in the 1930s (Fig. 98). Because of their small size it seems unlikely that the other yards would have been used for similar purposes.

Figure 96 Yard behind Grace Dieu and Fernie wards  
Looking south-west. Main corridor on right

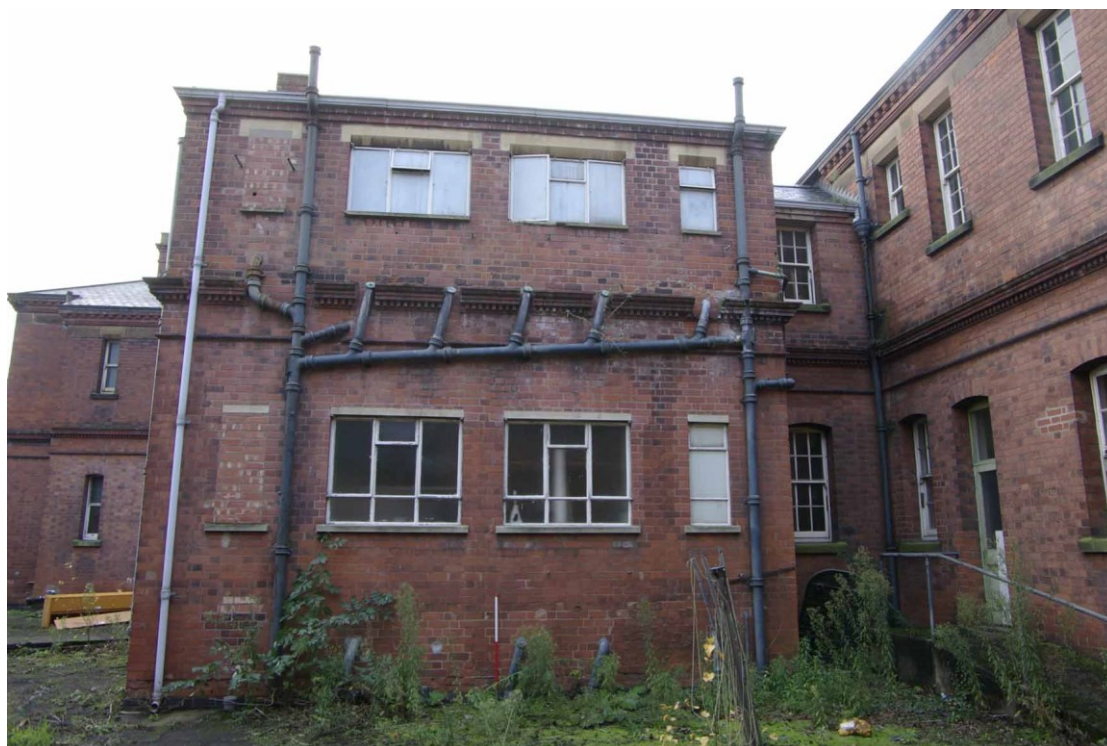
Figure 97 Toilet block behind Grace Dieu and Fernie wards  
Looking east, 1m scale

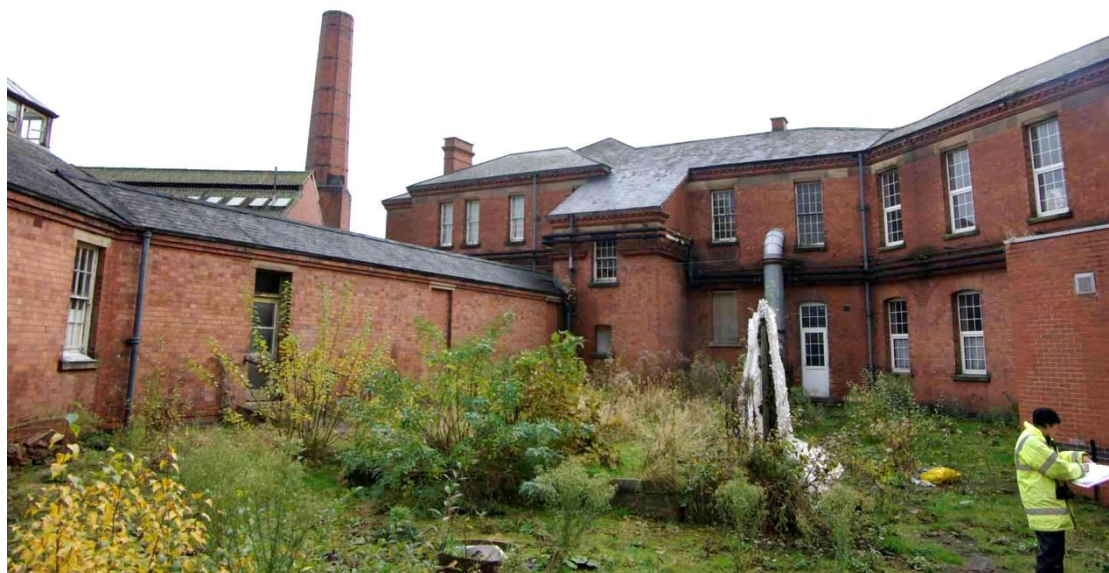
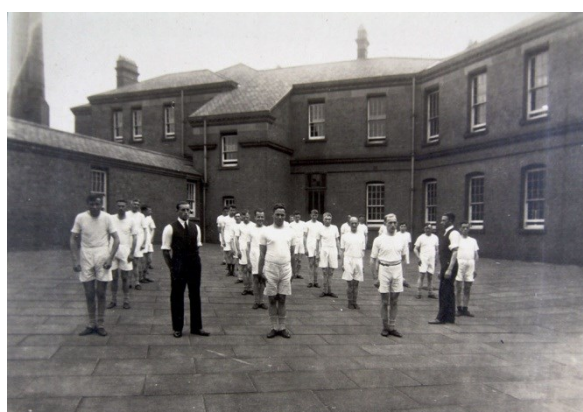
Figure 98 Courtyard behind Beaumanor ward  
Looking east. Angled and main corridors on left  
Lower picture same view during exercise in the 1930s
