**A Level 2 and 3 Historic Building  
Survey at the former Towers Hospital,  
Gipsy Lane,  
Leicester.**

**NGR: SK 618 060**

ULAS Report No. 2014-204  
©2015

**For: KRT Associates**

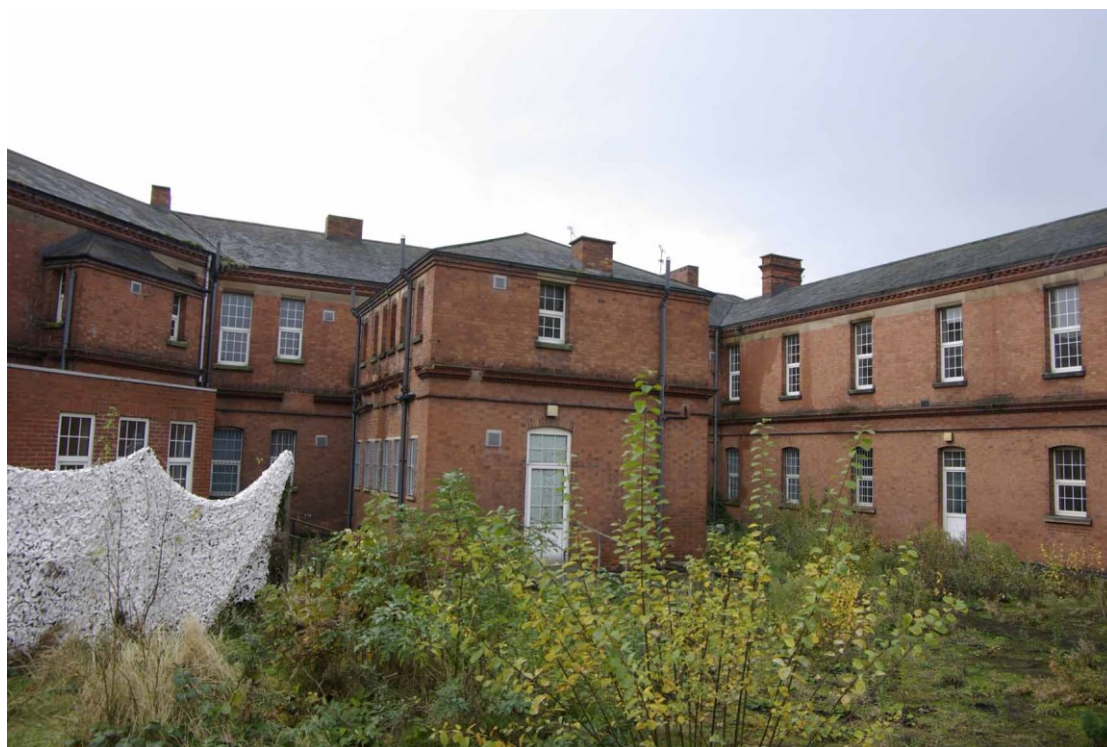
The echelon shape of the Daisy Peake buildings creates six roughly triangular shaped courtyards with the main corridor forming the northern boundary. The toilet blocks serving each ward project out into the courtyards which limits the useable space in all but the largest yard (Figs. 96 to 99). The brick dentiling at the eaves along with a string course seen on the southern elevation are repeated here but with slightly less embellishments. Limestone details can be seen around the windows but does not appear as a decorative band. As with the south facing elevation the windows are a mix of original wooden sashes along with later repairs and replacements. Doors set at irregular places lead out from each ward and, at a few points, from the main corridor. The toilet blocks are connected to the wards by a short linking passage but are otherwise free-standing to maximise the number of windows and ventilation. There is evidence that most of the yards were paved but some has since been removed and many are overgrown. The largest of the yards appears to have been used as a secure space for exercise purposes and a photograph held at the ROLLR shows an exercise class being held in the 1930s (Fig. 98). Because of their small size it seems unlikely that the other yards would have been used for similar purposes.

Figure 99 Courtyard behind Beaumanor ward and offices  
Looking south-west

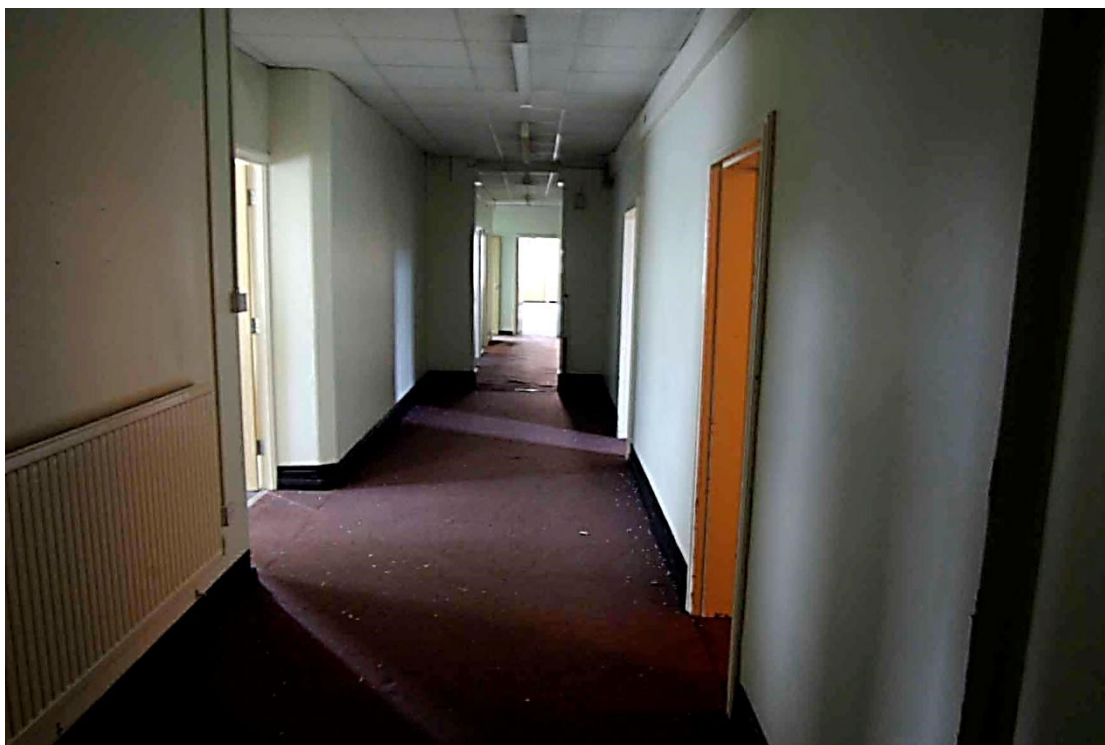
Figure 100 Ground floor corridor into Daisy Peake Building at east end  
Looking north. Note chamfered door jambs on left leading into former conservatory

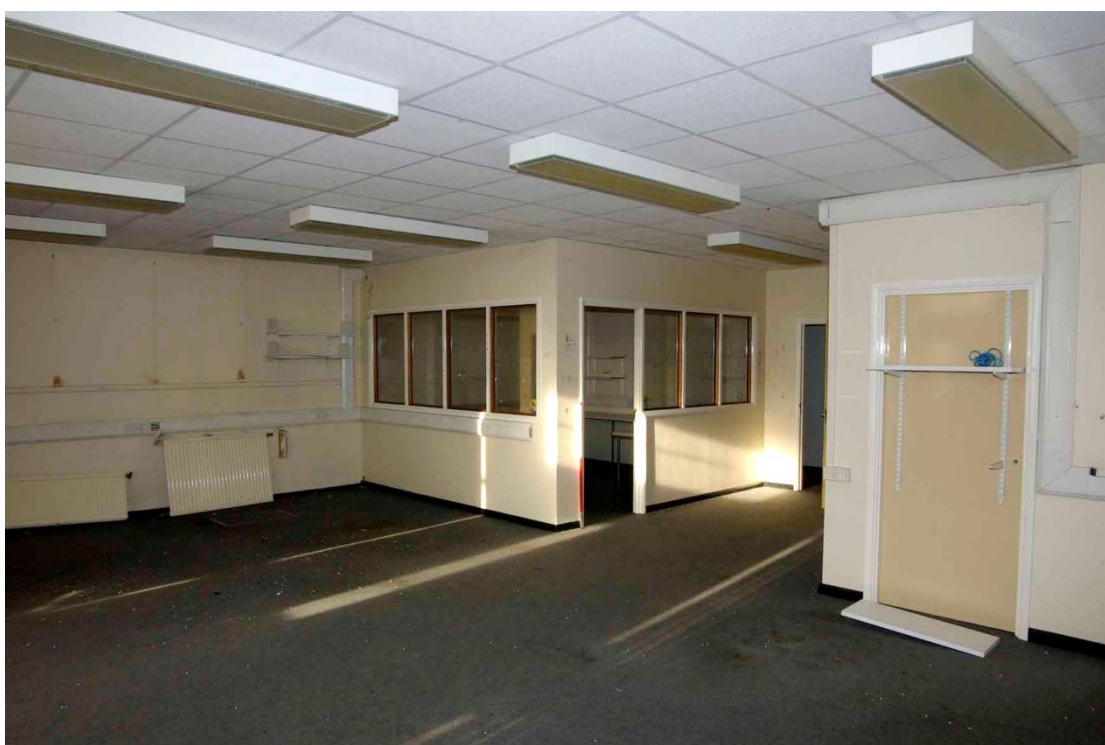
Figure 101 De Montfort ward dayroom  
Looking north-west, 1m scale. Inserted rooms centre and right

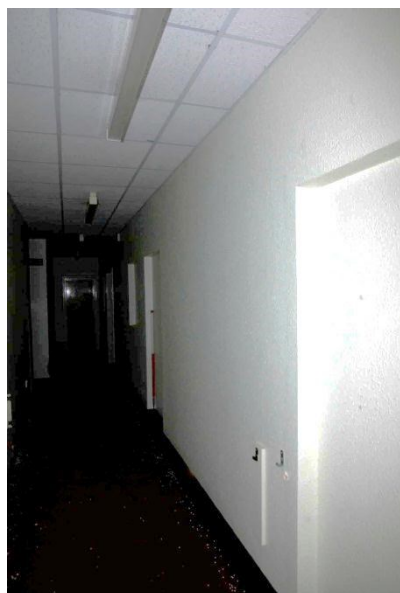
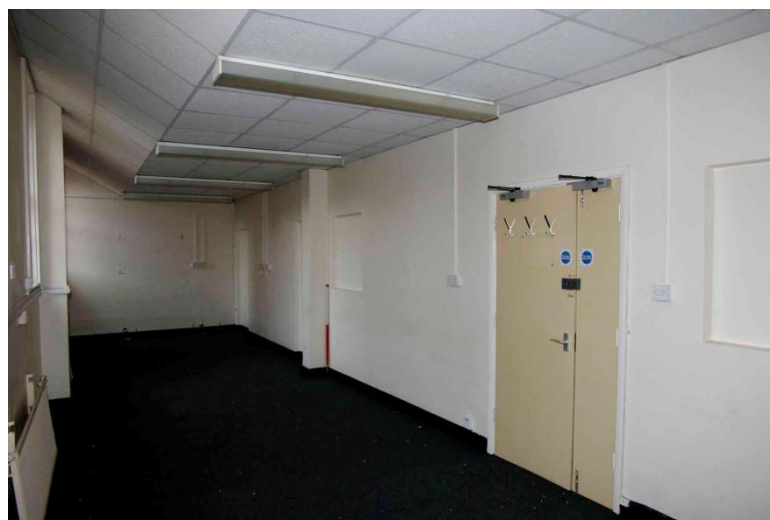
West of the subdivided ward the range turns at 90 degrees to the south with a corridor at the north end running past four individual cells which have been opened out to form a single room with most doors and windows being blocked (Fig. 103). The remainder of the echelon consists of a large open ward which has been subdivided with modern plasterboard partitions. The 1989 plan identifies this as the Fosse ward. Therefore when first built this would have been a large ward with separate isolation cells at one end. The southern end of the former ward opens out into another dayroom of the same two-bay style as the easternmost one (Fig. 104). The dayroom has wooden panelling up to window sill height and a blocked fireplace on the north wall. A plasterboard wall now divides the room into two and artwork proclaims the name of Daisy Peake. The work is signed by the Bright Sparks group and dated 2010 (Fig. 105). The Fosse ward area continues to the west of the dayroom with a corridor leading to five individual glazed tile lined cells (Fig. 106). The inserted lift shaft seen in Figure 90 is opposite these cells. The western end of the cell corridor joins the main corridor at Junction 5.

Figure 103 Blocked doors and windows of former cells  
Left: view from corridor, looking north-west. Right: view within cells, looking south-east

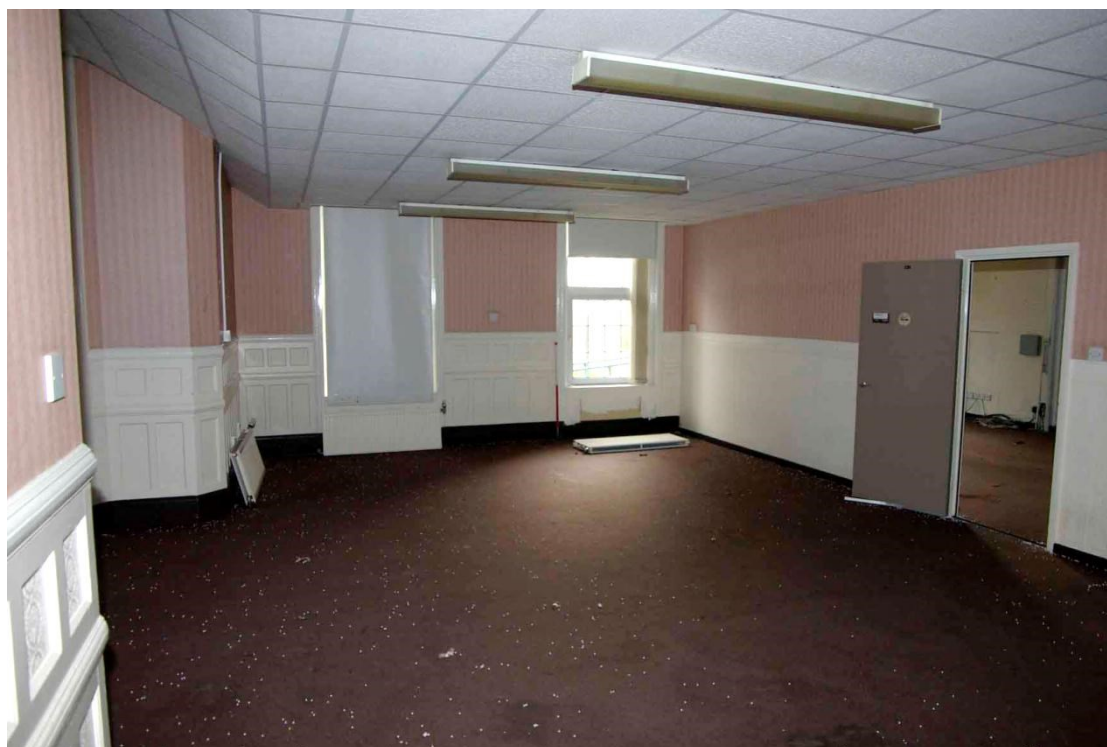
Figure 104 Fosse ward dayroom  
Looking south-west, 1m scale. Note inserted plasterboard wall on right

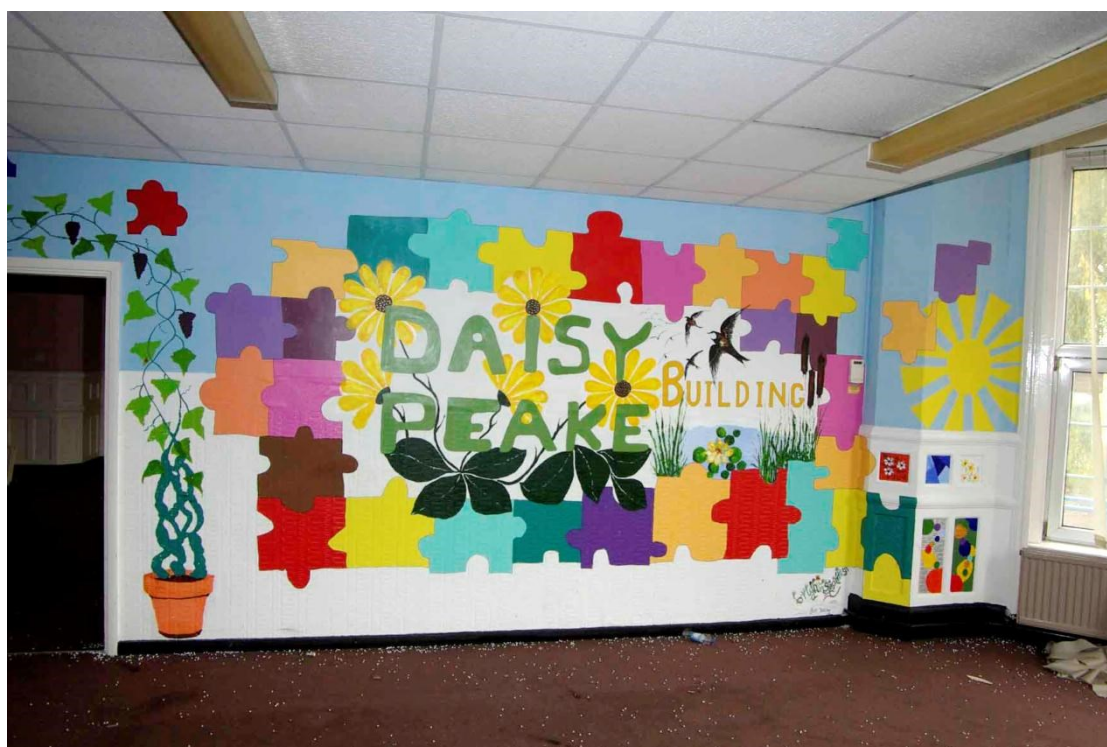
Figure 105 Artwork in Fosse ward dayroom  
Looking east. Art work painted on west side of inserted wall shown in Figure 104

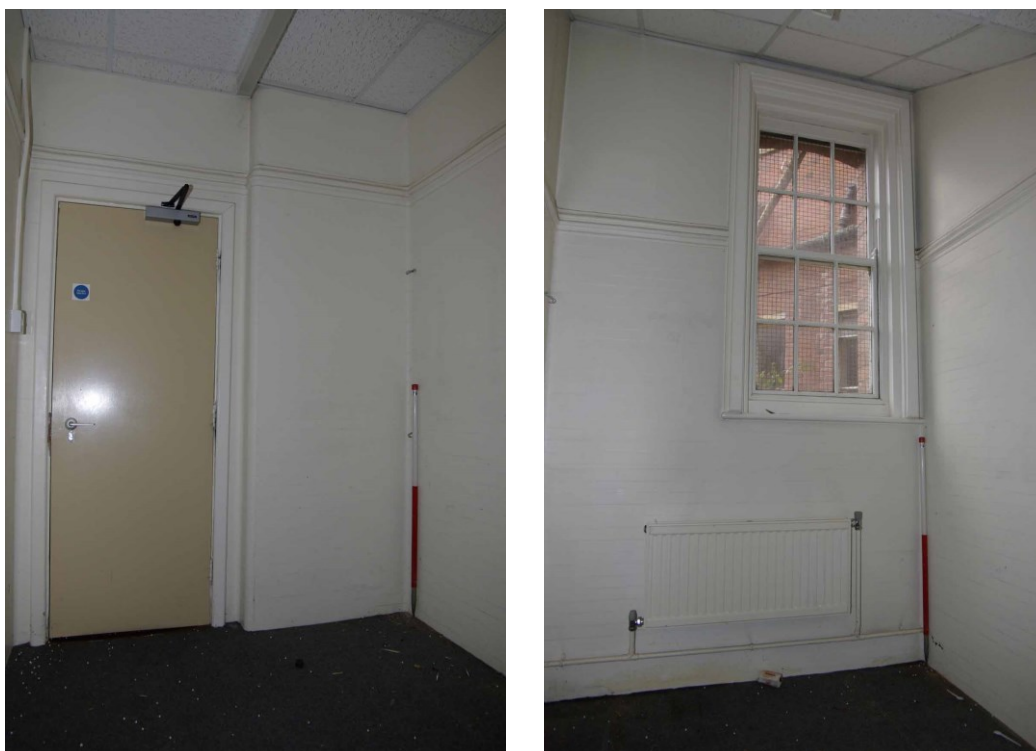
Figure 106 Cell in Fosse ward  
Looking south-west (left photo) and north-east (right), 1m scale. Note painted glazed tiles

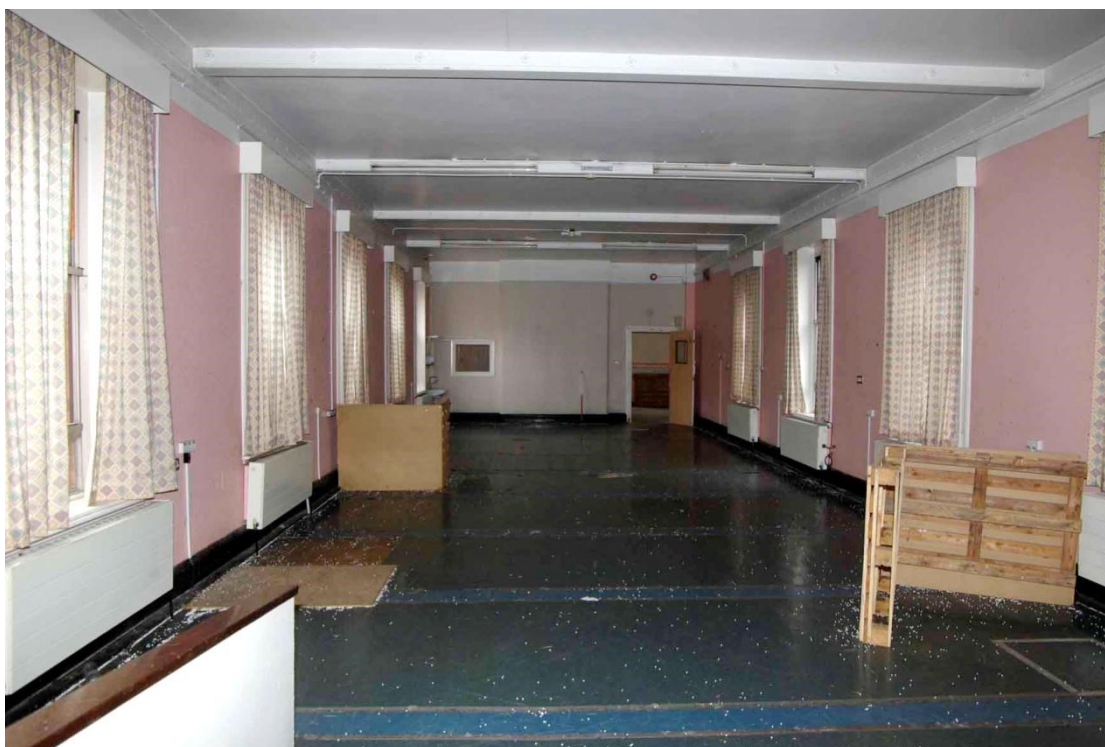
South of Junction 5 is the large open ward identified on the 1989 plan as the Grace Dieu ward (Fig. 107). This is a traditional looking ward with linoleum flooring and spaces for beds which would line the walls. The ward leads into another bay windowed dayroom (Fig. 108). The dayroom continues through a large glass panelled ward with more individual cells along the north wall. Another toilet block projects northwards at this point too (Fig. 109). The toilet block consists of a washroom on one side and a row of toilet cubicles on the other. More individual cells, some of which are covered in glazed tiles, are located at the west end of the dayroom where the long angled corridor leads from the Daisy Peake range to the main corridor. A flight of stairs adjacent to the angled corridor leads to the first floor. Beyond the stairs is a short corridor with a short flight of stairs down to the Beaumanor ward which runs at 45 degrees to the eastern echelons. The Beaumanor ward is another traditionally styled open ward but has had south western end boarded over quite recently to prevent access beyond this point (Fig. 109). West of the inserted wall in the Beaumanor ward is another open ward (apparently also known as the Beaumanor ward) with barred windows. The western wall used to have the glazed veranda as seen in Figure 92 but this area is now sealed and is inaccessible (Fig. 110).

Figure 107 Grace Dieu open ward  
Looking south, 1m scale

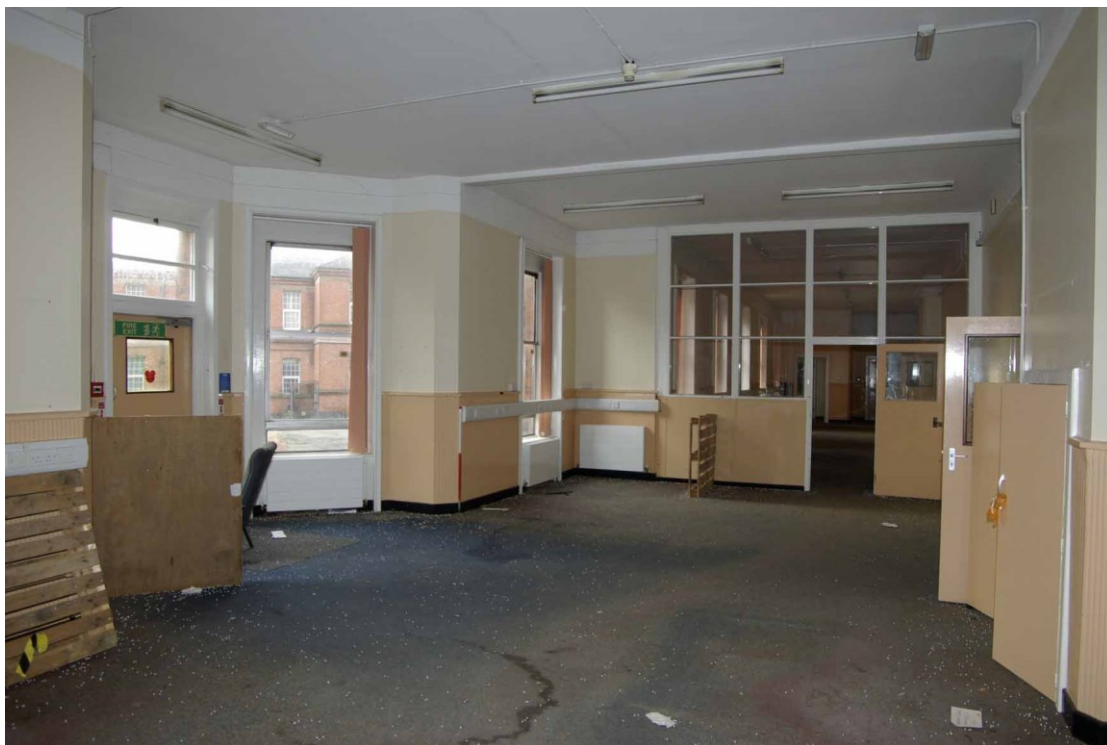
Figure 108 Grace Dieu ward dayroom  
Looking south-west, 1m scale

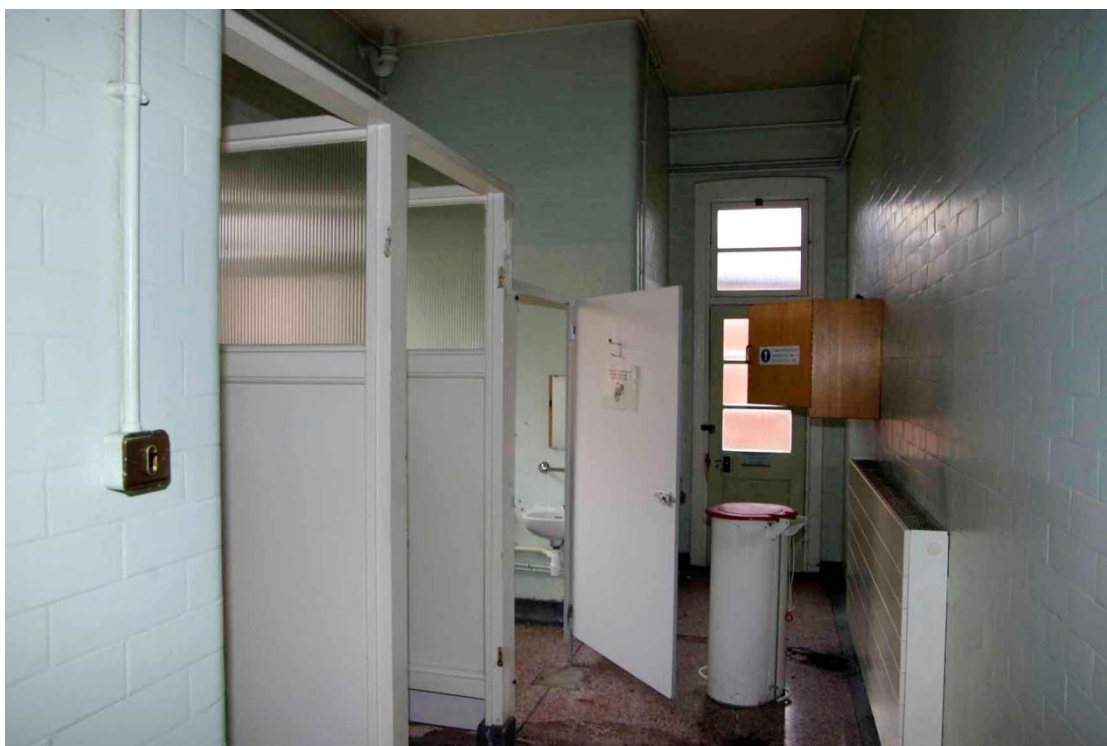
Figure 109 Toilet block on north side of Grace Dieu ward  
Looking north

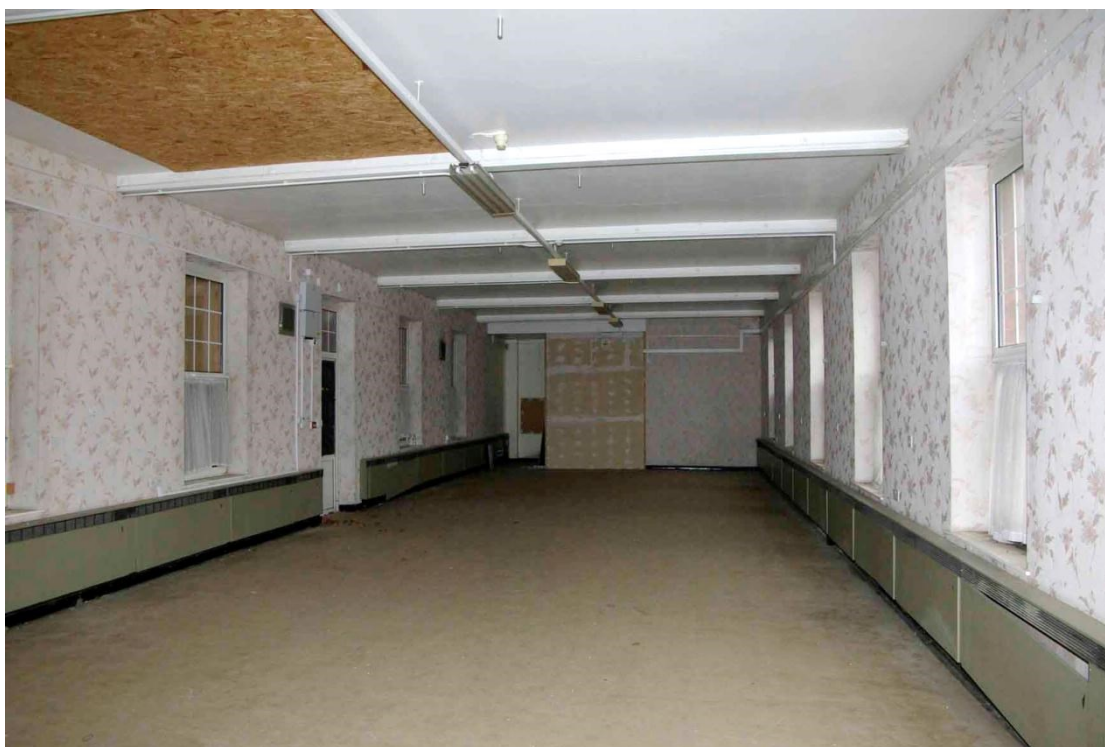
Figure 110 Beaumanor ward (east)  
Looking south-west, 1m scale. Note blocked end wall

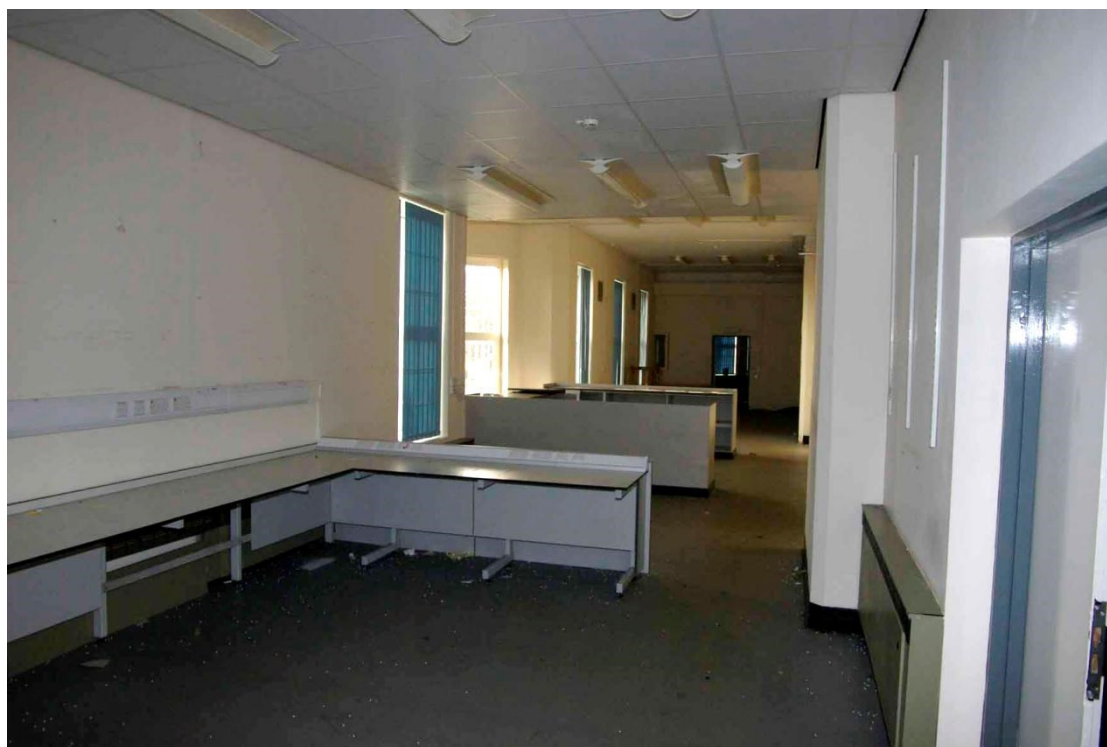
Figure 112 Pharmacy to west of Beaumanor ward  
Looking west. Individual cells on right of photo

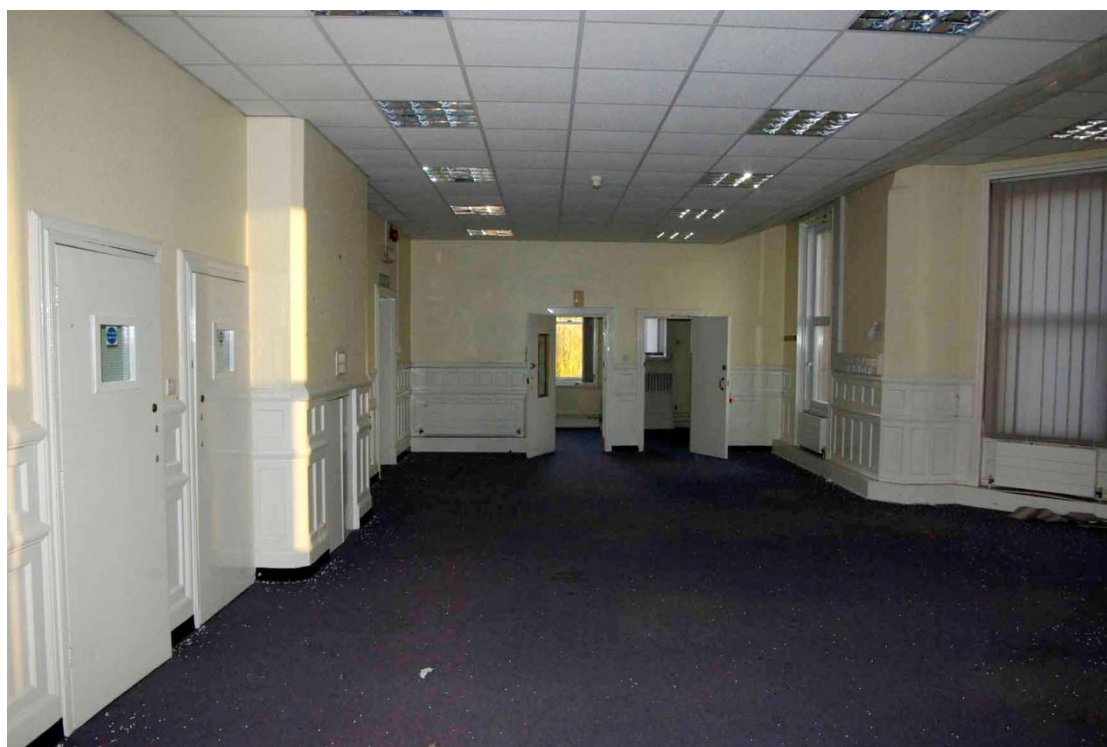
The first floor layout of the Daisy Peake range closely matches that seen on the ground floor. Panelled dayrooms serve wards on either side with a number of individual cells being built close to, or in some cases opening onto, each dayroom (Fig. 113). A number of the open wards have been modified by the insertion of partition walling to create more private spaces for the patients in keeping with later ideas of care (Fig. 114). Although at the time of the survey there were virtually no fixtures and fittings left there were a significant number of sockets and shelves to suggest that until recently much of the first floor had been used for office space. Most of the toilet blocks had recently been stripped of their pipework making these areas unsafe.

Figure 113 Fernie ward. Individual cells opening onto day room  
Looking east

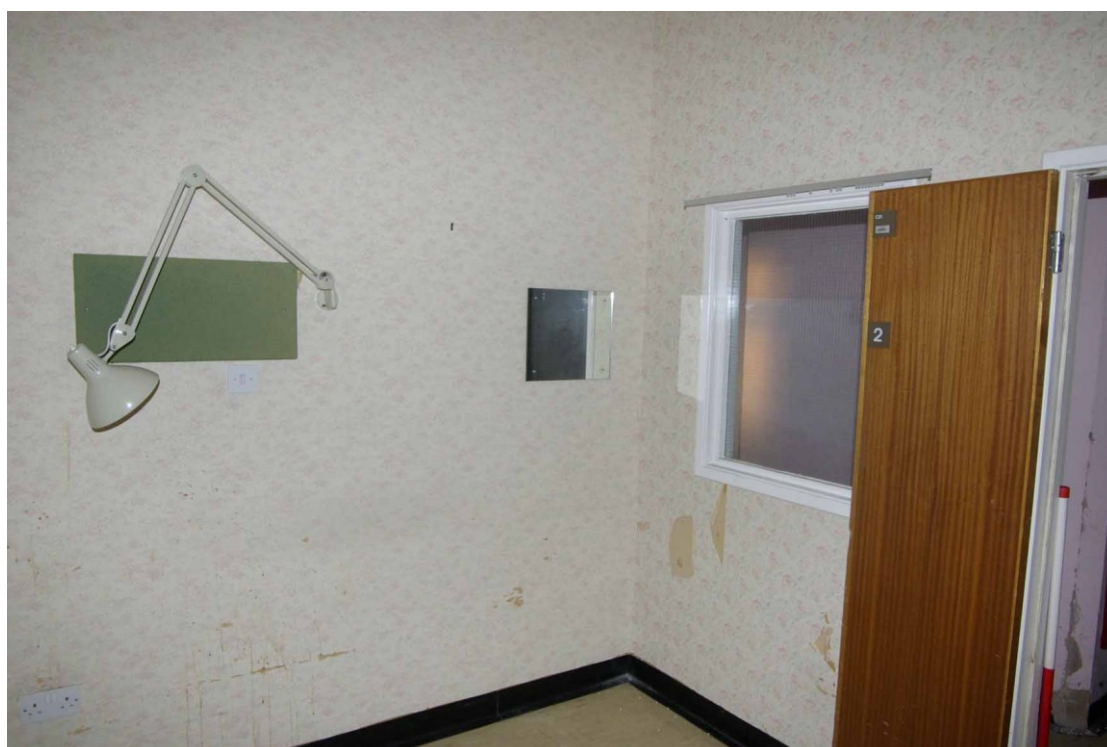
Figure 114 Interior view of an inserted room in the Cropston ward  
Looking north-west, 1m scale

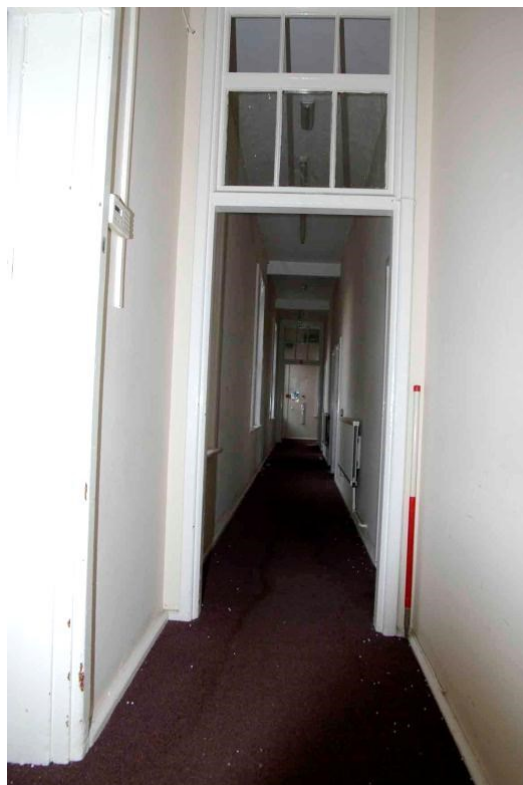
Figure 115 First floor corridor linking attendant's rooms  
Looking south over main corridor, 1m scale

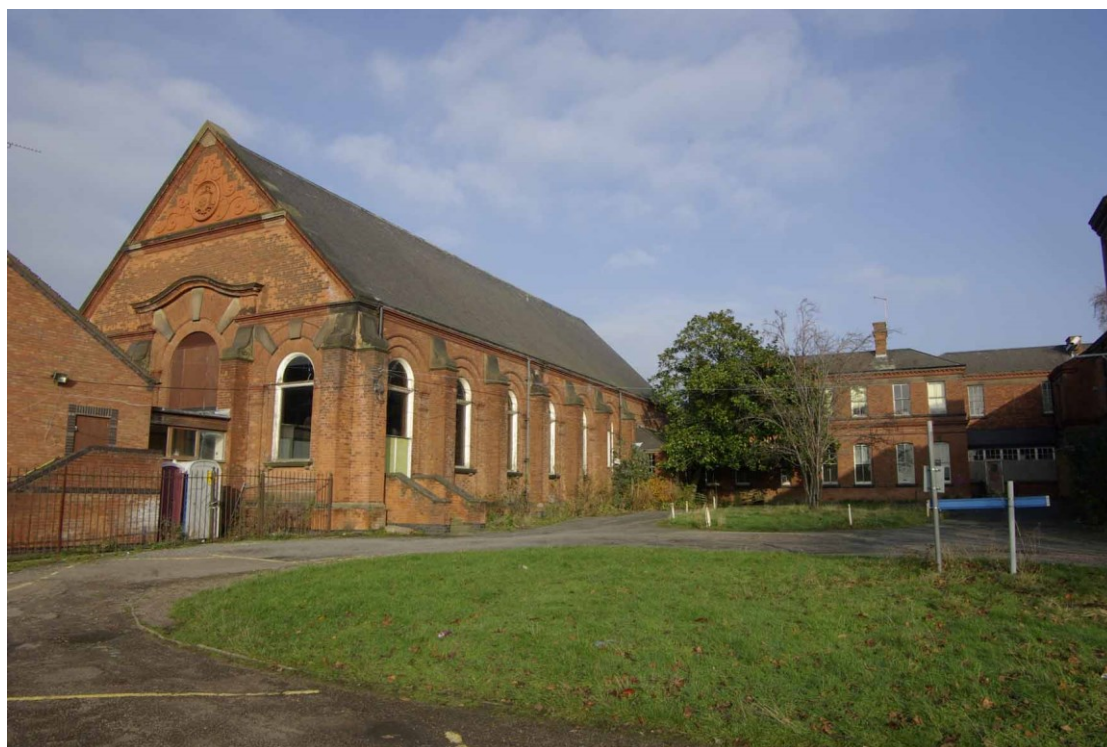
From the outside the hall has the appearance of a large, if rather plain, chapel which makes it understandable that the 1928 Ordnance Survey shows this as a chapel. As with the rest of the range red brick and slate are used throughout (Figs. 29 and 117). A modern brick addition has been built around the south western corner of the hall which obscures much of the building and spoils what is a very attractive structure. This new structure only appears on the 1991 Ordnance Survey map and is associated with the final phases of the Towers Hospital. The east and west elevations are identical with five tall Romanesque style windows with recessive brick detailing creating each arch. Brick pilasters run down either side of each window with larger limestone-capped buttresses in between. The limestone capping has decorative scroll work carved into each side (Fig. 118). The windows are formed from a single large sheet of plate glass with a smaller pane set into each arch. The small panes can be opened via a cranking system operated on the inside of each window linked to a mechanism which runs up the outside of each window (Fig. 119). Each window has a limestone sill supported by two small limestone brackets. The northern end of the hall on both sides has a short length of corridor which extends down from the main corridor as noted earlier. This gives access from the main corridor but only has doors to the outside on the western side. The southernmost bays on the east and west elevations are doorways leading to the back of the hall to the outside, possibly for fire escape purposes. These have a set of steps ascending to a door and window of the same style used on the east and west elevations.

Figure 117 South-east and south-west elevations of the recreation hall

Looking north. Modern building added to south west corner of hall on left of photo. Note boarded over entrance just above the blue sign on the right. Director of Nursing's office immediately to left of boarded doorway.

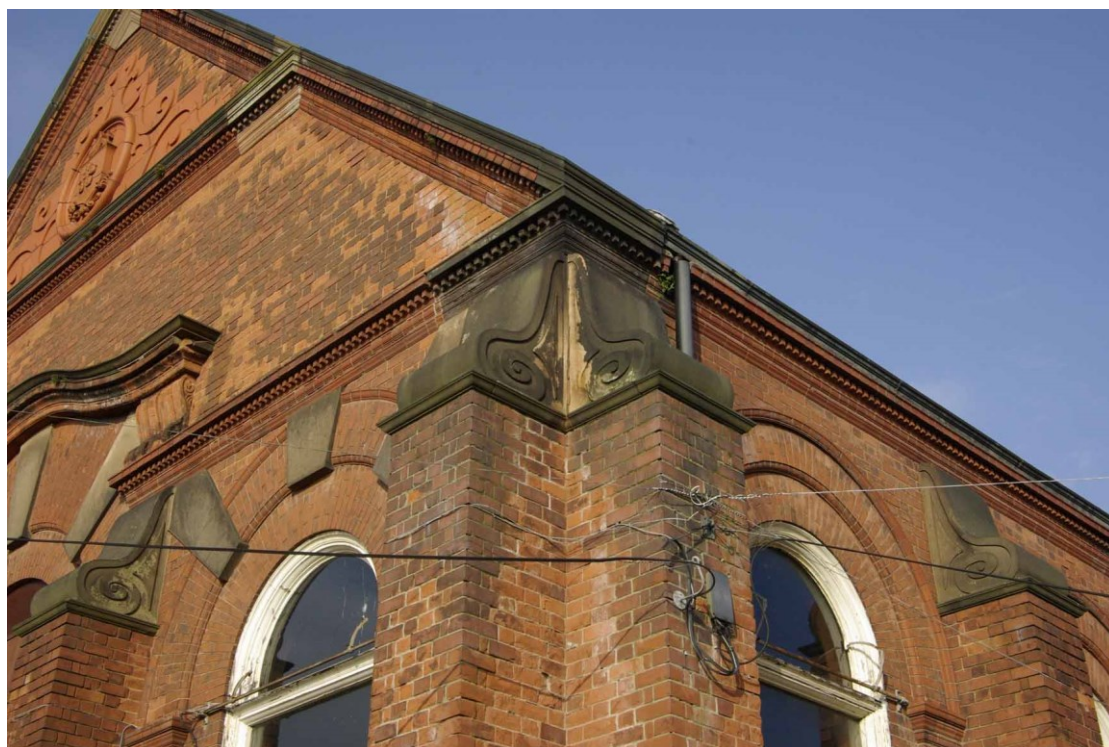
Figure 118 South-east corner of hall

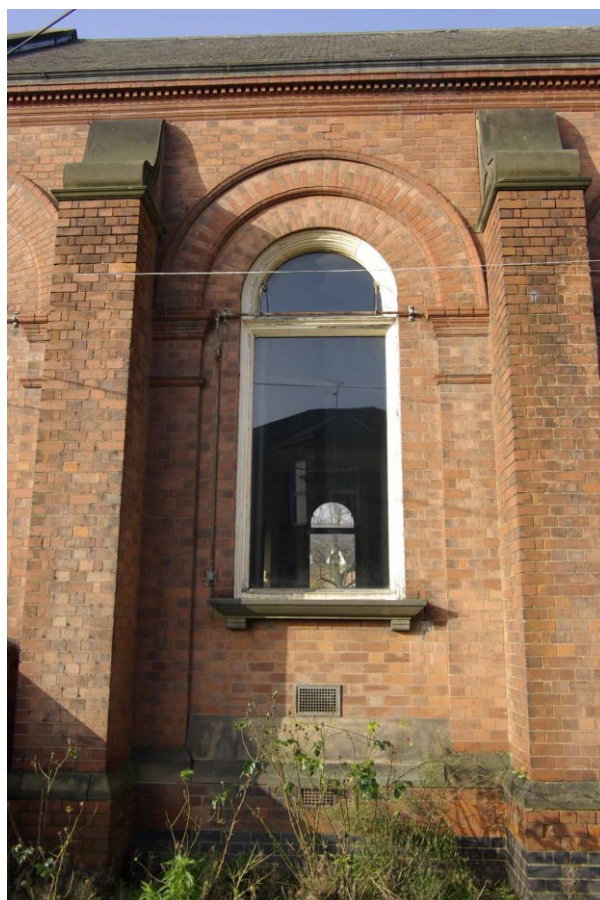
Figure 119 Side window detail of hall

The south facing elevation has a decorative terracotta panel featuring the City coat of arms set into the top of the flat gable end. Below this is an unusual eyebrow, style pediment set over a tall doorway. Either side of the doorway are windows of the same style as on the side elevations but with limestone embellishment in the arches. Until the addition of the modern building on the south west corner it seems likely that this was originally the main entrance into the hall for visitors. Iron railings, with the makers' name of W T Burbidge, Leicester, separate the southern doors from the rest of the Daisy Peake range suggesting that these doors were not for patients. Much of the western elevation is obscured by thick vegetation making photography difficult, however inspection reveals the same details as seen on the east elevation. The hall appears to be ventilated by a passive ventilation tower often seen in Board schools of a similar age. The tower is located on the north side of the main corridor behind the hall and consists of a tall brick-built structure with a lead cap and wooden louvres (Fig. 120). The design can also be seen on the proposed recreation hall drawings shown in Figure 16.

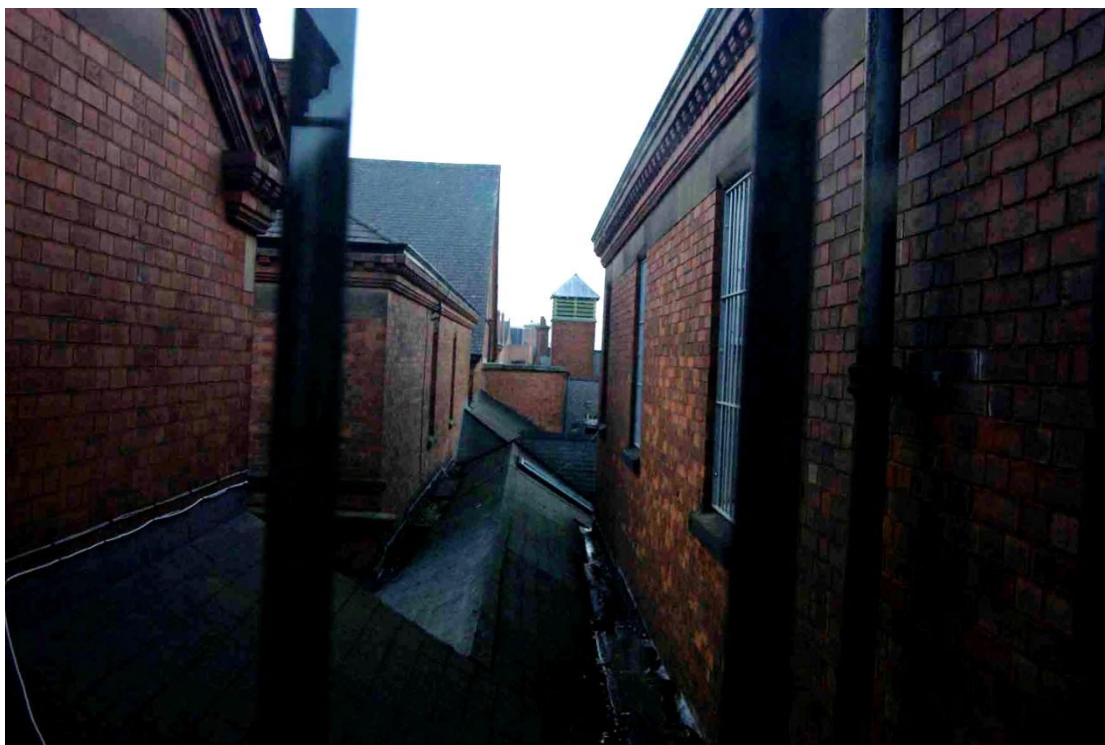
Figure 120 Passive ventilator seen from first floor of Daisy Peake Building  
Looking west over main corridor roof. Recreation hall gable end is in centre of photo

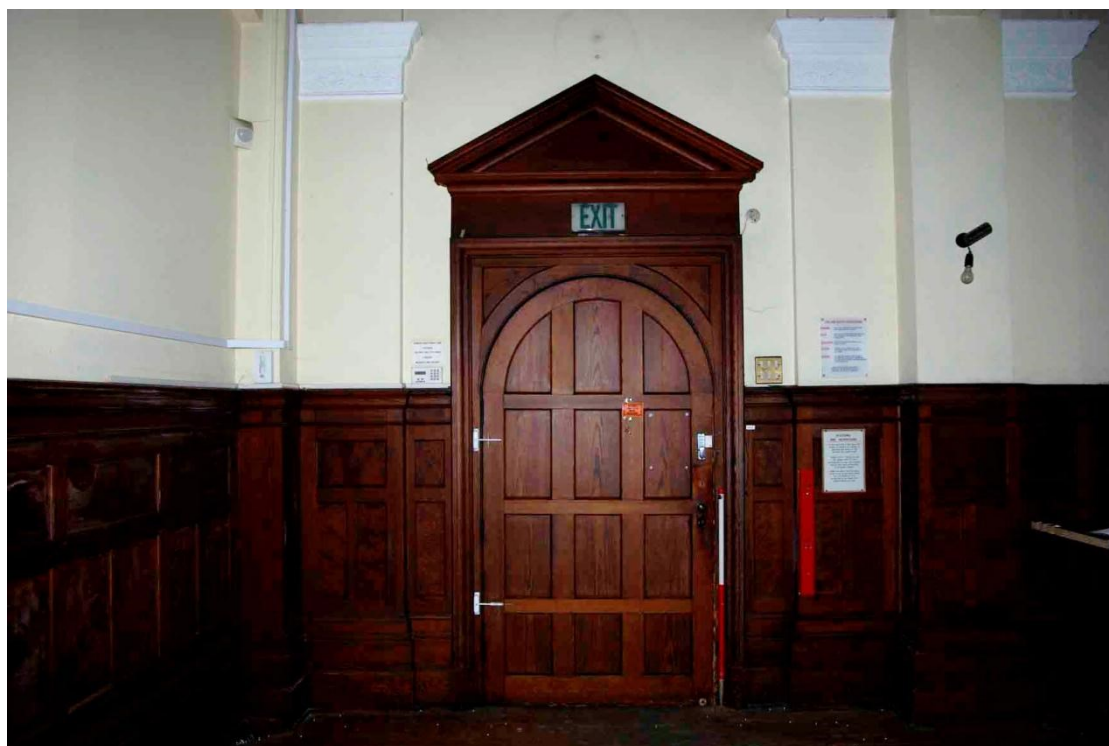
Figure 123 Side door of recreation hall  
Looking east, 1m scale

Inside the hall is a large open space with the stage at the northern end which backs up against the main corridor (Figs. 121 and 122). The side walls are covered in wooden panels to dado height above which is painted plaster with decoration at eaves height. The pilaster and buttress detail is emulated on the internal face by plaster detailing. The window opening mechanism is operated using a winder set into the panelling at the side of each window. A small modern booth has been built at the south end of the hall and is clearly a very modern insertion. The floor has markings on it showing it has been used as a sports hall. The roof is an elaborate wooden structure with suspended bosses hanging down from the tie-beam. Wooden panels in between the trusses have herringbone pattern boards. The panelled doors out to the corridor have large wooden pediments above them in keeping with the theatrical style of the hall (Fig. 123).

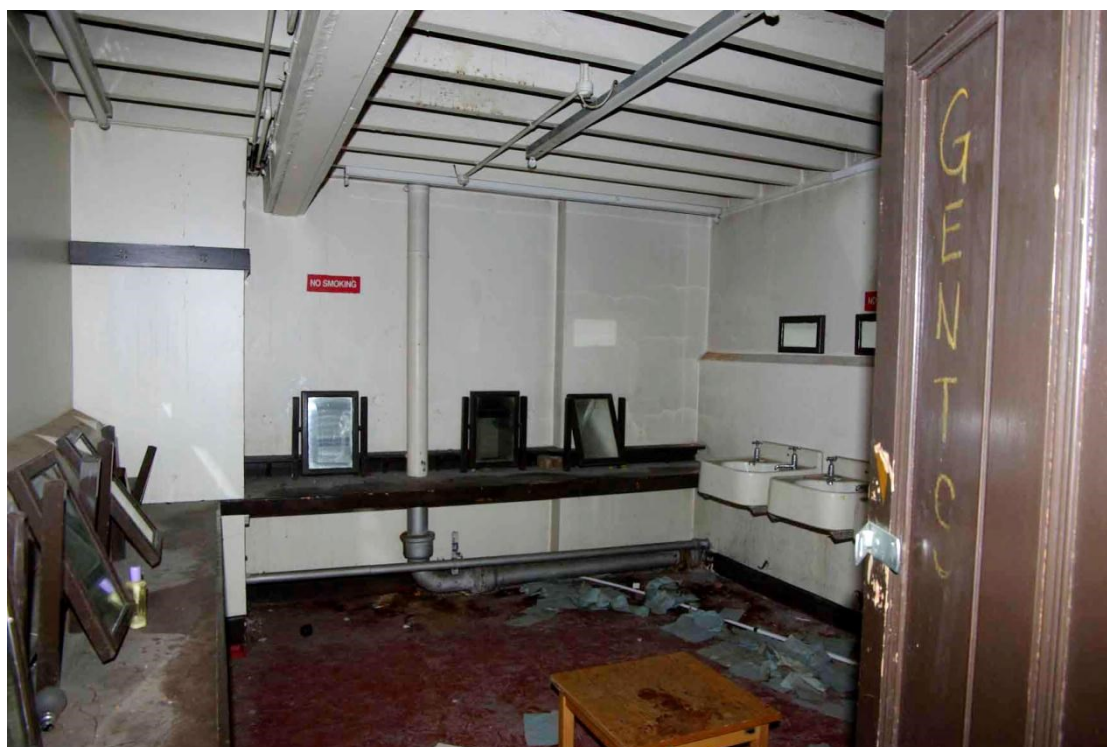
Figure 125 Men's changing room below stage

The stage fills the north end of the hall. The arch around the stage is quite plain and is as shown in the design drawing shown in Figure 16. A set of wooden steps lead up to the stage but otherwise the only access to the stage is from two doors in each flanking corridor as discussed earlier. The wooden stage has a slight rake on it and has winding apparatus on the east side to open and close the curtains (Fig. 124). There are other pieces of equipment associated with the lighting and backdrops. A set of stairs at the back corner of each side of the stage leads down to the doors to both flanking corridors. The stairs continue down to a large space beneath the stage into which has been built the male and female changing rooms and a large open space for electrical equipment. Each room has a bench running around two sides with wooden mirrors attached, a row of washbasins fills another wall (Fig. 125). Two small toilet cubicles have also been added into the under stage area.

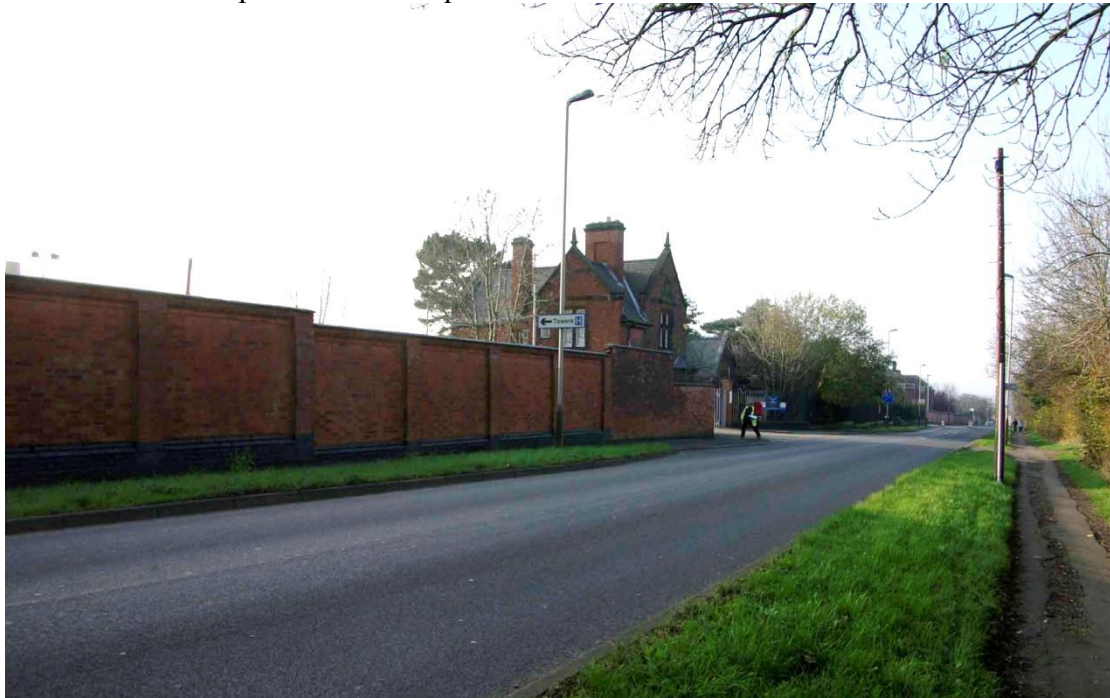
Figure 126 Original gate lodge  
Looking south-west from Gipsy Lane

The eastern lodge is a two storey red brick building with a slate roof. It has decorative limestone detailing around the windows and limestone coping on the parapets at each gable end (Figs. 126 to 128). The east and west elevations have shallow bays continuing up to form small projecting gables. Set at an angle into the north west and south west corners are two ground floor bays with leaded roofs. These may have been for surveillance of visitors and staff entering and leaving the premises. Wooden framed sash windows are used throughout the building. A small single storey extension has been added to the south eastern corner to increase the size of the room. The extension bricks look to date from the 1960s at the earliest (Fig. 128). To the rear (east) of the lodge is a small enclosed backyard with an outhouse and privy built along the north wall. Blue brick copings along the top of the backyard wall have a stamped maker's mark of Joseph Hamblet of West Bromwich and the date stamp of 1893.

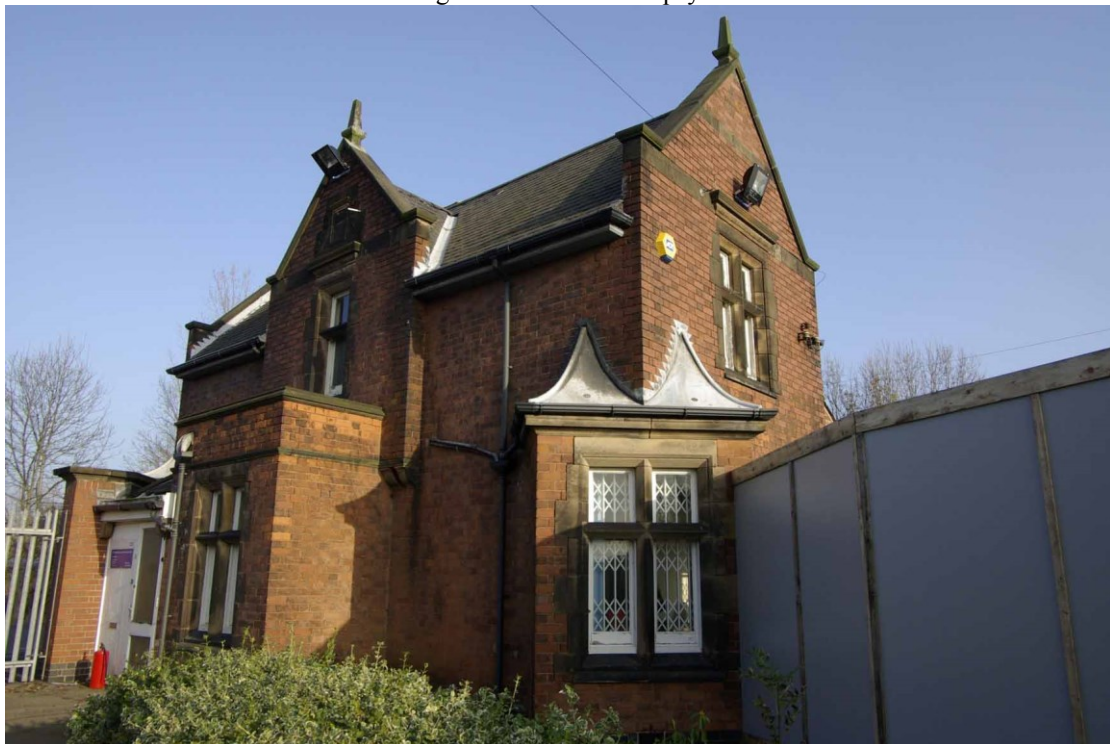
Figure 127 Lodge  
Looking north-east. Gates onto Gipsy Lane on left of photo

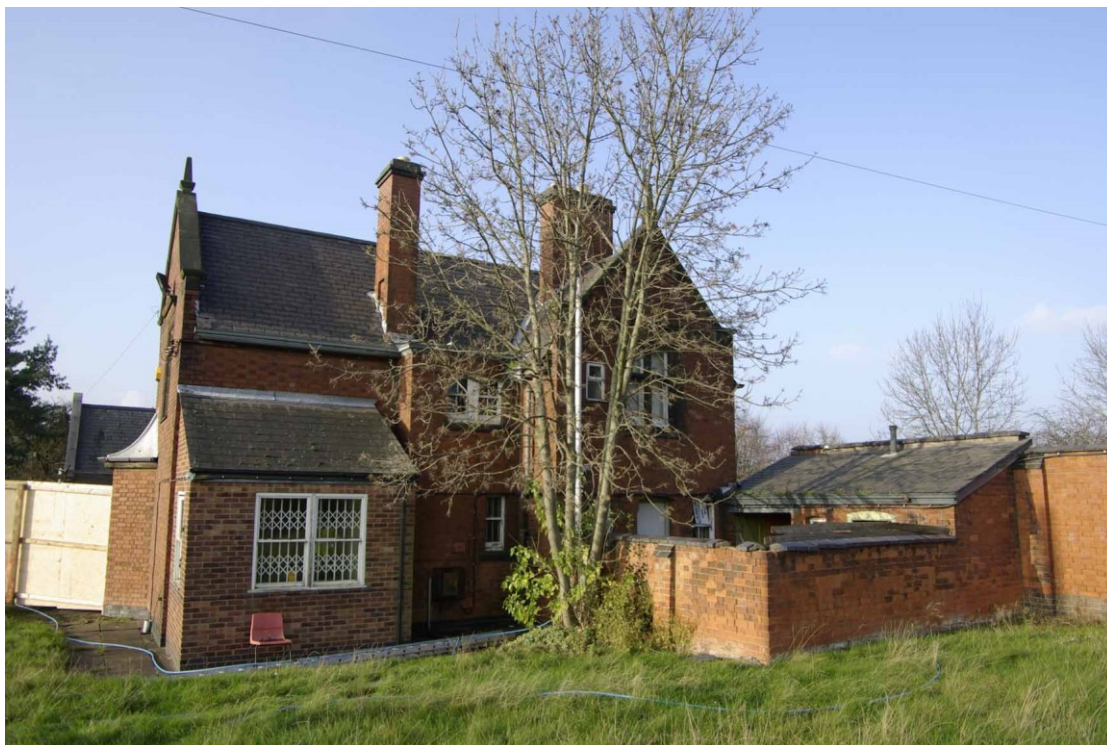
Figure 128 Lodge  
Looking north-west
