**A Level 2 and 3 Historic Building  
Survey at the former Towers Hospital,  
Gipsy Lane,  
Leicester.**

**NGR: SK 618 060**

ULAS Report No. 2014-204  
©2015

**For: KRT Associates**

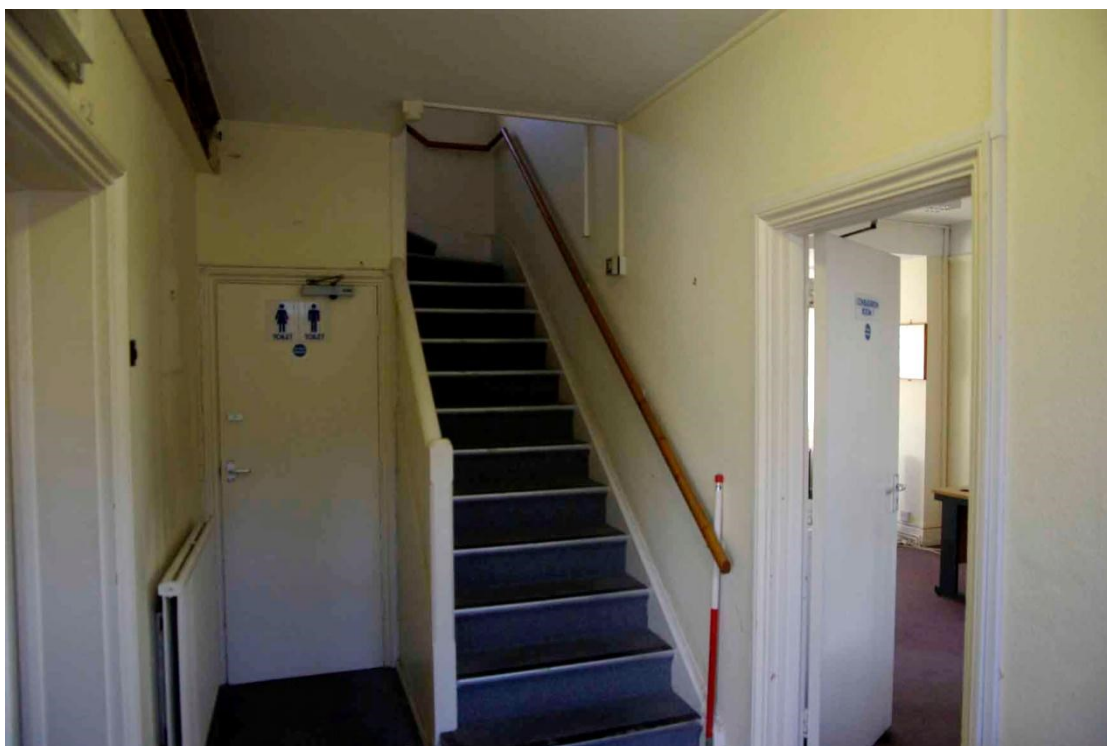
Figure 129 Lodge hallway  
Looking east, 1m scale

Inside the lodge has two ground floor rooms either side of a hallway and stairs to the first floor (Fig. 129). The southern ground floor room, which has had the modern extension, has a full height cupboard built over and around the corner fireplace but is otherwise bare of fittings. The room does however have a picture rail and a high moulded skirting board. The northern room has a blocked fireplace and a doorway leading into a small kitchen and pantry (Fig. 130). There is an enclosed cupboard to the side of the chimney breast and, as in the south room, there is a moulded skirting board and picture rail. The kitchen has a door to the back yard and another one to the pantry which has a stone slab for cold storage. The inclusion of a kitchen and pantry might suggest a domestic use for this building when first built. The first floor has two main bedrooms with a smaller one built over the kitchen on the north eastern side. The main bedroom has a blocked fireplace and looks down the slope towards the Daisy Peake range (Fig. 131). A bathroom has been fitted into a small room over the hallway. No fittings or decorative features survive in any of the rooms.

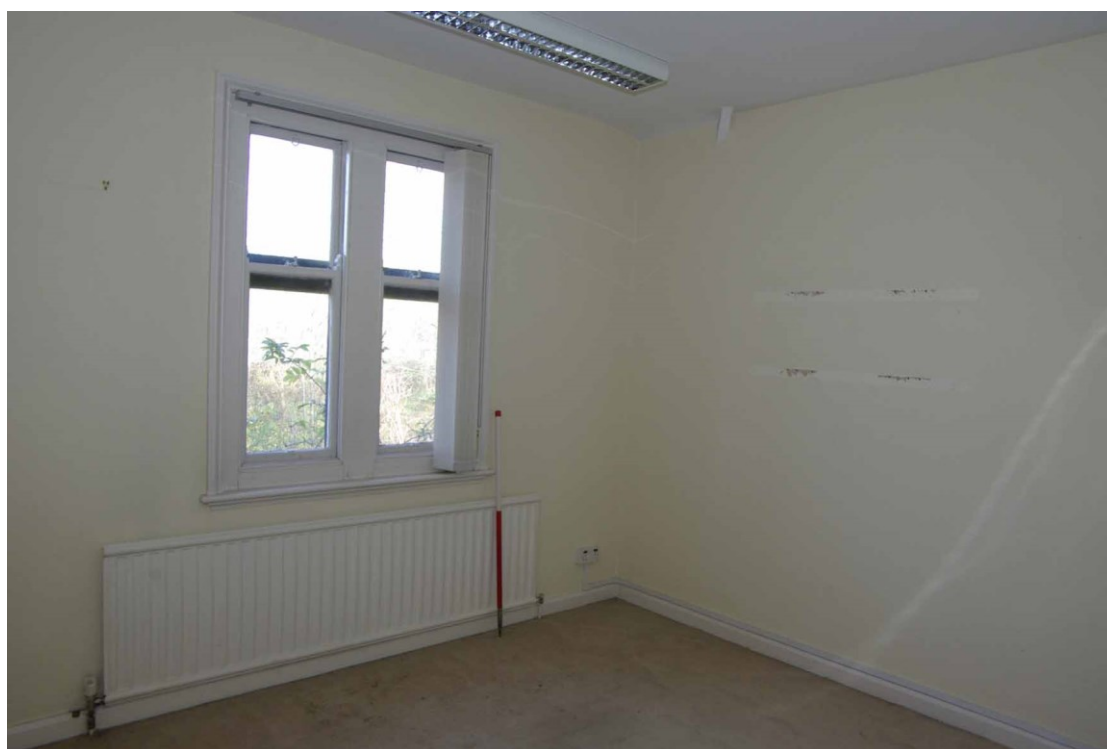
Figure 131 Lodge main bedroom  
Looking south, 1m scale

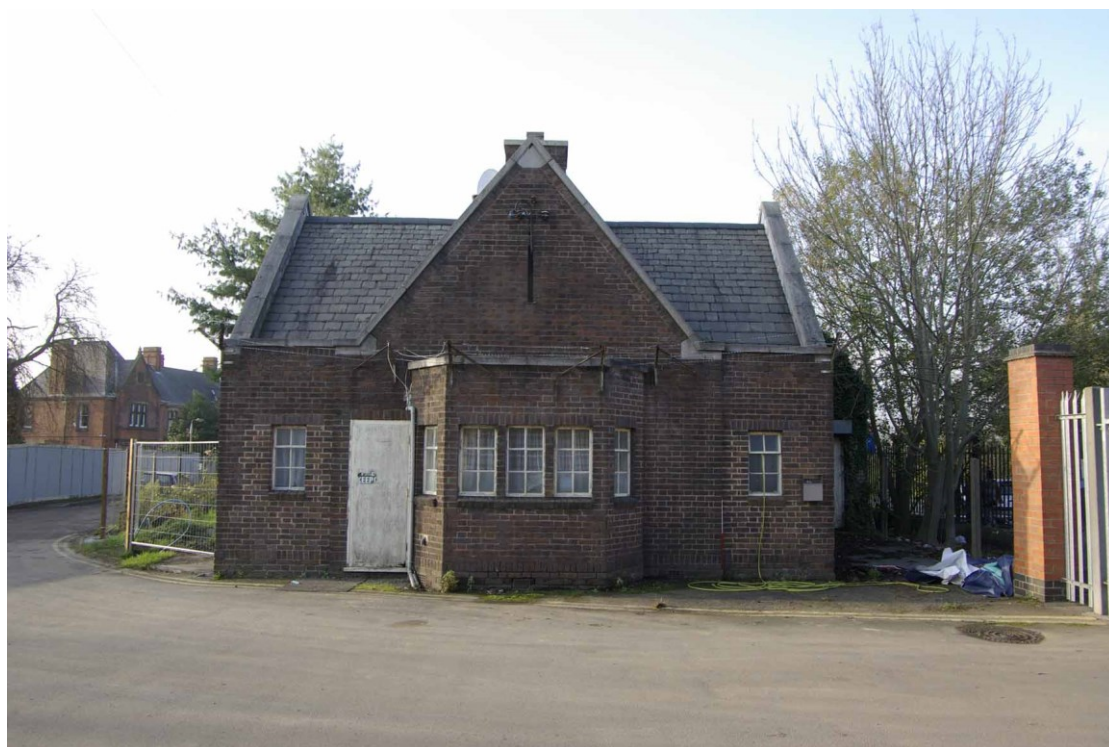
Figure 132 West lodge/ social club  
Looking west. Gate to Gypsy Lane on right of photo

The single storey western lodge appears to have tried to make an attempt at copying the style of the east lodge but uses modern dark brown bricks instead of the red brick used on every other building (Figs. 132 to 134). The slate has the appearance of having local Swithland slates instead of the Welsh slate used elsewhere. It has some limestone decoration around the eaves and gables but the windows have brick sills. The windows appear to date from the late 1940s or early 1950s and have metal

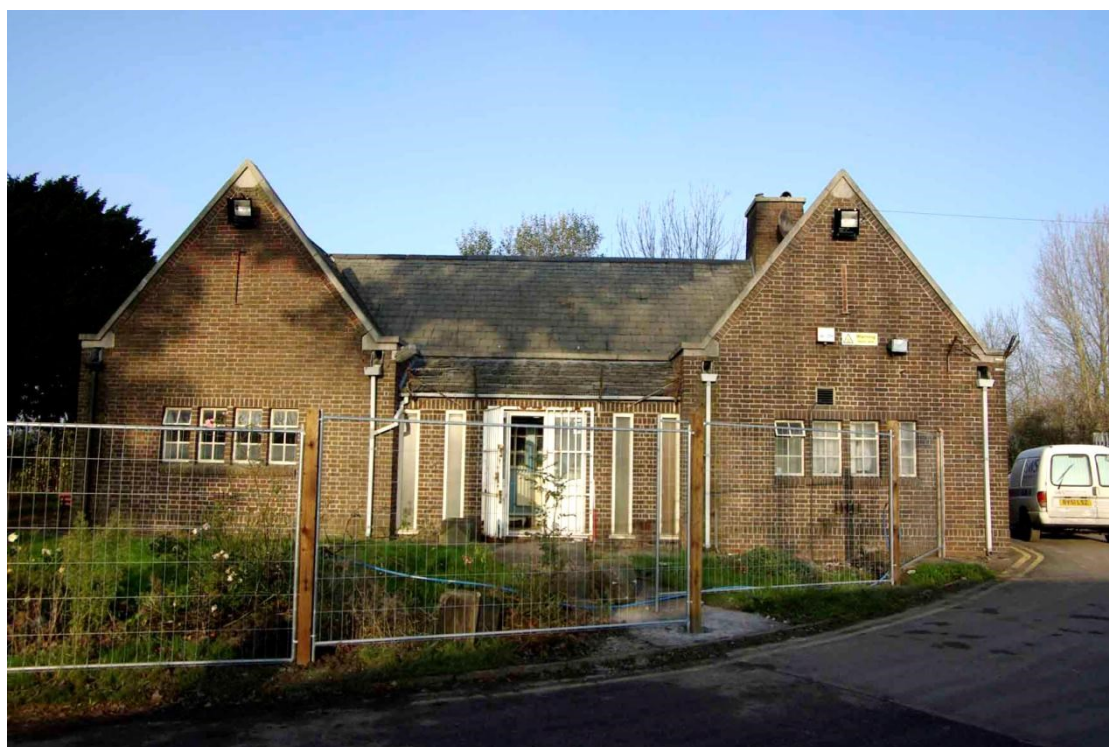
Figure 133 Lodge/social club main entrance  
Looking north

frames. The main entrance faces to the south and was originally an open portico supported by brick pillars but the gaps have now been glazed to create a narrow hall. The entrance leads into the bar room which has fitted seating around the corners of the room (Fig. 135). A doorway on the eastern side leads to the toilets and the barrel store which can also be reached from the outside. To the west of the bar room is the function room with a bar built into the north east corner (Fig. 136). Patio doors lead outside to a small patio and barbeque area.

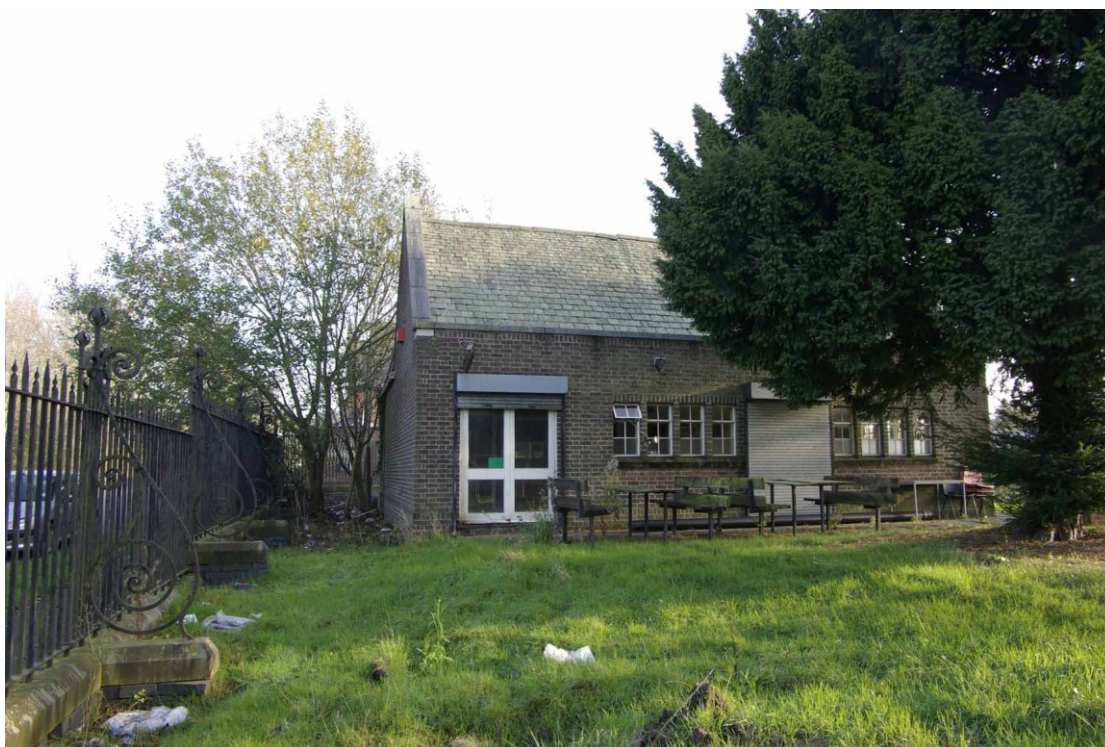
Figure 134 Lodge/social club  
Looking east. Note decorative railings along Gypsy Lane to left of photo

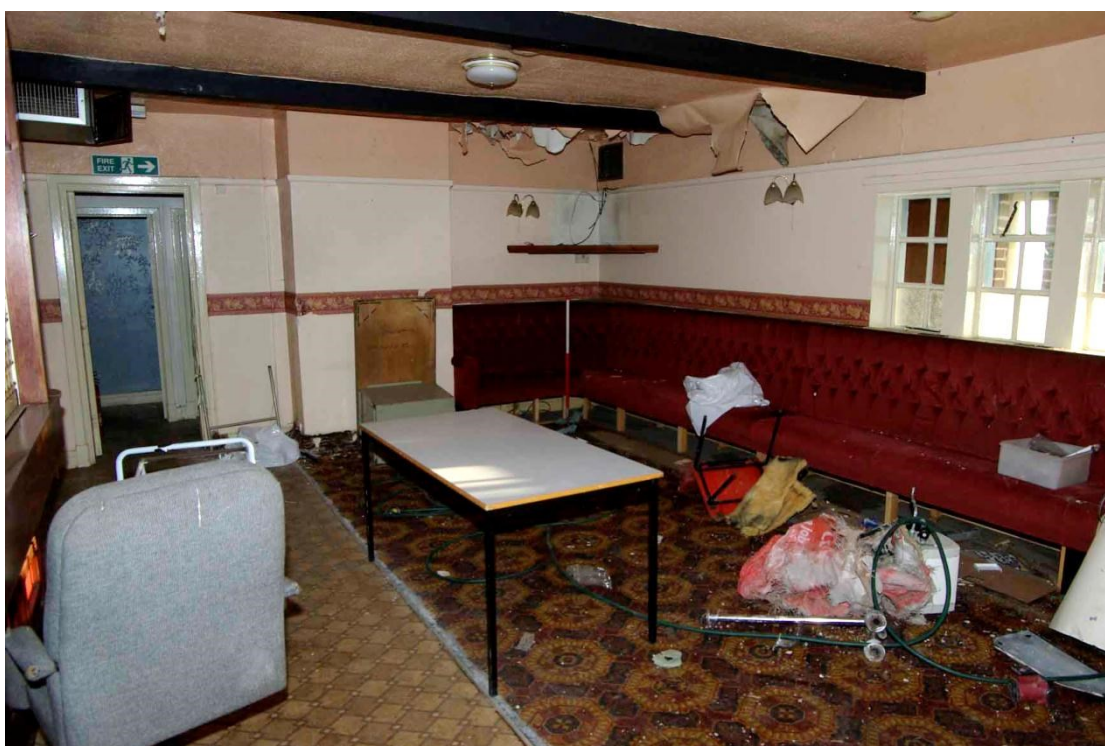
Figure 135 Social club bar room  
Looking south-east, 1m scale. Bar on left of picture

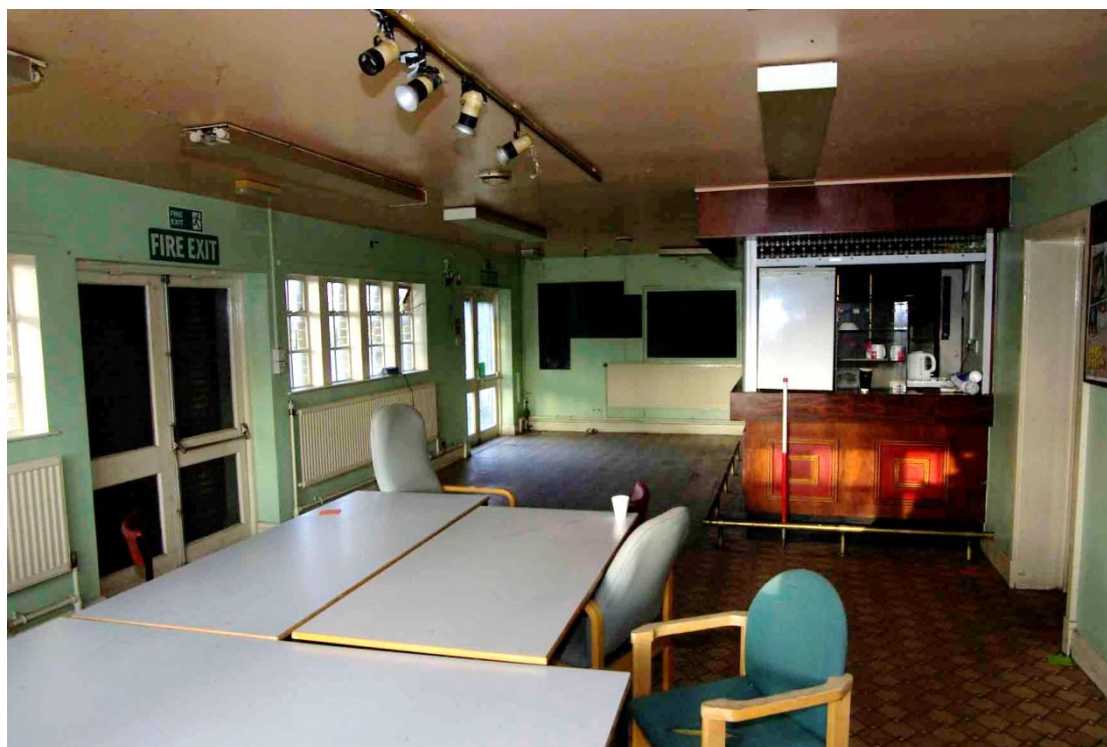
Figure 136 Social club function room  
Looking north, 1m scale. Door to bar room on right of photo
