**A Historic Building Survey
at the former
Great Central Railway Station,
Great Central Street,
Leicester.**

NGR: SK 58196 04723

ULAS Report No. 2018-038
©2018

For: Charles Street Properties

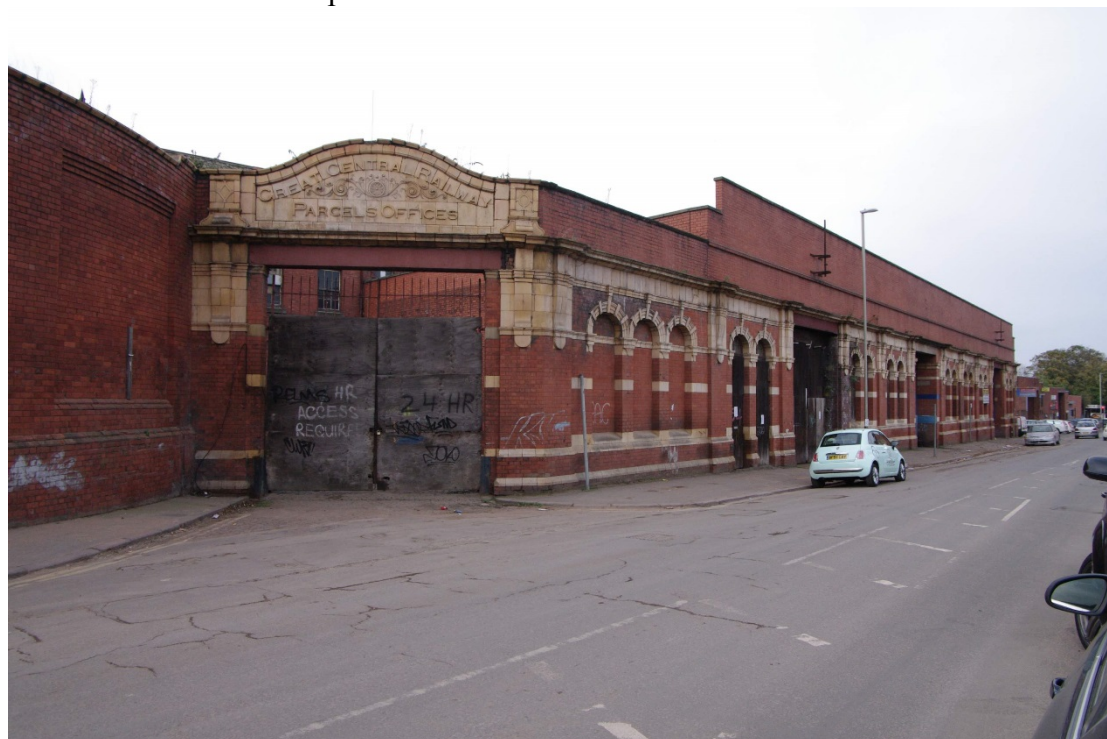
Figure 18 East-facing elevation of portico
Looking north-west. Curved wall on left of picture wrapped around the former
turntable

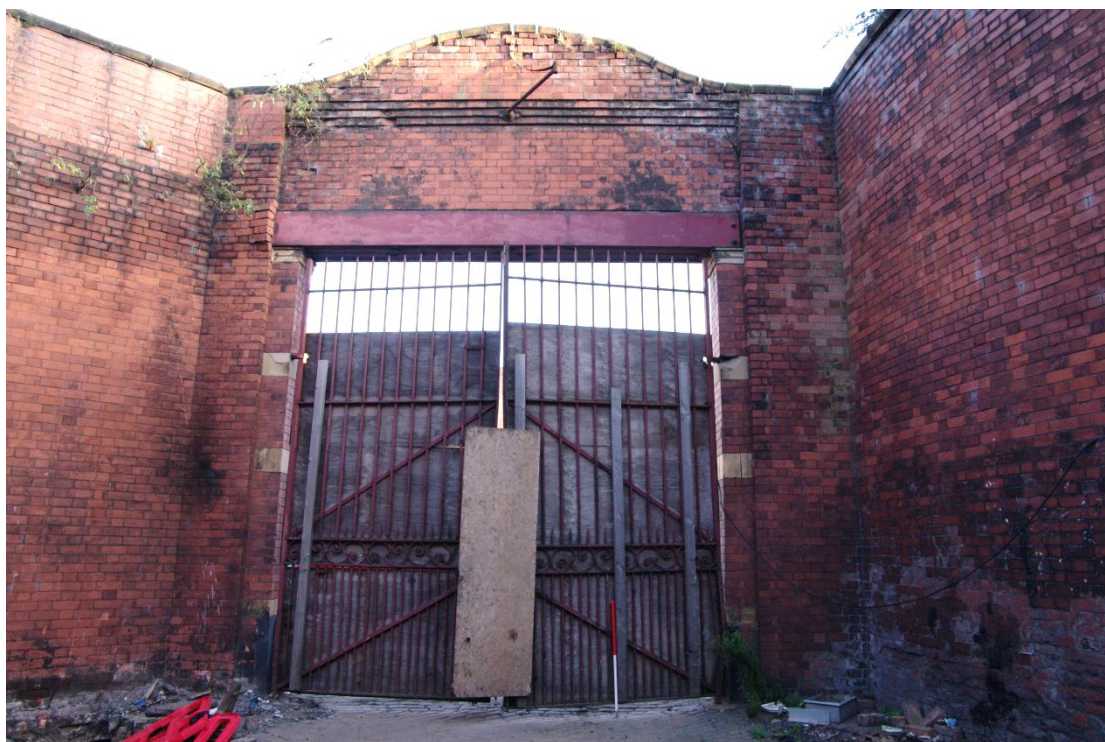
Figure 21 Parcels office yard gates
Viewed from the inside looking south-east. 1m scale

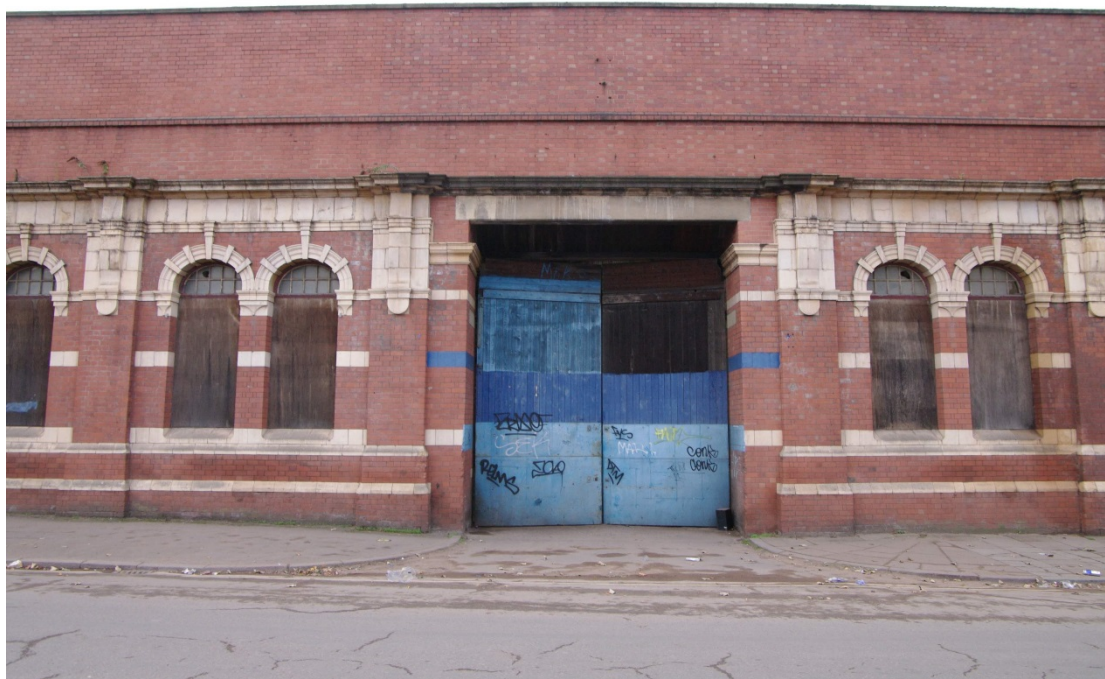
Figure 26 East-facing elevation of portico, centre vehicle entrance
Looking west. Note the concrete lintel which replaced a large archway beneath the
demolished clock tower

When first built the east-facing elevation had a series of Dutch gables above each arch and a large clock tower over the middle vehicle entrance (Figure 28). The gables had variety of pediments and urns giving the façade a rather unbalanced impression. The clock tower sat above a broad arch. In 1957 British Railways demolished the gables and clock tower along the façade as it was thought that the roof portico was unsafe. They were replaced by the much plainer red brick parapet which exists today. Despite its relative plainness some care has been taken over the brickwork which has been laid in header/stretcher bond to match the original brick courses. The arch below the tower was also replaced with the concrete lintel mentioned earlier. Two sets of brackets with

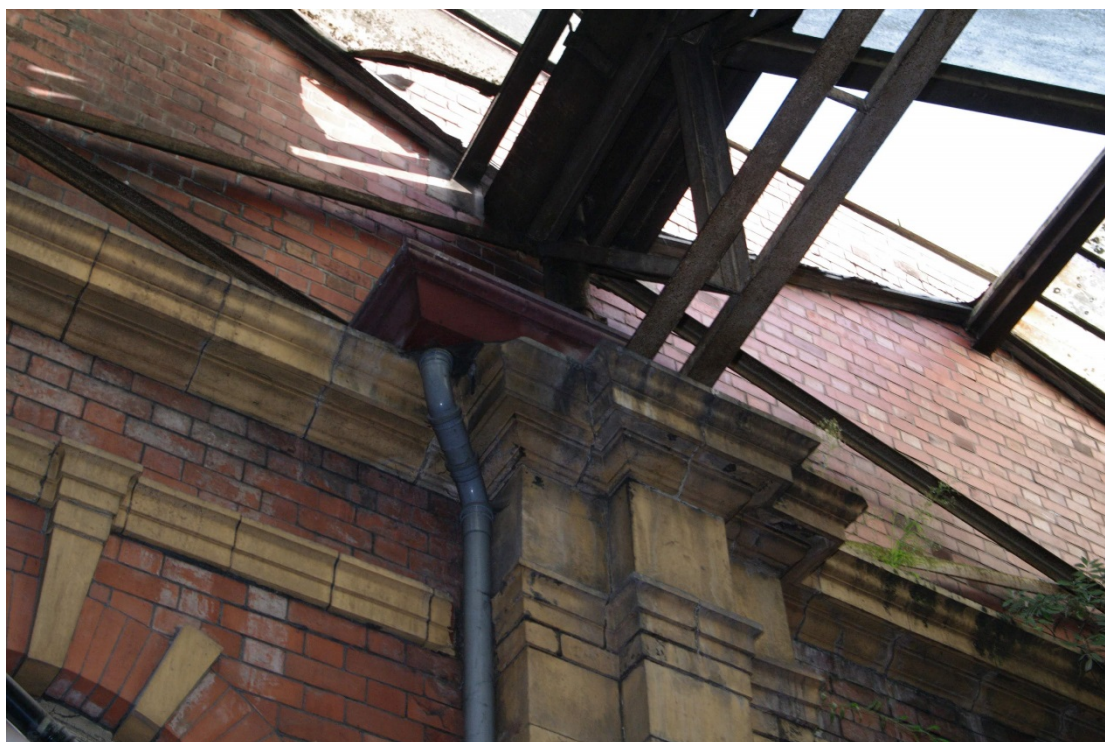
framed with arched windows above (Figure 36). At the top of the original wall is the rebuilt portion of the parapet into which the steelwork of the roof is attached (Figure 37). The roof structure is quite lightweight in nature consisting of L-section metalwork in many parts (Figure 38). This is likely to have been substantially rebuilt in the 1950s when the steelwork of the original roof needed to be repaired. At the apex of each brick gable a hand-painted number identifies each bay from Number 1 at the south end to Number 10 at the north. Most of the glazed roof panels still survive.

Figure 37 Portico area G1 east wall and roof structure
Looking east

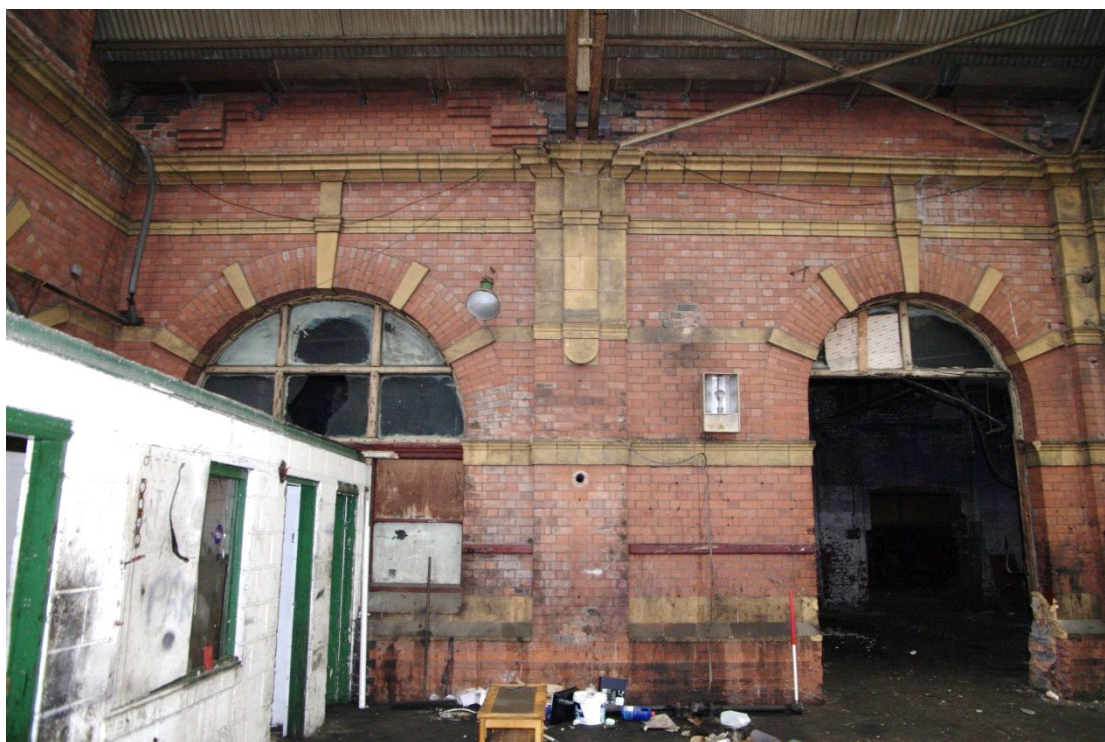
Figure 47 Portico area G7 west wall, southern end bays, entrances to G9. Looking west. 1m scale. Note partially smashed masonry at base of opening to right of scale

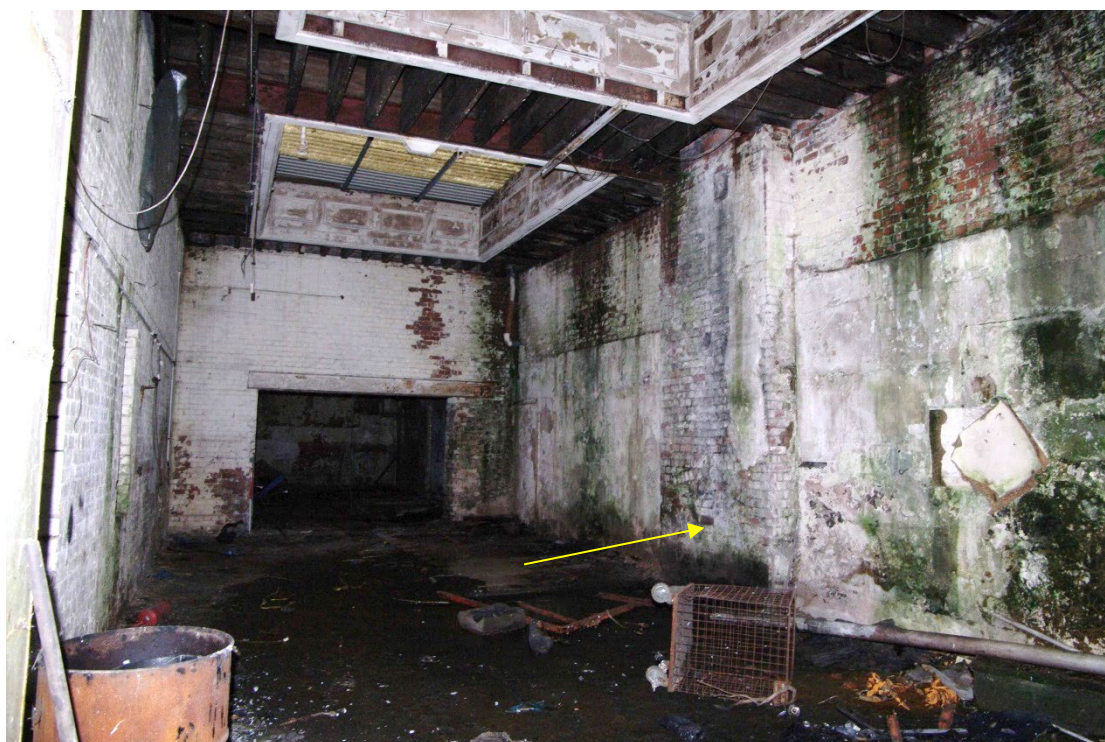
This area appears to have been for the use of staff only and was where the ticket office was located. The room is in a poor state of repair with damp causing a problem on the west wall which backs against the raised track bed (Figure 55). The walls are mostly painted although traces of plaster still survive in some places. Most of the walls are laid in English bond i.e. a course of headers followed by a course of stretchers. A blocked fireplace and narrow chimney breast rise up the west wall and can be seen at platform level outside (see Figure 102 below). Along the east wall is a small blocked single-width door and three blocked hatches through which tickets were sold to passengers in the booking hall G6 (Figure 56). The hatches and doorway have been blocked with modern bricks. Figure 57 shows the new ticket office as photographed by Newton shortly after it opened. No trace of the shelves holding tickets and other equipment have survived. The south wall presently has a large, car width, opening supported by a large steel RSJ beam which has been knocked through to room G4. Newton's photograph indicates that there were at least two hatches on this wall for passengers passing from the portico towards the subway. Presently the main entrance to this room is on the north wall from the open yard G2 via the large modified doorway (Figure 58). As discussed, this is a modern opening although it seems likely that there would always have been some form of access from the ticket office to the yard.

Figure 55 Room G3, ticket office
Looking south-west. Blocked fireplace arrowed

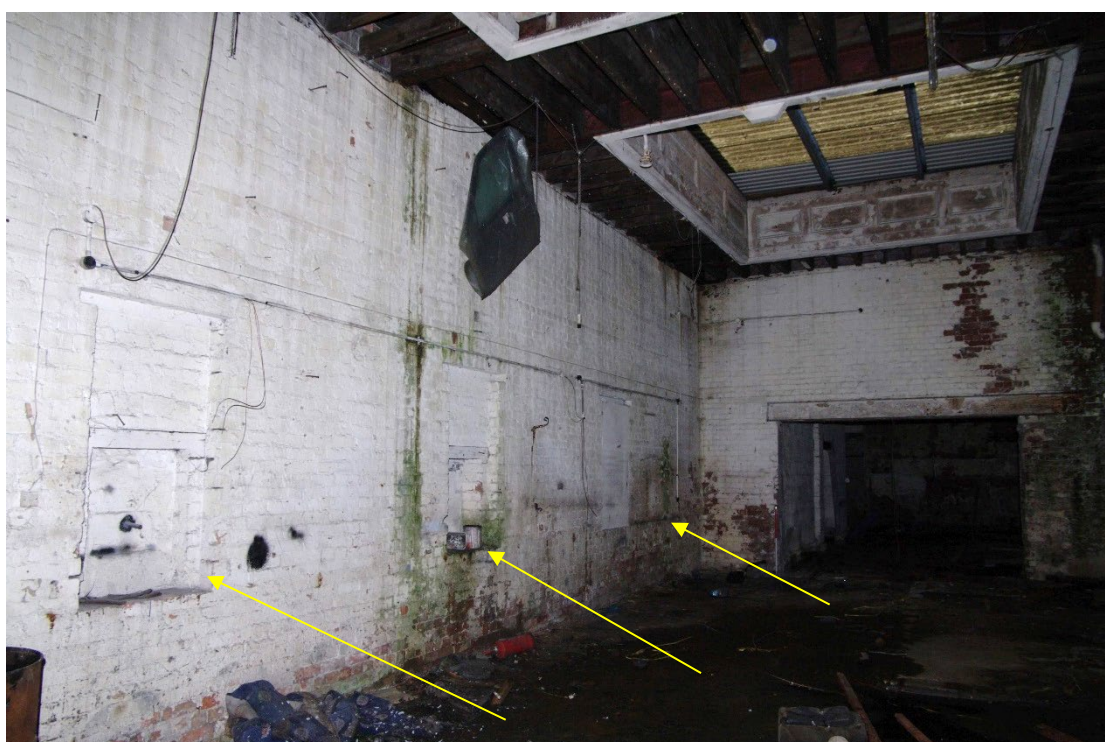
Figure 56 Room G3, ticket office
Looking south-east. Note blocked hatches (arrowed) on left-hand wall and modern opening on the end wall

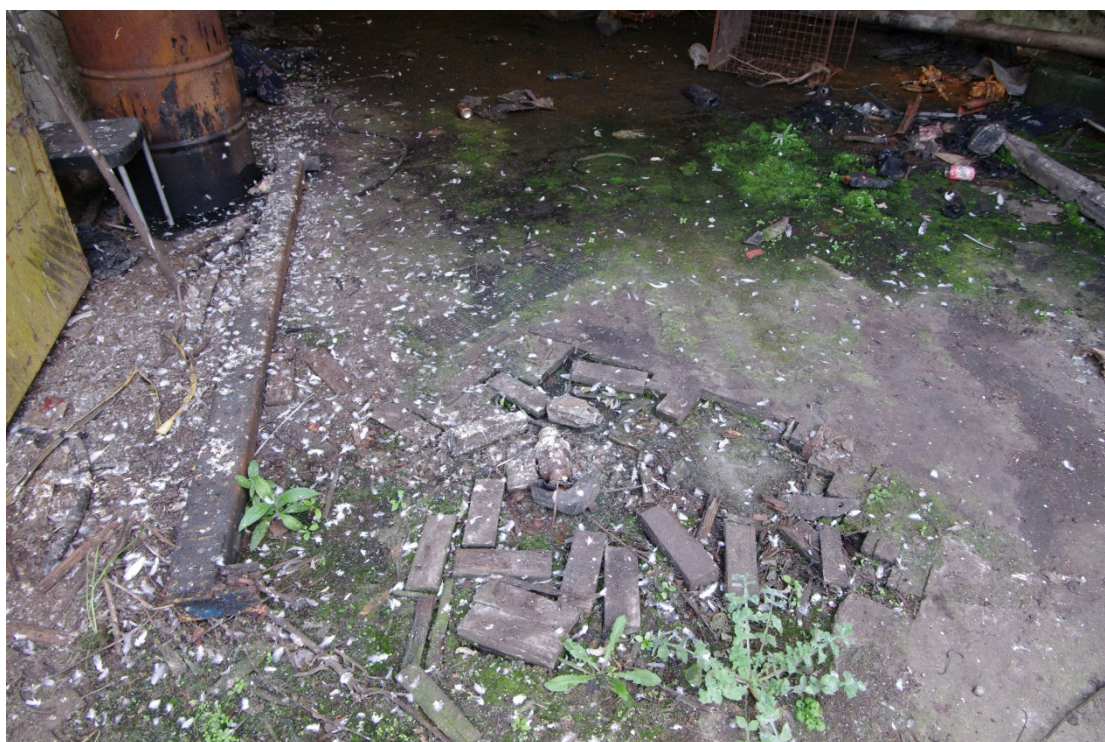
The floor still retains its woodblock floor laid in a herringbone pattern although it is soaked in engine oil from the car repair depot. Water from the leaking roof has also caused significant damage (Figure 59). Because of its semi-basement location Room G3 has no windows but has two large skylights in the ceiling (see Figure 58). These have wooden panelled surrounds but the original glazing has been removed. This style of skylight is seen in the other rooms of the booking hall area. The main ceiling plasterboard has been removed, or has collapsed, leaving the exposed ceiling joists which appear to be in a poor state of repair.

Figure 59 Room G3, woodblock floor
Looking west close to doorway to yard G2

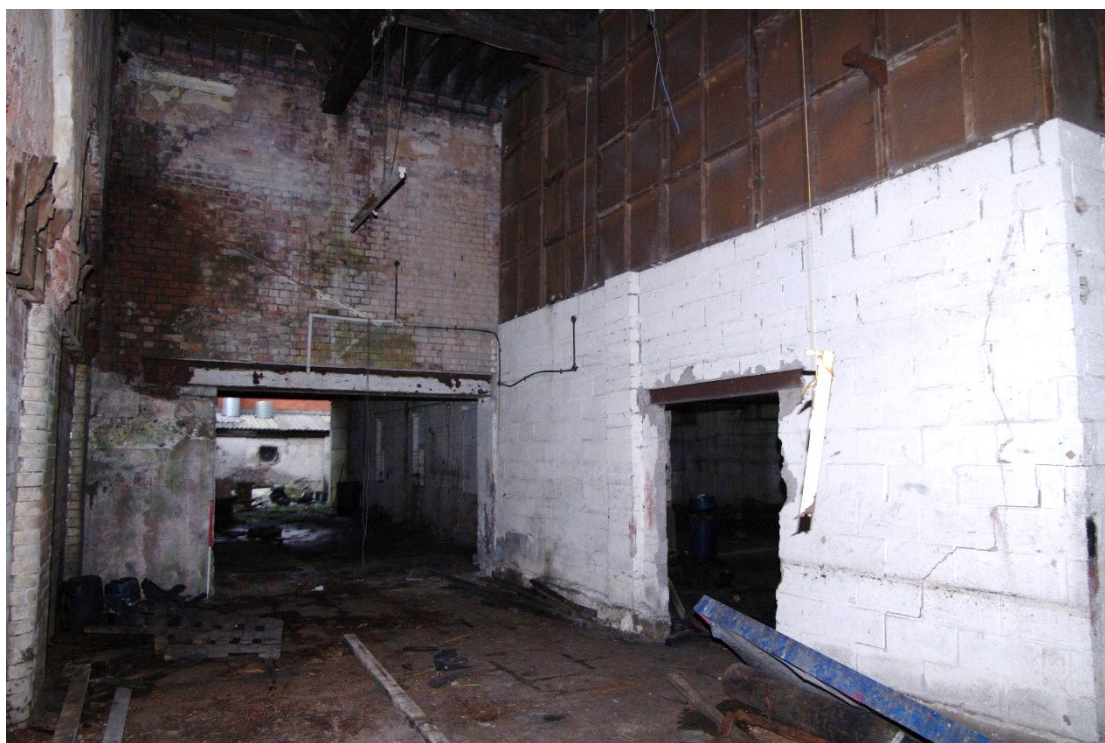
Figure 60 Room G4
Looking north-east through modern opening into G3. 1m scale. Modern partition wall
on right. Brackets over arch to the subway entrance are just visible on the left

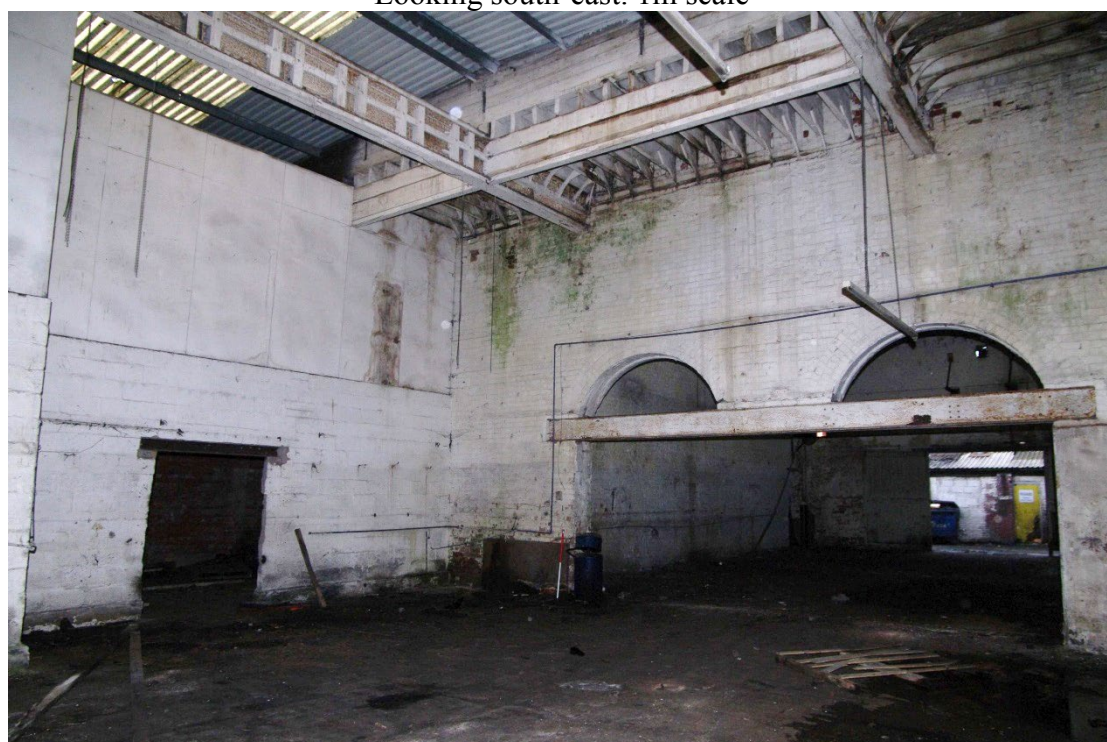
Figure 66 Room G5
Looking north-west into booking hall G6. 1m scale. Modern inserted wall on left.
Compare the truncated arches with the 1967 view in Figure 32 above

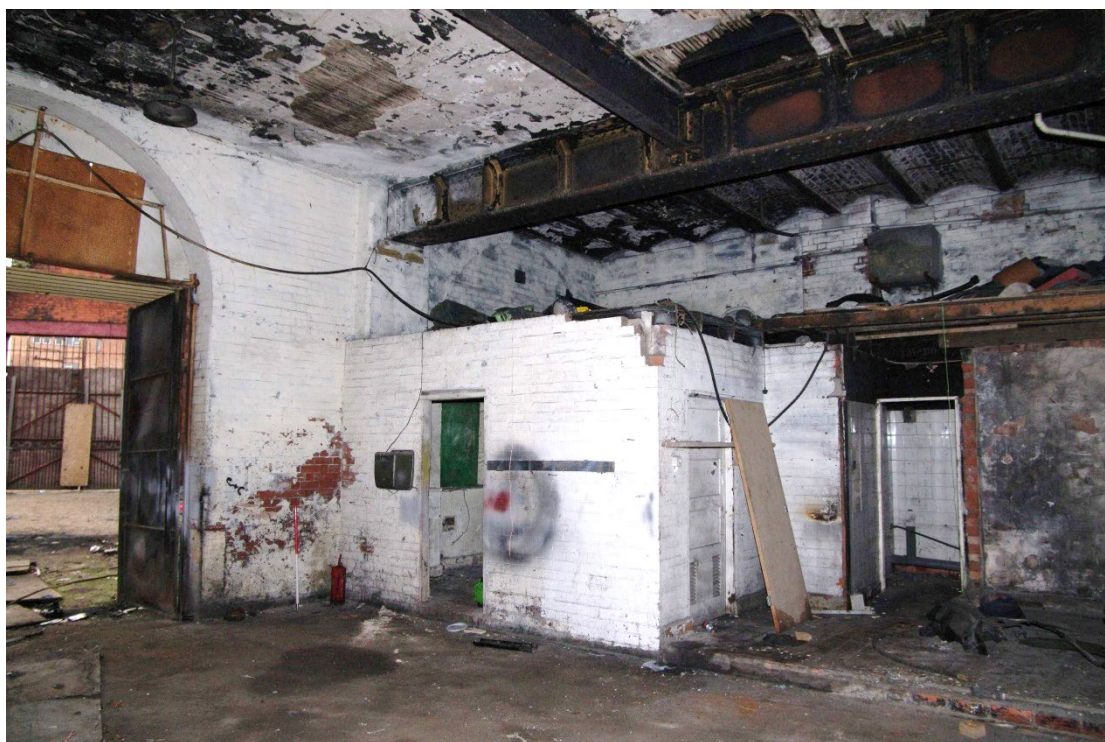
Room G8 is the southernmost of the parcels office ground-floor rooms and contains the main entrance from the open parcels yard which leads out to the street (Figure 73). The metal-framed doors to the yard are modern replacements and are flat-topped. The entrance is arched which suggests that the original door may have been arched too. The north wall of this room has two smaller arched openings, one of which has been bricked up (Figure 74). The arches have plain brickwork with no decoration but do have metal buffers attached to their jambs to avoid damage by trollies. The west wall is plain brick

Figure 73 Parcels office ground-floor Room G8
Looking south-east. 1m scale. Parcels yard on left. Note vaulted brick ceiling on right

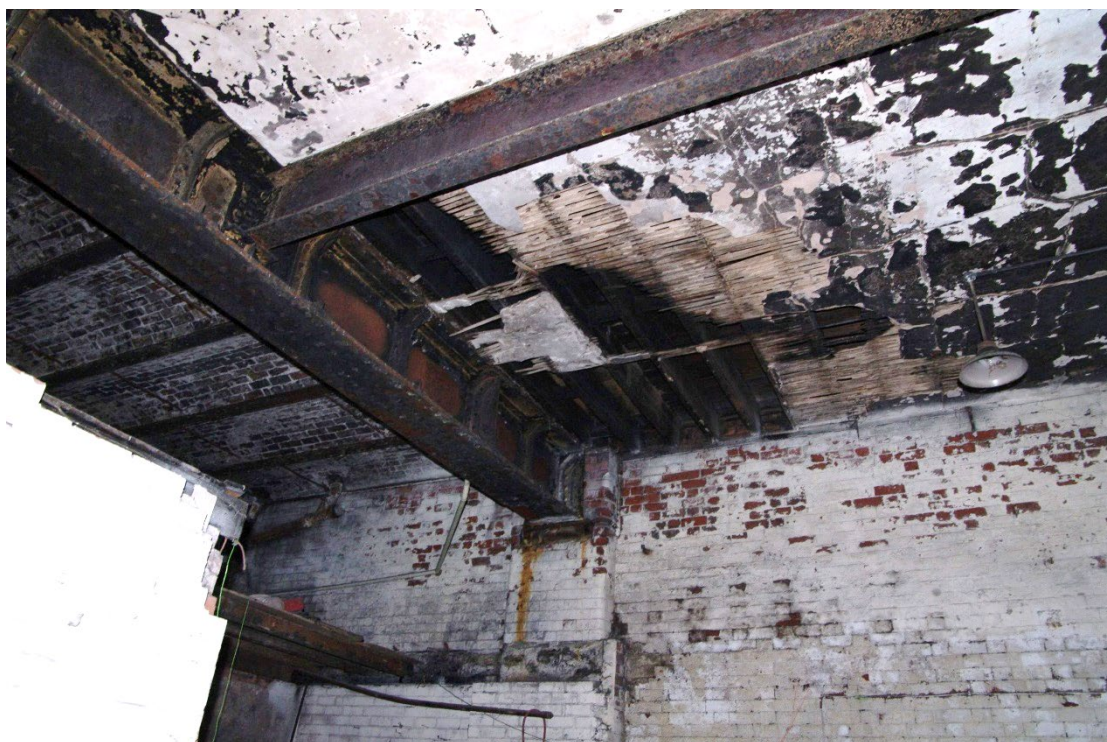
In addition to damaging the offices the fire has burnt away some of the ceiling (Figure 75). Fortunately the fire does not appear to have caused any significant structural damage. The ceiling of this room is built in two parts; the northern part has timber joists with plaster and laths whereas the southern part is vaulted brick. A large steel beam, which appears to be part of the original design, separates the two components. The east to west beam is supported at each end on brick pilasters. The brick vaulting coincides with the toilet block on the first floor and which is discussed in the section below.

Figure 75 Parcels office ground-floor Room G8 fire damage
Looking towards south wall. Note vaulted ceiling on left

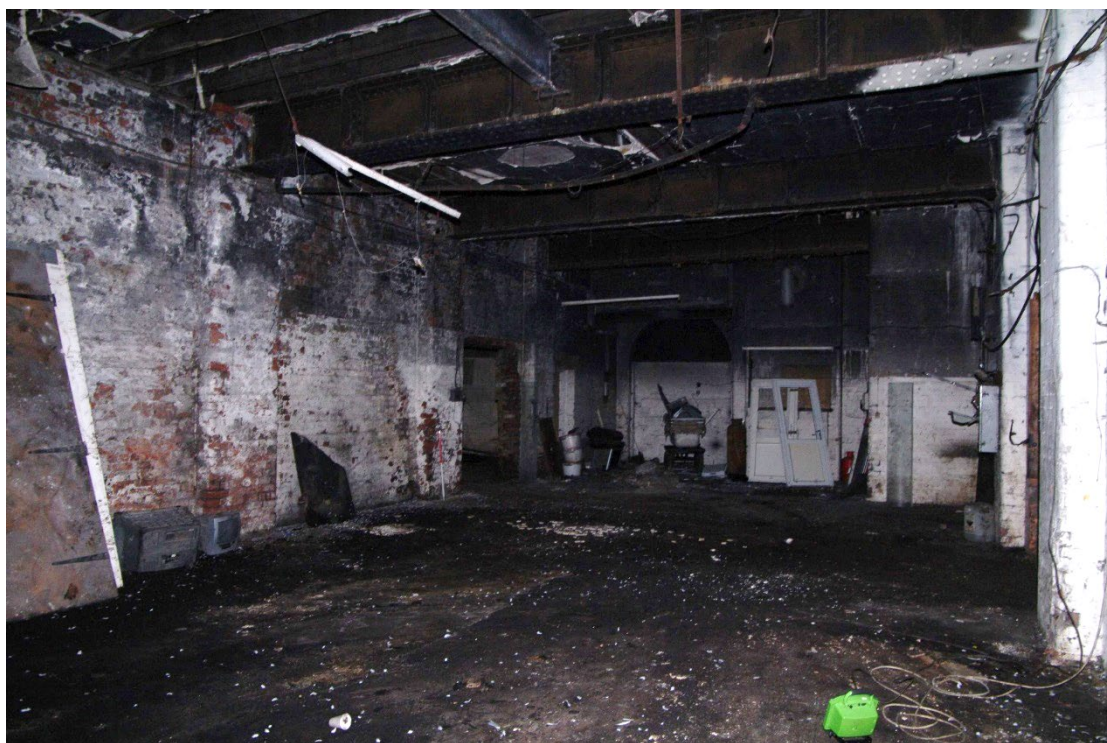
Room G9 is a long room extending to the north end of the parcels office ground floor (Figure 76). The room is very dirty having served as one of the main car parts storage and repair areas for many years. Many parts of the room appear to be smoke-blackened, possibly from welding activities. As noted two arches, one of which has been blocked, lead from Room G8. Two more arches, or bays, lead out eastwards to the portico area (Figure 77). One of these arches has been partially blocked with masonry following the insertion of the cabins seen outside in the portico. The glazed head of the arch however still remains. The other archway has no trace of any wooden frame and has been widened at its base to create a larger entrance to the room. Still on the east wall a third arch has been blocked with modern breeze blocks on the inside although from the portico it can still be seen that the wooden door and frame survive (Figure 78). Only part of this arch is visible as the rest is obscured by the base of the enclosed staircase leading up to the first floor (see Figure 49). The presence of a single doorway suggests that there was once a smaller room here, an idea which is further supported by a small fireplace built against the return of the staircase on the north wall (Figure 79). There are no traces of any internal walls although the layers of dirt and decay may well be hiding such details. Still on the north wall, beneath the return of the stairs is the blocked archway seen in Room G5 (Figure 80). This side of the archway does not have the plaster beading decoration as seen on the north side. It is not clear if this archway served the office with the fireplace or whether it led past it.

Figure 76 Parcels office ground-floor Room G9
Looking north. 1m scale. Doorway to portico on right, doorway to Room G10 far left

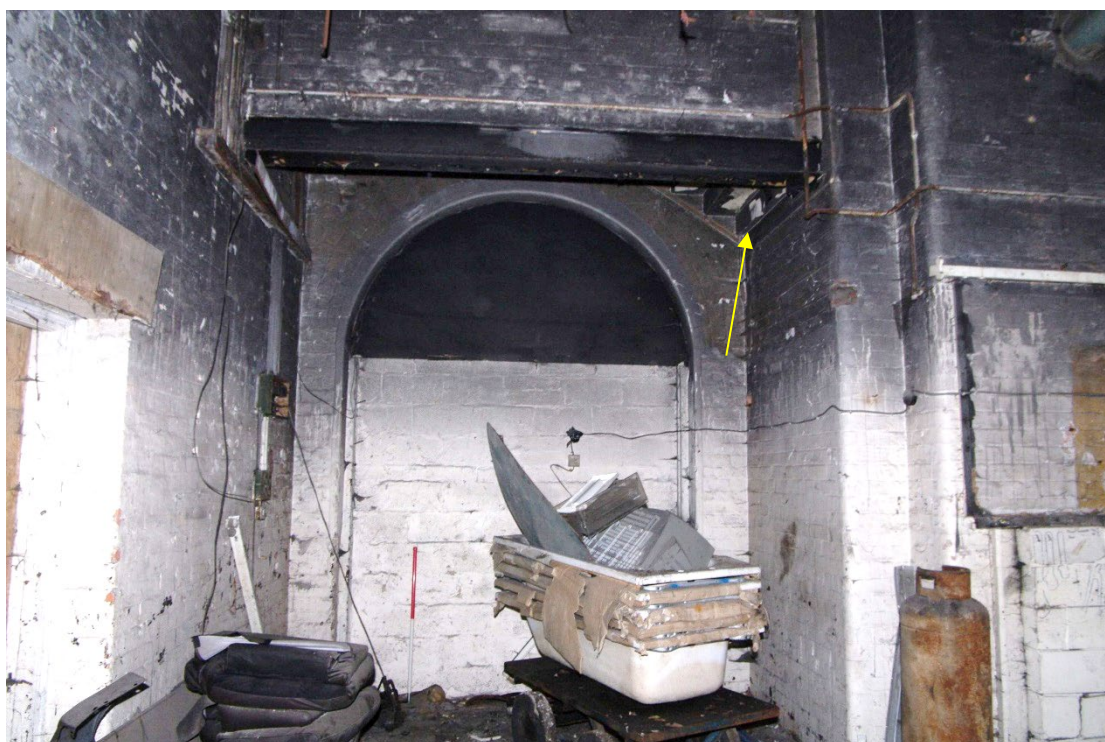
Figure 80 Parcels office Room G9 blocked archway to G5
Looking north. 1m scale. Underside of stairs arrowed. The fireplace is on the far right
of the picture. Doorway to G10 on left

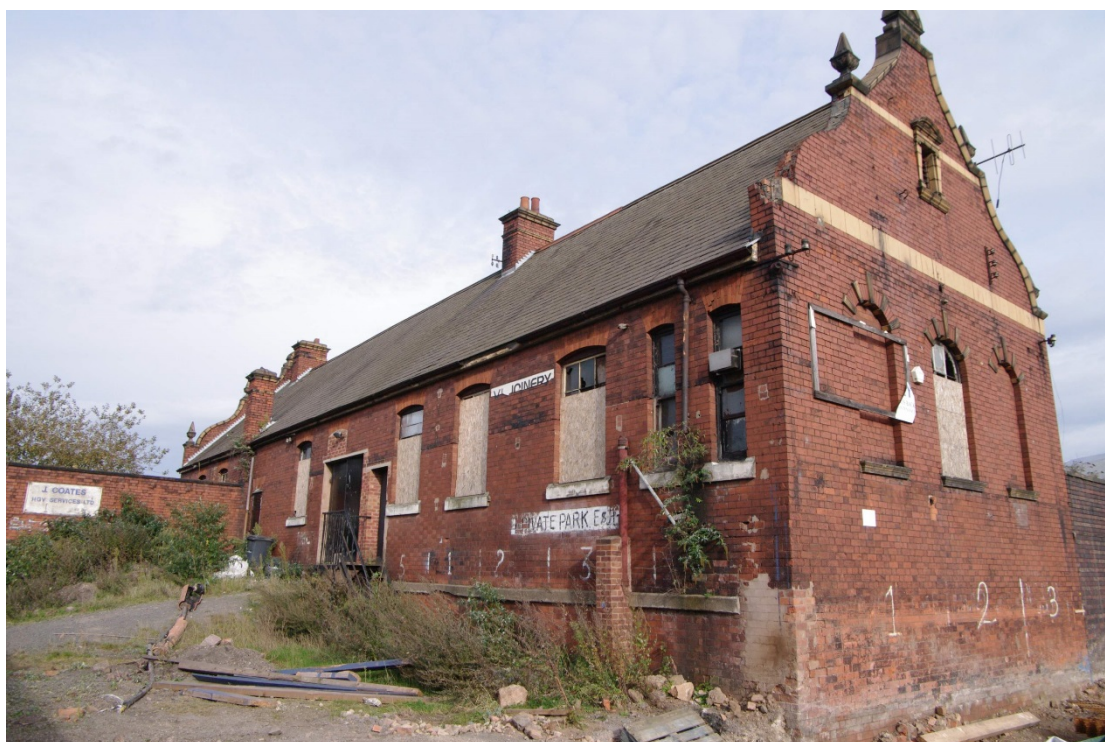
Figure 99 Parcels office west-facing elevation, south end
Looking north-east. The cement line beneath the painted numbers represents the
former platform level

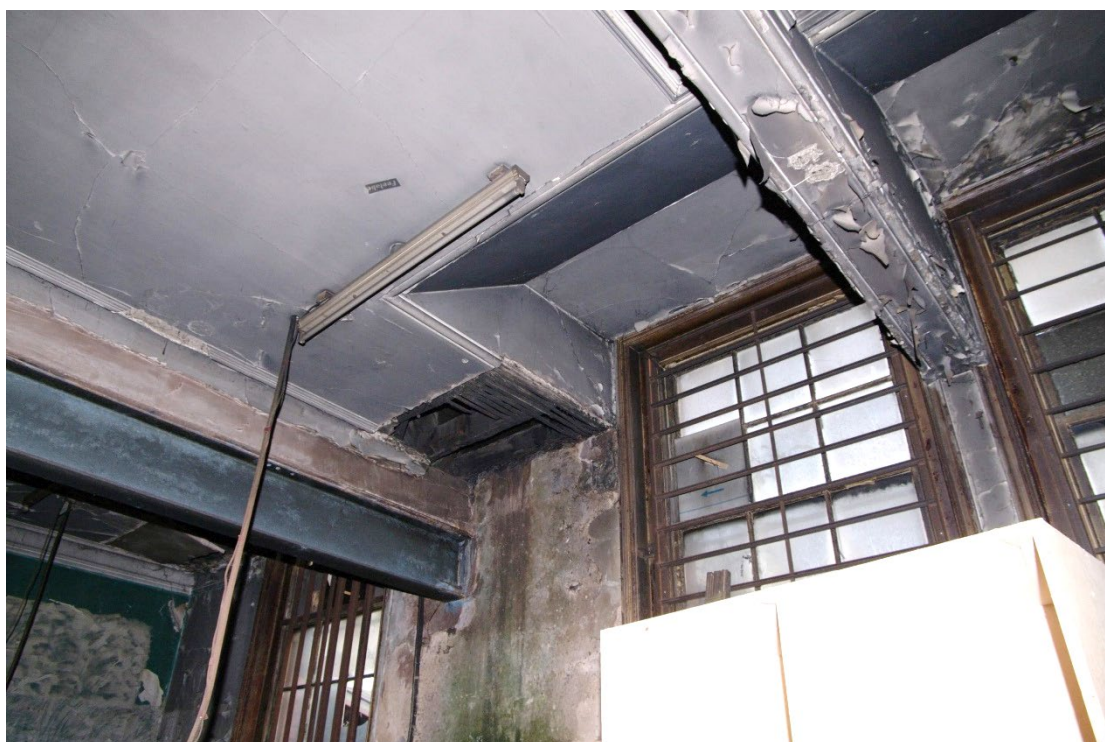
Figure 110 Parcels office Room F2 east wall window
Looking north-east. Note new steel support

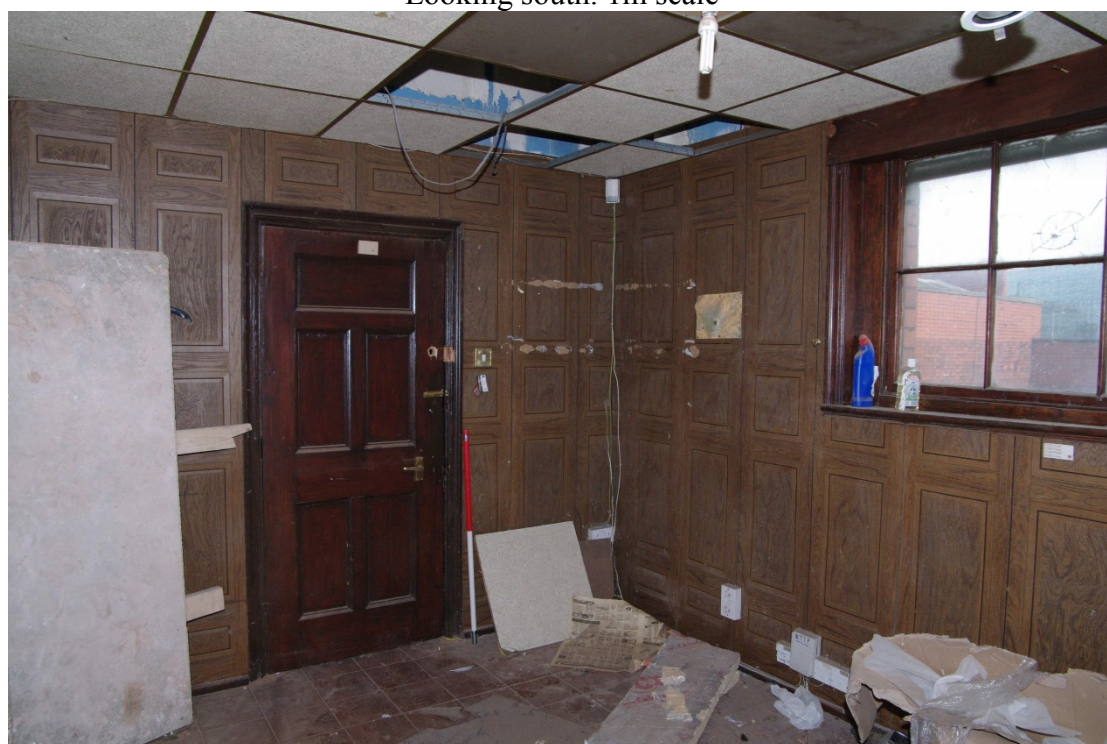
Figure 121 Parcels office Room F5
Looking north-east. 1m scale. Note false ceiling cutting sash window
