An Archaeological Watching Brief of land off Rykneld Road, Littleover, Derby. SK 31102 32477

Claire Brown
ULAS Report No 2018-047
©2018

ULAS Report Number 2018-047 ©2018 Accession Number ULAS – 2018-047 OASIS Number universi1-312535

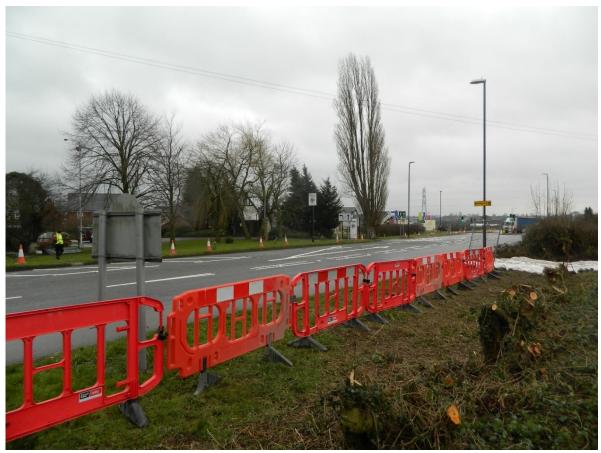
Figure 3: View of Rykneld way looking south

The proposed development is located on the southern edge of Littleover, a village close to Derby City, close to the junction with the A38, Burton Road, and is adjacent to Rykneld Road to the north, which runs along the route of the Ryknield Street, the Roman routeway (Figure 3).

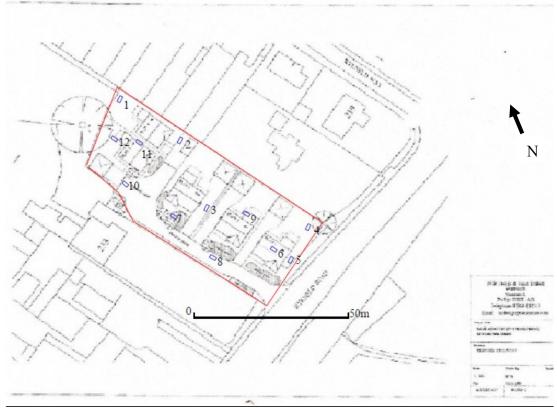
Figure 6: Location of the Geo Technical Pits

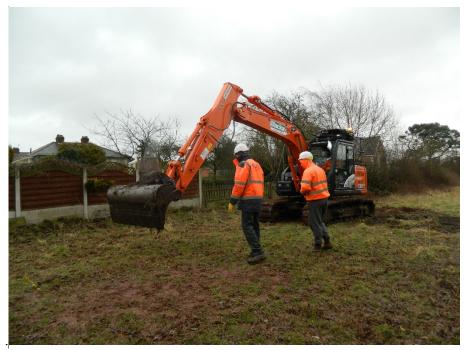
Figure 7: Mechanical excavator looking north

In March 2018 the area was subject to a second stage watching brief while the overburden was stripped off the entire site, with the exception of Test Pit 1, which was excavated by GRM as part of the required remedial works, prior to the commencement of building works. A mechanical excavator equipped with a toothless ditching bucket (*c*.1.6m wide) was employed under constant archaeological supervision to remove overburden, with excavation ceasing at undisturbed archaeological deposits (Figure 7). Archaeological deposits were recorded at an appropriate scale by photography and written records.

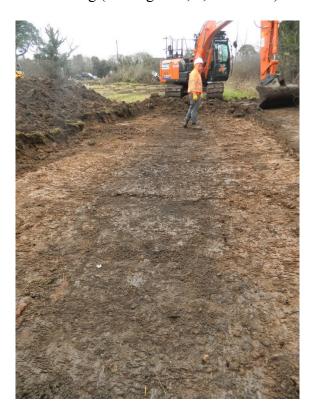
Figure 8: Dark linear formed by in-filling the furrows to level the area in the 19th century. Looking South.

The stripped area revealed evidence of ridge and furrow running approximately north to south across the site, with deposits of Victorian made ground containing Victorian pottery, glass, charcoal, brick and occasional animal bones forming linear 'stripes' in the furrows probably the result of 19th Century ground levelling (See Figure 8, 9, 10 and 11).

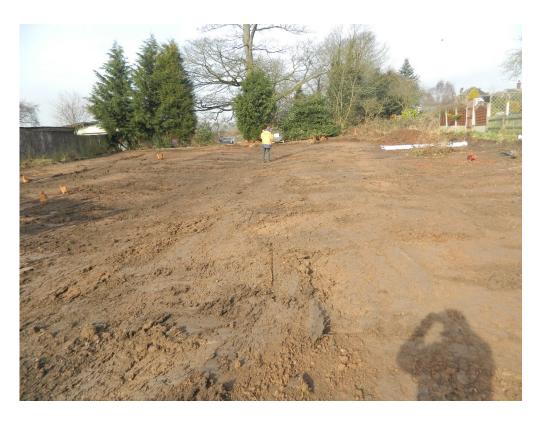
Figure 9: Site stripped of overburden apart from made ground remaining in furrows as dark 'stripes'. Looking north-west.

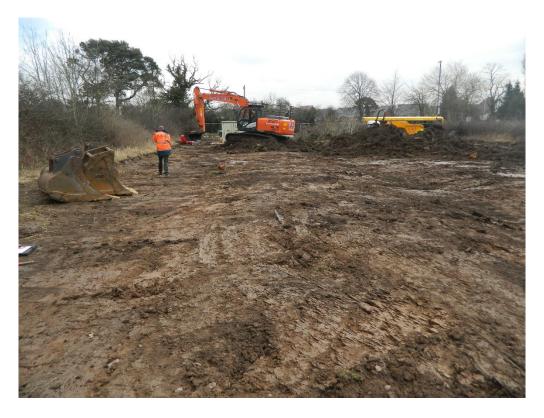
Figure 10: Site stripped of overburden looking south-east.

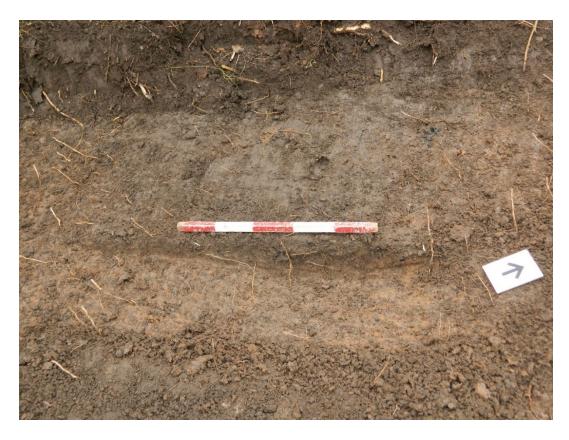
Figure 11: Excavation of furrow 'linear' formed by 19th century levelling.

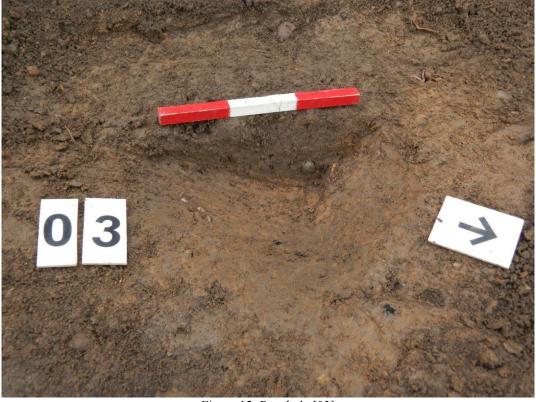
Figure 12: Post hole [03]

Two post holes [03] and [05] were identified in line with the western boundary of the site (Figures 12 and 13).

They were shallow, less than 0.1m in depth and less than 0.5m in diameter, and contained mid grey brown silty clay fill containing occasional charcoal and brick fragments but no dateable evidence.

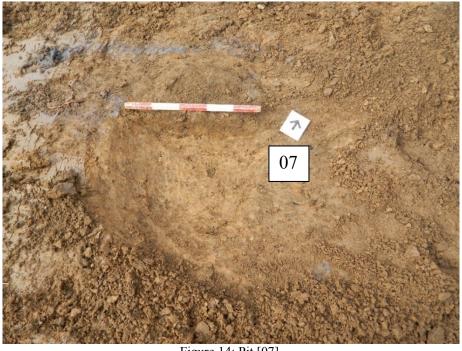
Figure 14: Pit [07].

In the centre of the site two small pits [07] and [09] containing Victorian material (pottery, glass, brick, and animal bone) were identified and excavated (although [10] only partially - excavation ceasing once modern material was discovered), [07] is seen in Figure 14.

Pit [07] was 0.1m in depth and 0.5m in diameter and the fill was mid-orange grey silty clay with charcoal inclusions.

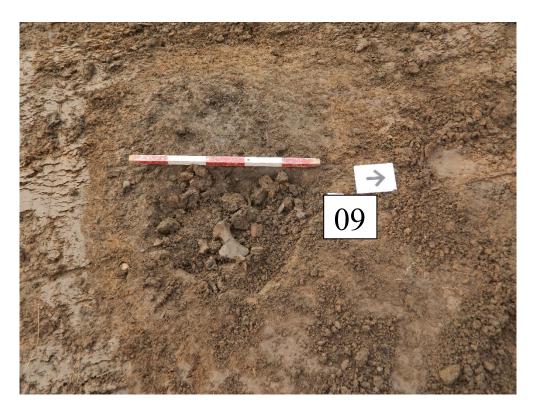
Pit [09] was larger, 0.75m in diameter and 0.12m in depth, with grey-brown silty clay fill containing brick, modern glass and animal bone. It was not fully excavated as the bone also appeared recent and was possibly a deposit of a diseased animal (Figure 15).

Figure 15: Partially excavated pit [09] containing ?diseased animal and modern brick/glass

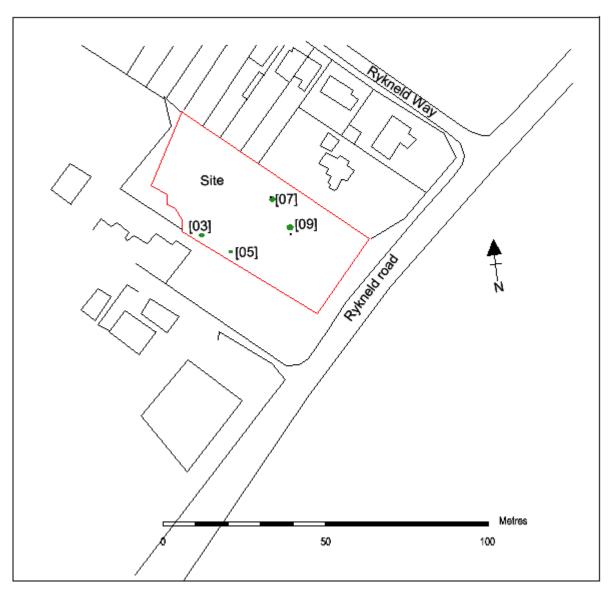
The location of these features can be found in Figure 16 (below).

Figure 16: Site plan showing approximate location of probable 19th century postholes and pits.

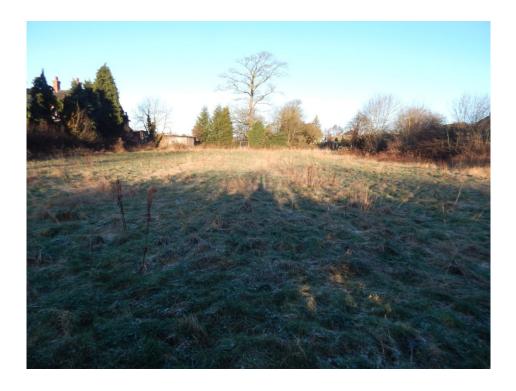
Ridge and furrow. Looking west from Ryknield Strasse
