Archaeological attendance
during groundworks at
Tudor Inn Hotel, Bondgate, Castle
Donnington, North West Leicestershire
(SK 44697 27678)

ULAS Report No 2018-066
©2018

Planning reference: 17/00814/FUL

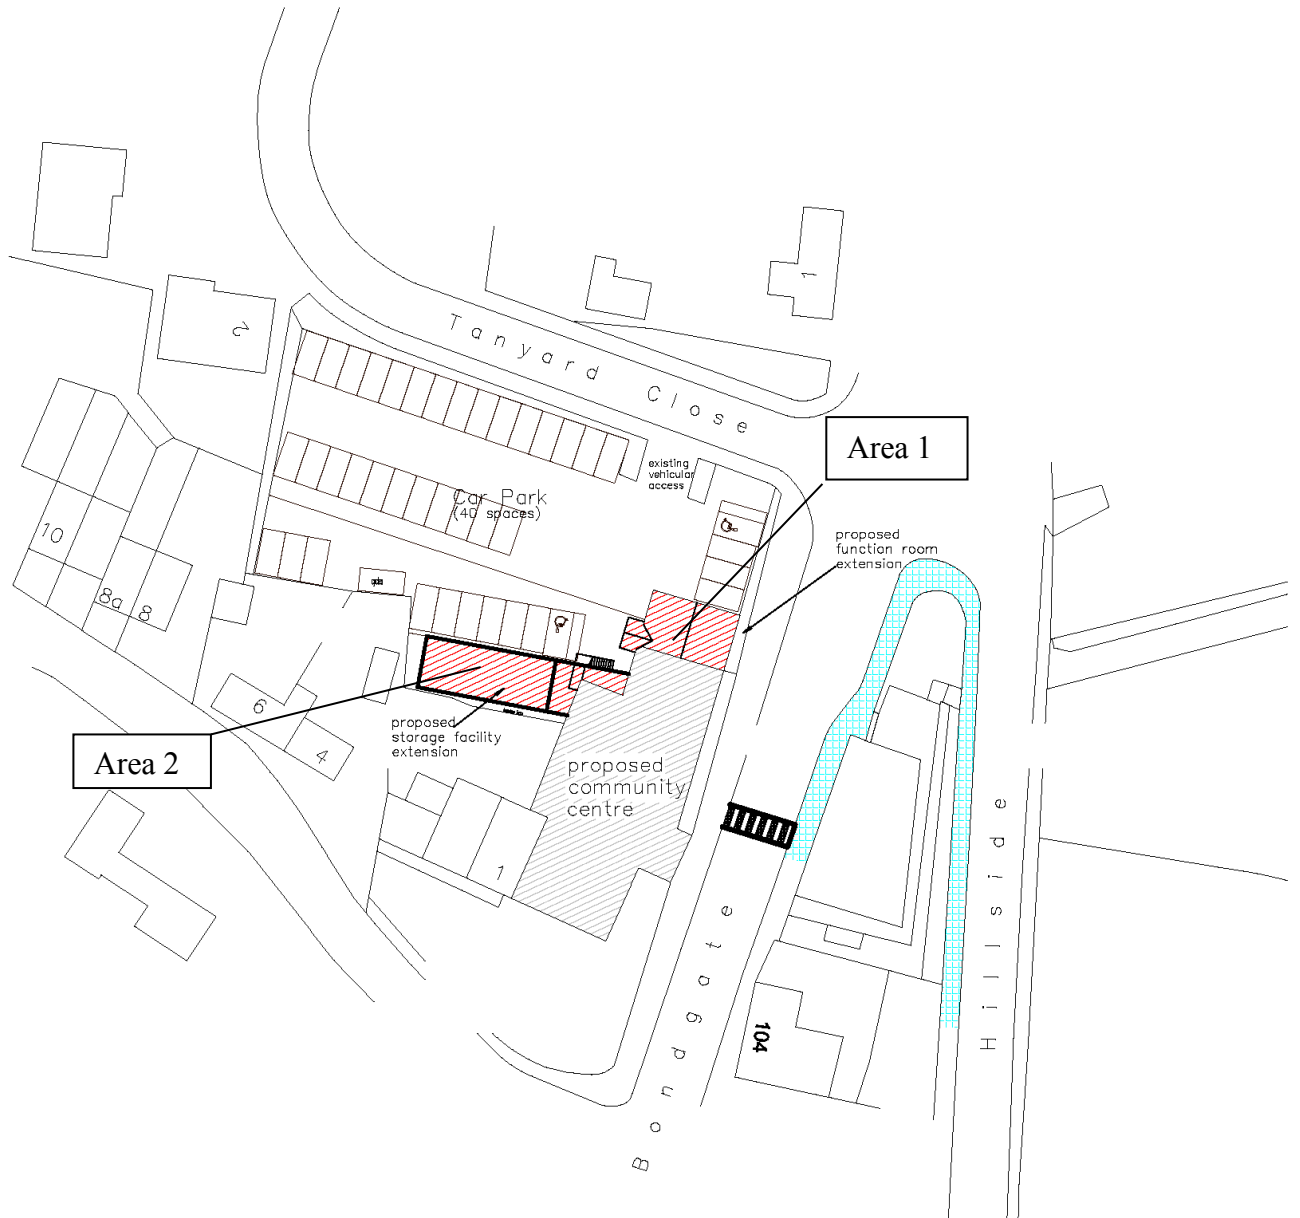
Figure 3: Proposed plan with works in Areas 1 and 2 (shown in red)

The programme of archaeological observation, investigation and recording (a Watching Brief) consisted of the observation of the excavation of foundation trenches for the extension of the existing building and the erection of a single-storey garage (Fig. 3).

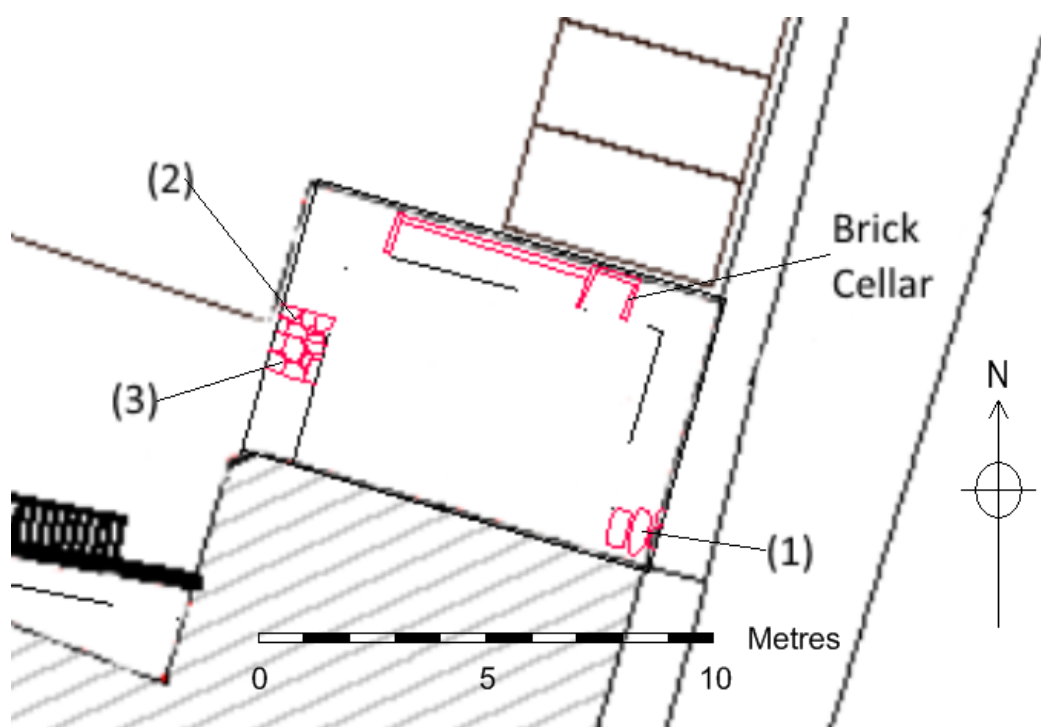
Figure 5: Detail of features (shown in red) in Area 1

Area 1 consisted of a tarmacked area immediately to the north of the existing building and will form the footings of a single-storey extension to the gable-ended former restaurant area (Fig. 6). The natural substratum for this area was a mid blue-grey silty clay with areas of black contamination from upper layers of burning. There was no evidence for subsoil, with the ground largely consisting of a variety of made ground layers as well as burnt demolition rubble and another separate layer of burning immediately above the natural substratum (Fig. 5).

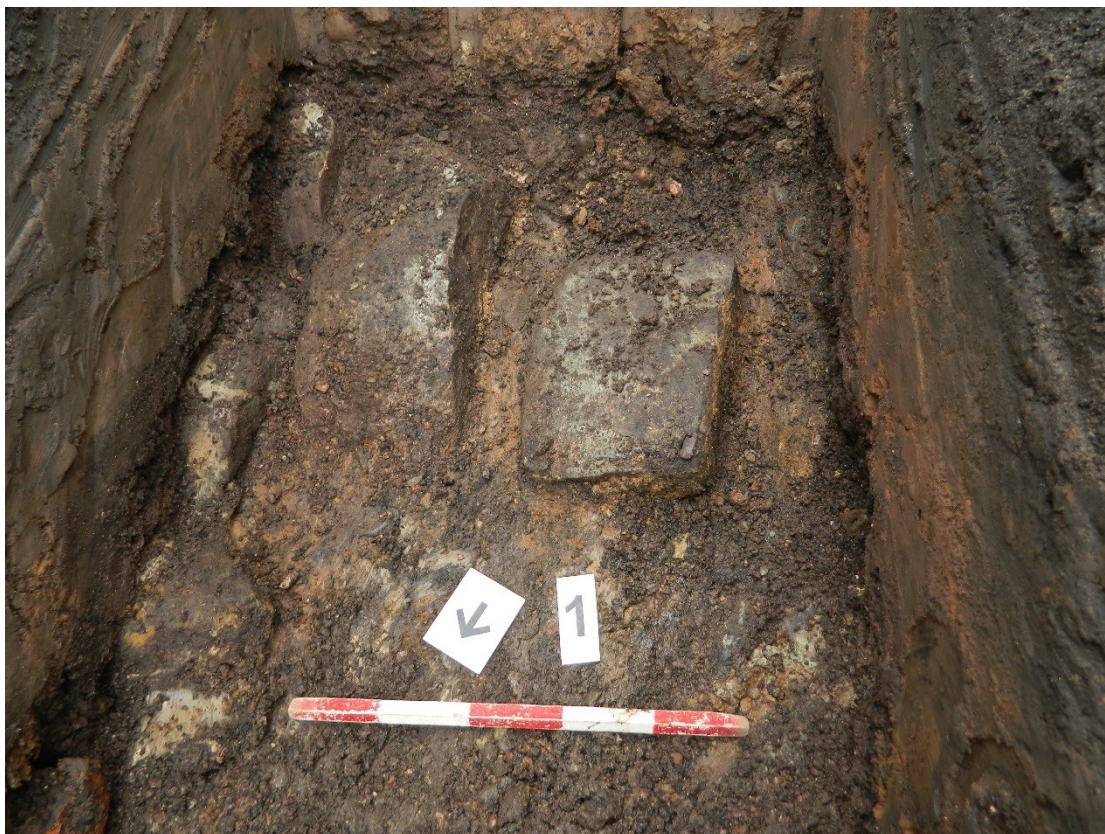
Figure 9: Wall feature (1) in Area 1, looking south east (0.5m scale)

In the south-eastern trench of Area 1 was evidence for a single-stone wall (1) orientated east-west across the trench (Fig. 9). The wall consisted of large grey-green sandstone basal stones with smaller fragments of the same material in between them. The lack of mortar suggests that this wall was earlier in origin than the other walls found in Area 1. No dating evidence was found within the wall itself however this feature was below the primary burning layer and showed no sign of heat damage. (1) Therefore pre-dated the 18th -19th century cellar that had burnt down and was found in this layer elsewhere in Area 1.

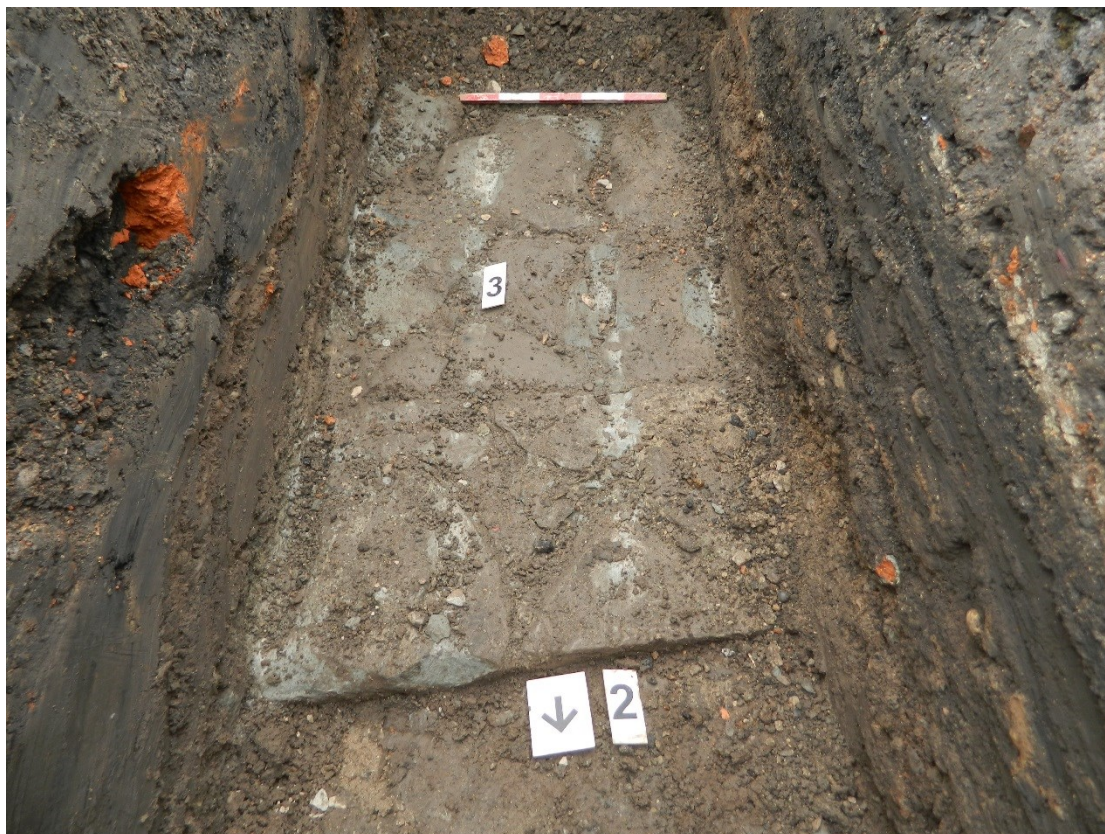
Figure 10: Wall (2) and surface (3) in Area 1, looking south (0.5m scale)

In the south-western trench there was also evidence for a wall structure (2) with an associated stone surface (3) (Fig. 10). Both features were made of a blue-grey sandstone and contained fragments of a mid brown-cream mortar. Wall (2) was 0.58m wide and double bonded. It is probable that this feature constituted the basal stones for a reasonably substantial building. Immediately south of this wall was what appeared to be a stone surface (3) of a mosaic construction. This surface was 0.92m in width with a straight edge at the southern end and consisted of wide, flat stones. The stones themselves do not appear significantly worn and are may be associated with an out building or garden rather than a main domestic building. Stratigraphically these features were below the level of 19th century brickwork and the mortar appeared to be of a lime-based material which would suggest a pre-19th century date.

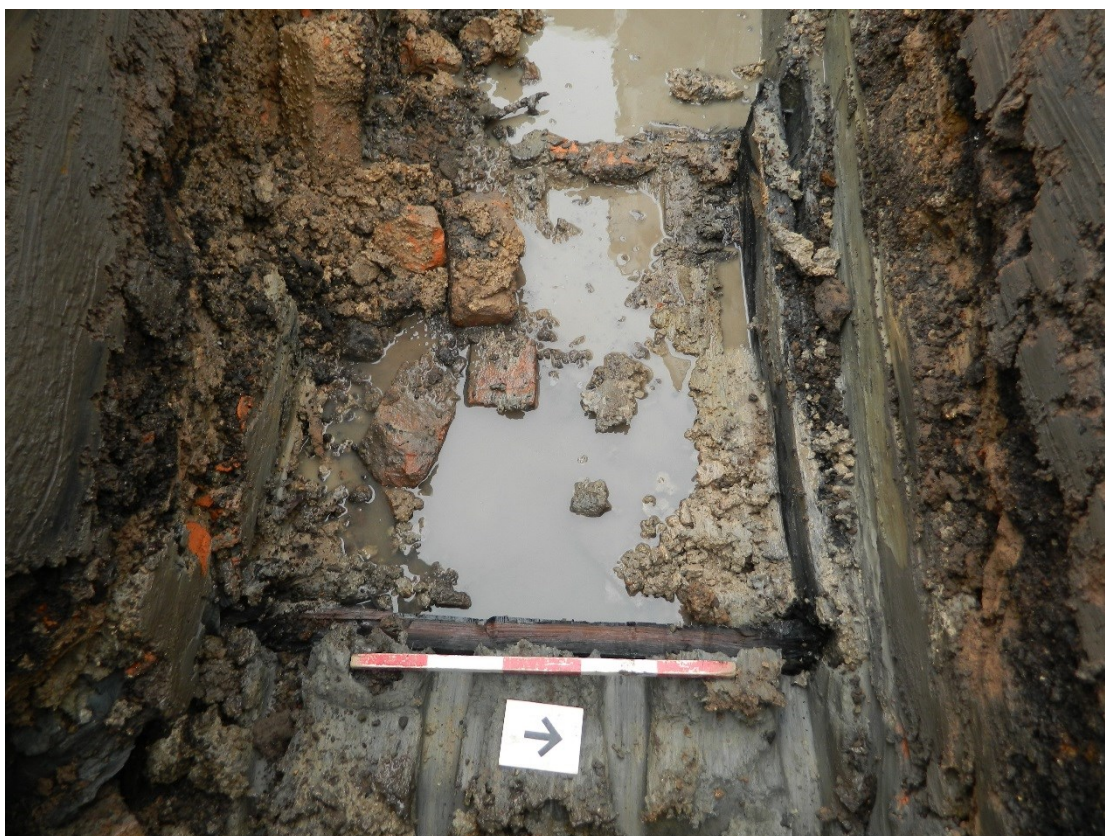
Figure 11: Remains of a timber and brick structure, looking west (0.5m scale)

The northern trench (east-west orientation) was dug to a considerably greater depth (1.65m) than the southern areas due to the presence of what appeared to be the remains of a collapsed brick and timber cellar. Evidence for a double-skin brick frame were identified as well as a wooden-lining to the brickwork in the eastern end (Figs 11-12). The northern end also appeared to show evidence for lime-washing. Most of the timbers were burnt and there were large amounts of burnt material surrounding this structure suggesting that the cellar had suffered fire damage and thus been backfilled with large amounts of outside materials. The presence of brick, glass and willow-pattern potter within this structures suggests a 19th century date.

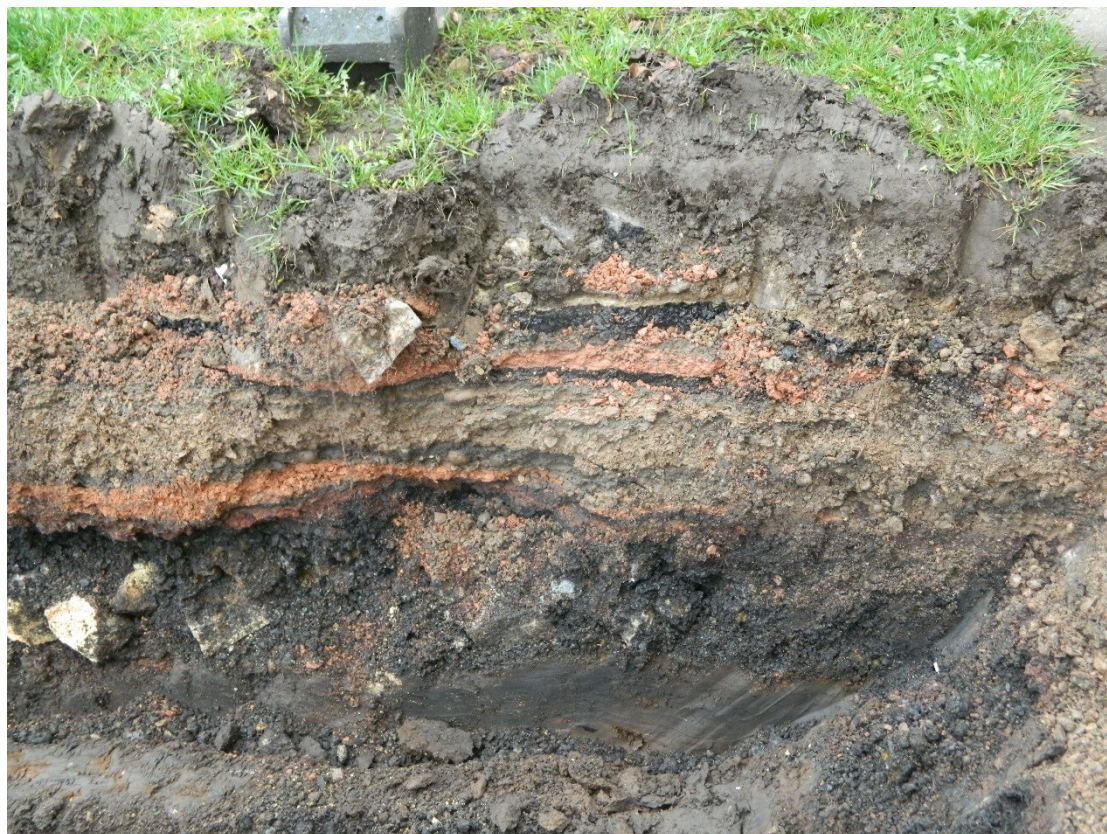
Figure 13: Mid-excavation section of Area 1 showing secondary burning layer, looking east

Across Area 1 there was evidence of a secondary burning layer which contained burnt stone and gravels approximately 0.5m below ground level (Fig. 13). This layer may be associated with a relatively recent fire which destroyed parts of the adjacent 17th century building. Above this layer were various other thin layers of made ground that were capped by tarmac.

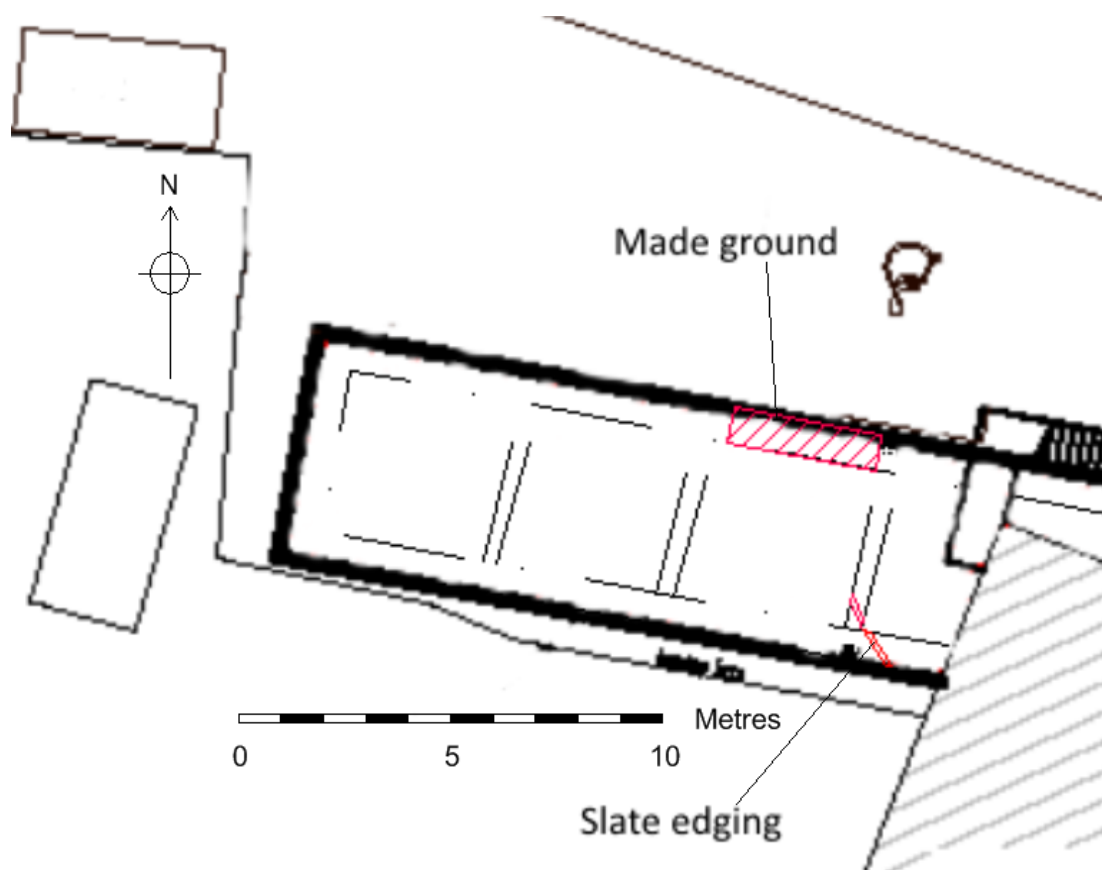
Figure 14: Details of the features (shown in red) in Area 2

Area 2 consisted of land immediately to the west of the existing buildings and had formed part of the carpark. This area had been tarmacked and included a single-storey garage to the far west of the site's boundary, which had been demolished prior to the arrival of the archaeologist. The footings dug in this area were a 22m by 9m rectangular outline for a single storey garage with 3 internal dividing walls separating the individual bays. The natural substratum in this area was a mid grey-brown silty clay to a depth of 2m to the south and 2.4m to the north. There was a small amount of a mid orange-brown sandy-loam subsoil to the south and west of the evaluation area however the rest of the site consisted of large amounts of made ground. Single width slate edging was identified running north-west to south-east across the eastern end of the site and a cattle horn assemblage was found within the made ground to the north.

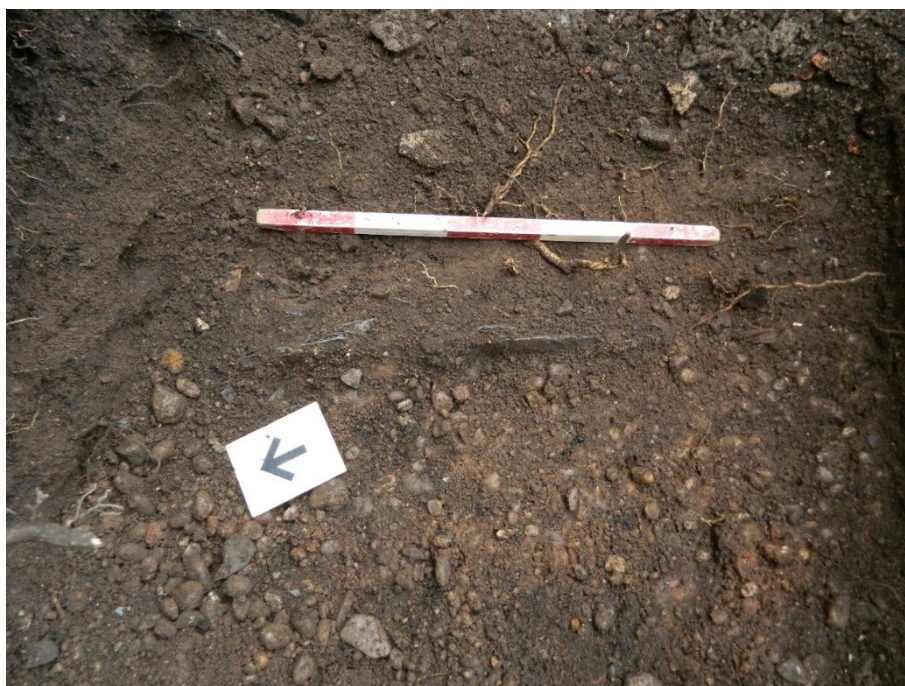
Figure 16: Shot of slate edging in Area 2, looking south

Slate edging was identified in the eastern area within the made ground layer and marked the edge of a loosely gravelled area close to the buildings. This layer contained modern glass and 20th century pottery and therefore is likely to be part of a modern yard or garden which predated the car park.

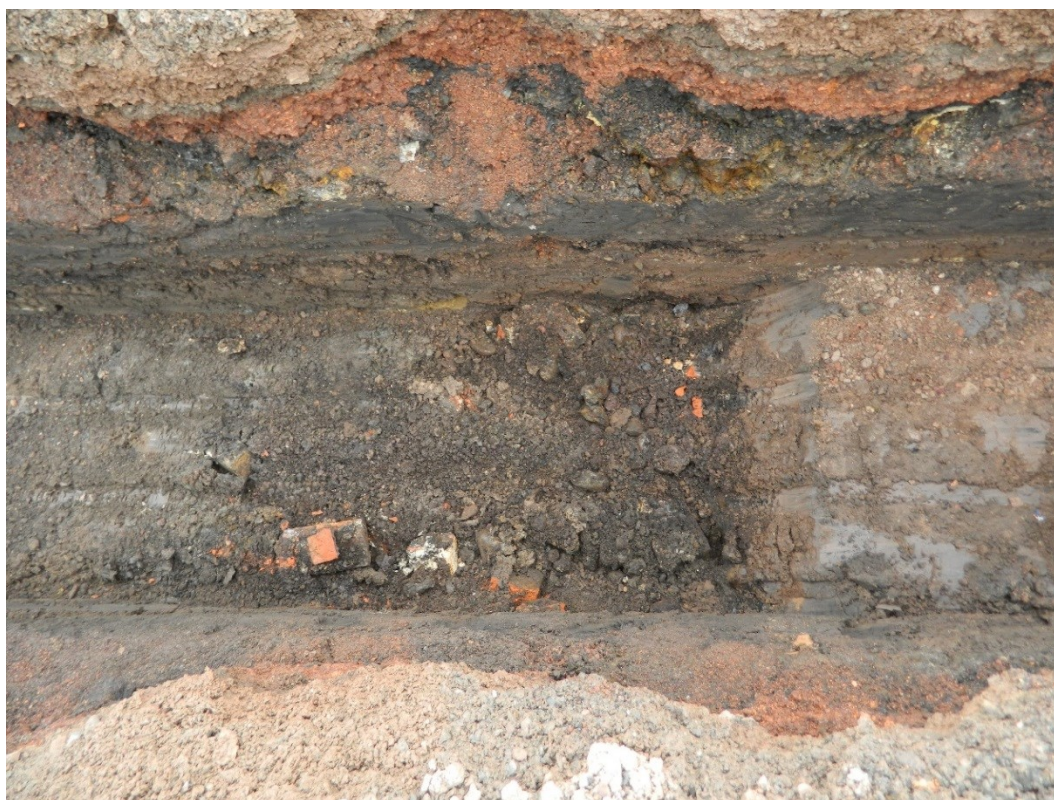
Figure 17: Pre-excavation shot of made ground in Area 2, looking south

Within the northern footing was a 4m long area of made ground which formed the deepest (2.2m) section of the trench and consisted of large amounts of dark black-brown silty clay (Fig. 17). This ground contained large amounts of ceramic building material fragments and glass as well as c.14 individual cattle horns. The horns all appeared to consist of only the corneal process and were missing a keratin dermis (Fig. 18). This assemblage is likely to be associated with the tannery that was immediately adjacent to the buildings on the 1901 Ordnance Survey map and recorded as disused by 1922. Post medieval pictorial evidence shows that cattle hides were often bought with the horns still attached with the horns cut out on site and then the outer sheaths sold on to horn workers (Armitage, 1972, p.84). Due to the proximity of the tannery it is therefore likely to have been deposited on the site as the result of waste industrial activity nearby rather than on-site processing.

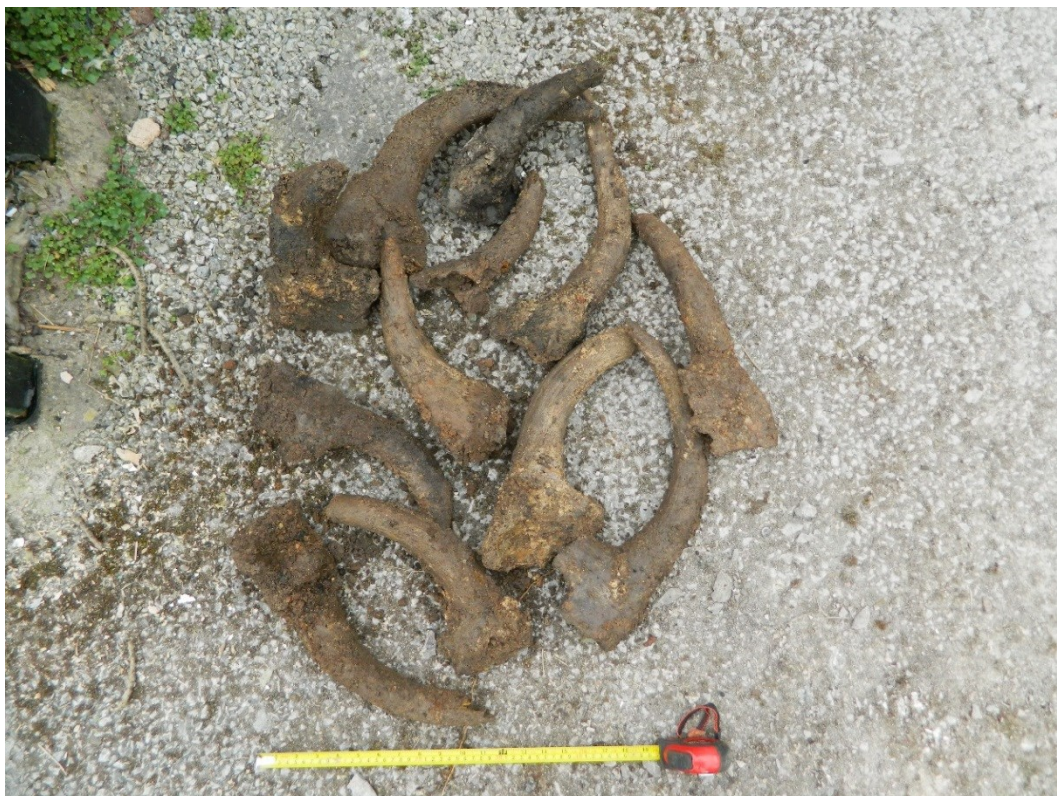
Figure 18: Cattle horns taken from made ground in Area 2 (0.5m scale)

Area 2 contained much less activity aside from an area of made ground which included a large cattle horn assemblage. These single horns were within a layer which contained large amounts of brick fragments and were likely to be deposits associated with the tannery that was active close to the site until the late 19th century.

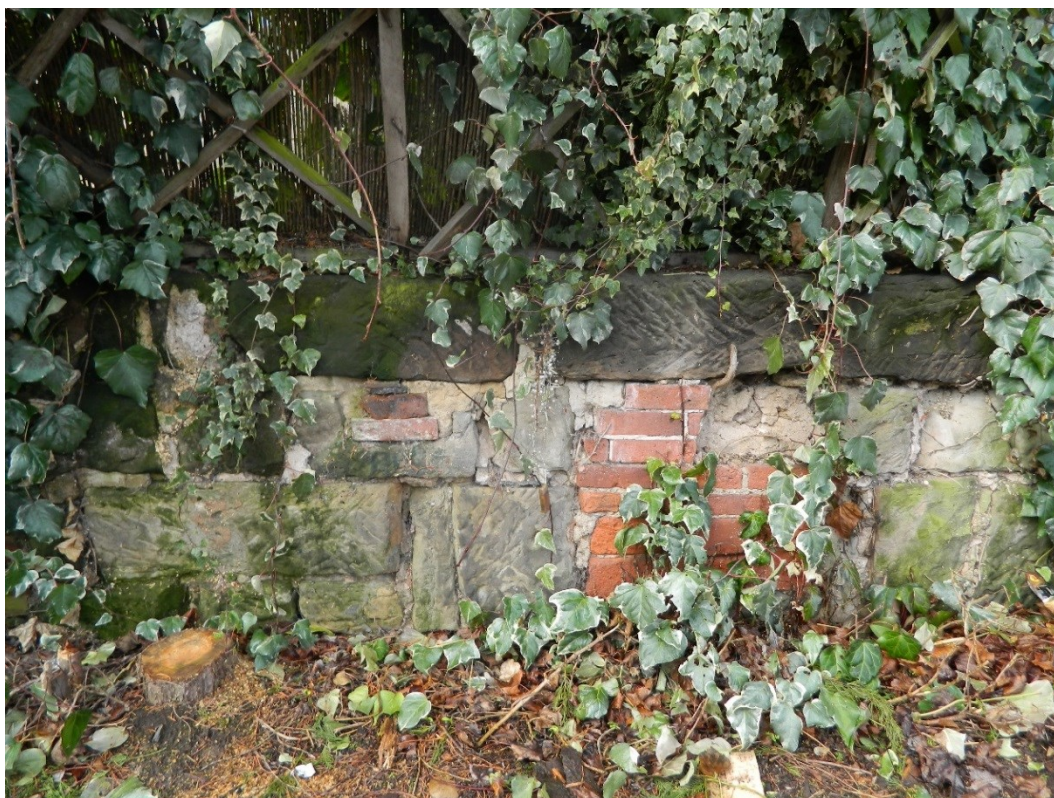
Figure 19: The western boundary wall including dressed stones probably from the castle, looking west

The fence line to the west of the site appears to have incorporated dressed stones from the nearby ruined castle and has obviously been repaired using similar bricks to those found in the adjacent made ground (Fig. 19). It is therefore probable that this boundary pre-dates the infilling of the made ground in Area 2.
