**Launde Abbey, Launde, Leicestershire:
Historic Building Assessment**

Part 2: Illustrations

University of Leicester Archaeological Services

Report 2005-096 ©2005

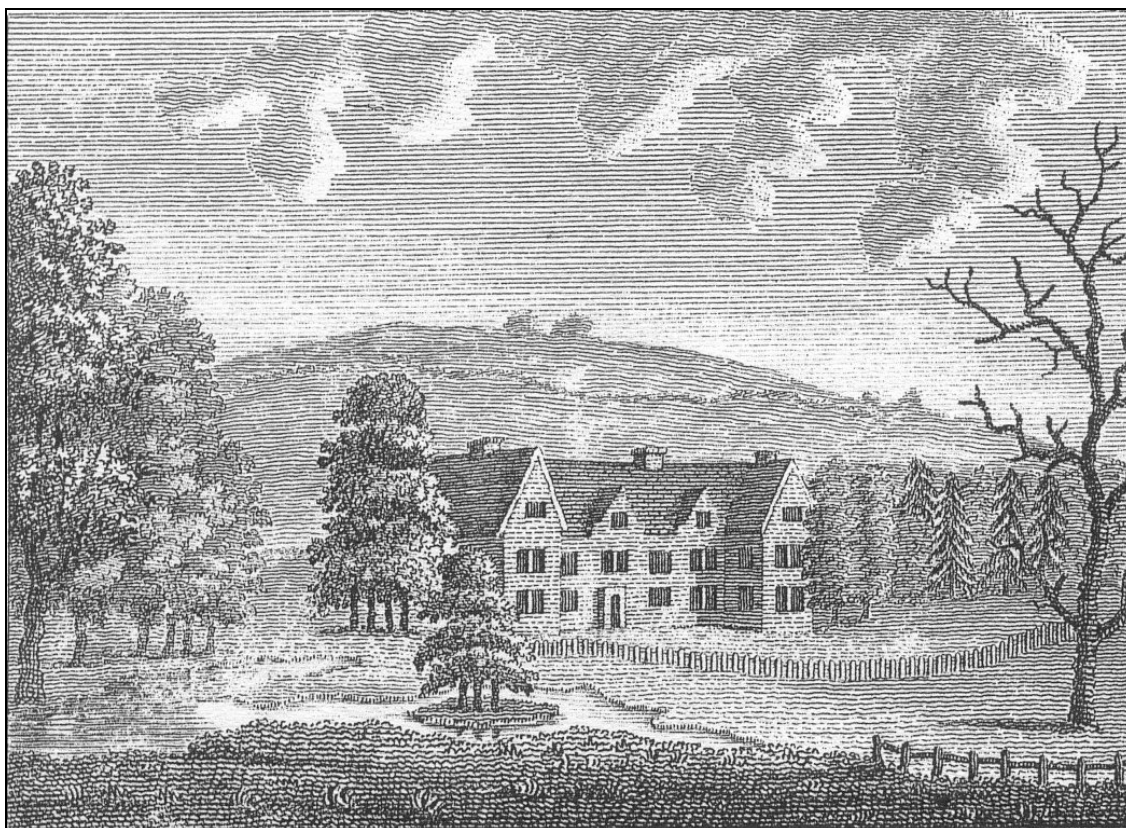
Figure 3. Launde Abbey: West front, from the NW. Illustrated in Throsby (1789).
Note the absence of bay windows to the cross wings and the flat roof to the porch.

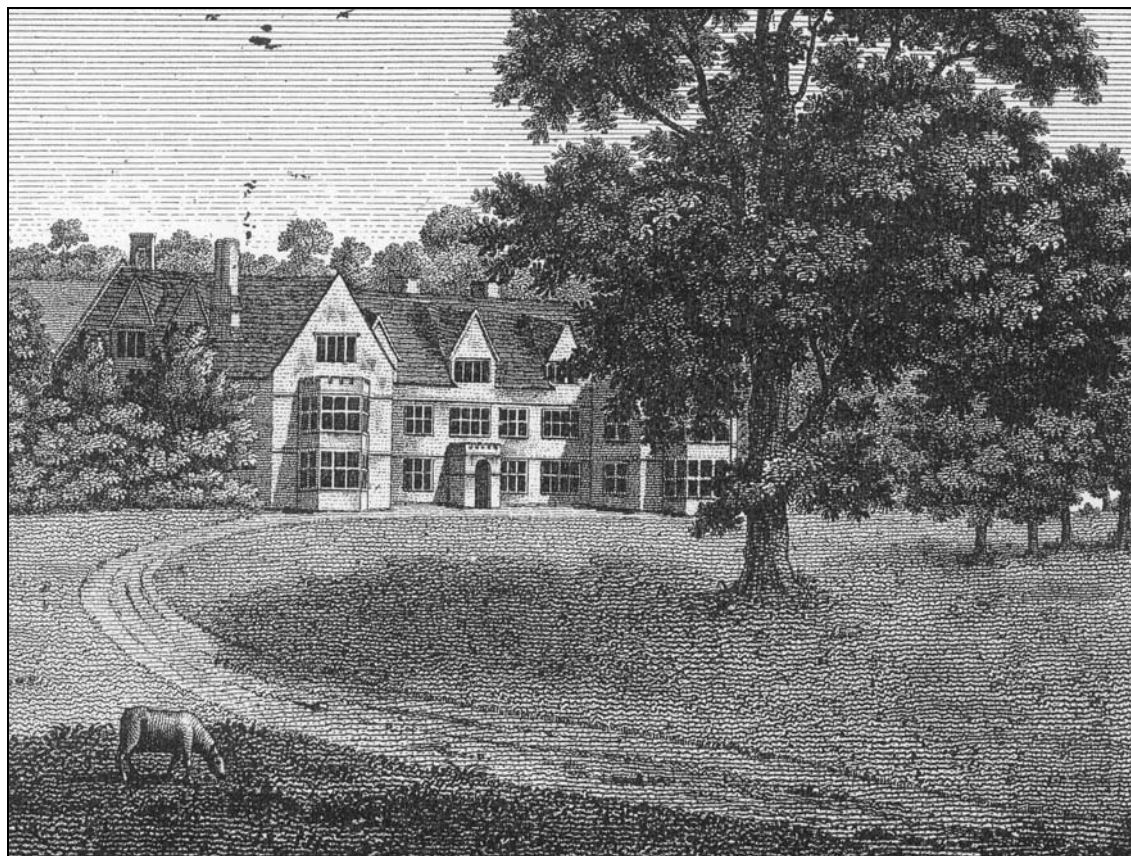
Figure 4. Launde Abbey: West front, from the NW. Illustrated in Nichols 1800 (Plate XLIV).
Note the embattled canted bays to the cross wings and the embattled porch.

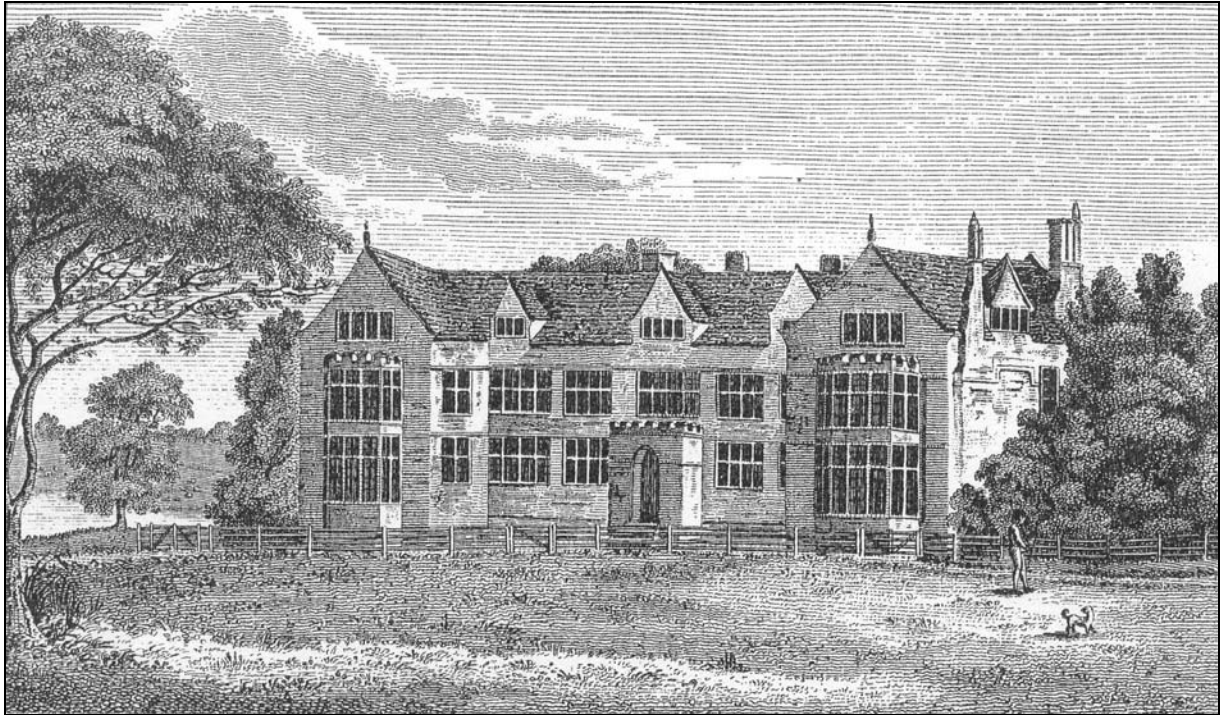
Figure 5. Launde Abbey: West front, from the SW. Illustrated in Nichols 1800 (at top of Plate XLV).
Note the discrepancy in sill height between the windows of the centre range and canted bays of the cross wings.

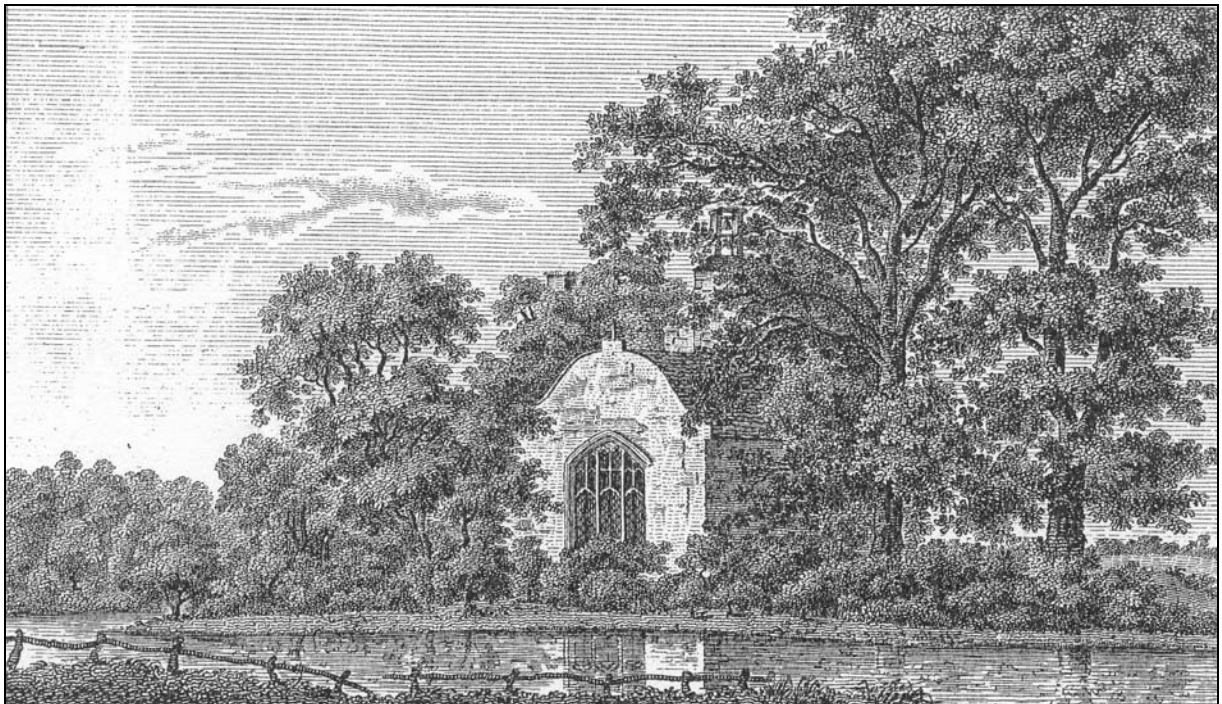
Figure 6. Launde Abbey: East gable of chapel, from the NE. Illustrated in Nichols 1800 (at centre of Plate XLV).
Note the Dutch style gable, the bell-cote partially obscured by trees and the pond in the foreground.

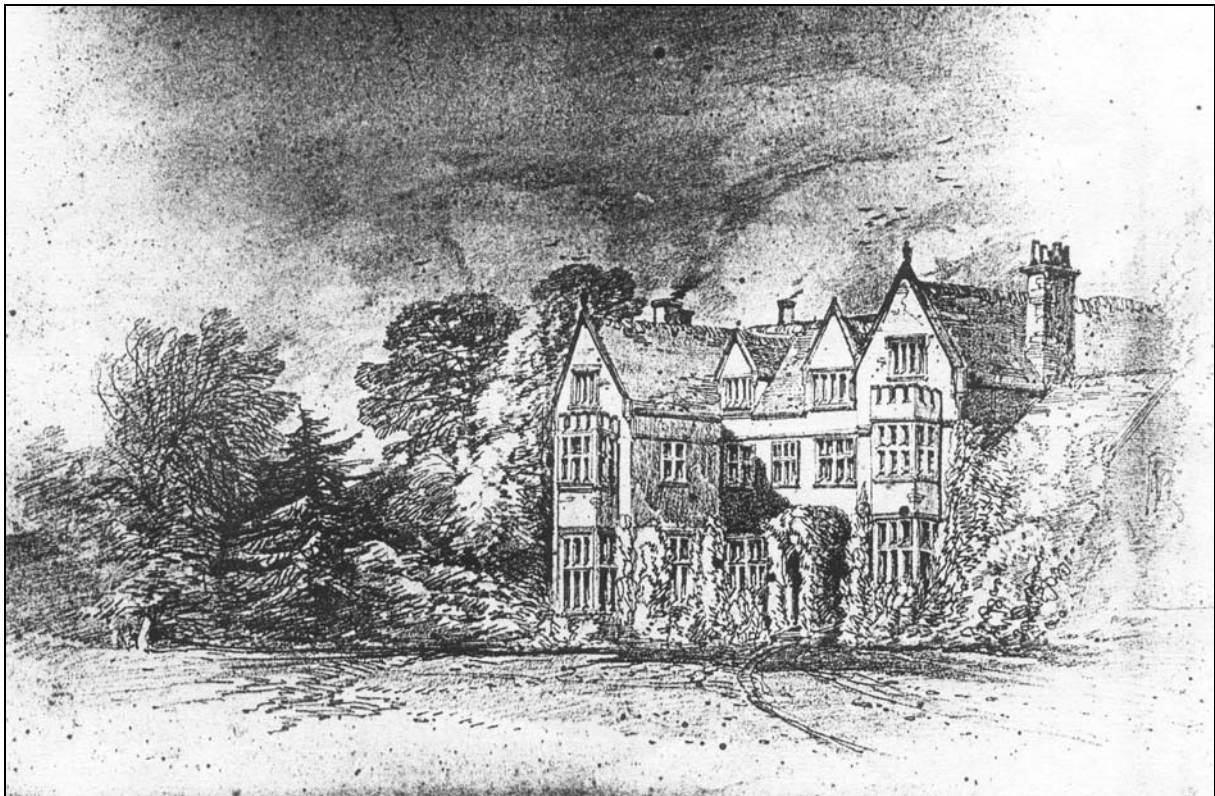
Figure 7. Undated 19th Century engraving in the possession of Launde Abbey.
Note the two-storey addition to the SW corner of the house, with first floor window just visible in the gable end.
This must have been built after c. 1800 and was demolished some time between 1884 and 1904.

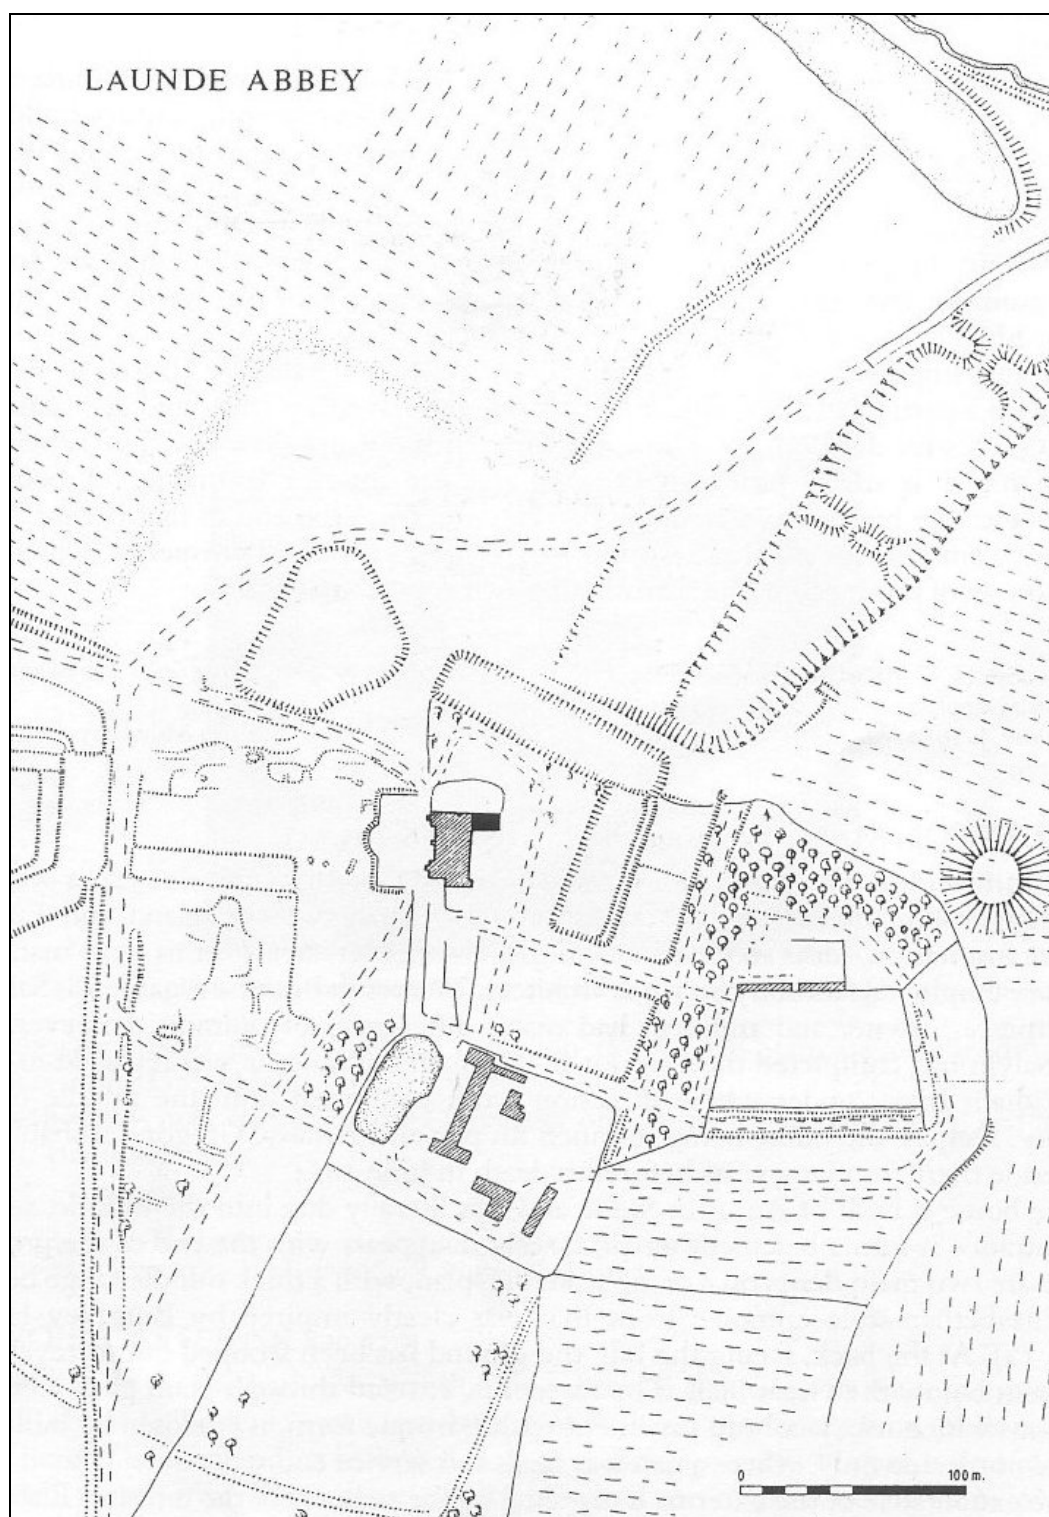
Figure 10. Launde Abbey: Earthwork survey by R.F. Hartley. Published in Schadla-Hall, Green & Liddle (2003)

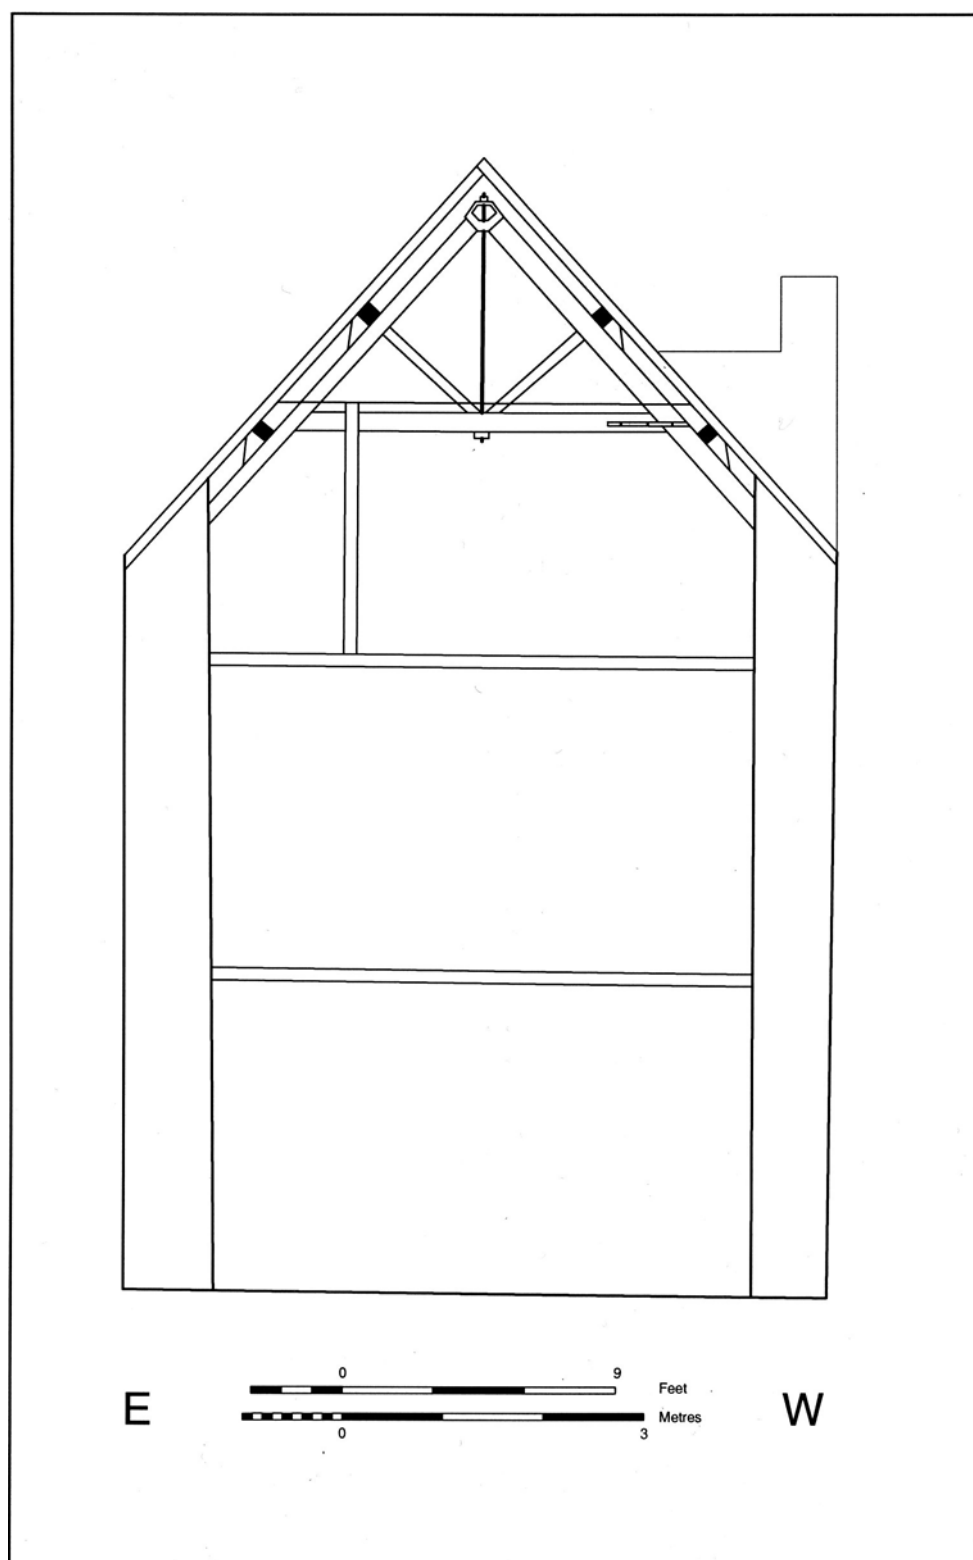
Figure 13. Cross section of western part of centre range illustrating form of roof structure.

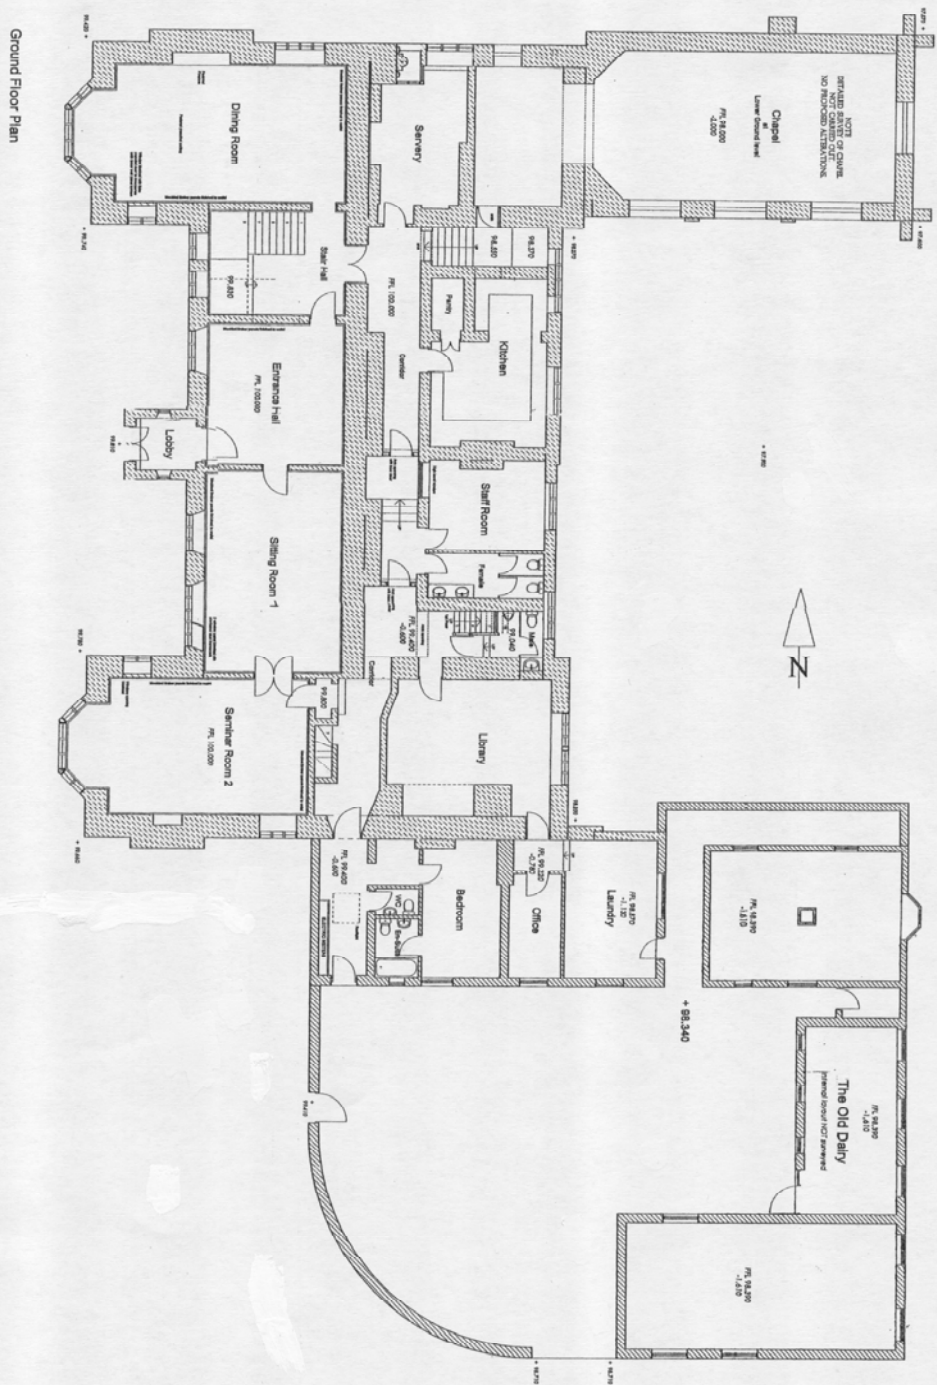
Figure 20. Launde Abbey: Ground Floor Plan. Scale 1:200.
Extract from Martin E Russell (Architects) Survey: Ground Floor Plan
Drawing number:03.1075 - 5a

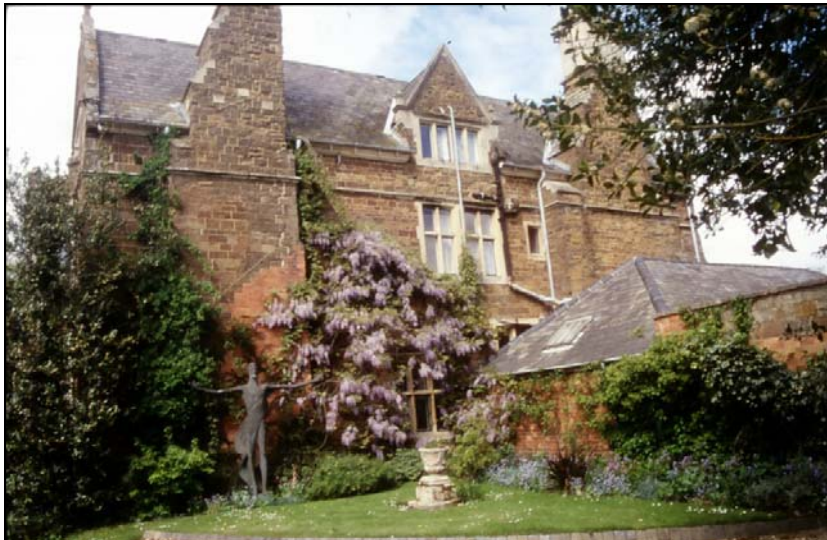
Plate 5. Launde Abbey: South elevation & brickwork scar of demolished C19 range at SW corner (behind statue)

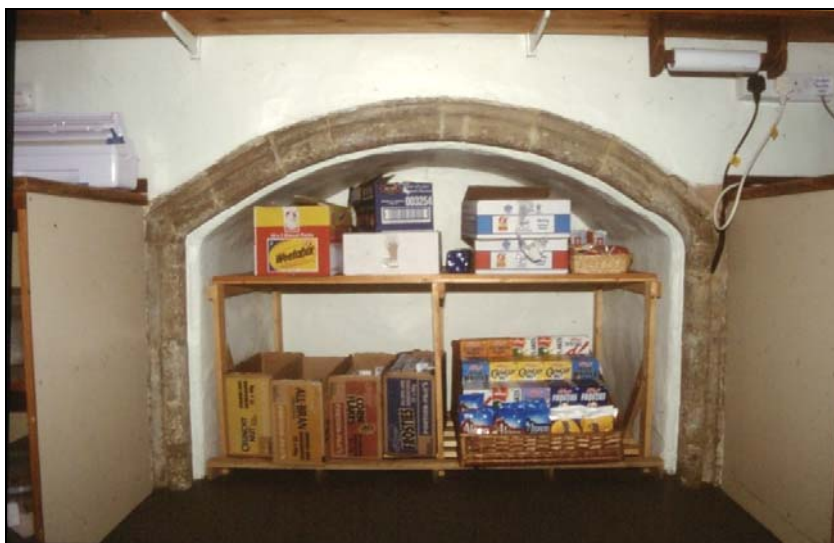
Plate 15. Medieval arch in N wall of *Servery*, possibly opening into cloister walk of Priory Church, looking N.

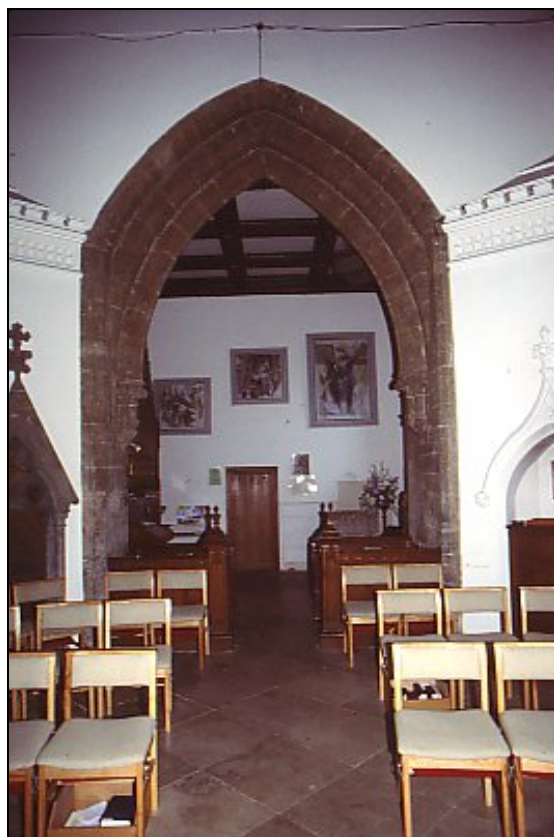
Plate 16: *Chapel* interior looking west towards *Vestry* showing doorway inserted c. 1957. Compare with Plate 42

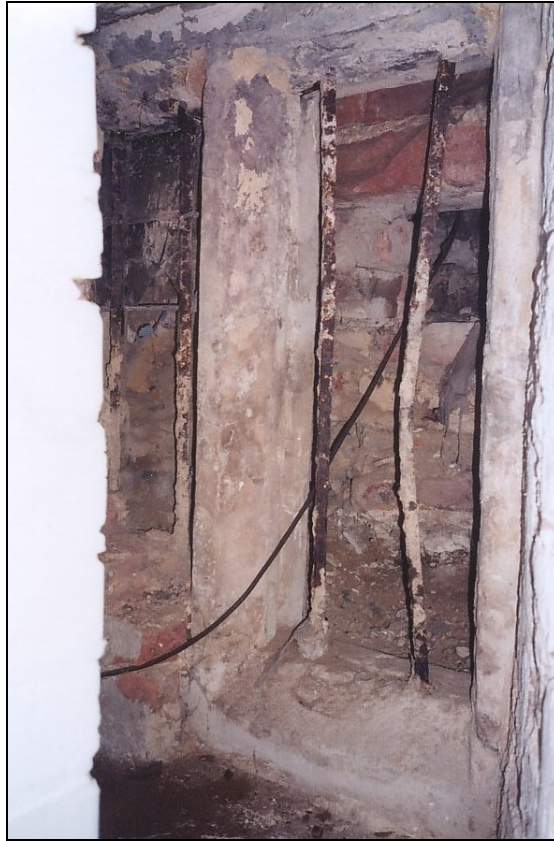
Plate 18. Detail of splay mullion window in 'spine wall' of the house in lower ground floor *Library Area*. Showing glazing bars still in situ and rubble fill behind.

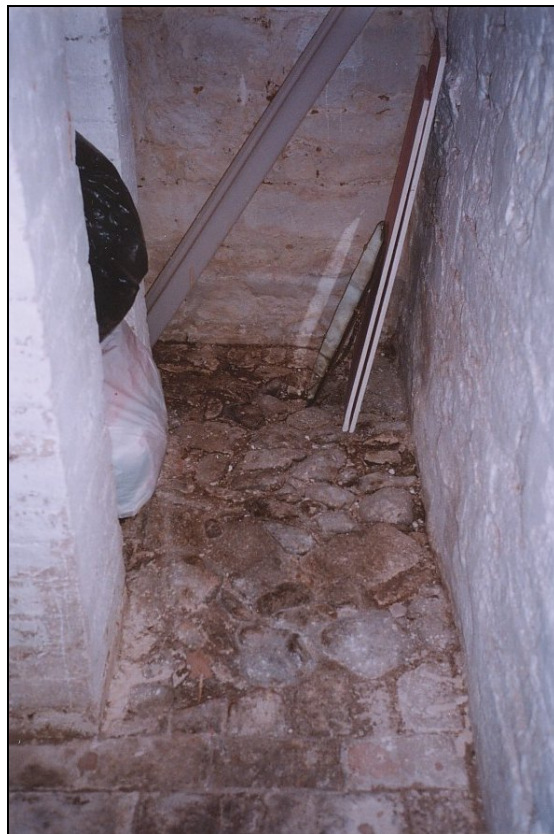
Plate 19. Detail showing section of roundstone cobbling in cellar floor adjacent to 'spine wall' (*Library Area*).

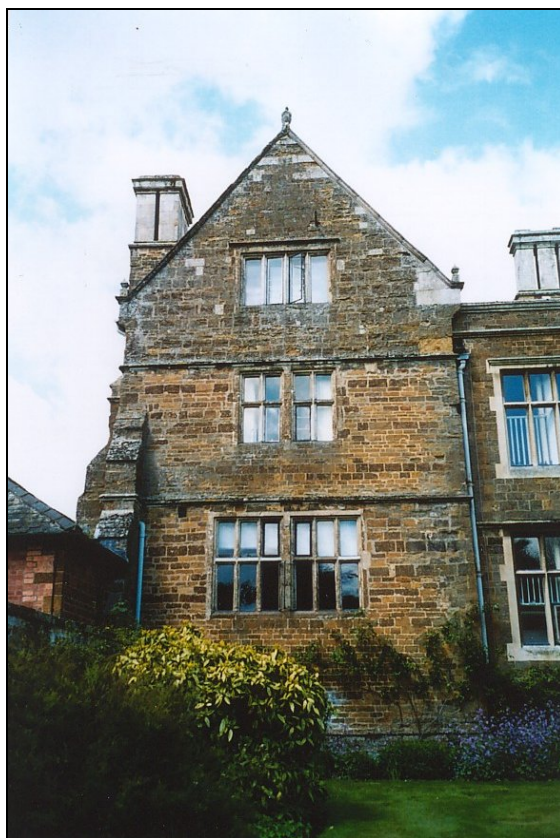
Plate 20. South-east gable showing the rising series of early C16 windows, particularly the paired, six-light ground floor window.

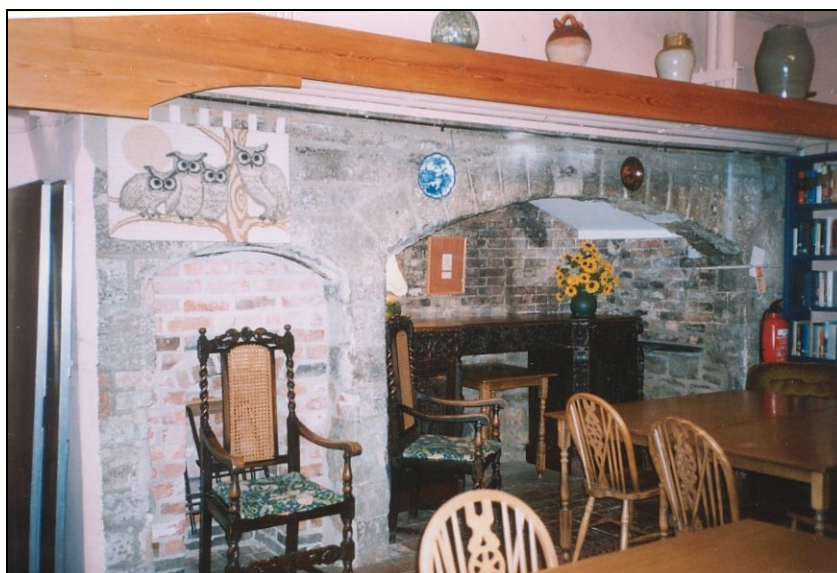
Plate 21. Fireplace with extended, low arch form, of characteristic late C16 form in the present *Library*, which is identified as the Kitchen on earlier plans.

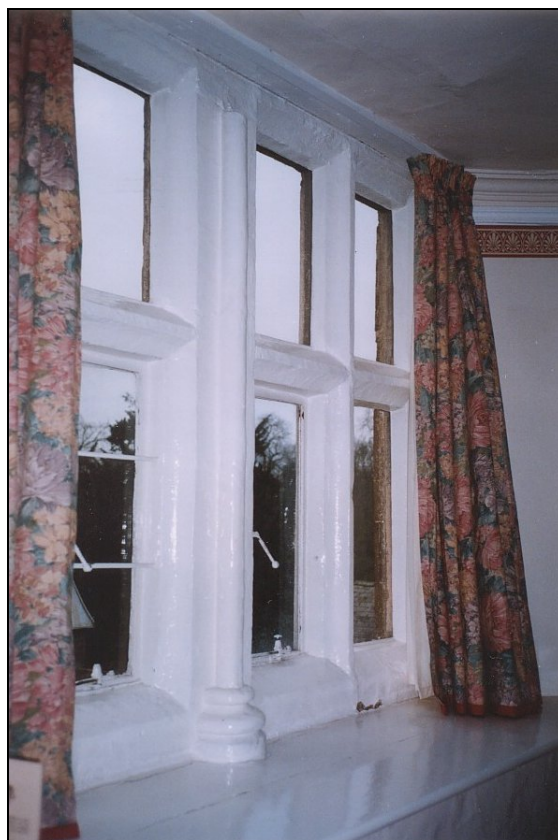
Plate 22. First floor C16 window in the south-east gable showing the capital detail missing.

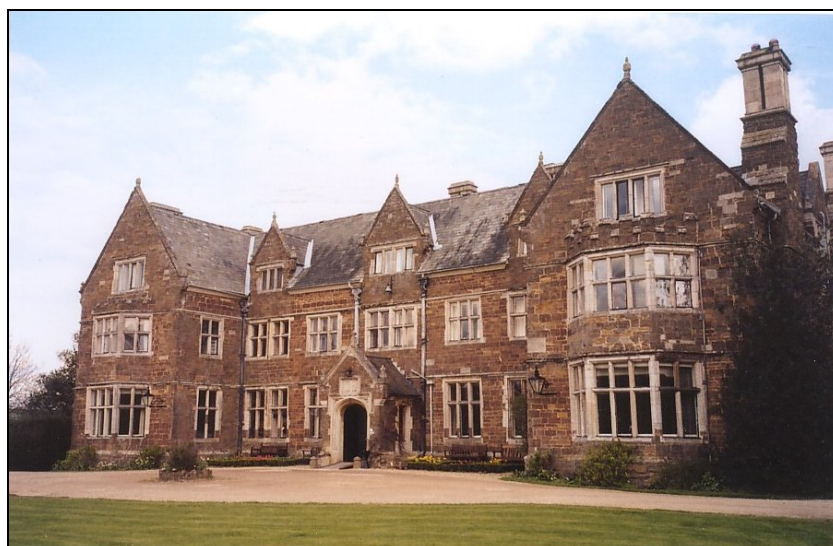
Plate 23. West front of Launde Abbey from SW. The ironstone sections set into the lower part of the ground floor windows of the main range can be seen as a dark band at the base of the windows.

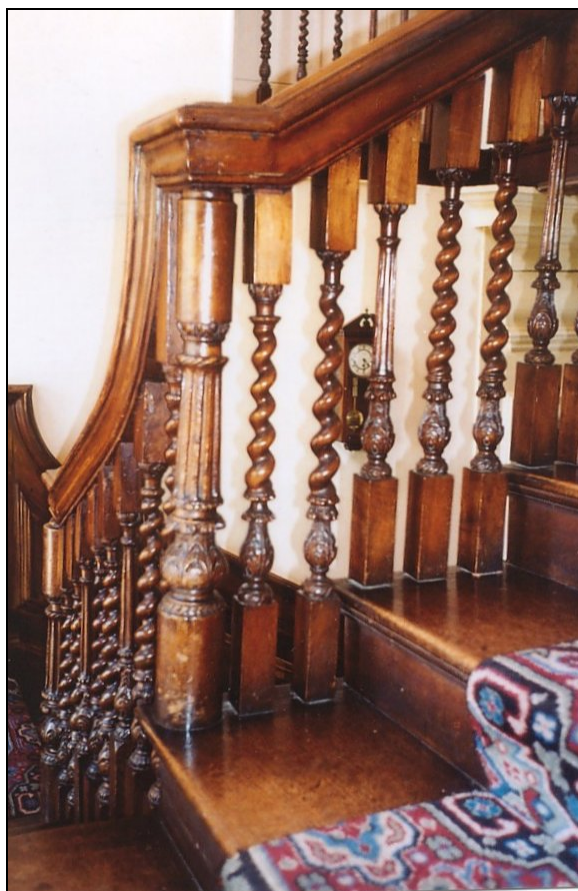
Plate 26. Detail showing staircase with two twisted and one fluted baluster to each tread, carved newel and ramped handrail.

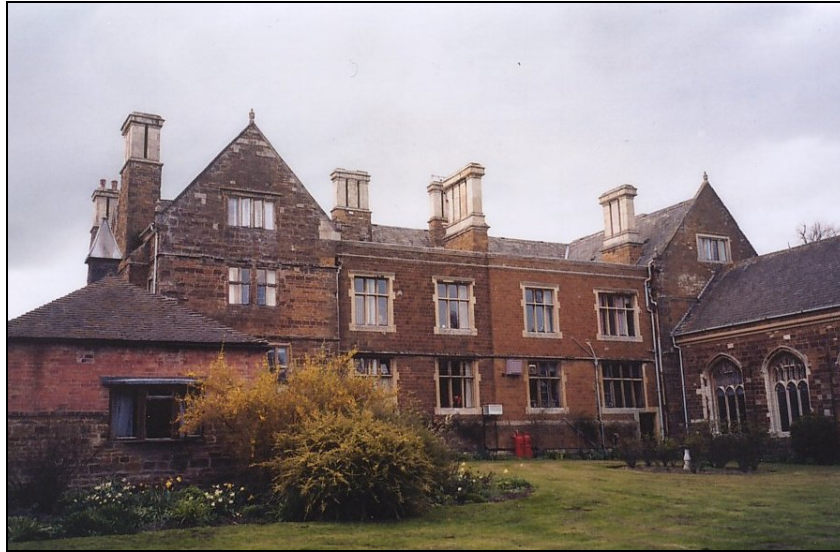
Plate 28. East (rear) elevation of house, showing the two distinct types of stone and chimneys in the work attributed to Thomas Rickman, 1829.

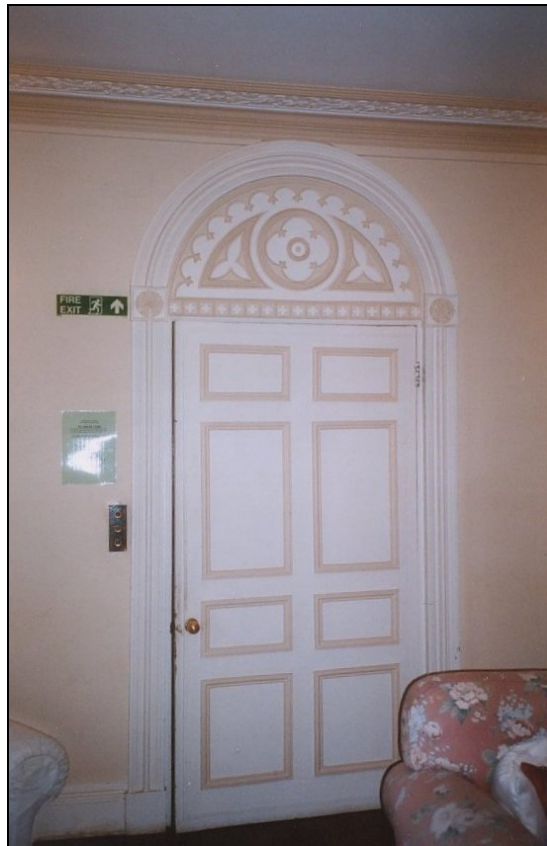
Plate 29. *Sitting Room 1* door showing eight panelled door with reeded detailing, decorative paterae and Gothic decoration in the rounded head above the door.

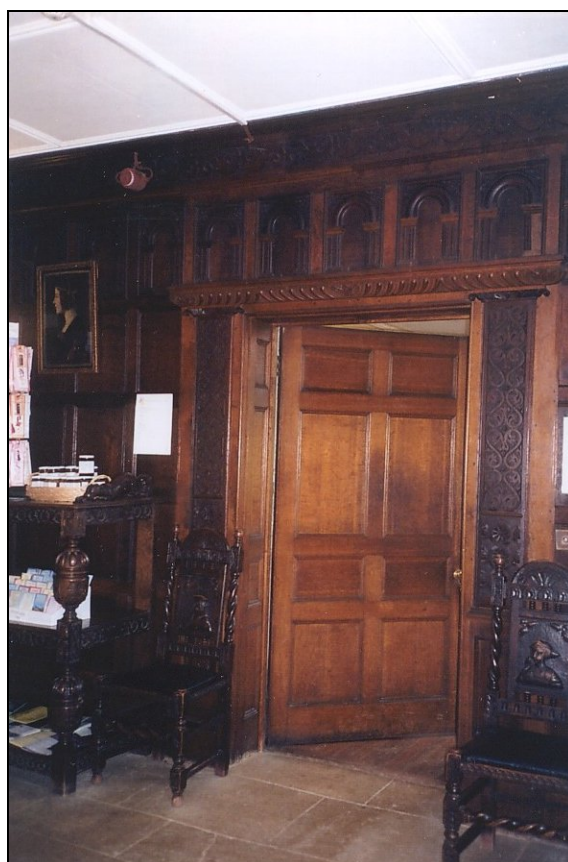
Plate 31. Section of the Entrance hall panelling showing mixture of strap motif panels with arcading, gadrooning and serpent motifs at frieze level.

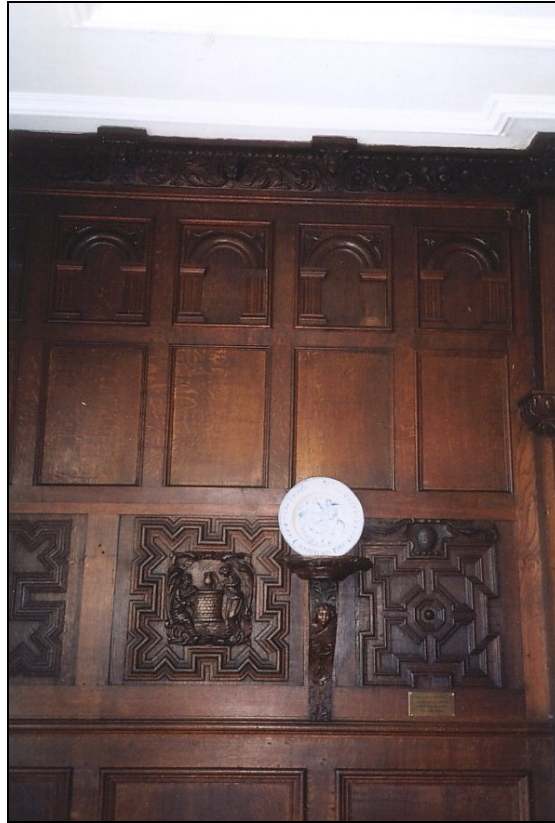
Plate 32. Detail of C19 rails and stiles with sections of C17 set into them and C19 Flemish carved vignettes planted on them. The arcading and the carved frieze are also C19 compilations.

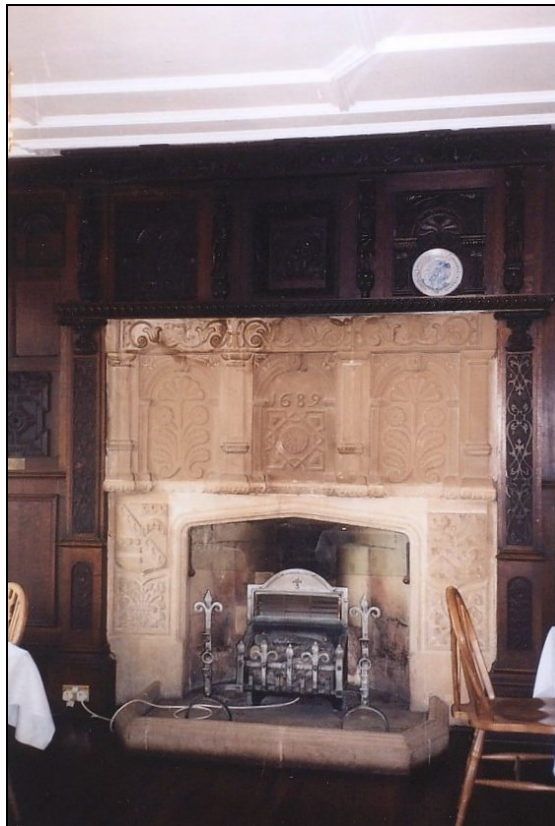
Plate 33. Fireplace in *Dining Room* showing as two distinct sections with the lower section, including the 4-centred arch being a C19 Gothic replication and the section dated 1689 which has frieze detailing at its top, wrongly relocated to its present low level.

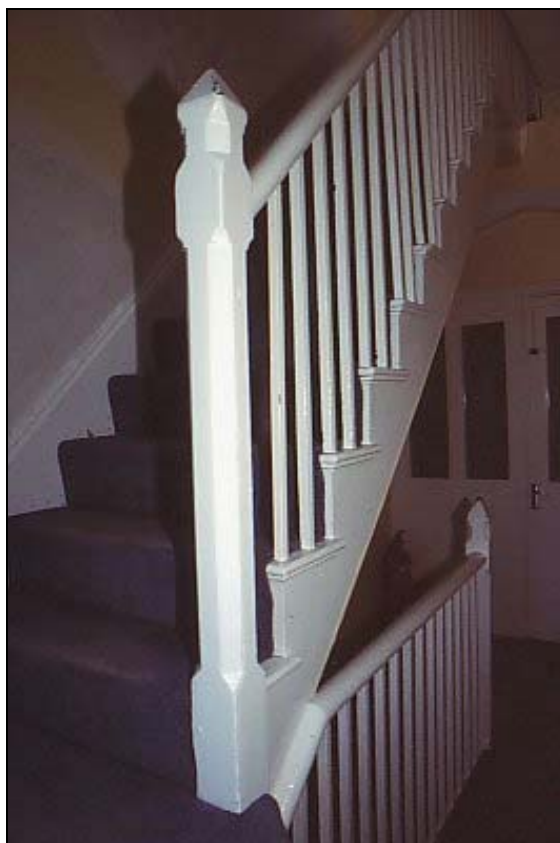
Plate 34. Service staircase with stick balusters and cut and chamfered newels with faceted finials.

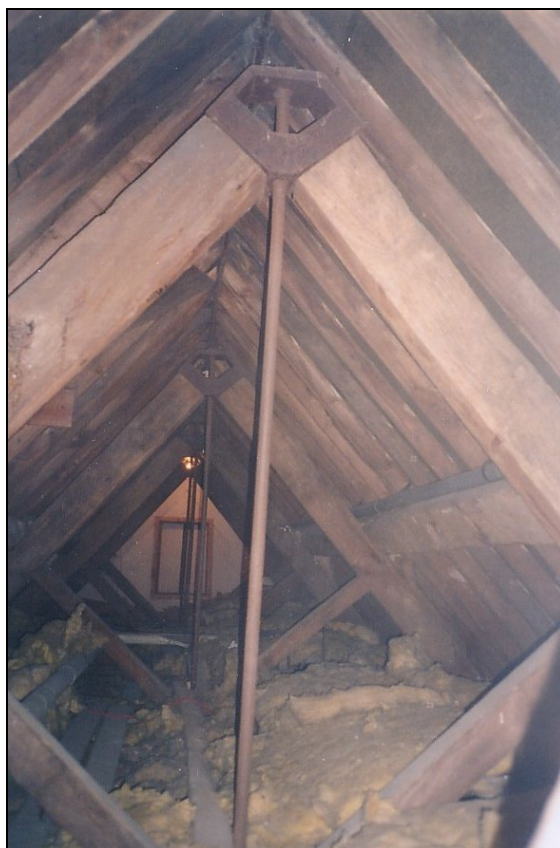
Plate 36. View through the roof of the main front of the house, showing the bolted, deal trusses with cast-iron yoke at the apex.

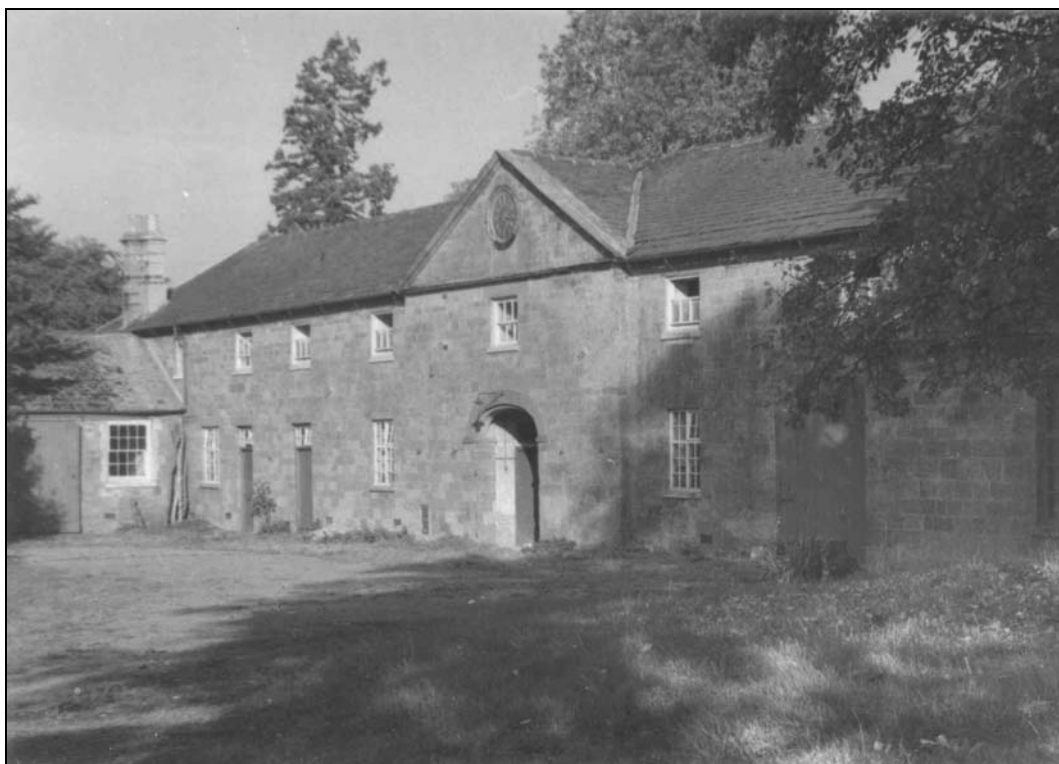
Plate 45. Launde Abbey: Stable block west front, looking NE. F. Lumbers 1957. Note arrangement of door and window openings prior to alteration in 1986.
