**An Archaeological field evaluation at
Area 1B, New Lubbesthorpe,
Lubbesthorpe, Leicestershire
(SK 528 018)**

ULAS Report No 2018-068
©2018

For
Mather Jamie Ltd.

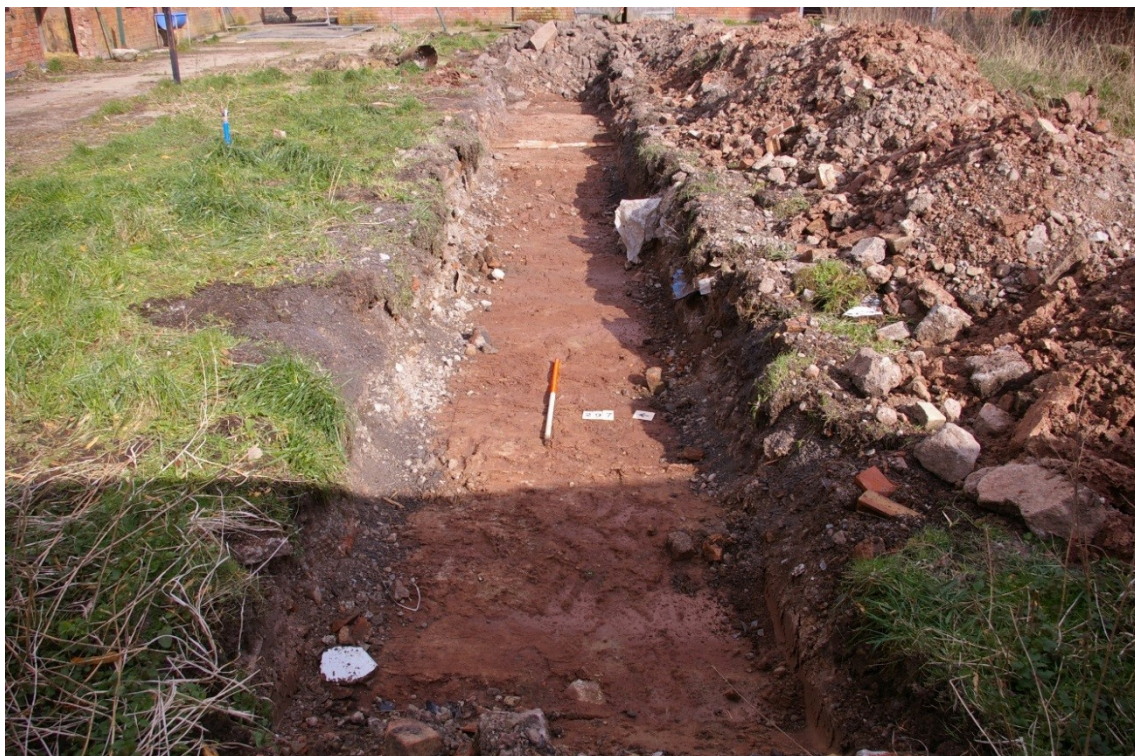
Figure 7: Trench 297. Area R2 Part 2.

A brick wall with buttressing either side was uncovered in T297, which was located within the central court-yard of the farm. Also within this trench was a linear feature of large stones (Fig 48). They were not mortared, so it is unlikely that they formed part of a structure of any kind. They were covered with a natural stone rubble

Trench 297 (Fig. 7) exposed two features. A linear stone feature (Fig. 9), and a brick wall with buttressing (Fig. 8). The linear stone feature did not show any signs of bonding, and the stones were quite flat but irregular in shape. It is possible that they were an earlier decorative surface.

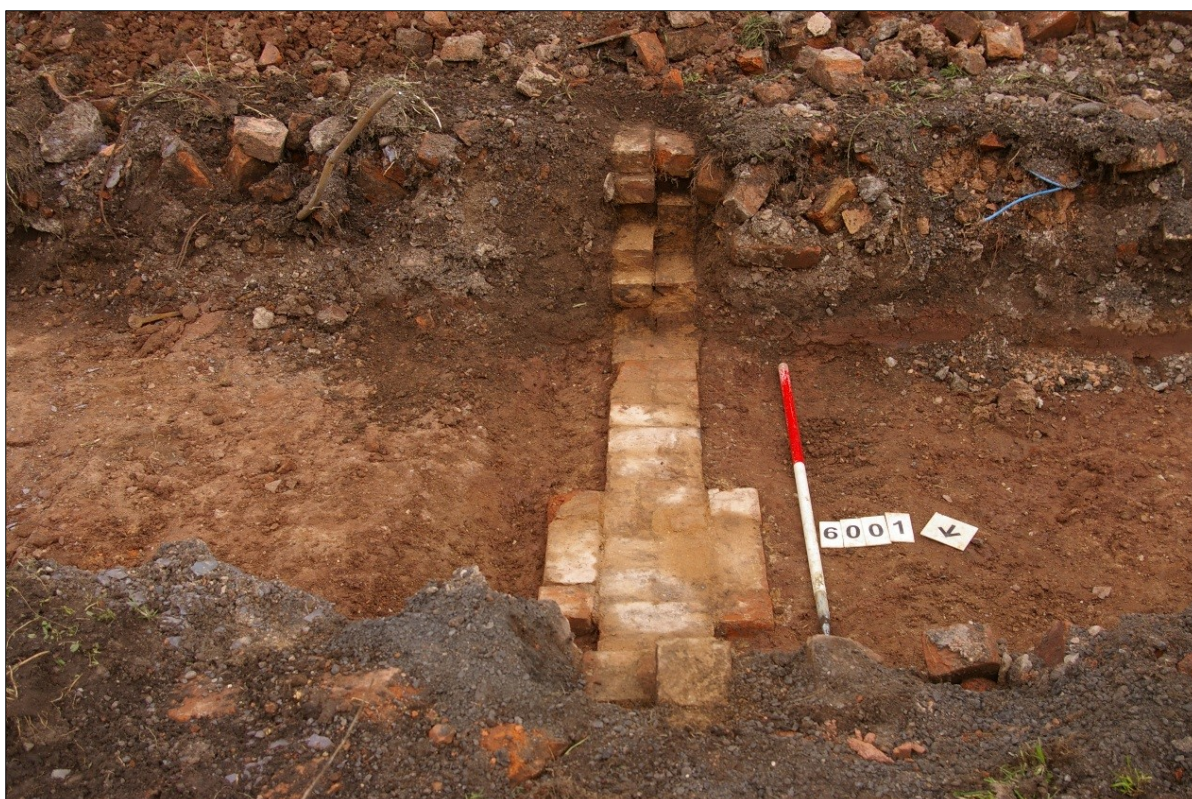
Figure 8: Trench 297. Wall feature [6001].

The brick wall was visible in section to six courses and had reinforcing buttressing either side of it, suggesting that this wall was a garden feature and not the supporting wall of a building. This was probably a garden wall associated with the farm – one is illustrated on the 1885 Ordnance Survey Map of the area (Fig. 10). It is possible that both features were contemporary and part of the original gardens of the farm house.

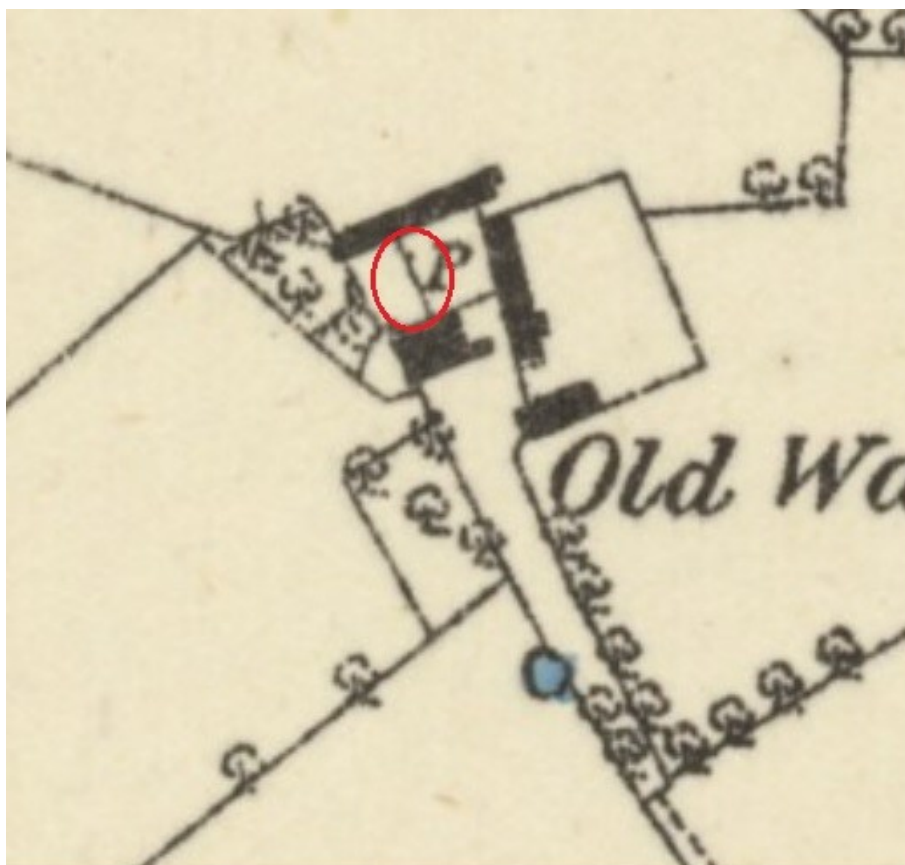
Figure 10: Ordnance Survey Map of Leicestershire, Sheet XXXVI.NE. Published 1885. Shows location of the garden wall (highlighted in red) within the courtyard of the farm running north-west south-east.

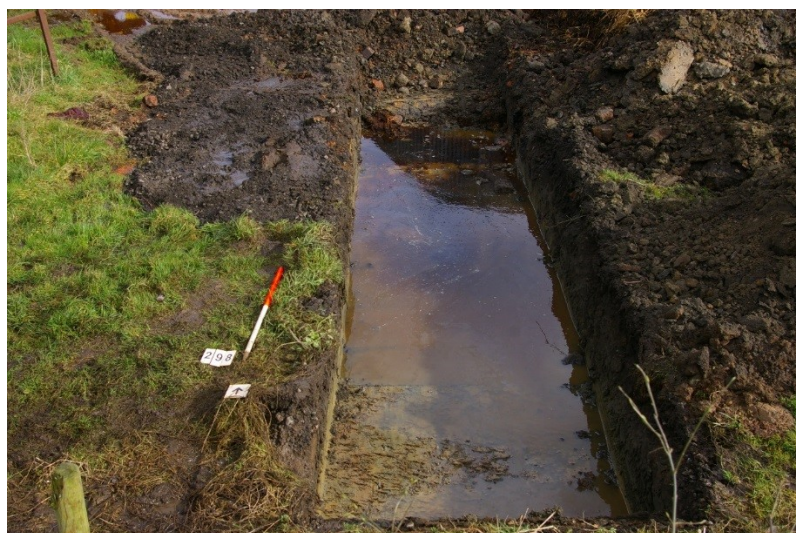
Figure 27: Trench 298. Trench abandoned due to flooding. Area R2 Part 2. Negative trench.
