**Launde Abbey, Launde, Leicestershire
'Oxford and Cambridge' Building:
Historic Building Survey
(SK 7972 0431)**

University of Leicester Archaeological Services

Report 2006-080 ©2006

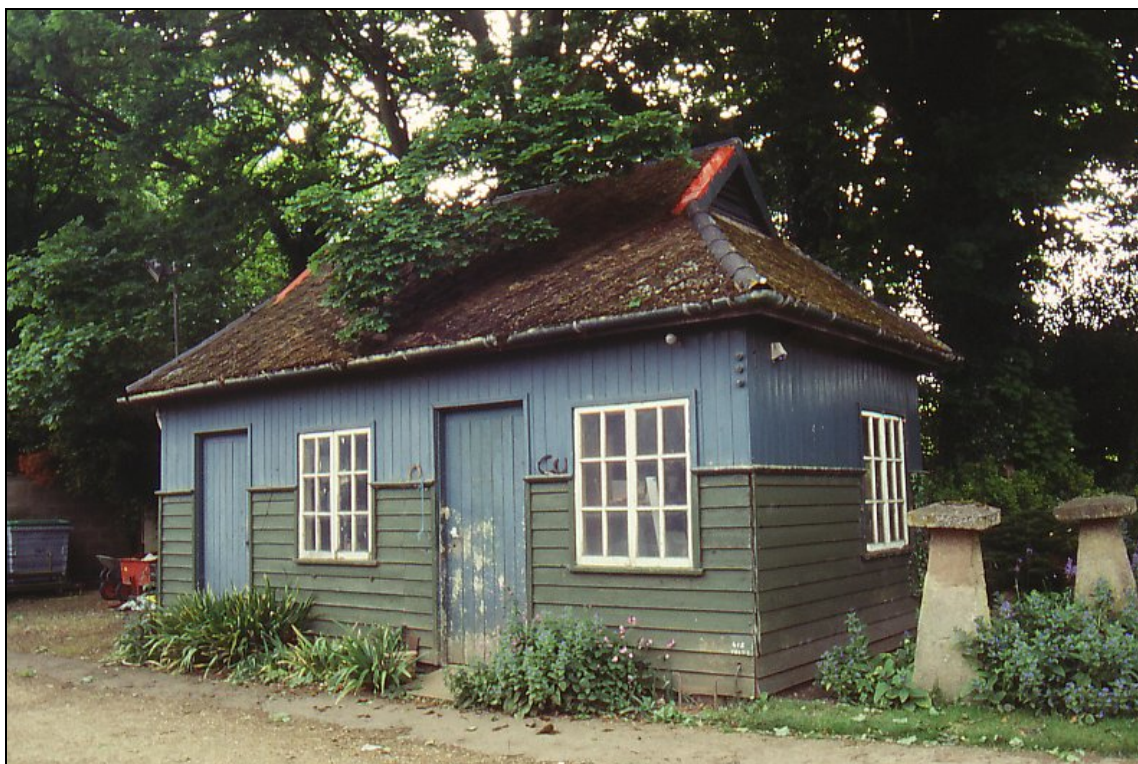
Figure 1. Oxford and Cambridge building, looking SW, showing the E front and N gable.

The Oxford and Cambridge building is a small, timber-built pavilion-type structure measuring c. 7.3m x 3.5m externally. The walls are clad with horizontal weather-boarding up to a height of 1.5m, above which there is vertical tongue and groove boarding. The junction is covered by a moulded rail which runs right round the building, interrupted only by the door and window openings, at which points the rail is neatly stopped. This combination of horizontal and vertical boarding appears to be the original arrangement, for decorative effect, rather than evidence of later replacement of the lower walling. There are two door and two window openings to the principal, east-facing elevation and a single window in each end wall. There are no openings in the west wall. All of the windows are of similar size and form being two-light casements, with one fixed and one opening side-hung light; each light has six panes. The two doors are similar, consisting of a basic framed structure with bead-edged planks fitted to the external face. The bottom rail is slightly raised, presumably to facilitate adjustment of door height as necessary during installation. The southern door retains what appears to be its original lock. The roof structure is hipped with louvered gables and is now covered with diamond-set asbestos tiles. The building rests on a brick and concrete base.

The external weatherboarding has been cut through on the front and rear walls, adjacent to the position of the internal dividing wall, suggesting that the building has been cut in half at some point, presumably to allow the structure to be moved. No evidence of this is seen internally which supports the suggestion that the internal tongue and groove cladding is non-original, presumably having been installed after the building was reassembled. The extant roof covering may have added at the same time.

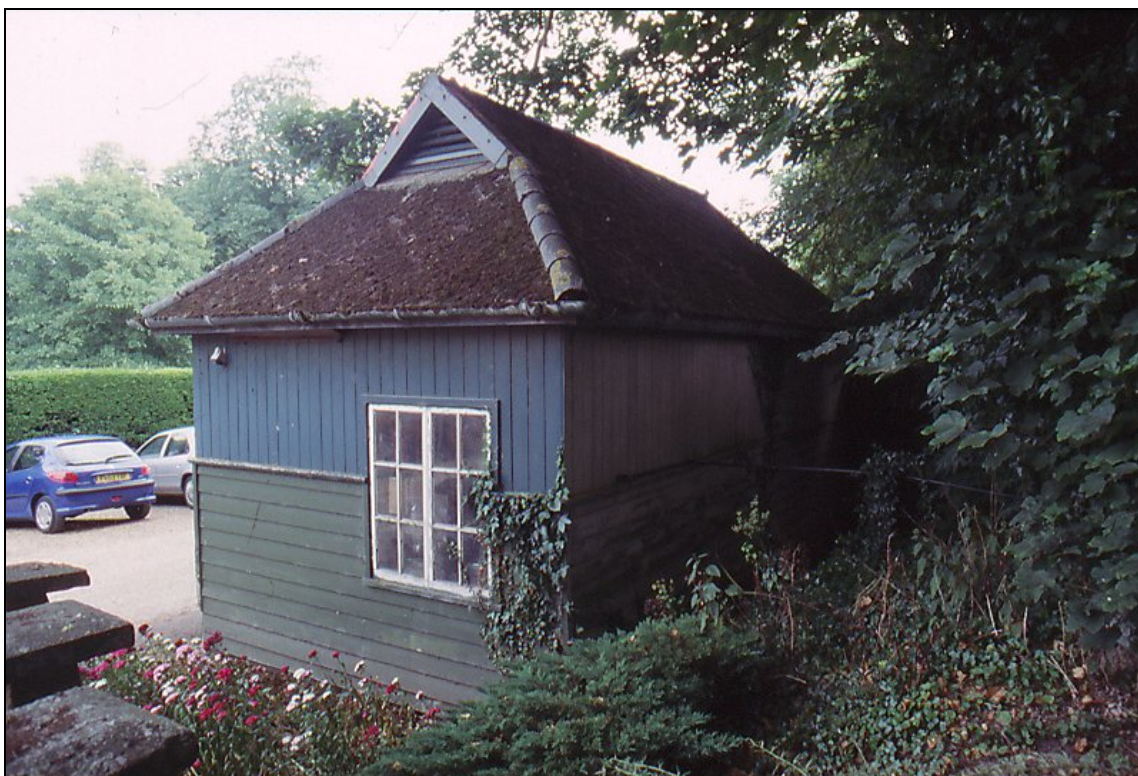
Figure 2. Oxford and Cambridge building, looking SE, showing the N gable and W wall.

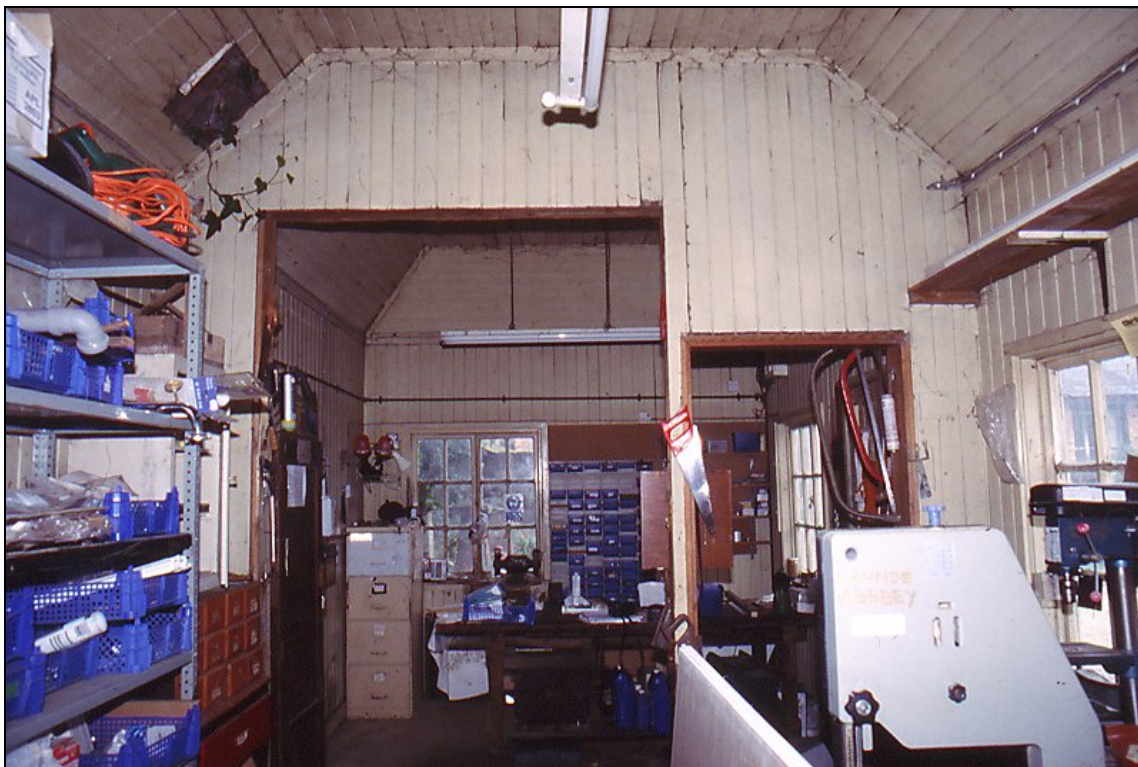
Figure 3. Oxford and Cambridge building, interior looking N, note former flue position in top left corner.

consistent with a structure formed from 100 x 50mm (4 x 2 inch) timbers, however. It is assumed that the timber-framework consists of prefabricated panels, though this is not certain. Nothing of the roof structure is visible internally. An opening in the roof, now blocked, evidently accommodated the flue of a stove positioned against the back wall on the south side of the internal dividing wall.

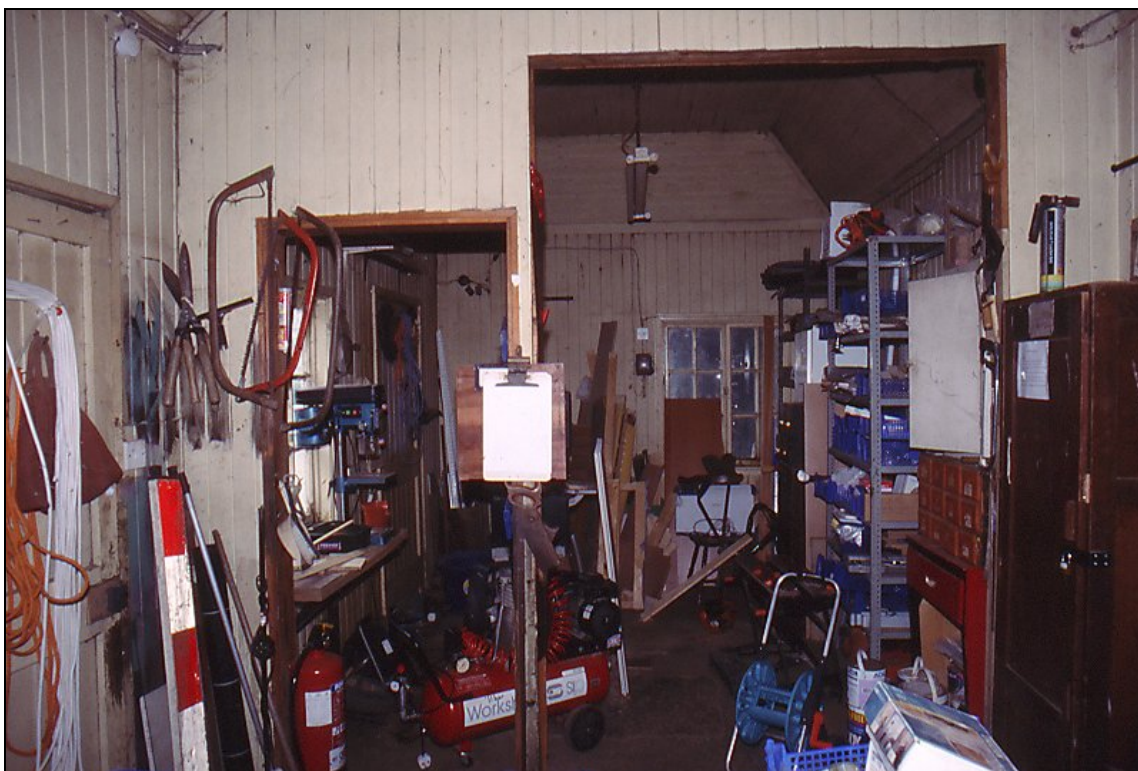
Figure 4. Oxford and Cambridge building, interior looking S.

The interior is divided into two rooms of unequal size, the larger southern room measures 3.67m x 3.24m and the northern room 3.27m x 3.24m. There are two openings in the dividing wall, the larger one is certainly non-original. The smaller opening may or may not be original. All internal surfaces are clad with tongue and groove boarding, apparently later in date than that of the external walls. Of the timber framework only a single 100 x 50mm (4 x 2 inch) stud forming part of the dividing wall is visible. The thickness of the external walls is
