**An Archaeological Evaluation
of the Ha-ha and stable block
at Launde Abbey,
Launde, Leicestershire.
NGR: SK 797 043**

Andrew Hyam
April 2007

Client: The Trustees of Launde Abbey

Report No. 2007-060 © 2007

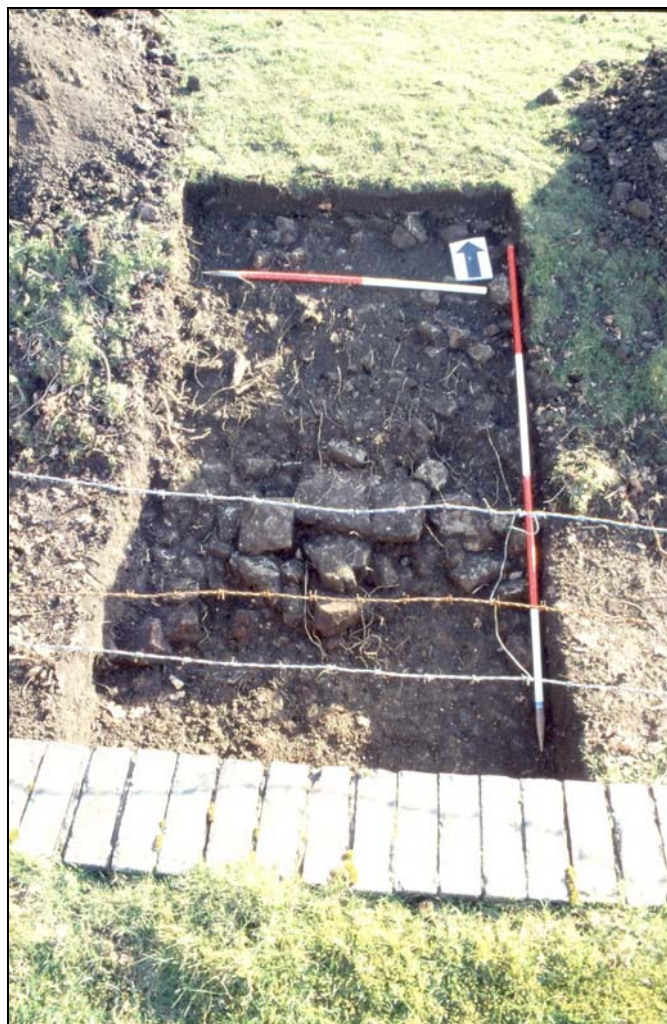
Located on the south facing leg of the Ha-ha this trench measured 1.5 x 2.6m with a maximum depth of 0.6m (fig.5, plate 1). At the top of the slope the turf was removed to reveal a mixed layer of dark grey brown silty clay containing many small fragments

of ironstone rubble (23) which appeared to be the original subsoil layer. Halfway down the slope, partially set into (23) was a band of closely laid unworked ironstone blocks (24) which followed the slope downwards until the cut levelled out approximately 1m from the face of the Ha-ha wall. At this point a dirty deposit of trampled natural silty clay (25) with ironstone fragments was exposed. The Ha-ha retaining wall sat directly on top of this layer which, despite being unexpectedly shallow at 0.6m below current ground level, appeared to be the original cut depth of the ditch.

Plate 1. Ha-ha south evaluation trench. Looking south.

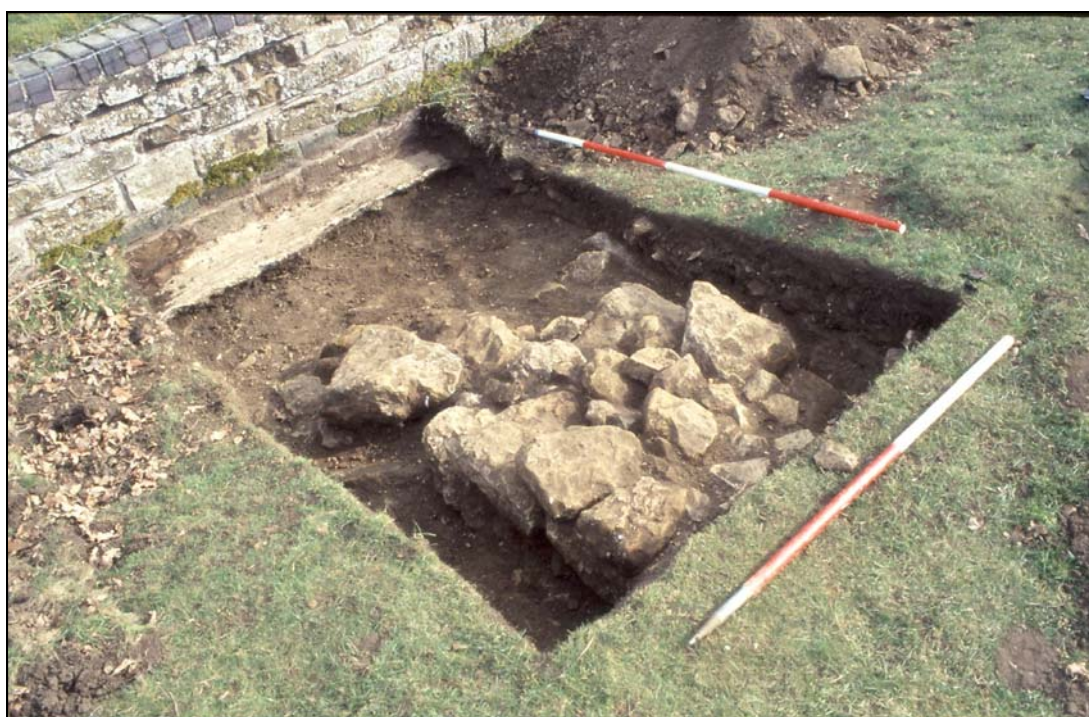
Located at the south end of the west facing leg of the Ha-ha this trench measured 1.5 x 2.6m with a maximum depth of 0.32m (fig. 6, plate 2). Removal of the turf layer revealed a layer of clayish silt and ironstone rubble (6) covering the remains of an ironstone wall (8). This wall consisted of three surviving rubble courses of roughly faced ironstone enclosing an ironstone and limestone rubble core. It appeared to have been shaped or demolished to follow the profile of the Ha-ha ditch which continued to descend from the edge of the lowest course which was approximately 1m from the Ha-ha wall. The length of exposed wall was in line with the south wall of the southern wing of the main house 24m to the east.

A dirty natural silty clay (12) similar to that seen in the south trench was observed extending from beneath wall (8) to the base of the Ha-ha retaining wall. Much of the Ha-ha wall at this point had been rebuilt quite recently as it was constructed on top of a wide concrete foundation. Although some attempt at decorative banding had been made the quality of the work was not as high as along the south wall despite reusing the original stones, most of the joints were also filled with a hard greyish pink mortar. The Ha-ha wall was tilting back slightly with some courses being more prominent than others. The top of the wall was capped by modern blue brick laid with the headers facing outwards.

Plate 2. Ha-ha south west evaluation trench. Looking north west.

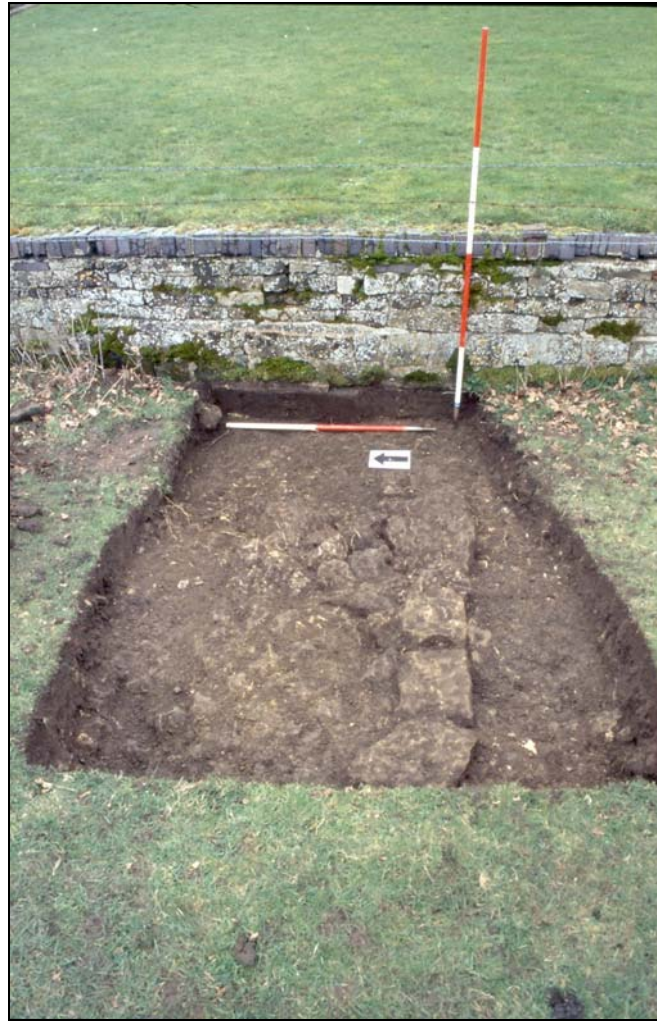
Located at the north end of the west facing leg of the Ha-Ha this trench measured 1.5 x 3m with a maximum depth of 0.5m (fig. 7, plate 3). This trench was very similar to the south western trench with a rubble layer (14) beneath the turf overlying the remains of a coursed rubble ironstone wall (16). Worn fragments of probably 14th century glazed floor tile were recovered from layer (14). As with the south west trench this wall had been dismantled to follow the profile of the Ha-ha ditch and had a similar depth to the base of its foundations which were set in a creamy yellow clay. Either side of wall (16) was a mid greyish brown clayish silt subsoil (15). At the lowest extent of wall (16) a band of ironstone rubble in a creamy yellow clay matrix (18) [19] was observed running from north to south. As this feature was not excavated it was not clear if (16) cut across this feature or if it related to an overcutting episode

A dirty natural mix of grey brown clayish silt and creamy yellow clay (20) covered the base of the Ha-ha ditch up to the retaining wall which had been built on top of this layer. The Ha-ha wall at this point had clearly been rebuilt using many original stones but not in the original positions, the occasional blue brick had also been used. Some of the larger joints had been heavily filled with a hard grey mortar with one particularly thick joint having a scratched inscription: *This wall was rebuilt by Mirfield...* the remaining text, which may contain a date, is badly worn and illegible. The Ha-ha wall was tilting back slightly with some courses being more prominent than others. The top of the wall was capped by modern blue brick headers.

Plate 3. Ha-ha north west evaluation trench. Looking east.

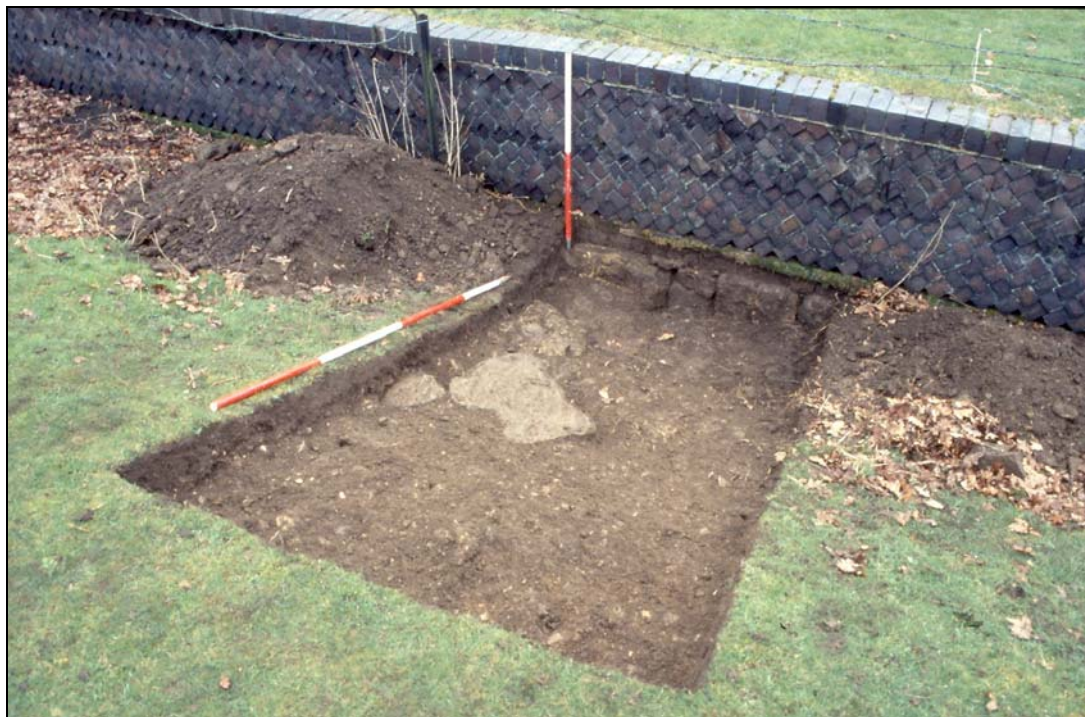
Located on the north facing leg of the Ha-Ha this trench measured 1.5 x 3m with a maximum depth of 0.25m (fig. 8, plate 4). Removal of a consistent 0.1m layer of turf down the slope of the ditch revealed a similar thickness of mid grey brown clayish silt and rubble (4) laid directly on the subsoil (5). At the base of the ditch was a cut [3] containing a dark orangey grey clayish silt with large angular lumps of ironstone and limestone (2). This fill extended across to the base of the Ha-ha although the full depth was not seen at this point as it was decided not to excavate this archaeological feature any further. A small number of large ironstone and limestone blocks were laid down the bank in an apparently random manner.

The lowest visible course of the Ha-ha retaining wall consisted of large roughly shaped blocks of ironstone with smaller stones between. Above this were two courses of ironstone or limestone similar in size to those used in the rest of the Ha-ha. Brick had also been used to fill in some gaps along the top course. Above this were nine courses of late 19th or early 20th century blue bricks laid with the headers exposed in a herringbone style. Trimmed bricks filled the gaps between the herringbone pattern and the headers laid as a capping along the top. The gaps at the base of the bricks were left open in most places, presumably to aid drainage. Because the bricks had been laid without the use of mortar entire courses have slipped forwards due to the pressure of earth behind them.

Plate 4. Ha-ha north evaluation trench. Looking south east.

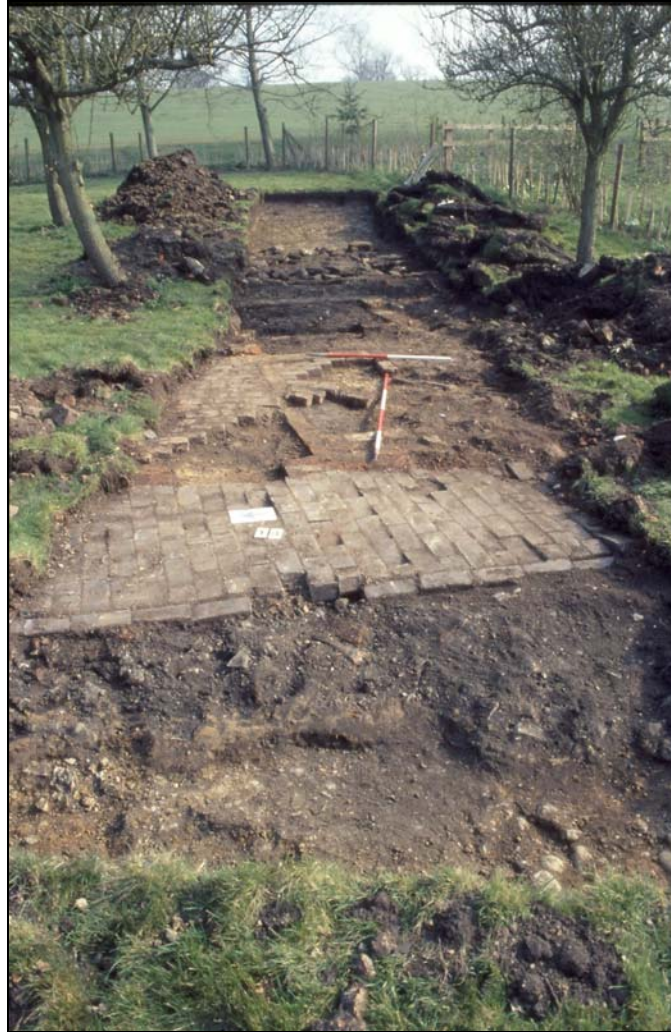
Removing the turf and topsoil revealed only a small amount of subsoil for the first 4m at the east end of the trench. Beneath this was a clean creamy yellow clay natural with no evidence of archaeological features. Beyond this point the topsoil gave way to a rough fragmentary brick surface which was removed to reveal a layer of unworked ironstone blocks (45) laid directly on natural clay. Layer (45) also contained a small number of faced pieces of limestone along with a number of red bricks. A strip of stones within layer (45) was lifted to try and understand how this had been laid and what, if anything, it had been laid on. A 0.5m wide strip was lifted along the entire length to reveal that the layer sat on clean and undisturbed natural clay.

At the western limit of layer (45) was a circular section ceramic land drain running along the eastern edge of a red brick wall foundation (44) with two courses visible running from north east to south west. The bricks measured 70mm x 110mm x 232mm and were laid in English Bond (alternating courses of headers and stretchers) using a lime mortar. Wall (44) formed the eastern wall of the sawmill building and contained a brick-lined possible sump or pit feature (43) using the same type of bricks as in (44). The sump measured approximately 1.6m x 1.8m and was backfilled with building rubble and silty clay which was not excavated. This feature cut into and was surrounded by natural creamy yellow clay. 3m west of wall (44) was another similar wall foundation following the same alignment with a red brick surface (42) laid on a bed of ash and mortar to the west. Removal of a small area of this bedding layer showed it to be approximately 0.02m thick and laid on top of natural clay. The western edge of surface (44) butted up against a blue brick surface (41) which appeared to border the remains of the cart track (40) also seen in Trenches 2 and 4.

Plate 5. Stable block. Trench 3. Looking east.

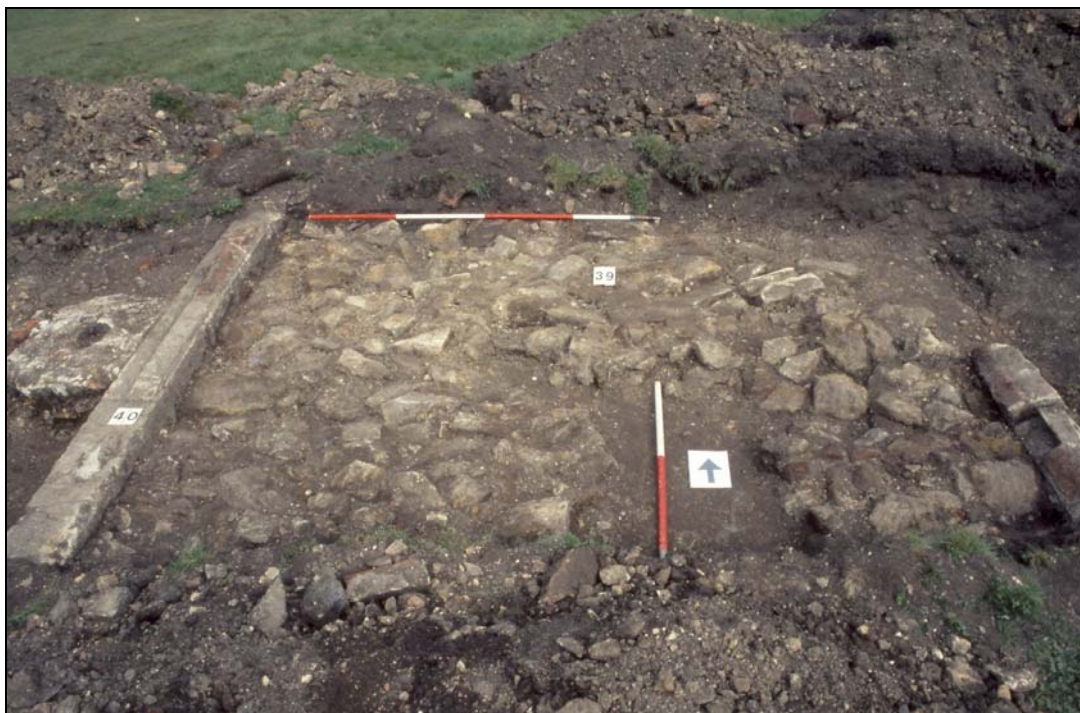
As with all of the other trenches the topsoil and subsoil were of the same consistency and approximate depth. Removal of the subsoil revealed evidence of two structures: the first was a layer of ironstone, limestone and brick (39) running across the centre of the trench in a north east to south west direction. Some of the limestone had been faced to create blocks of a similar shape and size to those seen in the Ha-ha wall. Removal of a strip of stones showed them to be only one layer deep and set on top of natural clay. This surface was bound on both sides by a concrete foundation supporting the remains of a red brick single skinned wall. This foundation can be seen breaking through the grass to the north of the trench. A circular section land drain had been laid along the outer, uphill, wall in the same way as the drain in Trench 3. The second building was shown by the remains of two rectangular blocks of concrete with holes in the centre to support steel stanchions possibly for a dutch barn type of building.

A land drain was observed running down the slope from the western edge of the brick-walled building down through the middle of the trench. A variety of modern pottery was recovered from the subsoil as was a Collyweston slate which may relate to earlier buildings on or near to this site. No other archaeological features or deposits were noted within this trench.

Plate 6. Stable block. Trench 5. Looking north.
