**An Archaeological Evaluation for  
Land at Uppingham Road,  
Houghton on the Hill,  
Leicestershire  
(NGR SK 6787 0398)**

ULAS Report No 2018-079

**For: CgMs Heritage**  
**Planning Ref: 15/01975/OUT**

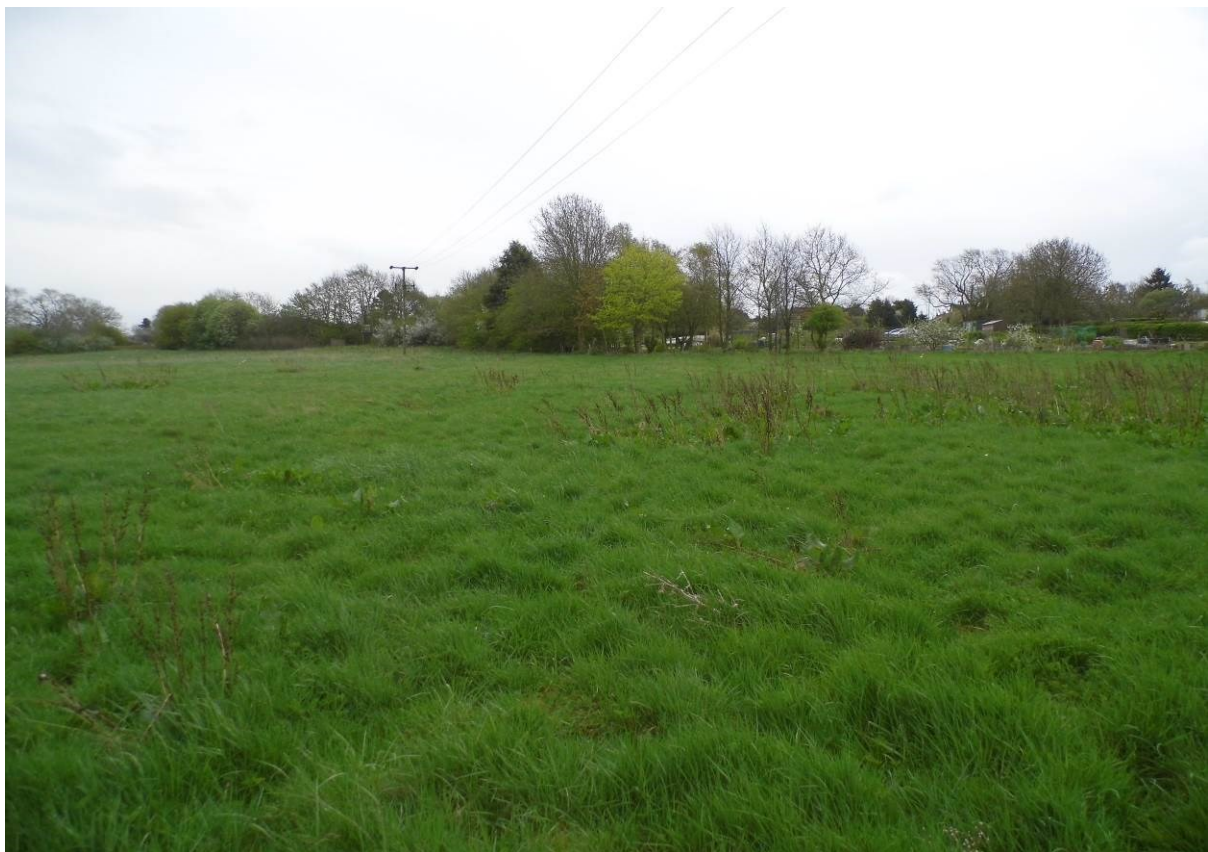
Figure 3: Development area looking south-east showing overhead electric cables.

A total of fourteen trenches were excavated using a machine with a flat-bladed bucket. The trenches were positioned according to the WSI (Clark, 2017), however the position of three trenches had to be adjusted and moved slightly due to the presence of overhead electric cables close to the main road (Fig. 3).

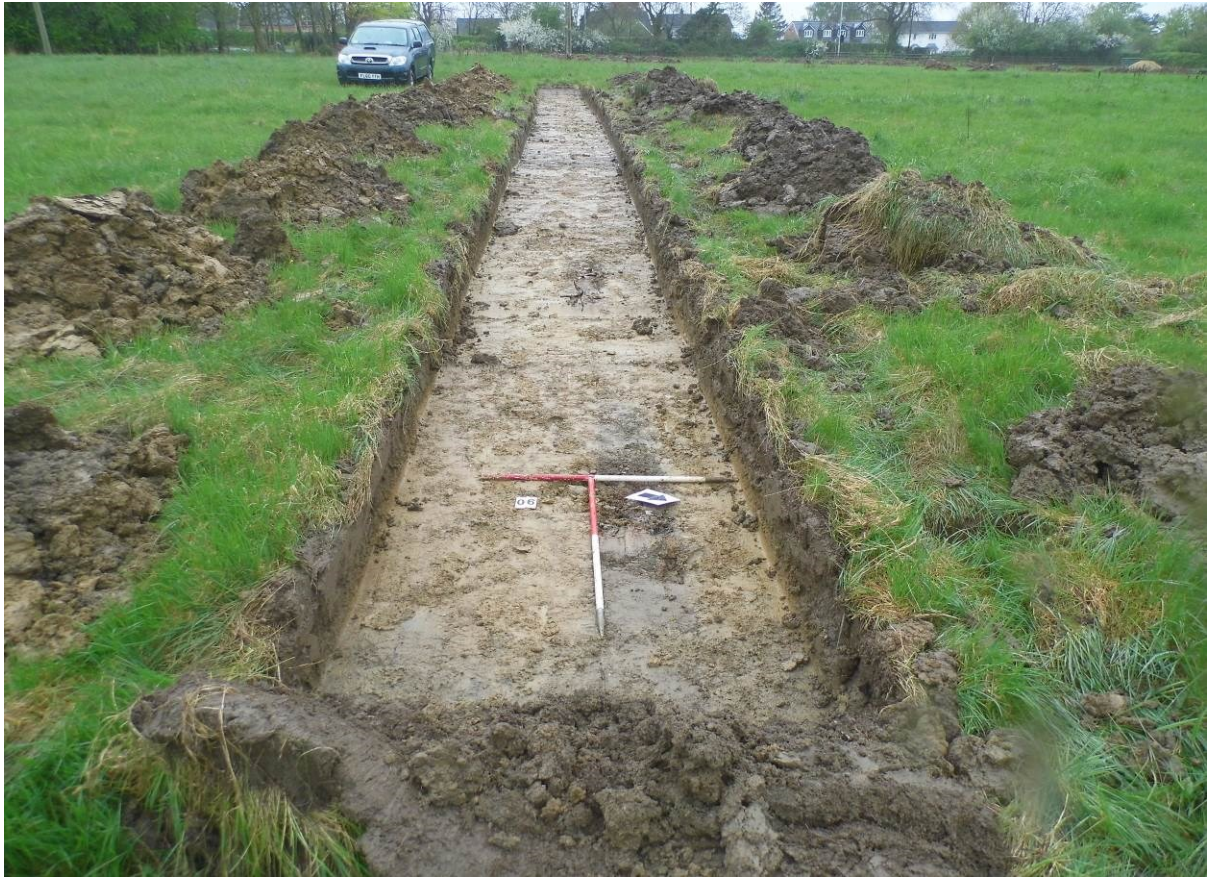
Trench 6 was located north-east of trench 3 and was orientated on a north-east to south-west alignment. The trench had a depth ranging from 0.3-0.45m and was found to contain 4 furrows and a plough scar orientated north-west to south east (Fig. 6). The 2 northern furrows were excavated and found to be approximately 0.05m deep. The northern end of the trench was found to contain a shallow feature orientated along a north-east to south-west alignment (Figure 5, p11). This feature measured >6m long by 0.7m wide and was also approximately 0.05m deep. The feature was filled with a dark brownish grey silty clay that contained a large proportion of modern ceramics, modern glass and iron cables. This was interpreted as a modern feature and was not excavated.

Figure 5: Trench 6 with the modern feature in the foreground.

The north-eastern end of trench 6 found a shallow linear feature which wasn't identified in the geophysical survey, however this feature was not excavated due to the large proportion of modern material within it. The only other activity identified from the trenching was bioturbation caused by collapsed animal burrows.

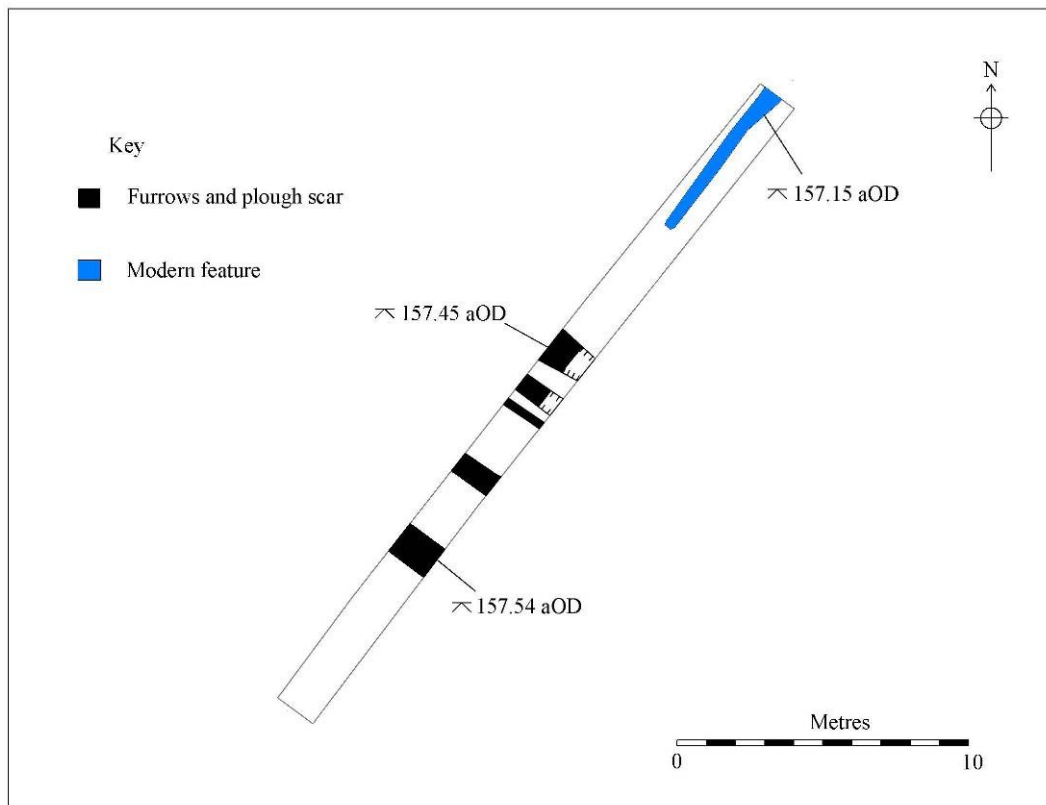
Figure 6: Plan of trench 6.

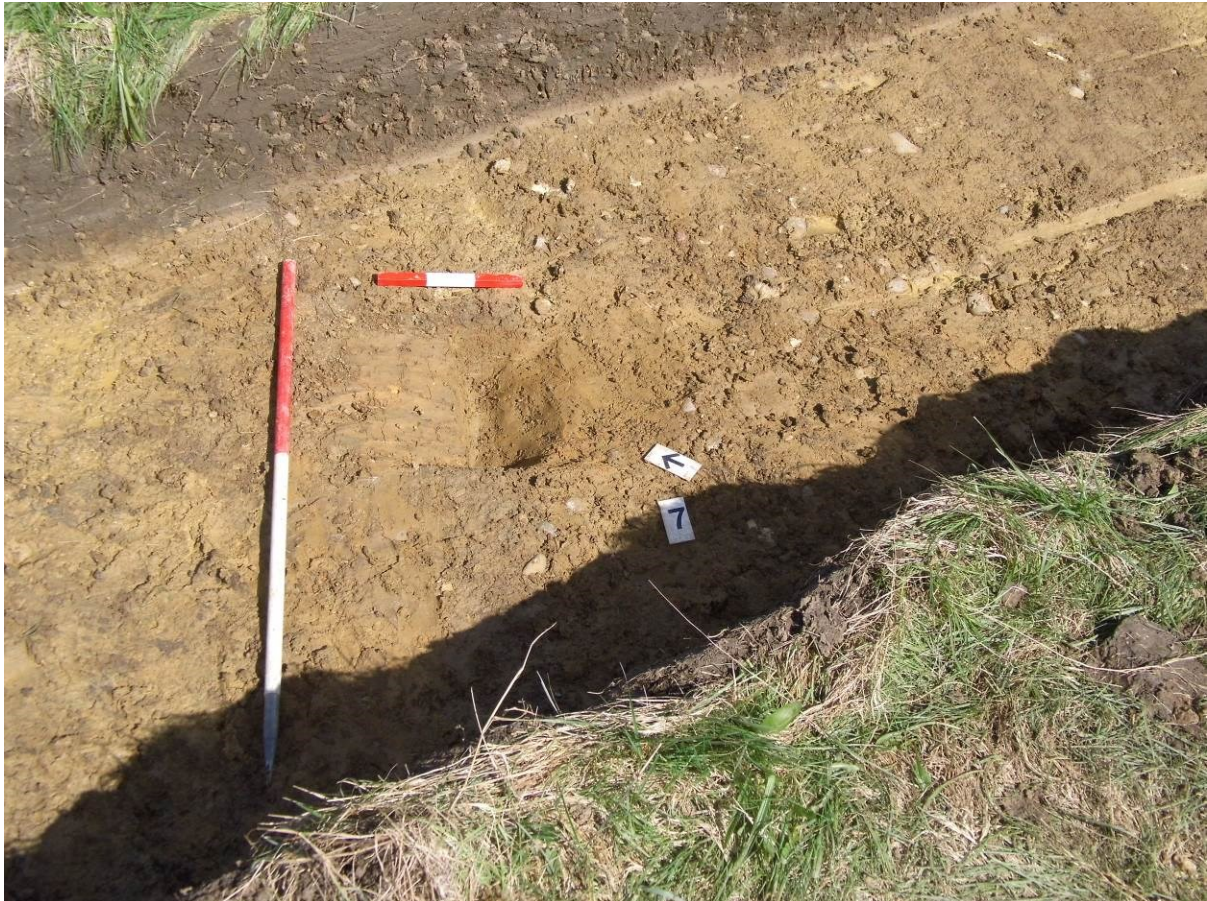
Trench 7 was located to the north of trench 6 and was orientated on a north-west to south-east alignment. This trench had a depth ranging from 0.4-0.5m and was found to contain a shallow furrow orientated north-west to south-east located in the western half of the trench. Close to the centre of the trench a shallow irregular feature was found which measured >1.6m long by 0.4m wide and approximately 0.1m deep. This feature was orientated on a north-east to south-west alignment and had irregular sides that ranged from steeply sloping to undercutting. The feature had an irregular base and was interpreted as being a plough scar (Fig. 7). No other features were present within this trench.

Figure 7: Plough scar in trench 7.

The trenching found a plough scar 2.5m to the south-east of geophysics anomaly 1 (Davies, 2015) in trench 7. Both the plough scar and the geophysics anomaly are orientated north-east to south-west and it is probable that the geophysics anomaly is related to this activity.

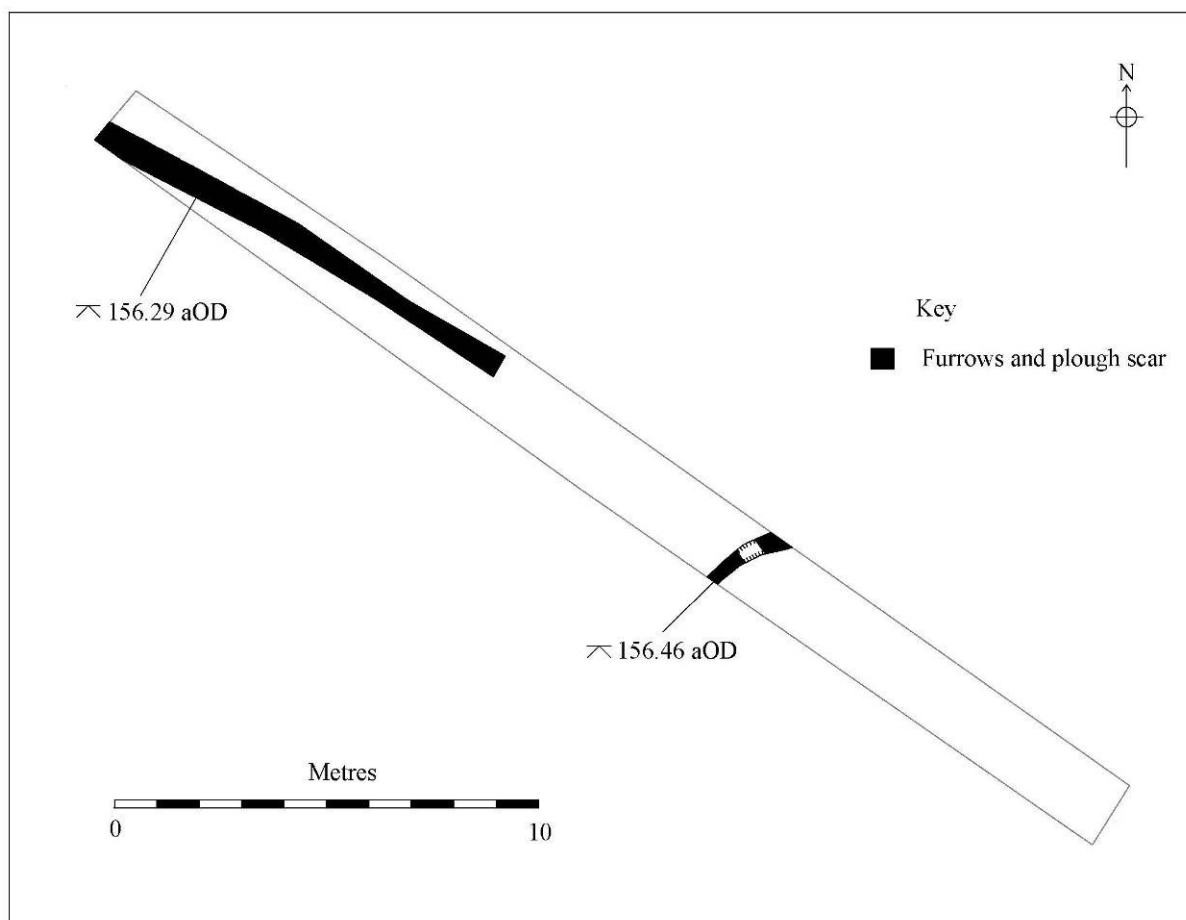
Figure 8: Plan of trench 7.

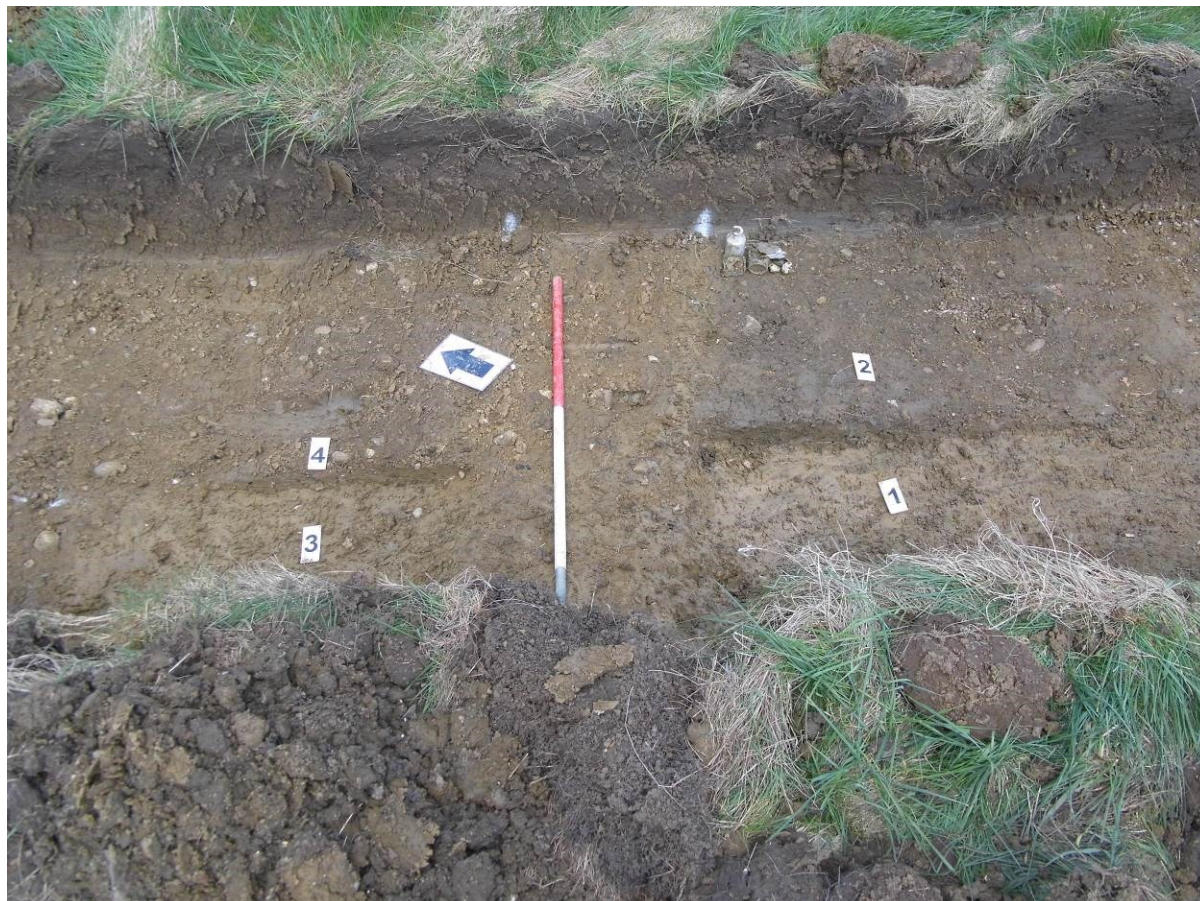
Trench 9 was positioned in the centre of the development area and orientated north-west to south-east. It had a depth ranging from 0.42-0.5m and was found to contain a furrow orientated north-west to south-east. Truncating the furrow were 2 shallow parallel linear features orientated north-east to south-west (Fig. 9). The eastern feature [1] measured >1.6m long by 1.4m wide by 0.07m deep and had moderate to steeply sloping concave sides with a concave base. The feature was filled by a dark greyish brown firm silty clay (2) that contained small rounded pebbles and a large proportion of modern glass and ceramics. To the west of [1] a smaller linear feature was found [3] which measured >1.6m long by 0.8m wide

by 0.07m deep. This feature had shallow concave sides with an irregular concave base and was filled by a firm mid-greyish brown silty clay (4). This deposit contained small rounded pebbles and shards of modern glass.

Figure 9: Shallow features [1] and [3] in trench 9.

The trenching also confirmed the presence of a north-east to south-west field boundary (Davies 2015). It was excavated in trench 9 and found to consist of 2 shallow parallel linear features [1] and [3] that contained modern ceramics and glass which was discarded. These features could either represent a field boundary that has slightly shifted or a boundary that is composed of a hedge and a ditch. These were found to truncate a furrow which indicates the field boundary is a modern division.

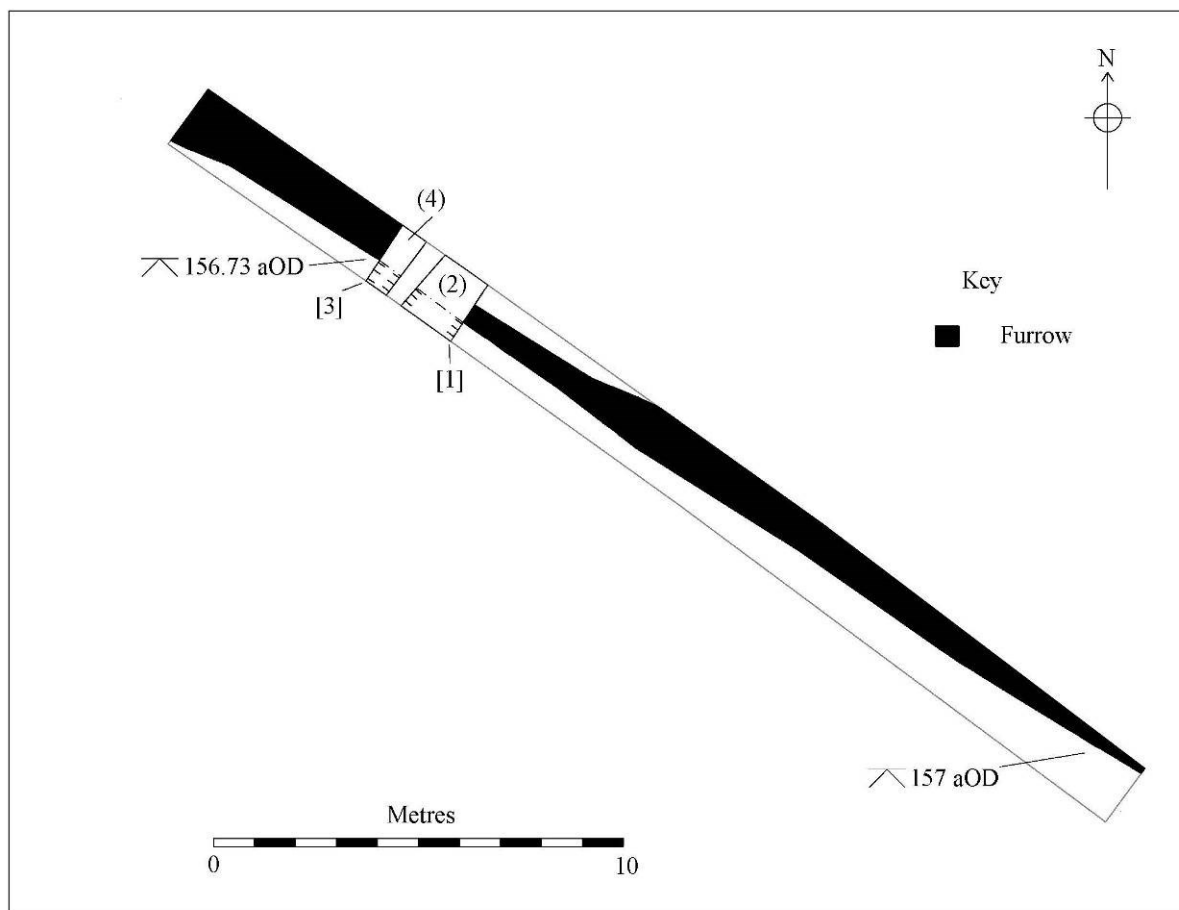
Figure 10: Plan of trench 9.

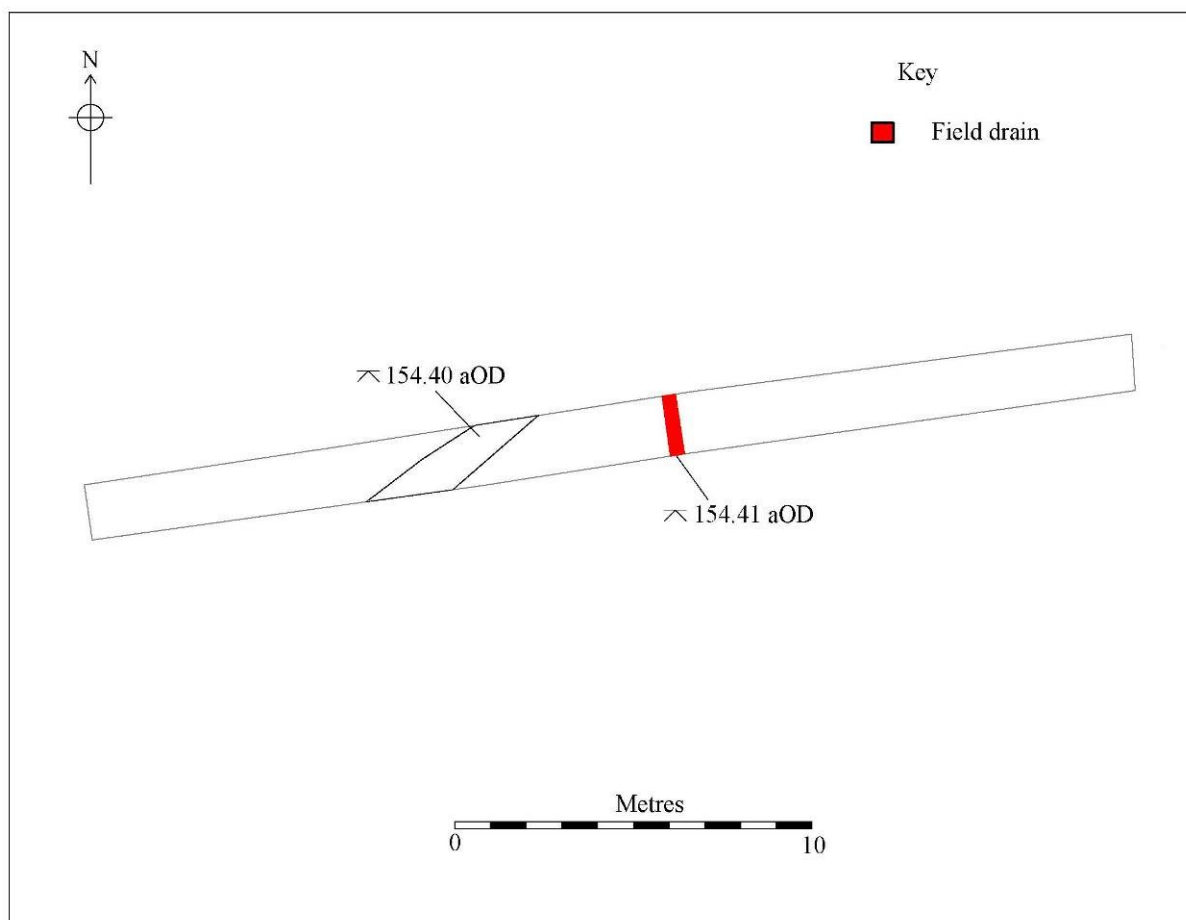
Trench 10 was located to the north of trench 9 and was orientated on an east north-east to west south-west alignment. This trench had a moderate slope to the south-west and a depth ranging from 0.35-0.47m. It was found to contain a linear feature orientated north-west to south-east which was filled with a dark greyish brown silty clay that contained a modern glass bottle. This feature measured >1.6m long by 1.2m wide and was interpreted as a continuation of [1] in trench 9 and was not excavated. Approximately 5m to the east of this feature a field drain orientated north-west to south-east was found. No other features were found within this trench.

Figure 11: Plan of trench 10.

The field boundary was found to continue in trench 10. A field drain that was orientated north to south was found 5m to the east of the field boundary and it seems likely this was the source of geophysics anomaly 2 (Davies, 2015).
