**The Former St. Mary's Vicarage,
The Newarke, Leicester:
Historic Building Record and Excavation**

University of Leicester Archaeological Services

Report 2005-137 ©2005

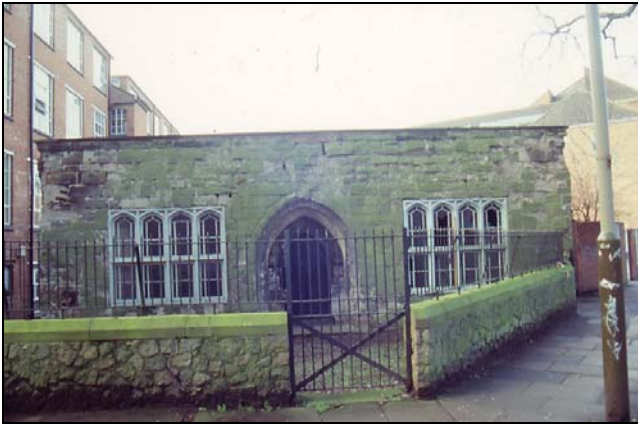
Plate 1. Former St. Mary's Vicarage: East elevation.

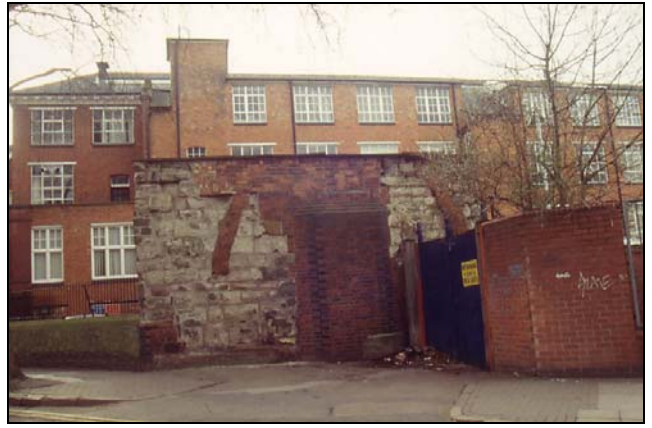
Plate 2. Former St. Mary's Vicarage: North elevation.

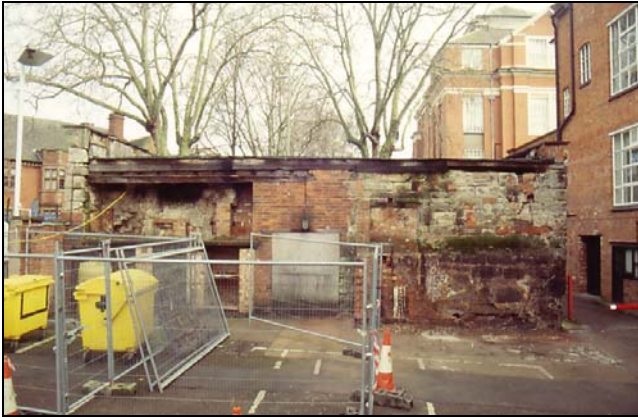
Plate 3. Former St. Mary's Vicarage: West elevation.

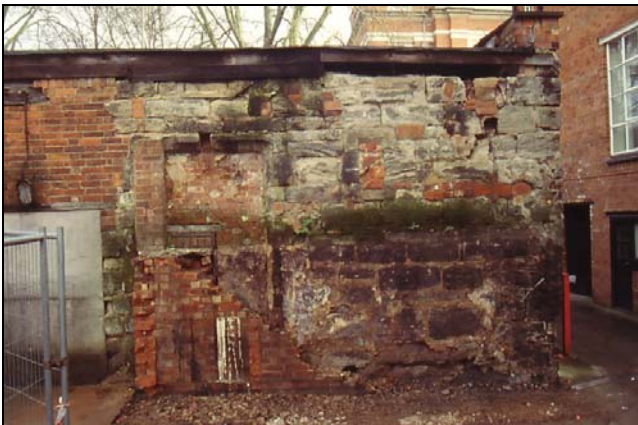
Plate 5. S end of W elevation after demolition of chemical store.

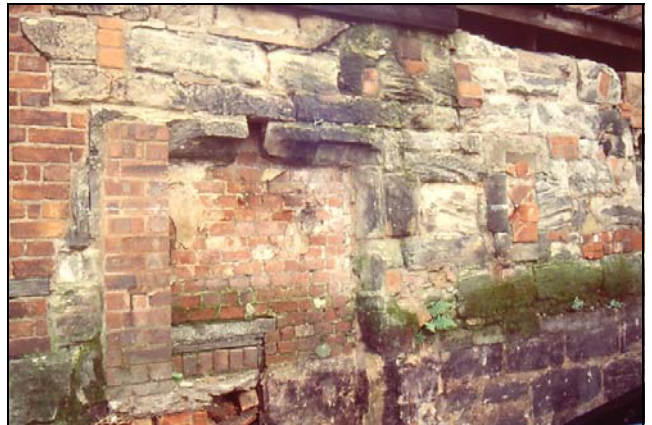
Plate 6. Detail of brick-blocked windows at S end of W elevation.

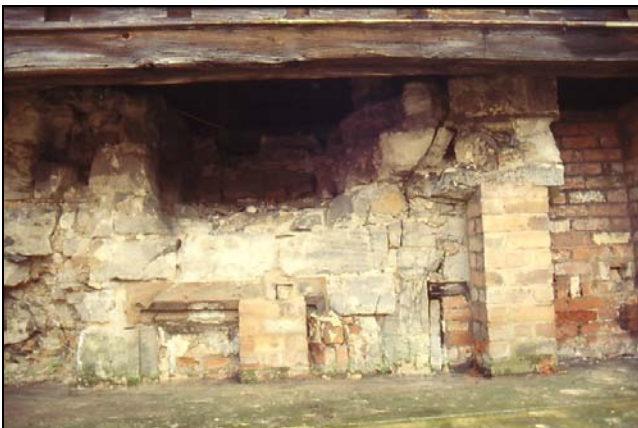
Plate 7. Window head & stair turret remnant N end of W elevation.

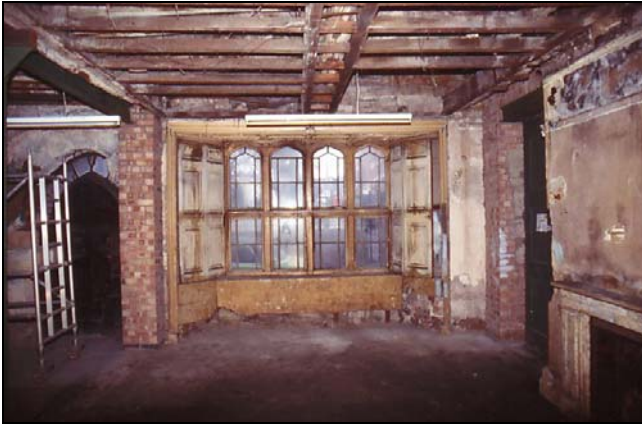
In the south room more of the 19th century fixtures and fittings have survived. There are again panelled shutters to the timber mullioned window in the east elevation (Plate 9). A fireplace was inserted into the south wall at ground floor level; this has a good quality white marble surround, now quite badly damaged, with a tiled cast iron insert (Plate 8). In the thickness of the west wall is a large recess with Tudor arch head and adjacent to this a serving hatch, now blocked, suggesting that this had been the dining room (Plate 8). Sections of skirting, picture rail and coving survive. Successive layers of wallpaper were noted in some areas, the earliest of these appeared to predate the mid 19th century remodelling. The scope of this commission did not permit detailed analysis of the wallpaper, however.

Plate 9. Interior of S end of former vicarage, looking E.

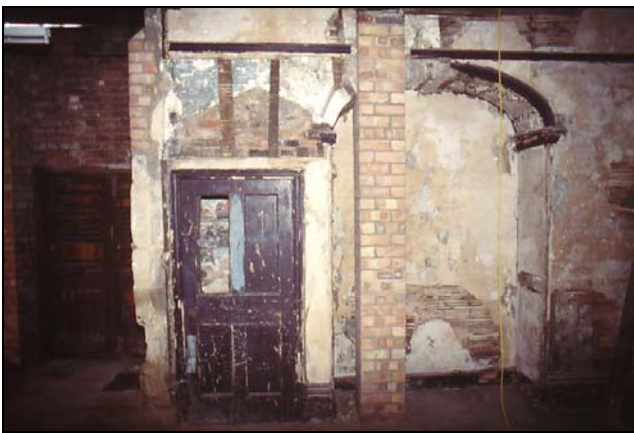
Plate 11. Medieval cross passage door & C19 cupboard in W wall.

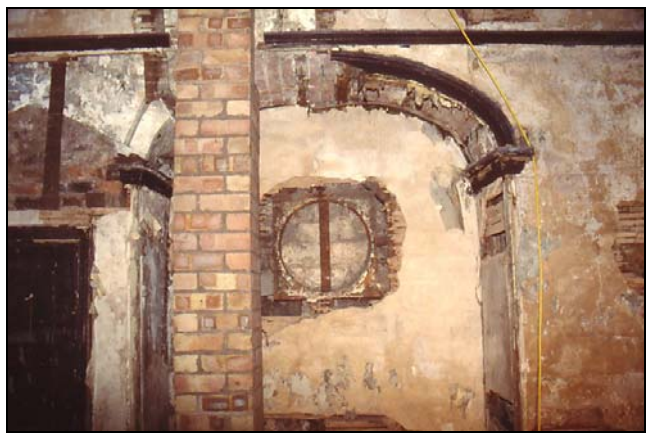
A recess with basket-handle arch head, in the internal face of the west wall, probably dates to the later 18th or early 19th century. Set within the recess, behind decayed lathe and plaster attributable to the mid 19th century renovations, was a wooden frame that would have accommodated a picture or roundel of some kind (Plate 12; Figure 5). To the north of this, again covered by lathe and plaster, was an area of brickwork, apparently infilling another recess of unknown date. On the internal face of the east wall there is evidence that the tall opening with four-centred arch head was modified to create a smaller window, which was subsequently infilled with brick, probably in the mid 19th century (Figure 5). Other areas of brickwork relate to repairs and patching of decayed stonework at various times.

Plate 12. C18 or early C19 recess with ?picture frame in W wall.

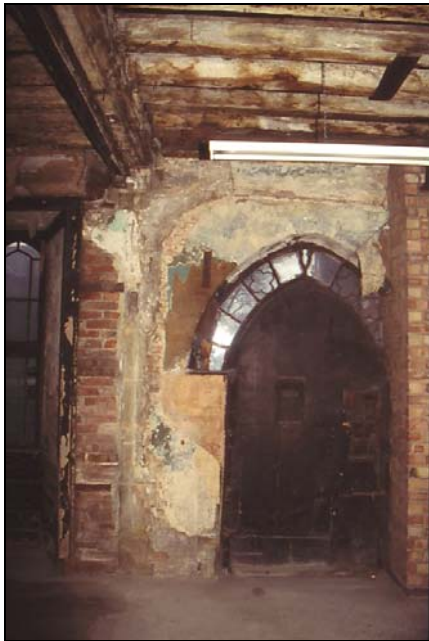
Plate 13. Blocked medieval openings on inner face of E wall.

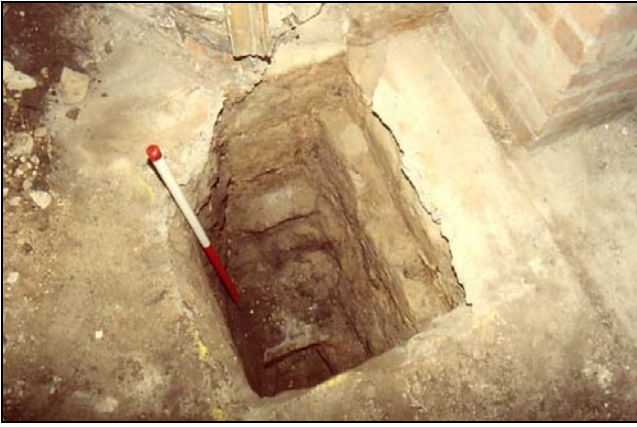
Plate 15. Excavation trench T1, looking SE. Scale: 1m.

Trench T1 was located just inside the south-east corner of the building (Plate 15; Figure 10). Beneath the concrete floor surface a series of soil deposits was encountered (15, 16 & 17). Excavation was terminated at a depth of 1.4m (57.23m above OD). Pottery and clay pipe fragments recovered from the excavated deposits suggest a date in the 18th or possibly the early 19th century for these contexts (see Appendix 2). The stepped foundations of the east and south walls of the medieval structure were exposed in the sides of the trench.

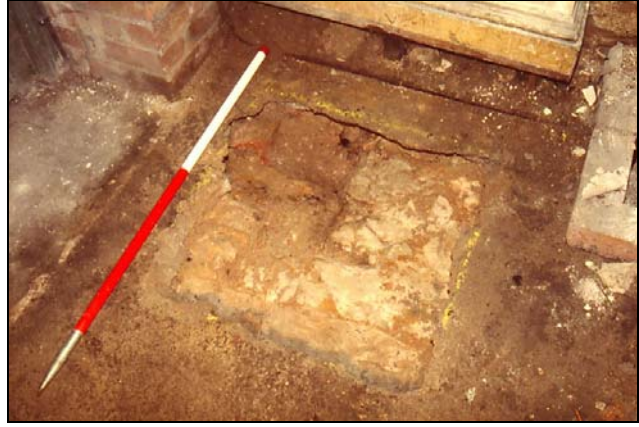
Plate 16. Excavation trench T2, looking SW. Scale: 1m.

Trenches T1-T4 were within the building, positioned to coincide with the proposed locations of mini-piles to support the new roof structure. Removal of the concrete floor surface and associated formation deposits in trenches T2 (Plate 16) and T4 (Plate 18) exposed the Dane Hills sandstone foundation of the west wall of the medieval structure (Figure 10). An area of 19th century quarry tile flooring, cut into the earlier wall foundation, was also revealed in trench T4 (Plate 18). No further excavation was undertaken in either of these trenches.

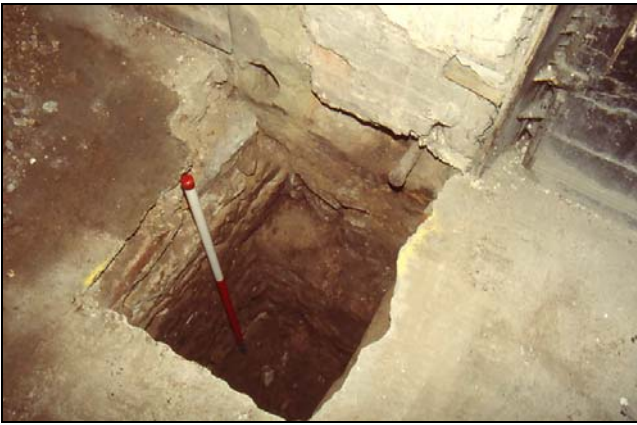
Plate 17. Excavation trench T3, looking NE. Scale: 1m.

Trench T3 was located towards the centre of the east wall of the building (Plate 17; Figure 10). Beneath the modern concrete floor surface an east-west aligned brick wall foundation (2) was encountered (brick dimensions: 241 x 105 x 59mm); this was constructed on a course of Swithland slate pieces (3) laid on a thick bed of mortar (4). This was the foundation of the wall separating the central hallway from the north room in the 19th century layout. Below (4) a structure (5), composed of Dane Hills sandstone blocks bonded with mortar, may be interpreted as a foundation for the sill plate of the spere on the south side of the blocked early doorway (see above). A series of deposits below this (6, 7, 8 & 9) contained a few sherds of transitional Iron Age/Roman pottery, Roman Samian ware, and medieval wares of 12th to 14th or 15th century date. In addition a single fragment of 18th or 19th century clay tobacco pipe was recovered. These deposits appeared to post-date the construction of the stepped east wall foundation. Excavation was terminated at a depth of 1.10m below floor level or 57.55m above OD.

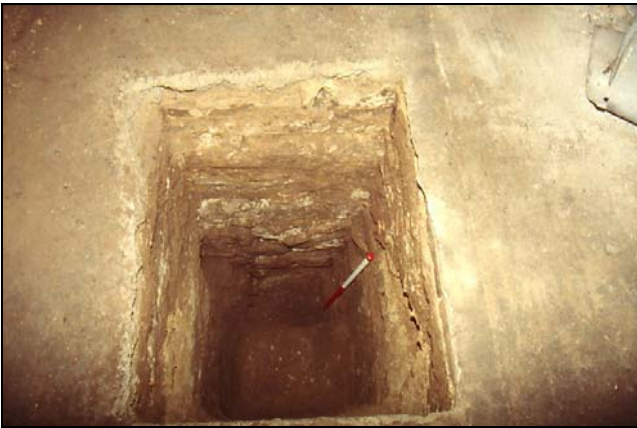
Plate 19. Excavation trench T5, looking W. Scale: 1m.

Trench T5 was positioned to establish the depth and character of the west wall foundation, in order to assess the suitability of this to provide a load bearing support for the new roof structure (Plate 17; Figure 10). It was excavated down to the base of the wall foundation, 2.00m below the internal floor level at 56.70m above OD. Beneath the modern concrete floor surface, a brick wall foundation (25) was exposed in the north section of the trench (brick

dimensions: 241 x 105 x 59mm). This wall had separated the central corridor from the south room in the mid 19th century layout (Figure 9); it was founded on a mortar bed (26). A series of dumped deposits (27, 28 & 29) overlay the backfilled construction cut (32) for foundation of the west wall. Medieval pottery recovered from the lower fill of the construction cut (31) ranged in date from *c.*1250 to the later 13th or early 14th century (see Appendix 2). The construction trench for the wall was cut through a series of earlier deposits (33-37) from which pottery and medieval ridge tile, roofing slate and possibly medieval window glass, of a similar date range to (31) was recovered. The earliest of these deposits (37) overlay natural orange gravelly clay which occurred at 57.06m above OD. This in turn overlay natural pinkish red Mercia mudstone clay at 56.88m above OD.

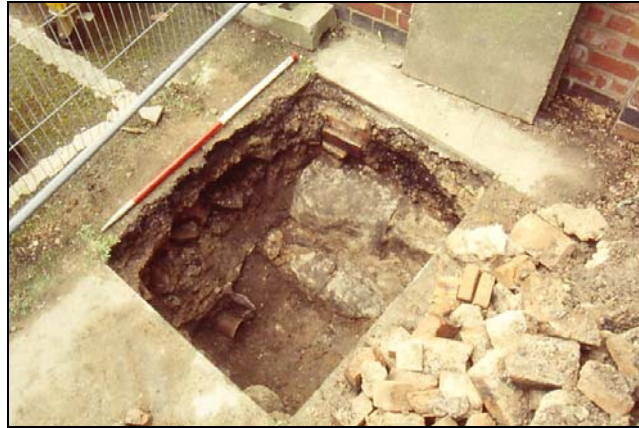
Plate 20. Excavation trench T6, looking NW. Scale: 1m.

Attached to the north-west corner of the former vicarage is the stub of a wall constructed from the same Dane Hills sandstone. The excavation trench T6 exposed a section of the foundation of this wall just to the west of the upstanding fragment (Plate 20). It seems probable that this was a boundary wall, broadly contemporary with the construction of building, which seems to have defined the north side of the plot to its rear. The inventory of 1546 records that each of the canons houses within the precinct had a garden; in addition the dean's house also had an orchard (Hamilton Thompson 1910, 529-30). The Roberts' map of 1741 shows a wall in approximately this location running westwards then turning to the south to form the west precinct wall of the Newarke enclosure. It has been suggested in the past that the River Soar formed the western boundary to the Newarke and that there was never a wall on this side. Recent excavation, however, has located the foundation of a substantial wall constructed from Dane Hills sandstone in the same position as the west precinct wall shown on the Roberts map (Hallam and Webster 2001, 6).

The external trenches were positioned to assess the potential impact of the installation of new services on any buried archaeological remains. Trench T6 (Plate 20; Figure 10) exposed a ceramic drainage pipe (48), of 19th or early 20th century date, at a depth of 0.85m below ground level (at 57.73m above OD). All of the excavated material (46 & 47) was made up of backfill associated with the installation of this pipe. The foundation of the boundary wall attached to the northwest corner of the medieval building was partially exposed along the north side of the trench. Three courses of mortared Dane Hills sandstone were visible but the base of the wall foundation was not reached.

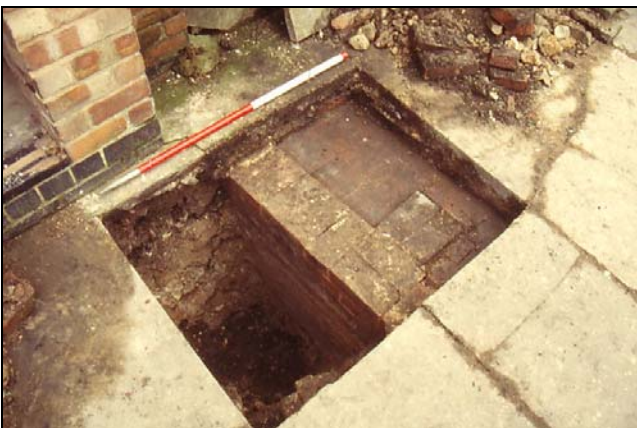
Plate 21. Excavation trench T7, looking SE. Scale: 1m.

In trench T7 (Plate 21; Figure 9), a 19th century brick wall foundation, orientated approximately east-west, was exposed. This survived to a depth in excess of 10 courses, laid in Flemish bond pattern (brick dimensions: 241 x 120 x 67mm). To the south of this a quarry tile floor and brick floor were partially uncovered.

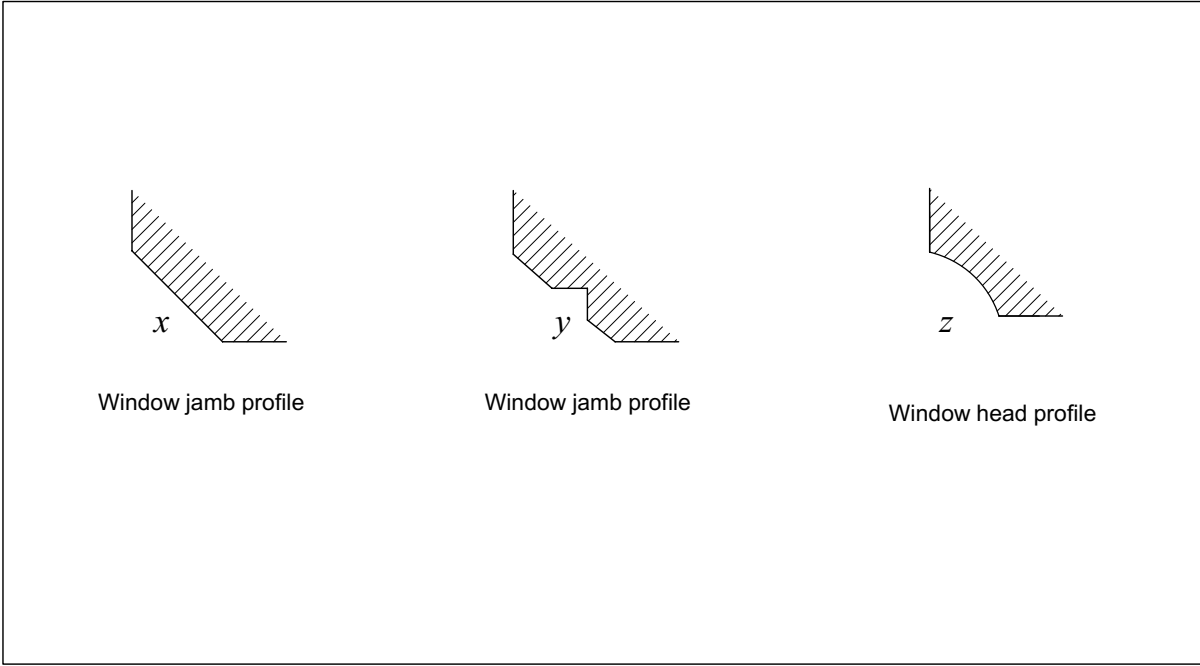
Figure 7. Profiles of stone window jambs & head (located on Fig. 2). Scale 1:10.

Window jamb profile

Window head profile
