**The Old School House,
57 Leicester Road, Groby, Leicester:
Historic Building Assessment**

University of Leicester Archaeological Services

Report 2006-152 ©2006

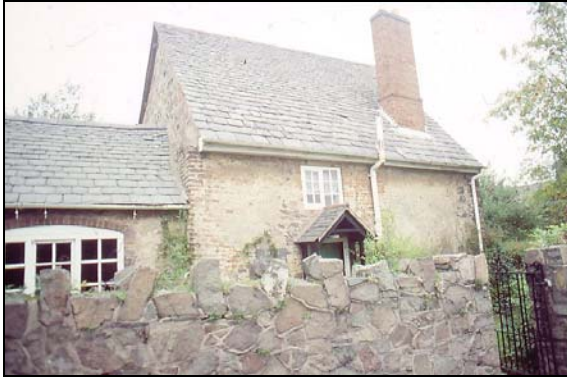
The building consists of a number of distinct structural elements identified as ranges **A-D** on Figure 2. The earliest element appears to be **A**. This is a two-storey range constructed from rendered granite rubble and roofed in local slate (Photo 1). There is an exposed roof truss in the east gable with 18th century and later brick infill (Photo 3). There are further areas of 18th century brickwork in the principal (street-facing) south elevation and at the south-west corner of this range. All of the window openings have brick detailing. There is evidence for at least one blocked window in the south elevation at first floor level, partially obscured by render. In plan this range consists of two bays of unequal size. The front door opens onto a hallway and staircase within the shorter bay, beyond which is a small scullery, formerly heated by a corner chimneystack backing onto the staircase. The larger bay is occupied by a living/dining room heated by a fireplace against the south wall, which is served by a 19th century brick stack. On the first floor of this range are a bedroom, bathroom and W.C. Within the roof space there are two timber trusses: one at the east end (Photo 5) and the other at the bay interval. It seems likely that a third similar truss was located at the west end, though the west gable has been rebuilt (badly) in stone at some stage. The two roof trusses are of generally similar form having curved principals with inset feet and a scissor apex, a collar at mid-height and presumably a tiebeam (though in neither case is this visible). The truss at the bay interval has

Photo 1. Front elevation of 57 Leicester Road (A to right).

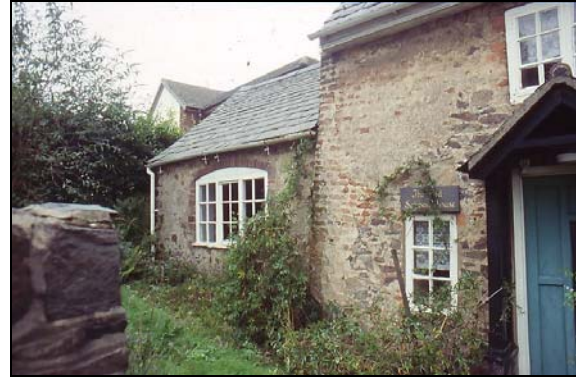
B is a single-storey range on the west side of **A** (Photo 2). It is constructed from granite rubble and roofed in local slate. Internally it consists of a single room lit by a large window in the south elevation with late (i.e. 20th century) brick detailing and a barred window set high in the west gable wall (Photo 7). Sockets in the stonework of the north wall suggest there was formerly shelving here. The room has no fireplace and no evidence for one having been removed. The walls had been lined with panelling composed of timber and asbestos sheeting, which had been largely removed at the time of the inspection. The roof structure was not exposed.

Photo 2. Suspected single-storey school room B (to left).

In terms of the specific question of whether the single storey west range **B** ever functioned as a schoolroom, it appears that this was not built until after the adjacent schoolhouse was constructed in 1842. However, this range is not obviously domestic in character and may therefore have been built to serve some other function. Its form is not inconsistent with what would be expected of a schoolroom, but equally a framework knitting workshop, for example, would share similar characteristics.

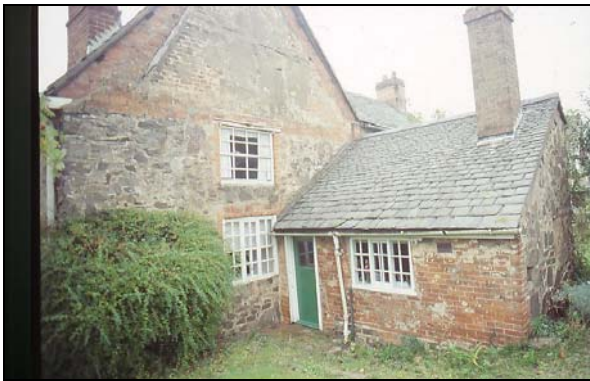
D is a single-storey range on the east side of **A**, presently a kitchen (Photo 3). The north and east walls are constructed from granite rubble, the south wall is 19th century brick. The roof is local slate. The north wall (and possibly a portion of the east wall) is of comparable thickness to the walls of **A** and the remainder of **D** is effectively a lean-to built against this wall. There is evidence of a former window in the north wall now converted into a cupboard. There is a door and three-light window in the south elevation. The south wall is splaying outwards under the weight of the roof.

Photo 3. Range A to left and single-storey kitchen D.

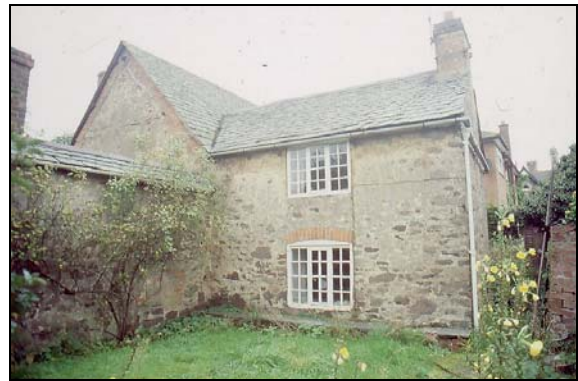
C is a substantial two-storey range on the north side of **A**, again constructed from granite rubble with a local slate roof (Photo 4). 3-light casement windows in the east elevation have 19th century brick detailing and L-hinges. Internally this range comprises of a single large room on either floor, each heated by a fireplace in the north gable wall. On the ground floor there were formerly fitted cupboards either side of the fireplace, now removed. The fire surround, now also removed, was of mid-20th century type. The walls are lined internally with lathe and plaster. The roof of this range was visible from within the roof space of **A** but was not directly accessible.

Photo 4. Two-storey rear (north) range C

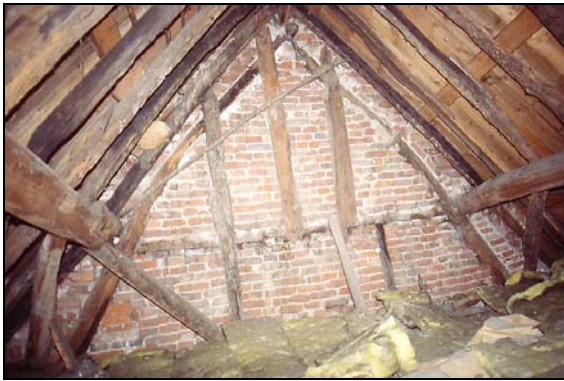
raking braces rising to the underside of the collar. The east gable truss has a series of vertical staves nailed into position that may have formed the basis of earlier infill to this gable (Photo 5). There are heavy side purlins and a square-set ridge purlin. Slender windbraces are nailed to the backs of the principals and tenoned into the undersides of the purlins. Much of the timber in this roof structure is clearly reused; craftsmanship is generally poor with crudely formed joints. Several of the timbers display evidence of scorching or charring suggesting a fire, however these pieces appear in the main to have been reused in their current positions.

Photo 5. Roof structure of A, looking towards east gable.

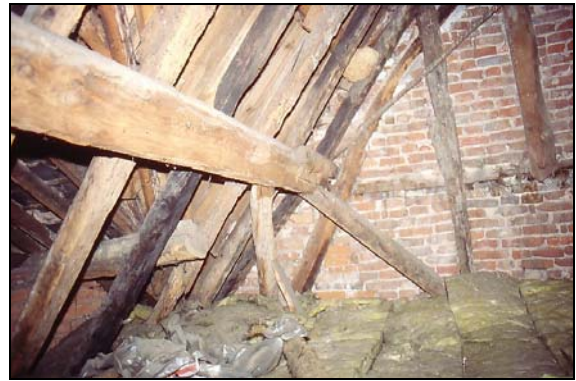
There is some evidence to suggest that this structure originally extended further to the east, most notably the scarf joint in one of the purlins just inside the east gable wall (Photo 6); also the fact that the north wall of range **D**, the kitchen, is stone-built and of comparable thickness to the walls of **A**. The 1757 map shows a chimney at the east end of the building (Figure 4); there is no evidence within the extant fabric of an early chimneystack on the line of the present east wall and it is suggested that there may have been another bay to the east with the original east gable wall falling approximately on the line of the east wall of the present kitchen.

Photo 6. Detail: roof structure of A showing scarfed purlin.

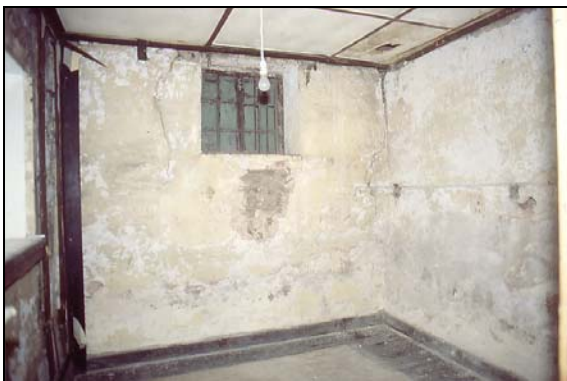
Photo 7. Interior of suspected schoolroom (B).

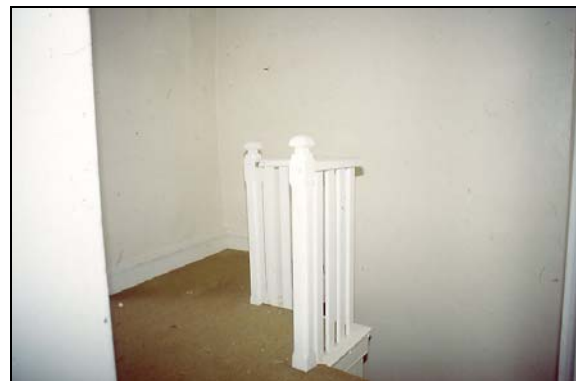
Internally, first floor structures are of gypsum plaster type throughout. The staircase has faceted newels and plain, rectangular-section balusters and is typical of the mid 19th century (Photo 8). Fixtures and fittings such as the ledged doors, door furniture, architraves and skirtings are comparable throughout the building, pointing to a single episode of refurbishment, these would all be consistent with a mid 19th century date, as would the two remaining bedroom fireplaces.

Photo 8. Landing area showing faceted newels to staircase.
