**An Archaeological Watching Brief during
Reconstruction of the Stop Lock and Upper Arm
at Foxton Inclined Plane, Leicestershire.
(SP 69230 89590, Centre)**

Gerwyn Richards and Matthew Beamish

For British Waterways

ULAS Report Number 2007-005 © 2007

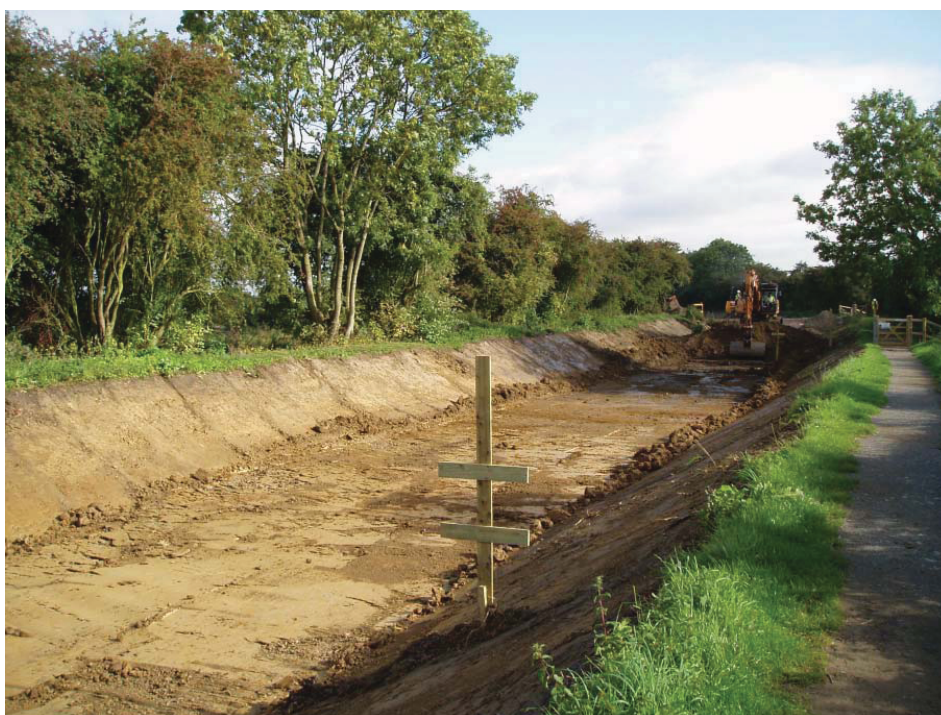
Figure 2: Re-excavated Upper Arm

Excavation of the arm was limited to the removal of vegetation and accumulated topsoil to reveal the puddle clay lining; this revealed a profile which is likely to be similar to the original (Figure 6). Nearest the plane the clay was grey in colour, similar to that observed within the bottom basin while the clay became yellow further to the south, away from the plane. The greyer clay probably reflects made ground derived from the *blue lias* clays excavated from the lower half of the incline and bottom basin whilst the more yellow may be *in situ* clay of the *middle lias* or Dyrham Formation. There was little of artefactual interest within the cut - a number of early twentieth century bottles were observed and a selection retained.

Re-watering of the arm required the strengthening of the banks which had been weakened by badger sets and some resulting subsidence. A guide trench for sheet piling was excavated within the eastern towpath which allowed a limited examination of the embankment (Figure 16). As expected the bank consisted of mixed layers of both the yellow and grey clays and occasional fragments of brick and stone.

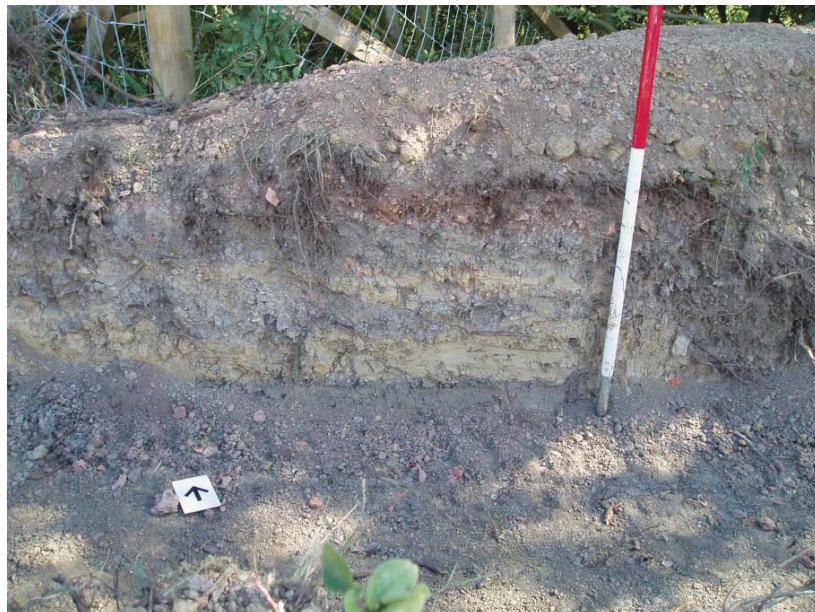
Figure 3: Section through eastern towpath showing reddened shale.

The towpath nearest the plane had a surface of burnt shale (Figure 3 - Figure 5), reddened with heat; the same type of tow-path surface was recorded during the excavation of the test pits within the bottom basin (Richards, G. ULAS Report 2006-114).

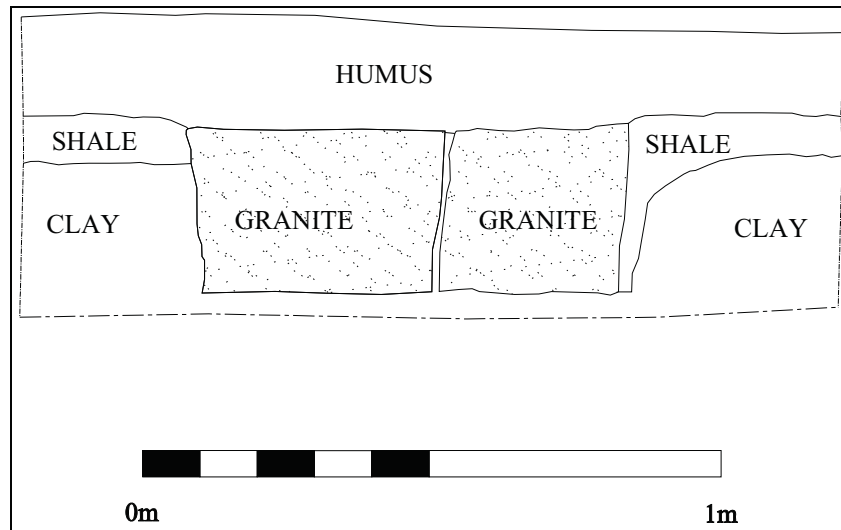
Figure 4: Granite blocks observed within Upper Arm towpath.

Approximately 30 metres south of the plane two granite kerb stones were uncovered within the towpath, which although undoubtedly placed rather than dumped, provided no evidence of their original purpose. The shale surface appeared to abut both the front and back of these stones, suggesting that the stones were originally visible in the surface of the towpath. Fortunately the stones were visible in section and not disturbed by further works and were therefore left *in-situ*.

The location of the stones may indicate that mooring or strapping posts were installed; certainly the Upper Arm would have become congested with loaded and unloaded boats awaiting passage on the incline, and mooring points would have been required.

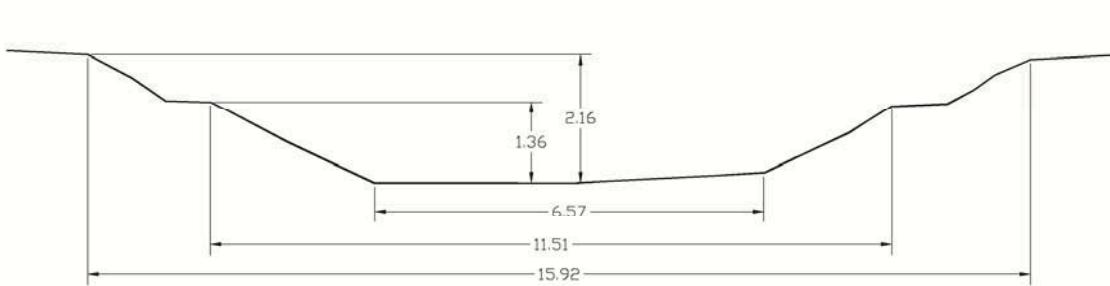
Figure 6: Surveyed profile of re-excavated Upper Arm to north-east of Stop Lock (dimensions in metres)

After the completion of the initial strip a terrace, approximately 800mm deep, was excavated on each side of the cut, altering the original profile. Nothing of archaeological significance was observed during this excavation; the new profile was then surveyed (Figure 6).

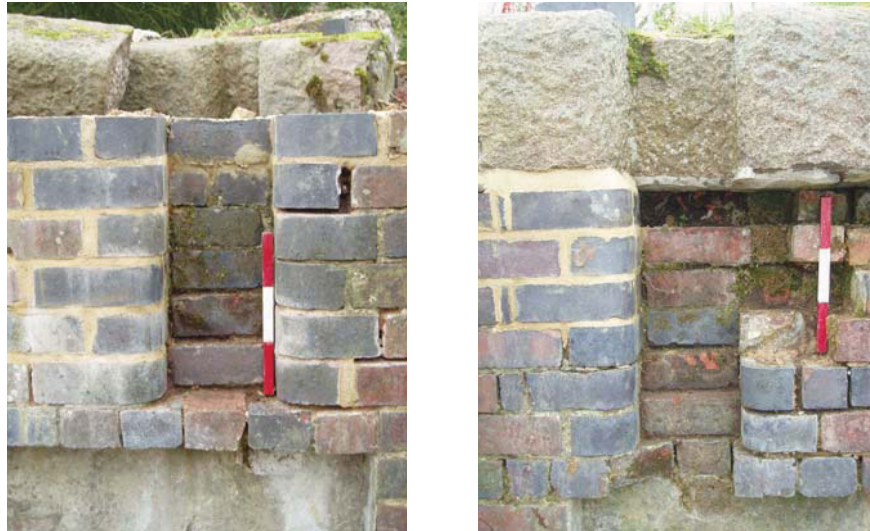
Figure 8: Recesses for Paddle Gear (damaged eastern wall to the right).

Within the walls there were two rendered recesses to house the paddle gear when the gates were open (Figure 8); unusually these were off-centre and were much closer to the heelpost than is normally seen. The recess for the paddle gear is also unusually short (650mm); there is a course header bricks perhaps indicating the base of the paddle gear. These anomalies may have been because the paddle on a stop lock gate needs only to allow adjusting slight changes in level to re-open the gate during day to day use, and not the large change managed by a pound lock where the paddles are set near the base of the gate. The course on the eastern wall had been damaged, creating the impression that the recess is full length, while in fact it is not, the damage probably occurring during the scrapping of the gates. The paddle gear is likely, therefore, to have been gate-mounted and the paddle possibly near the top of the gate. The exact form and workings of the paddle gear remains unclear as no surviving drawings or photographs have been identified.

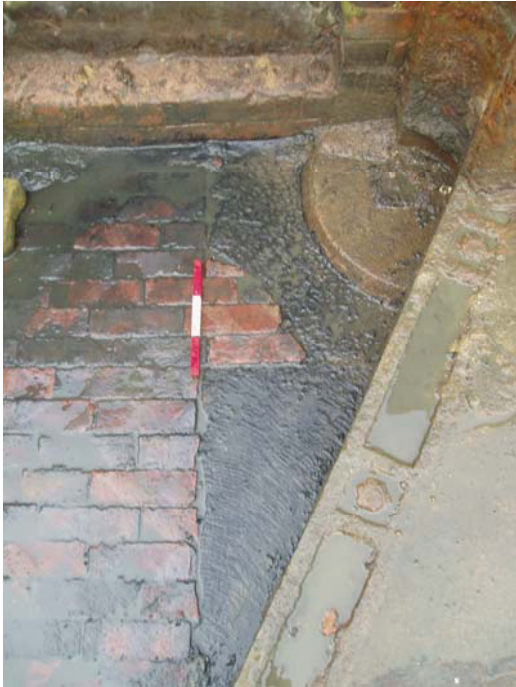
Figure 11: Detail of brick repair to sandstone flag

The slab on the western side appeared to have been broken prior to being laid as a corner was missing which had been repaired by extension of the brick floor to fill the void. The leading edge of the slabs has been attractively rounded, although probably for practical reasons, lessening the likelihood of grounding of boats when the water was low; it was possible that the aesthetic was also considered when this work was carried out.

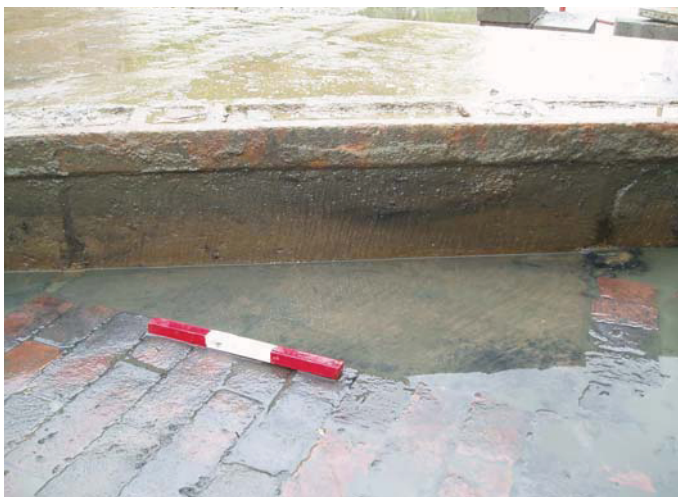
Figure 12: Iron clad rebate in Sandstone flags

The apron into which the gates closed was of sandstone, consisting of seven individually carved slabs each with a 300mm rebate for the gates at the southern end (Figure 12). The edges of the rebate were re-enforced with an iron shoe bolted to each slab, onto which the gates would butt when closed to provide a water tight seal. The slabs are laid so that there are straight edges onto which the brick-work can be laid; and are also tied into the chamber walls to the height of two courses (100mm).

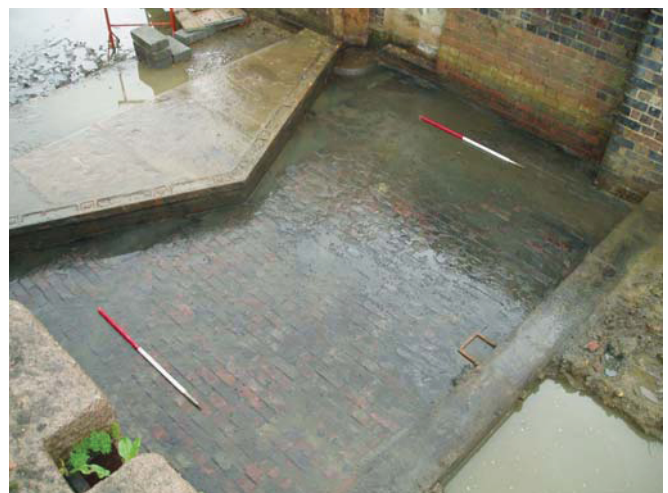
Figure 14: General view of Stop Lock floor

The brick floor of the sill was of 9 inch by 3 inch bricks, laid on their faces. The majority of the bricks were red but of mixed quality with some very over fired and some occasional near vitrified examples. Other than in appearance, these bricks are of acceptable standard and have survived well; it is possible that they were purchased as "wasters" or as reused kiln-bricks expressly to be used as the lock floor.

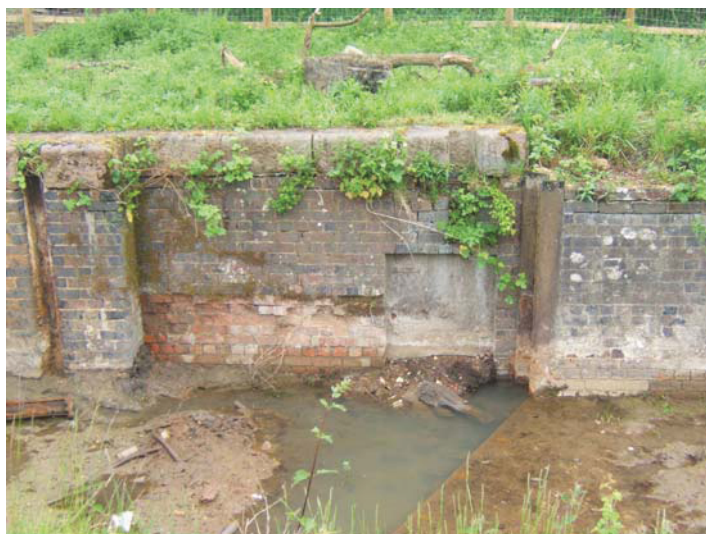
Figure 15: Chamber wall condition. May 2006

The removal of the coping stones during the ensuing restoration works revealed that the upper courses of blue bricks were only single skin with an inner skin of red bricks. As with only using blues on the upper courses of the outer skin, the use of reds on the inner skin can again be seen as an economy measure. The removal of the coping stones also allowed for the removal and inspection of the iron fenders; these proved to be of substantial size, being the full width of the walls and as a result there is no direct bond between the coping stones and the brickwork. There is, however, a substantial deposit of concrete behind the coping stones which would have kept the coping stones in position. The burnt shale seen elsewhere within the site was again used on the towpath.
