An Archaeological Standing Building Survey of the Former Fernie Hunt Stables, Nether Green, Great Bowden, Leicestershire (NGR SP747 889).

Gerwyn Richards

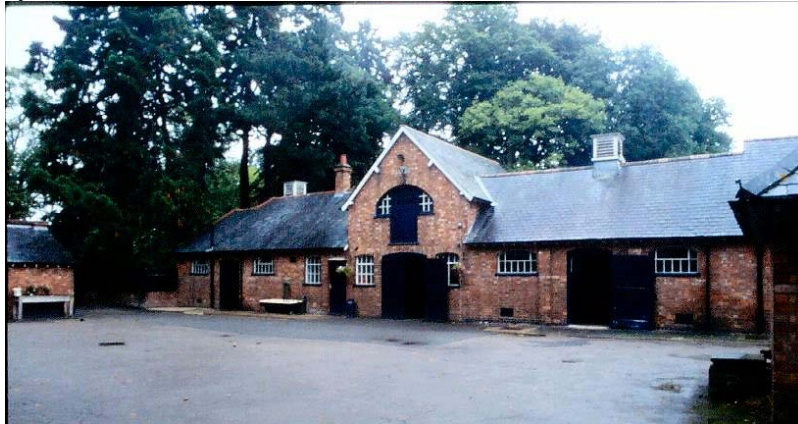
Building 4 is the most substantial of the buildings within the proposed development area and consists of a brick built, three bay building. The bricks themselves are 9 inch by 3 inch machine made bricks atop a blue brick damp proof course and cement bond in Flemish Garden Bond. The roof is of Welsh Slate with red ceramic ridge tiles and

two timber louvered and leaded ventilators and a central chimney. The building is mostly single storey, but there is a first floor grain loft set at a right angle within the central bay (04c) and the front elevation is well balanced, but not entirely symmetrical.

Photo 1 Building 4 Front Elevation

Fenestration consists of six paned steel framed arched windows with central four paned opening lights in white. There are flat cambered arched lintels above

in brick and concrete sills below in Royal Blue. Access to the right (04b) and left (04d) bays are via stable doors, central to their bays. The central bay has double coach doors set beneath a single grain loft door with a pulley system set above it. There is a single door to the left of the central bay.

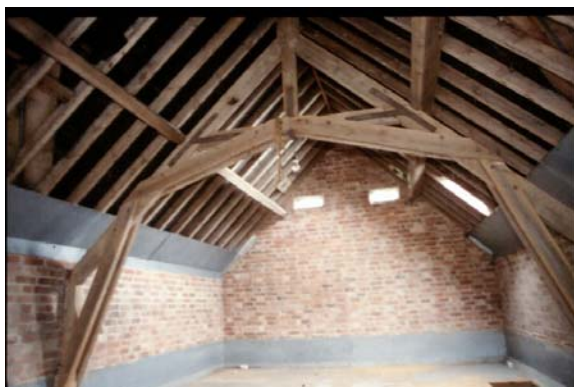
The central grain loft bay has very little in the way of internal features and the ground floor was probably originally for general use and feed preparation. There is a hopper still *in-situ*; possibly original bearing the name of Bamford, Uttoxeter, which later became JCB, the plant manufacturer. Access to the grain loft is via a ladder and trap door to the left of the coach doors, as expected for a grain loft, there are very few diagnostic features, there is an exposed central roof truss of an interesting design. It is a principal roof truss with king post rising from a collar with three way stirrup straps securing the collar to the principals. Additional timbers have been bolted through the king post, principle and collar to triangulate the structure to facilitate the omission of

a tie beam, opening up floor space. To similar to Peters' Type 9 roof trusses, in his survey of post-medieval roof trusses in farm buildings in Staffordshire. To the left of the central bay there is a small room containing an iron stove set within a chimney breast. This room has been boarded in tongued & grooved panelling and the left wall has a number of hard wood saddle trees, probably original.

Photo 2 Roof Construction Within the Grain Loft

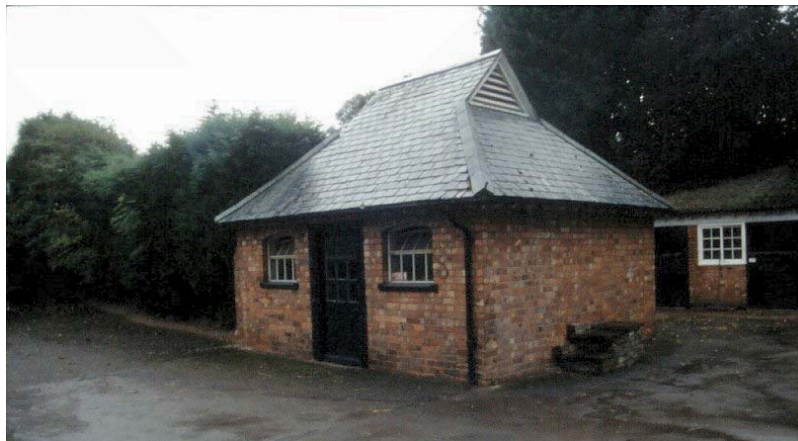
The next building to be recorded, building 5, was a small single storey building facing building 4. It too was of a red brick construction and a Welsh Slate roof with wooden louvers in the gables of the Gambrel style. As with building 04, the bricks are 9 inch by 3 inch machine made bricks in Flemish Garden Bond, with no damp proof course. There is a large half glazed panelled door set between two steel frame six pane windows to the front and no other fenestration. There are flat cambered arched lintels above in brick and concrete sills.

Photo 3 Building 5 Front & Right Elevation

Internally, the building consists of a single room, which has been boarded with tongued & grooved panelling. This panelling forms

a forty five degree angle in the left rear corner of the room, the reason for which is unknown, externally; there is no evidence for a chimney, so a fireplace is unlikely. One possibility, however, is as the majority of the other stalls have corner troughs, it is possible, therefore, that building 05 was originally built as an individual stall, possible for the Master's horse before being converted and the boarding concealing the trough. The room is currently used as a mess room/general store.

Externally on the right wall, there a mounting block, probably contemporary but having been repaired by the addition of modern concrete slabs.

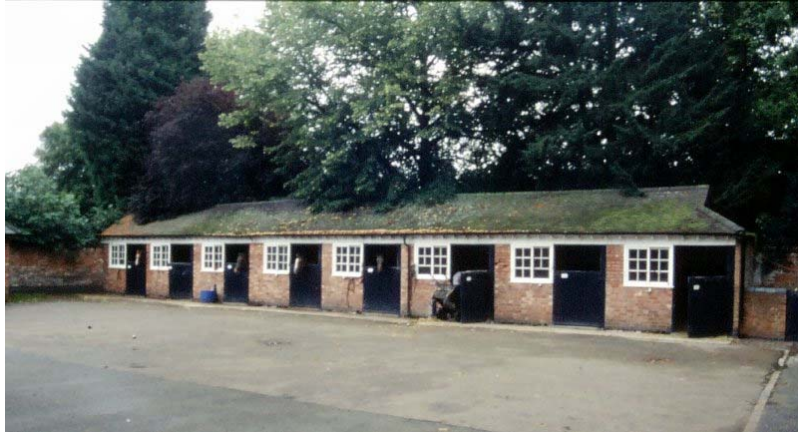
Building 6 is the westernmost building within the quadrangle; the building consists of eight single stalls with plank divisions. The brick work again is 9 inch by 3 inch red brick in a Flemish Garden Bond, with a blue brick damp proof course, but unlike the other buildings, the mono pitched roof is of flat tile, rather than Welsh Slate (significant moss coverage prevented closer identification).

Photo 4 Building 6 Front Elevation

All stalls have a stable door to the right and a timber Yorkshire horizontal sliding sash window to the left. There is also a ceramic pipe

exiting the wall at ground level, acting as a drain away.

Internally the roof has been over boarded so its exact construction is unknown, although King post design is likely. There is a corner trough in all of the stalls and nothing else of significance.

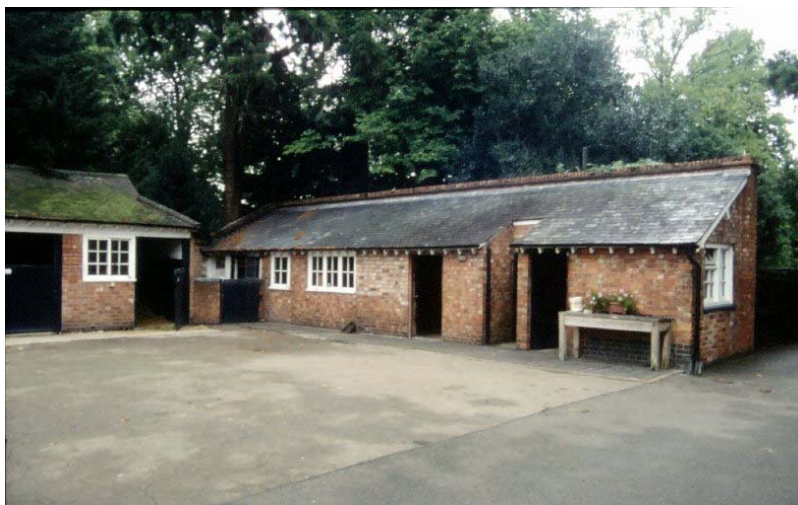
The final building within this standing building survey is building 7, forming the northern part of the quadrangle. Building 7 is a lean-to construction of 9 inch by 3 inch red brick, again in Flemish Garden Bond.

Photo 5 Building 7 Front Elevation

The rearmost wall doubles as the northern perimeter wall. The roof is of Welsh Slate. The doors all appear to be modern replacements and the windows are timber. Towards the left of the building there is evidence of replaced brickwork, so the windows on this side of the

building may not be original or in their original positions.

There are three rooms within the building; all accessed from doors on the front wall, internally there was very little of architectural significance within the two visited rooms. The room on the far left was in use as kennelling and, therefore, not inspected internally. The room on the far right contained a Belfast sink in the rear right hand corner, possibly original. The central room was locked at the time of the visit but appeared to be in use as a tack room, possibly continuing in its original use.
