**An Archaeological Evaluation at
39 – 41 Castle Street,
Leicester.
Scheduled Monument Leicester Castle
and the Magazine Gateway**

NGR: SK 5826 0426

ULAS Report No. 2018-126
©2018

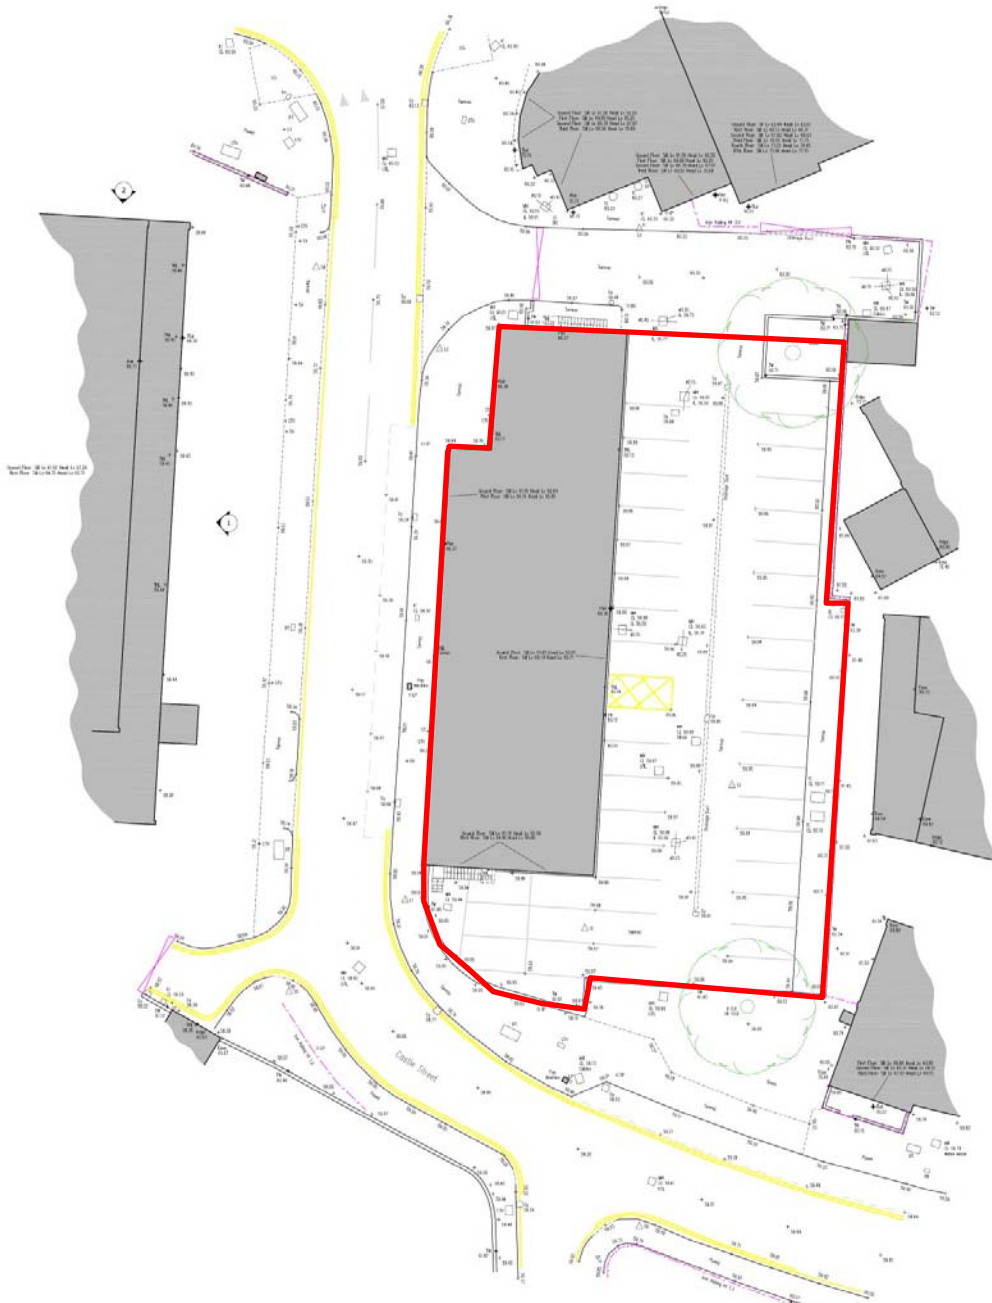
Figure 3 Existing site plan
Plan supplied by client. North to top of plan. Castle Street highlighted in yellow

At the time of the evaluation, the site consisted of a long sub-rectangular two-storey office block running from north to south along the eastern side of Castle Street (Figure 3). The architectural style of the building places it somewhere in the late 1950s or early 1960s (Figure 4). The building has a 2m deep cellar beneath it. A private access road on the northern side of the office block leads to a large open car park to the rear, eastern side, of the building (Figure 5). The total area of the site, including the offices, covers approximately 1700 square metres. The site lies at a height of around 59 metres OD and is generally flat despite the surrounding land dropping slightly towards the south and rising towards the north-east. The drop in the surrounding ground level means that the southern end of the site car park is between 0.8m and 0.9m above street level.

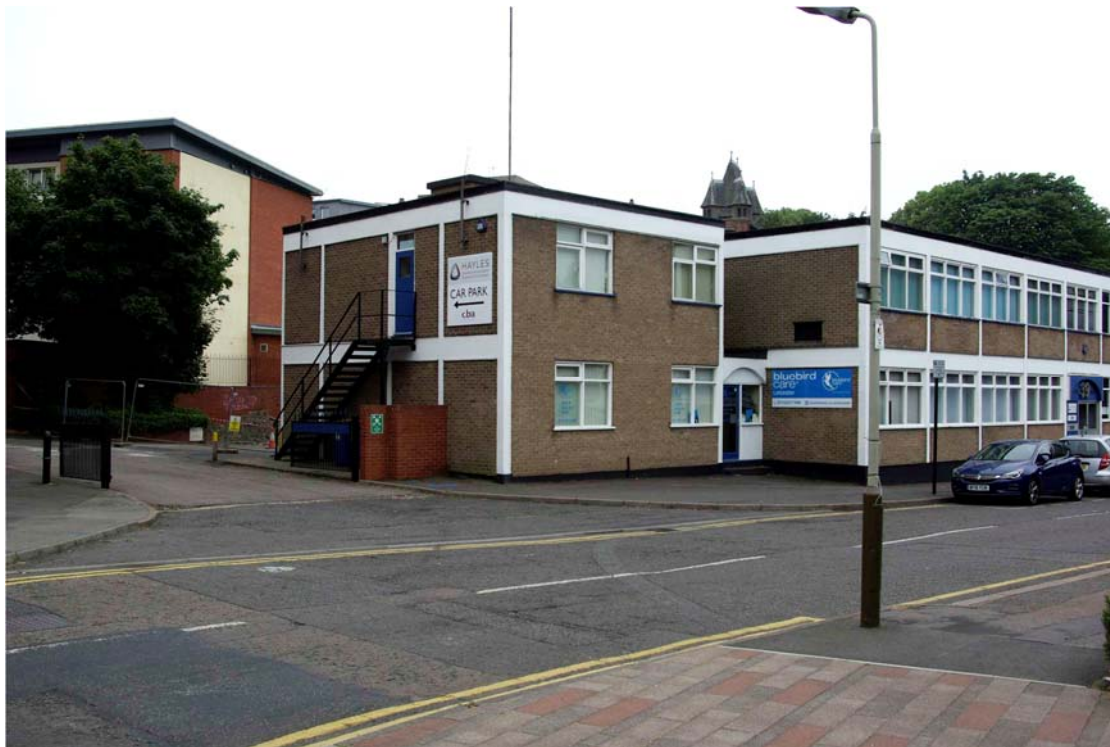
Figure 4 Site viewed from Castle Street
Looking south-east. Entrance to site car park on left of picture

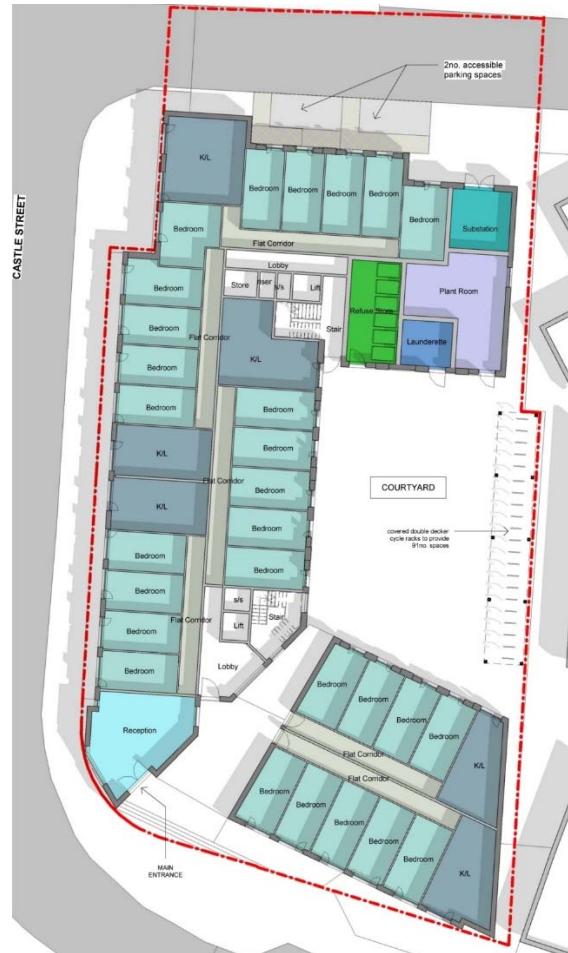
Figure 6 Development proposals
Plan (ground floor) supplied by client. North to top of picture

The development proposals are to demolish the office block and replace it with new student accommodation which would be positioned alongside the existing student accommodation complex which has been built to the east of the site (Figure 6) constructed in 2007. The proposals will create buildings along the north, south and western edges of the site leaving an enclosed courtyard on the east side of the site.

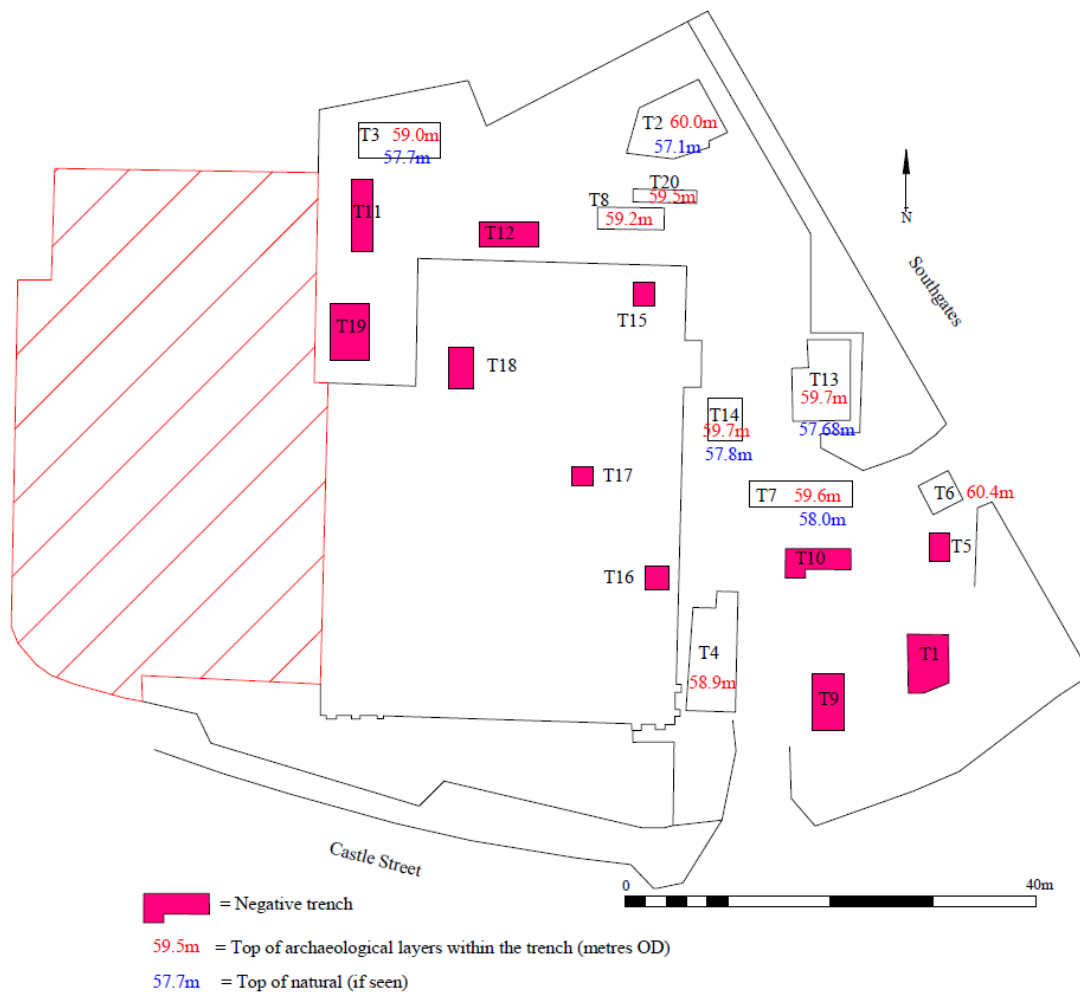
Figure 11 Location of 2001 evaluation trenches
Current development site highlighted

In 2001 the car park of a former exhibition centre immediately to the east of the development site exposed surviving Roman archaeological deposits only 0.75m (approx. 58 – 59mOD) below the existing ground level. Most of the deposits were located towards the eastern edges of the 2001 site with survival levels reducing the closer the trenches got to the present development site (Figure 11). A similar result was obtained with medieval deposits although no sign of the possible castle bailey ditch was seen in this phase of work.

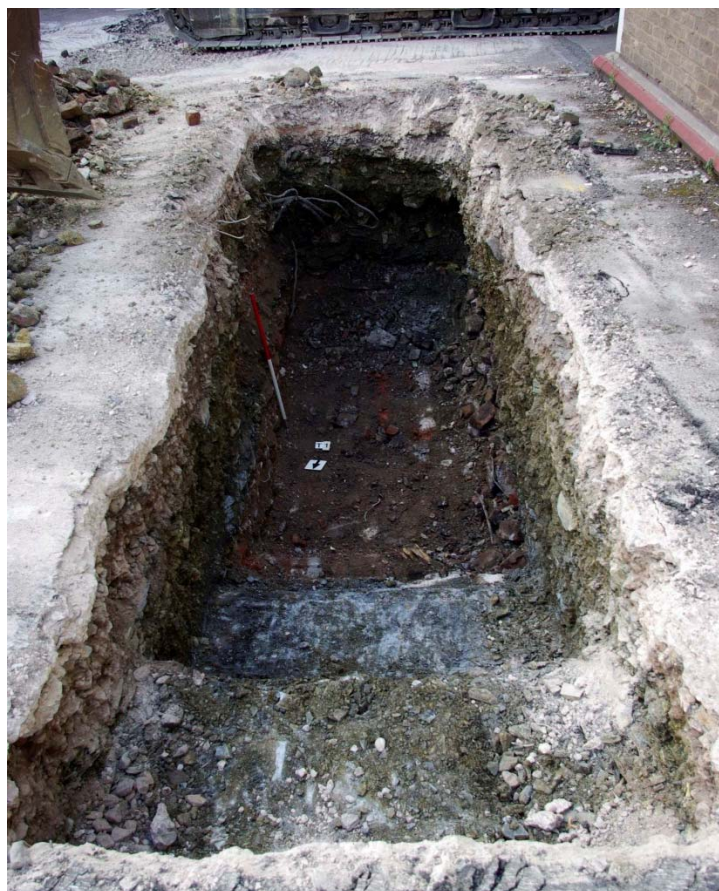
Once the reinforced concrete and a loose-stone bedding layer had been removed, a 0.85m-thick layer of degraded slate and sandstone rubble contained within a yellow-brown silty sand matrix was encountered. This layer was very compacted and appeared to have been laid as solid base for the car park surface. No building rubble or rubbish was seen in this homogeneous layer during excavation. Beneath this layer was an approximately 0.25m-thick layer of densely packed mid-grey slate and sandstone debris. Again this layer was quite clean with no building rubble or other material within it. Removal of this layer exposed a deposit of broken brick rubble with many lumps of reinforced concrete and other modern debris including an aluminium Coca Cola can (Figs 14 to 16). This layer continued down to 2.09m below car park surface level at which it was decided to halt machine excavation due to the trench's proximity to the building (1.1m away). A small hand-dug sondage continued for a further 0.2m before a large block of reinforced concrete prevented any further digging. It is not known how much deeper this layer continues for.

Figure 14 Trench 1 at final depth
Looking south. 1m scale

Trench 1 appears to be full of building rubble probably relating to the initial clearance of the 19th century buildings removed in the 1955 demolition phase. The upper layers then seem to be related to the reorganisation and concreting of the present car park following the removal of the large bottling plant in the late 1970s or early 1980s. The ground around Trench 1 may also have been disturbed during the excavation of the 2m deep office block cellar.

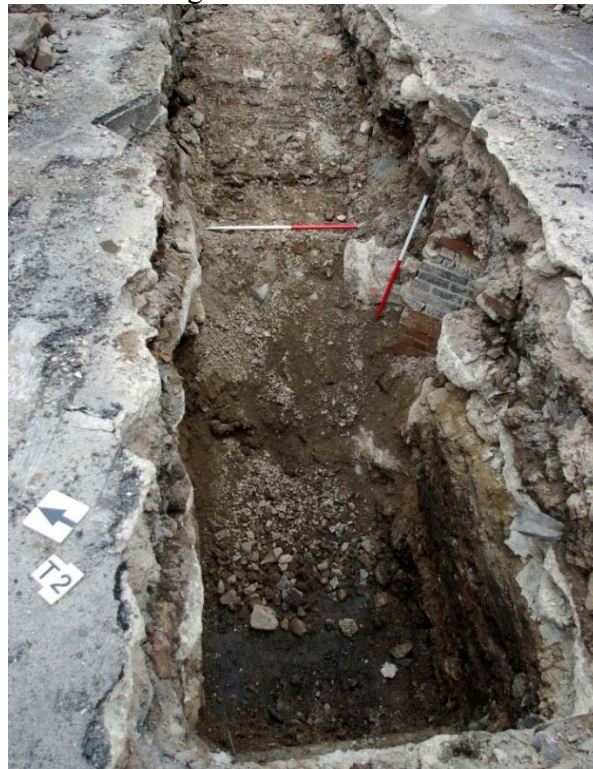
After breaking through the reinforced concrete and bedding layer (approximately 0.4m thick) a loose and disturbed rubble layer 0.85m thick was encountered. This layer contained a high quantity of modern brick rubble and broken stone. In the centre of the trench, the base of a brick wall projected across this layer. The bricks were laid in a stretcher bond with red bricks laid as a base with seven courses of blues on top. The bricks appeared to be quite modern mass-produced bricks dating to the second half of the 20th century. The wall ran on a north to south alignment and coincided with the step in the site boundary wall. The 1969 Digimap image shows an access gateway and wall in this location which would suggest that the wall in this trench is likely to be part of this. On the eastern side of the wall was a thick reinforced concrete beam against which the wall appeared to be built (Figure 18).

Figure 18 Trench 2
Looking north-east. 1m scales. Note that the wall has been broken through and removed

Trench 2 within the Scheduled area gave a possible glimpse of what may be the upper fill of the bailey ditch but at a very truncated depth. The brick wall and concrete beam coincide with, and are likely to be associated with, the 1960s entrance gateway to the site from Castle Street. If vehicles were entering site from the street it would suggest that the ground level may be built up now but was probably at same height as the road hence the second layer of reinforced concrete.

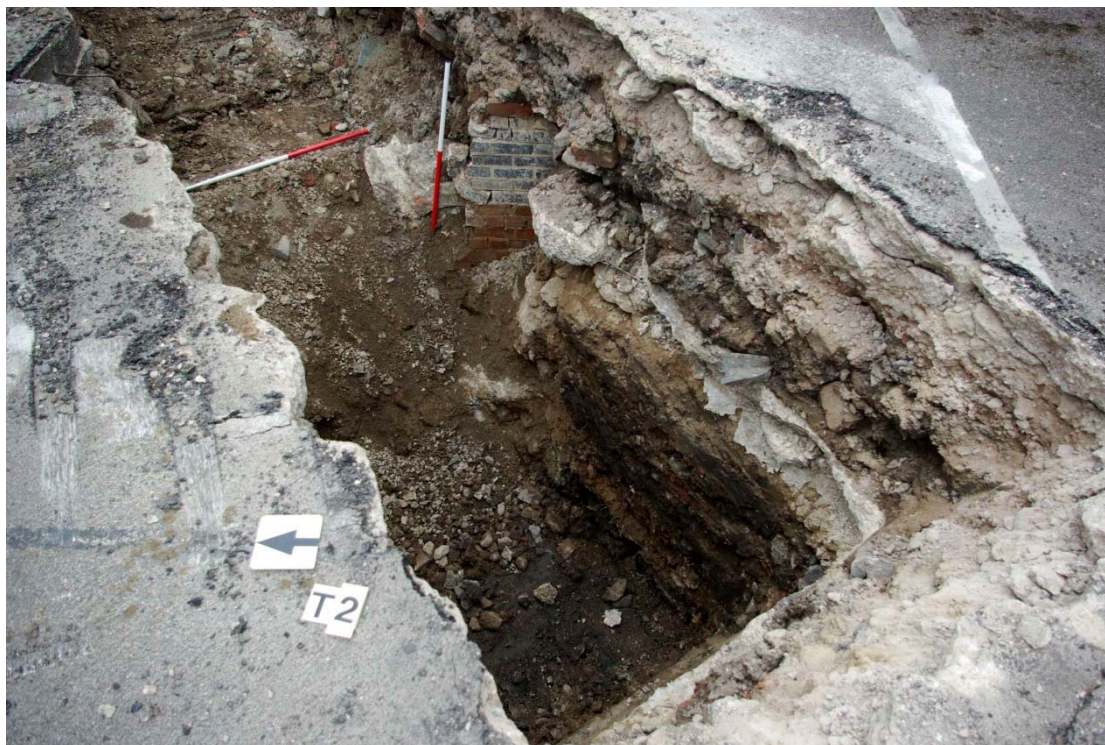
At 2.95m below current ground/car park level the rubble layer ended to reveal a dark grey brown silty clay deposit with frequent flecks of charcoal. This homogeneous deposit had a firm and almost waxy texture (Figure 19). At nearly 3m down the trench could not be entered safely and site constraints meant that the trench could not be widened therefore excavation stopped at this point. The machine bucket removed a thin spit of this material for inspection but no finds, modern or otherwise, were recovered. It is possible that this may be the upper layer of the backfilled bailey ditch although this cannot be positively stated.

Figure 19 Trench 2 NW facing section
Looking south-east. 1m scales

The rubble layers below the second layer of concrete in Trench 2 are probably debris from the demolished 19th century buildings. These layers cover the homogenous dark brown fill seen at the base of the trench. The view of this deposit was extremely limited but it did not appear to contain any building debris so it could be archaeological in nature although this is by no means certain.

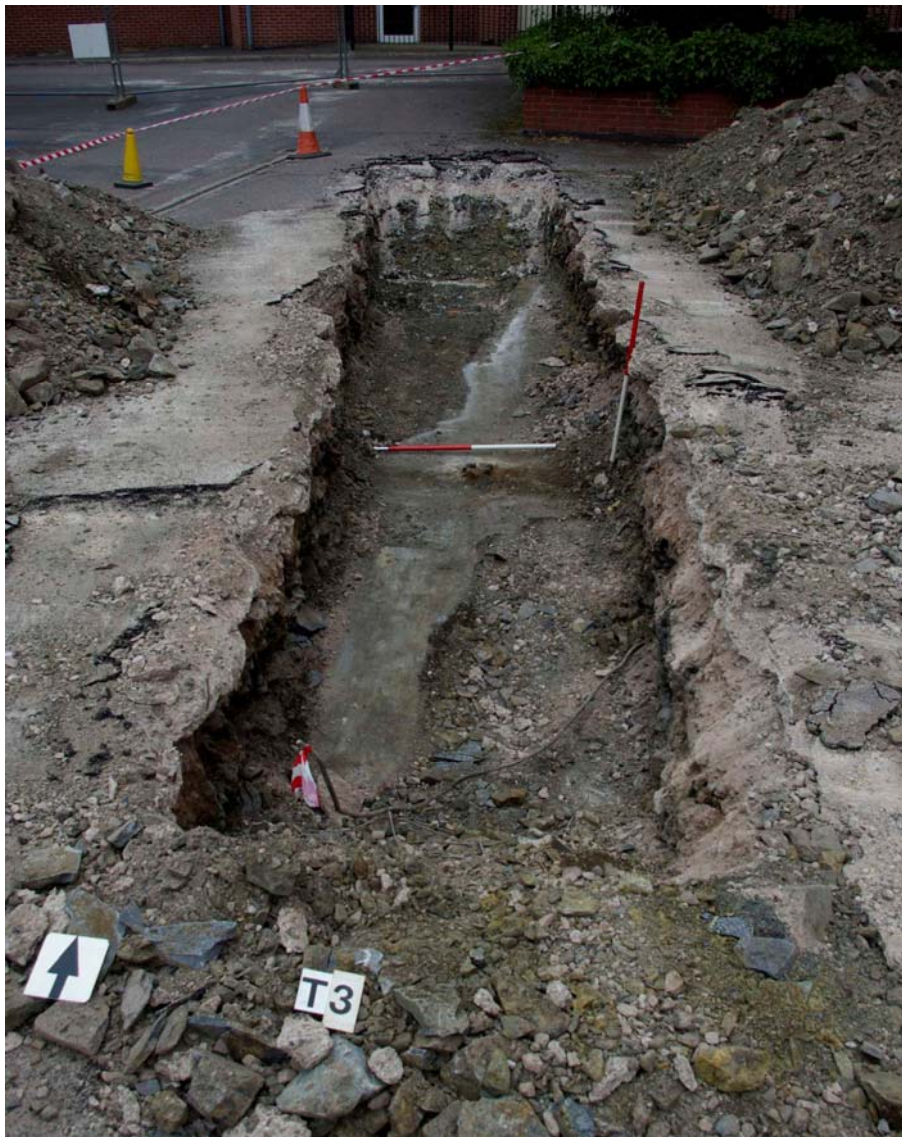
Trench 3 was placed in the north-eastern corner of the site close to a large tree planted within a large rectangular brick planter. There were fewer constraints with services for this trench allowing a 10.2m by 1.65m trench to be excavated. As with the other trenches this trench was covered in a thick layer of reinforced concrete laid on a bed of mill waste type material. Beneath this was a layer of building rubble and rocky debris with later 20th style bricks and waste throughout. At between 0.86m and 0.92m below current ground level a solid concrete foundation wall with reinforced piles was exposed running from north to south along the trench (Figure 20). This was on the same alignment as the adjacent office block 10m to the west and is the foundation of the large building shown in Figure 9 above. The building rubble and rocky debris continued down either side of the foundation but the decision was made not to excavate any deeper in this trench (Figure 21).

Figure 21 Trench 3
Looking north. 1m scales

Trench 3 was excavated down to the top of the concrete foundation base for the large bottling plant building in place between the mid-1960s to the later 1970s. The excavation work in 1966 suggests that this building had a cellar but there is every indication that the ground on either side of the foundation will be disturbed.
