**An Archaeological Attendance,
Supervision and Recording of
Groundworks at
Cutts Close, Oakham, Rutland**

NGR: SK 86235 09040

ULAS Report No. 2018-128
©2018

For: Oakham Town Council

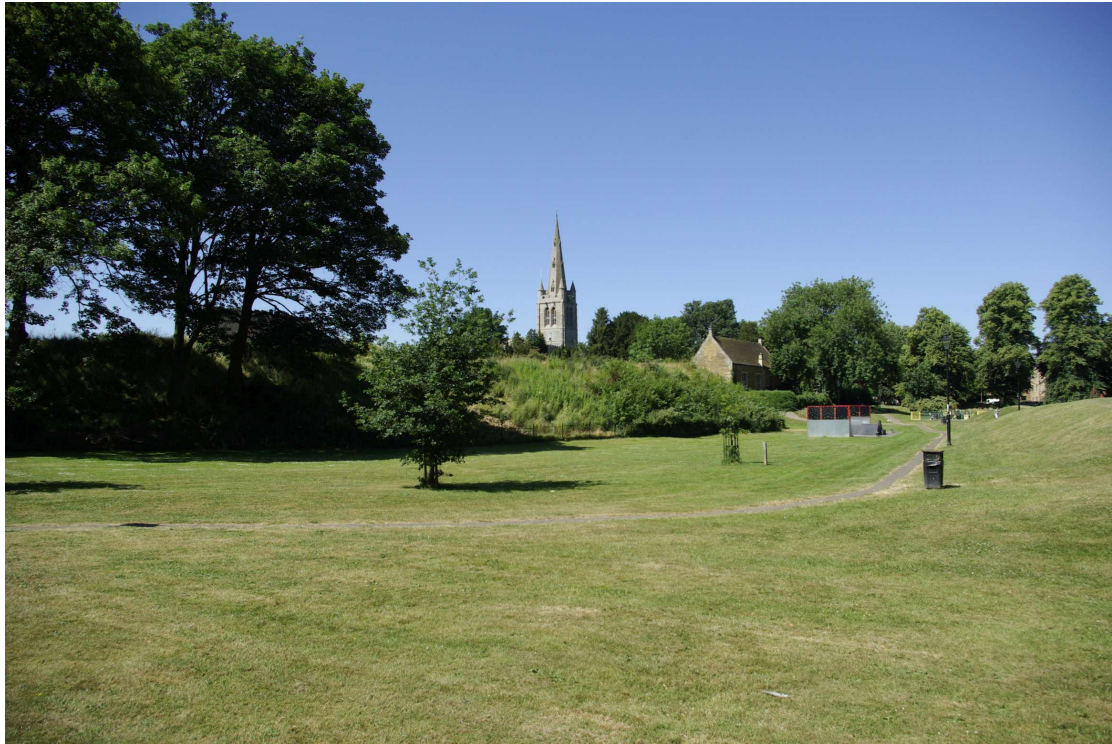
The renewal of the pathways (shown in Figure 2) requires the removal of the existing tarmac which is worn and is likely to be of insufficient width for wheelchair access (Figure 4 and Figure 5). The old tarmac and bedding was removed to a depth of approximately 230mm below present ground level. New concrete edgings and a new tarmac surface will complete the work.

Figure 4 Pathway to be renewed
Looking south-west. Castle mound on left and centre

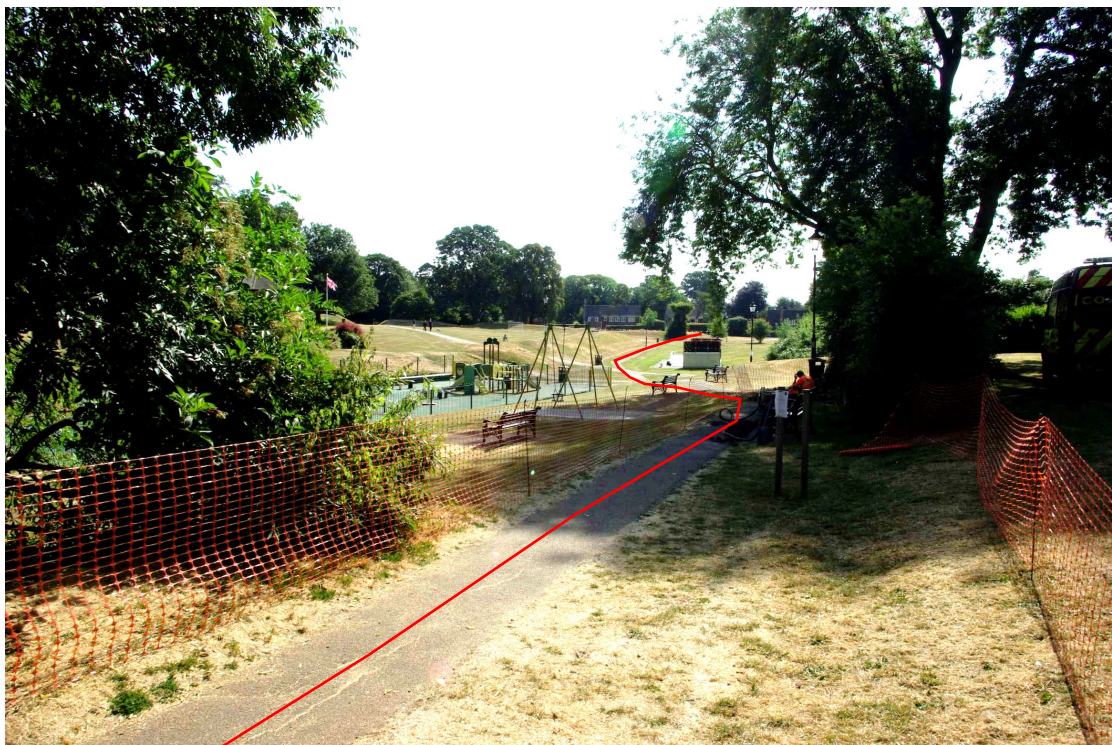
Figure 5 Pathway to be renewed
Looking north-east from Church Street. Red line indicates the path to be renewed

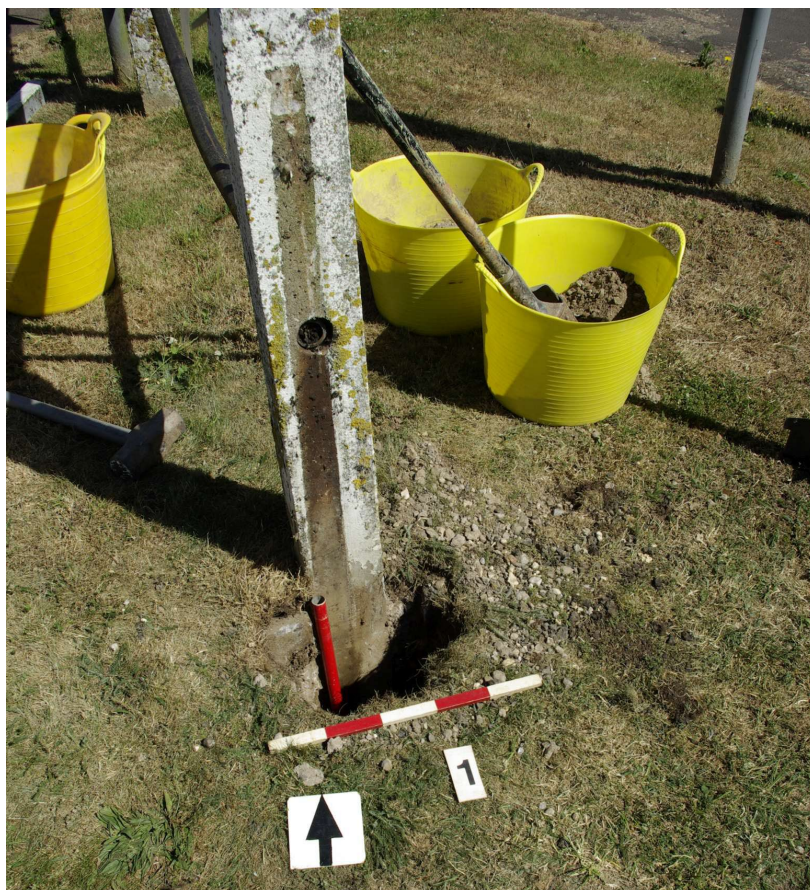
Post One was the north-easternmost of the three posts in the position of an existing gate post (Figure 6). The existing metal post, which was bedded in concrete, had to be removed using a small pneumatic drill. Following removal of the post the resulting hole was hand cleaned and widened to create a square-section hole 0.35m by 0.40m wide and 1m deep. The north, east and western sides of the hole were obscured by the

former concrete bedding and the remaining concrete post. The southern side of the hole contained an upper disturbed 0.2m thick layer of sandy silt which was probably backfill from the earlier post construction. Beneath the disturbed layer, and continuing down to the base of the hole, was a mid-red brown sandy silty clay which contained small fragments of ironstone or ferruginous limestone. No finds were recovered from the fill.

Figure 6 Gate Post 1
Looking north. 0.5m scale and 1m scale within the post hole

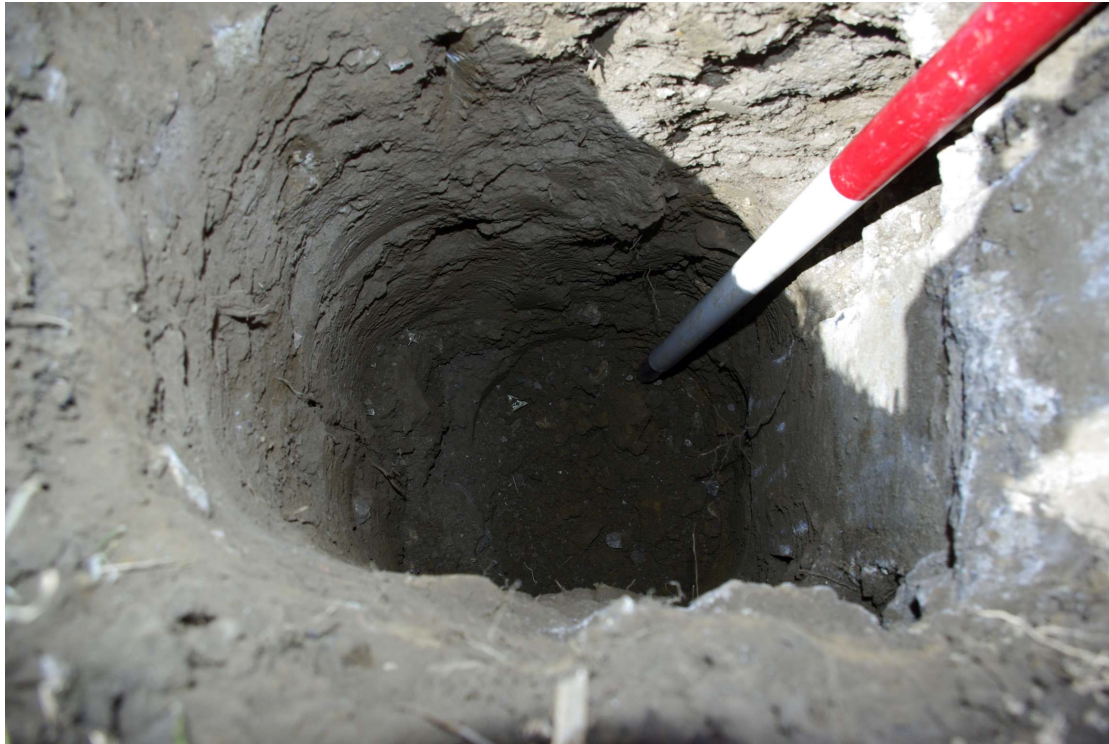
Post Two was placed to the south of Post One across the pathway. The upper 0.15m of the post hole was blocked by concrete from the path edging and had to be broken through with a pneumatic drill. Once through the concrete layer the 0.4m by 0.4m and 0.8m deep hole was then dug by hand. A homogenous mid yellowish brown silty clay was encountered all the way down to the base of the hole (Figure 7). The fill also contained a number of small fragments of ironstone or ferruginous limestone. A single abraded sherd of post medieval cooking vessel was recovered from the fill (see appendix 2). No other features or deposits were present.

Figure 7 View into Gate Post hole 2
1m scale

A single a body sherd of wheel thrown Earthenware, EA2, weighing 37 grams, was recovered from the post hole 2 during the excavations. The sherd was covered both internally and externally in an iron rich slip and is not closely datable, but probably lies within a 17th or 18th century date range. One likely source is Chilvers Coton in Warwickshire, (Gooder 1984, Sawday 1989).

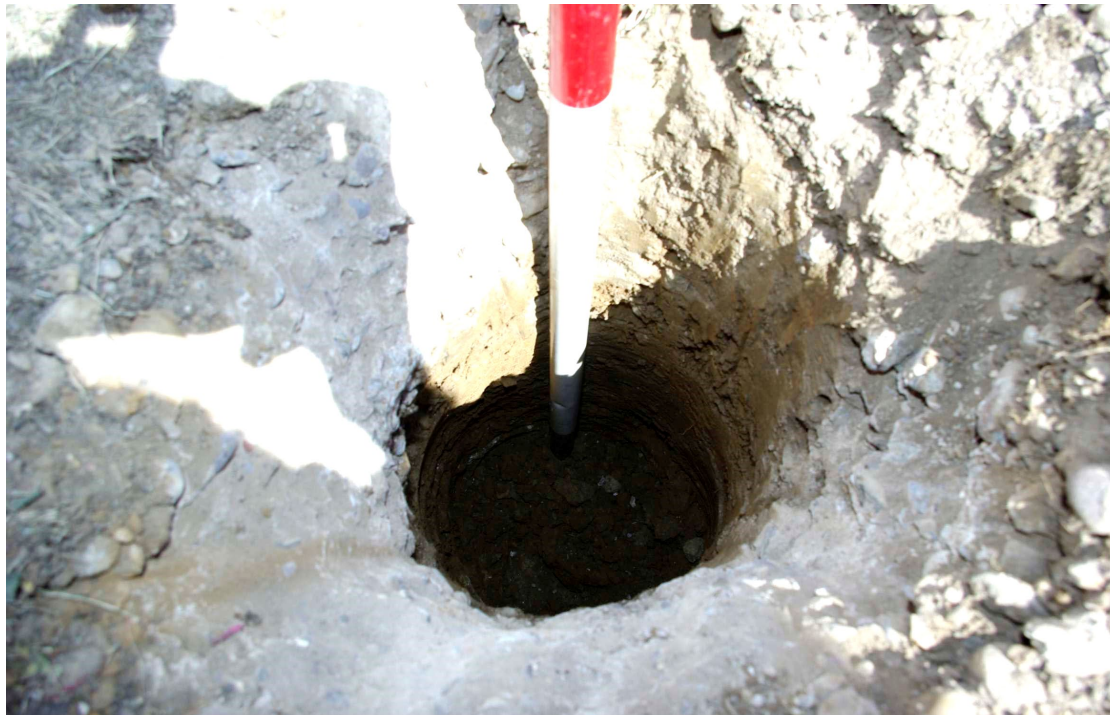
Post three was placed to the west of the other two posts to act as a hold-back post when the gate is open. Its location was just in the grass at the junction of two paths. A thin deposit of silty clay covered a layer of concrete extending from the path edges across much of the post position (Figure 8). The silty clay and concrete had an approximate depth of 0.25m and had to be removed using a pneumatic drill. Beneath this the same mid yellowish brown silty clay as seen in Post Two was observed. No features, deposits or finds were present in this 0.35m by 0.35m by 0.7m deep hole.

Figure 8 View into Gate Post hole 3
1m scale

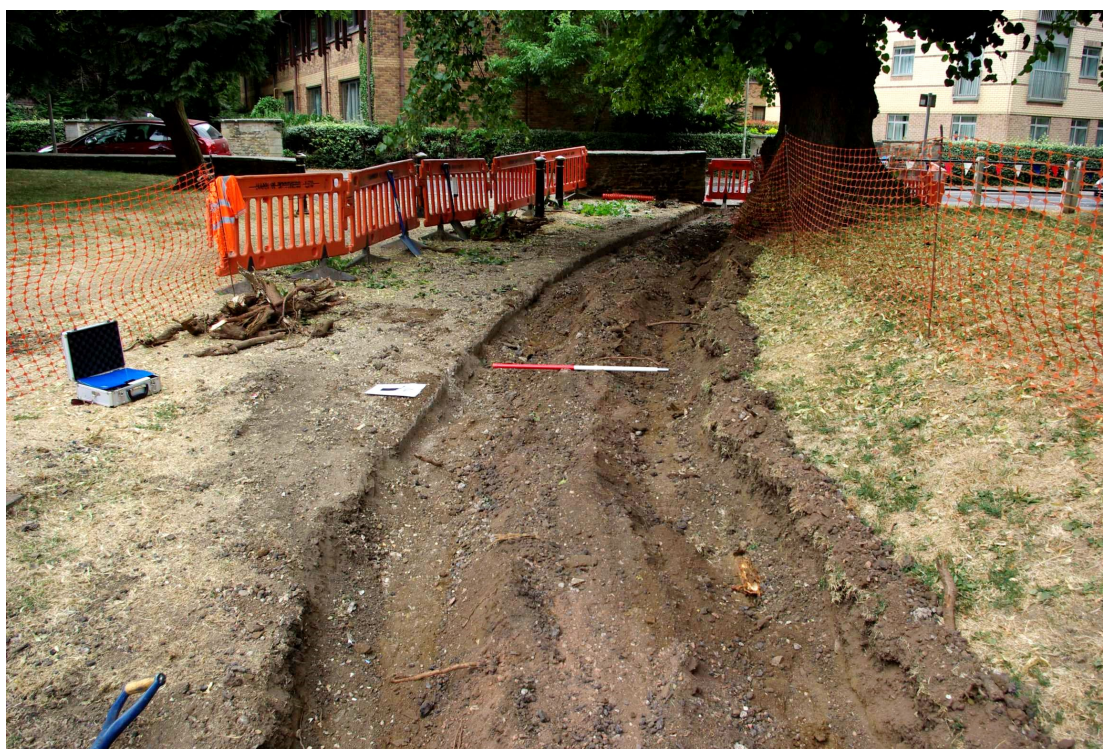
Starting at Church Street the line of the path ran along the southern edge of the bailey embankment before turning northwards to run over the top of the bank (Figure 10). Removal of the old tarmac exposed a gravel and mill waste base which was partially removed down to a disturbed overburden of mid brown sandy silt with modern rubbish in it which included some decimal coins. A fragment of a clear glass bottle (beer or mineral water) with the embossed name Oakham was also recovered from this layer. Due to the curving nature of the new path and the proximity to the bank the excavated width varied between 1.3m and 1.45m in width. The edges of the new path were excavated down to between 0.22m and 0.3m to accommodate the new concrete edging strips. In places the stripping exposed the top of a mid-yellow-brown silty clay deposit which was similar in nature to the deposit seen during the excavation of the gate posts. The groundworks did not extend into this deposit. No features were seen within this deposit nor was there any indication of any structural remains relating to the bank construction seen.

Figure 10 Pathway Stage 1, final excavated level
Looking west towards Church Street. 1m scale

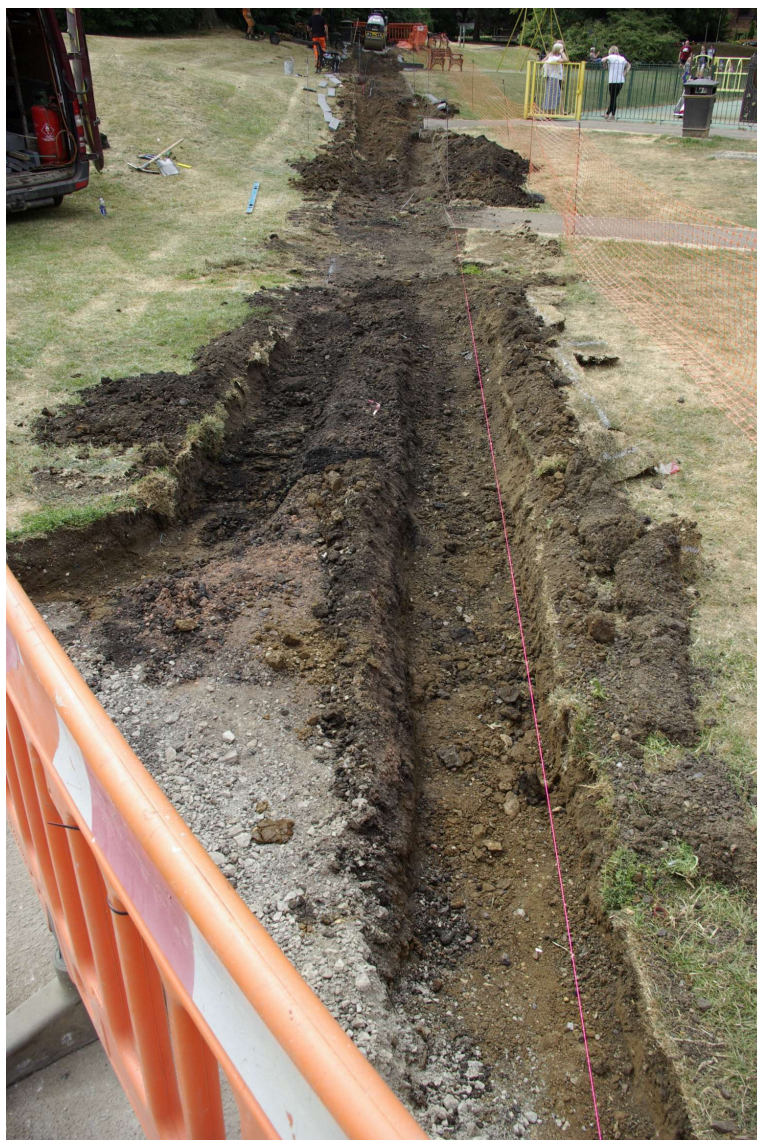
The second stage of the path renewal ran from the eastern end of Stage 1 down a slope in the bank to join a cross-roads in the paths (Figure 11). Beneath the tarmac was a layer of gravel and mill waste over a layer of disturbed mid-brown sandy silt exactly as seen in Stage 1 of this work. The excavated path had an average width of around 1.25m and a maximum depth of between 0.2m and 0.25m. More modern finds including plastic fragments and a ball point pen were recovered from the sandy silt layer but were not retained. The underlying mid-yellow-brown silty clay deposit was

only seen in a few isolated patches and no features were seen within it. No archaeological material or artefacts were seen.

Figure 11 Pathway Stage 2, final excavated level
Looking south-west

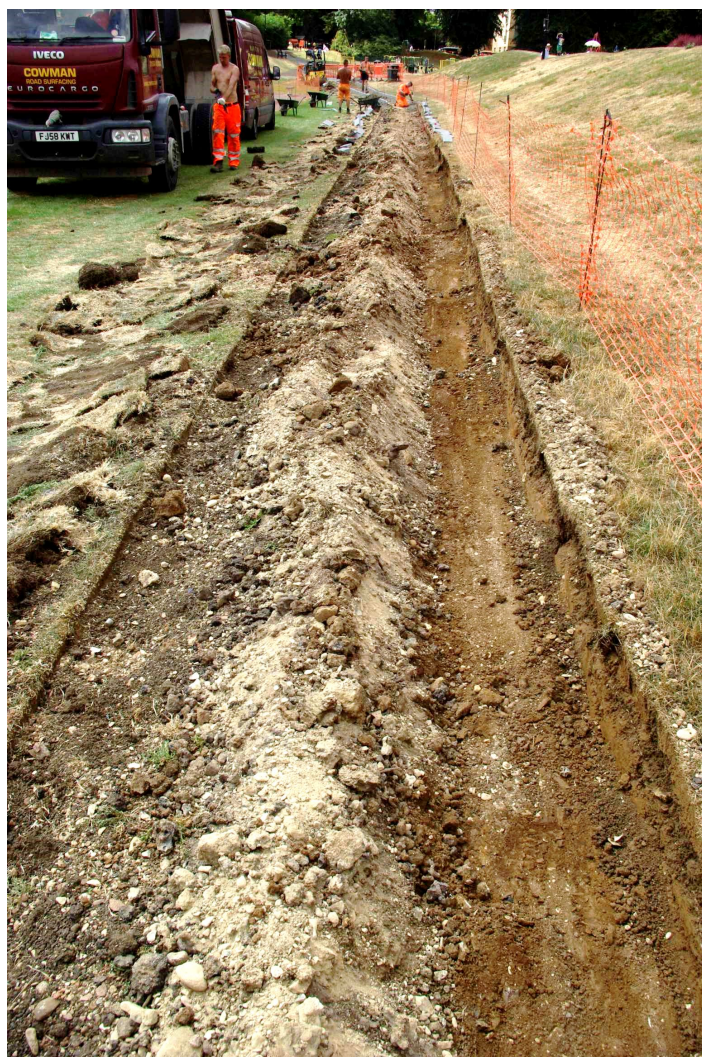
The third stage of the path renewal programme ran from the path crossroads at the eastern end of Stage 2 westwards for just over 50m. The line of the new path ran along the southern side of the long bank running from east to west across Cutts Close. As with the previous stages of work an approximately 0.2m thick layer of gravel and mill waste below the old tarmac was removed to expose a disturbed layer of mid-brown sandy silt containing modern debris and rubbish. Rather more of the underlying mid-yellow-brown silty clay deposit was seen in this stage but no finds or features were exposed or found.

Figure 12 Pathway Stage 3, final excavated level
Looking west

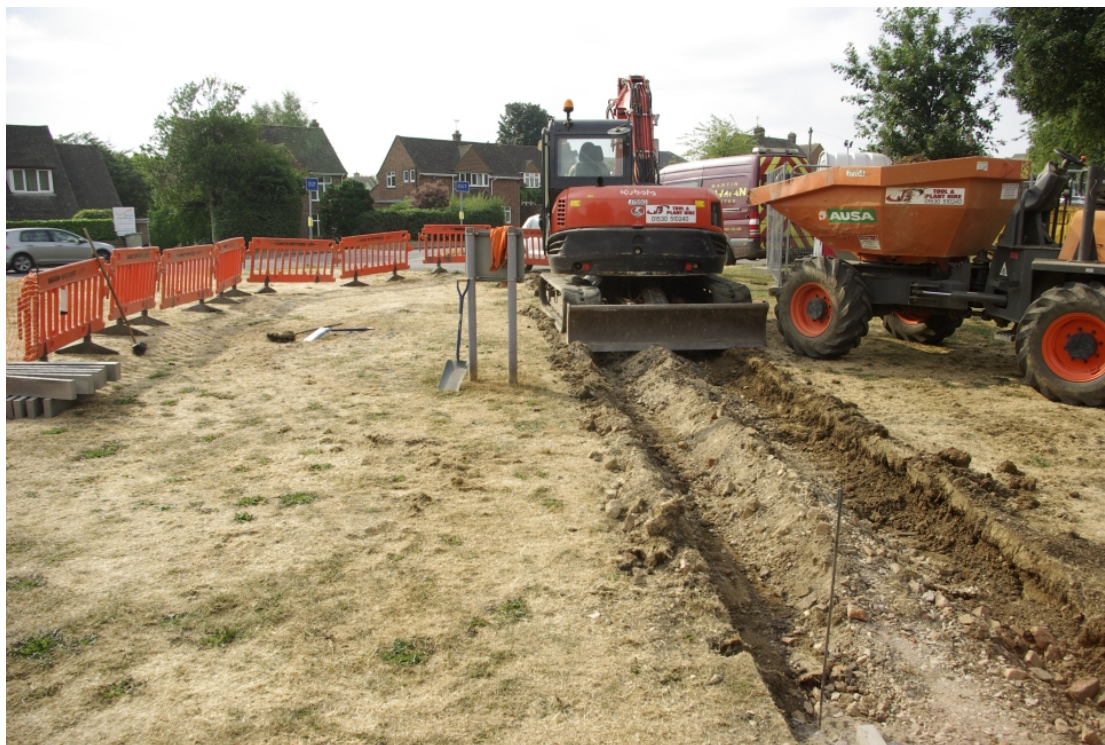
The final stage of the path renewal programme ran eastwards for approximately 50m to join the north-west corner of the public car park running along Burley Road (Figure 13). Stripping off the old tarmac exposed the same gravel and mill waste deposits as seen along the earlier stages of the path. A small area of apparently dumped late 19th or early 20th century bricks was observed at the point where the path turns from its east to west alignment to follow a north-west to south-east line. Many of the bricks were broken and none were deliberately laid to form a surface. The bricks had an average size of around 230mm long by 112mm by 65mm and appeared to be handmade, or at least not factory mass-produced. The brick area was laid within the pathway bedding layer suggesting that the deposit was a levelling dump rather than a deliberately built feature. The maximum depth of Stage 4 was 0.2m below current ground level and the underlying mid-yellow-brown silty clay deposit was only glimpsed in places.

Figure 13 Pathway Stage 4 being completed
Looking south-east towards car park
