**An Archaeological Evaluation on
land to the rear of
8 Bowling Green Street, Leicester.
NGR: SK 588 042**

Andrew Hyam
September 2006

Planning permission Ref: 20042124
Client: CGF Estates

Report No.2006-119 © ULAS 2006

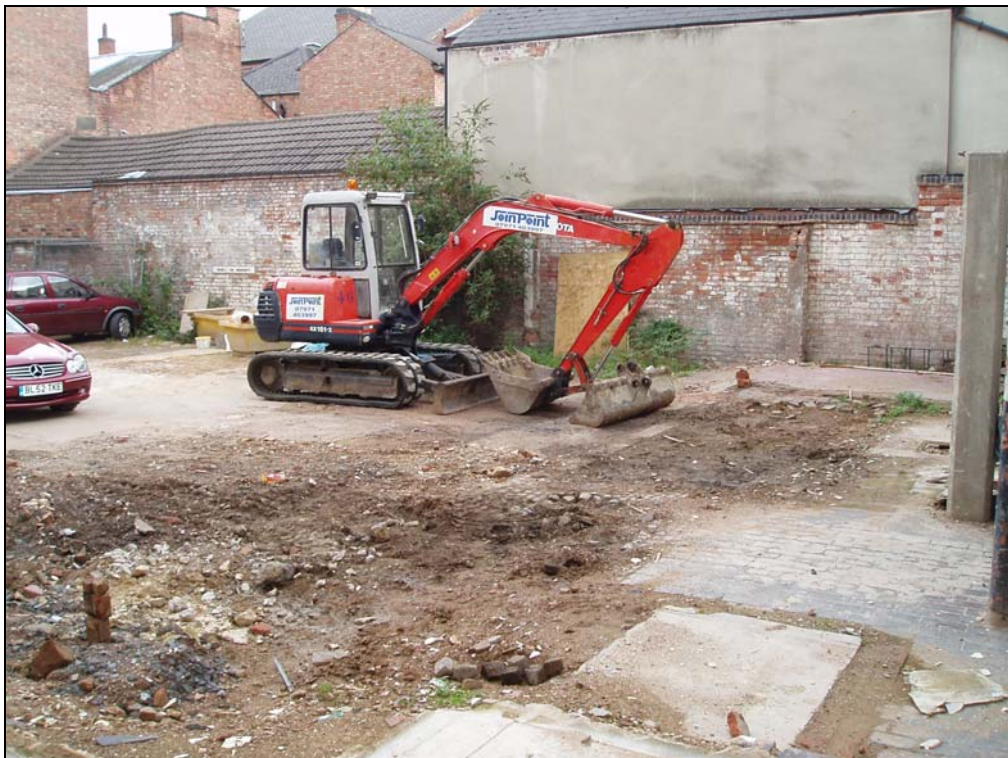
Plate 1. Trench location before excavation. Looking north.

The development site is located on the eastern side of Bowling Green Street and between Bishop Street, to the north, and Belvoir Street, to the south (figs 1 and 2). Number 8 is a Grade II listed building with a paved and tarmac rear yard enclosed and surrounded by other properties (plates 1 and 2). Until recently the southeast and southwest corners of the development area contained modern buildings which have now been demolished leaving a deep open-air basement passage running along the length of the southeast boundary.

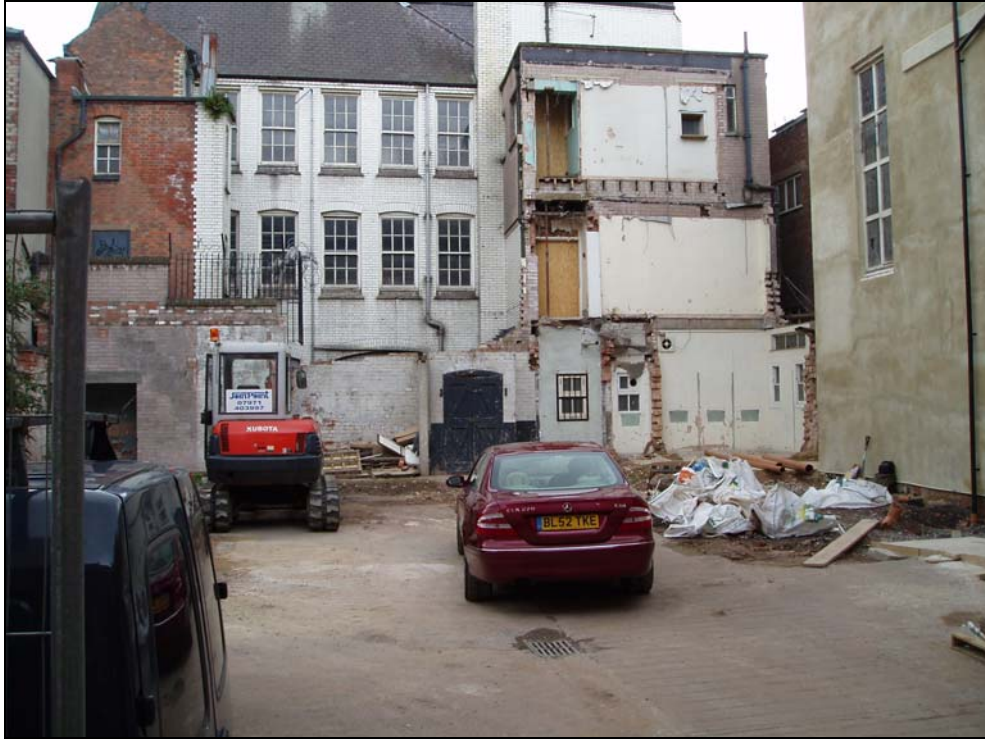
Plate 2. Trench location before excavation. Looking east.

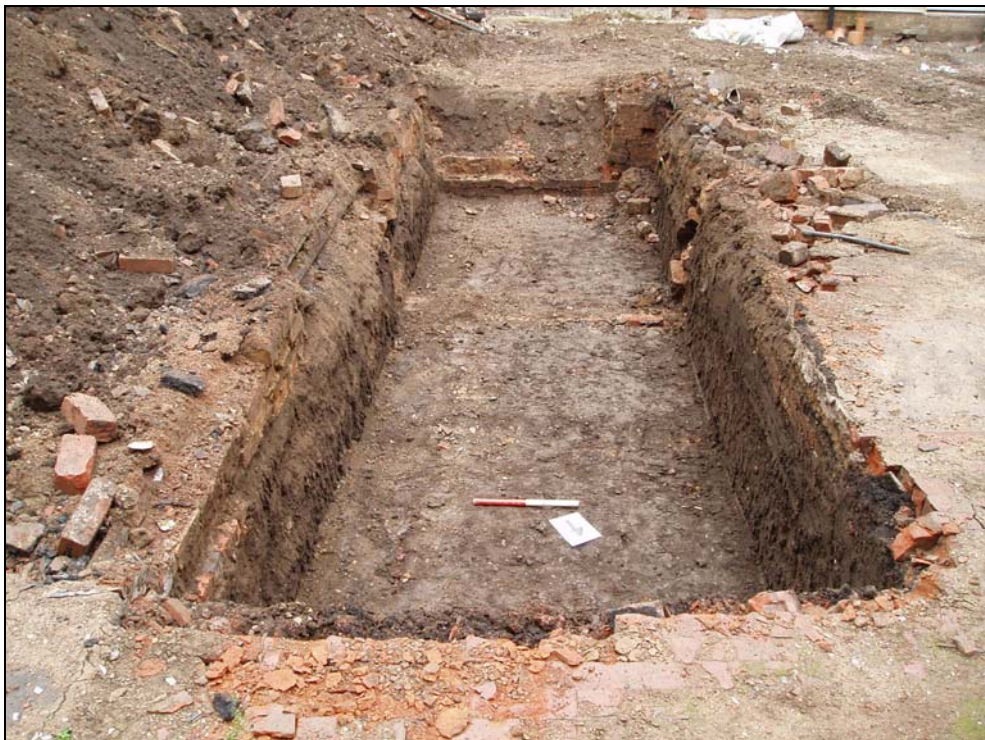
Plate 3. Evaluation trench. Looking south.

The trench, measuring 8.5m x 2.2m, was located midway between the rear wall of No. 8 and the northwest boundary wall (fig 4 and plate 3). A number of cast iron service pipes and footings of a brick wall running north to south across the eastern side of the yard indicated that there would be a certain level of disturbance and so this area was avoided. After removing the brick and tarmac surface a dark grey-brown clayish sandy-silt garden soil was observed. This continued down as the same homogeneous fill to the maximum trench depth of 1.2m below ground level. Because of the proximity of surrounding buildings it was not possible to excavate a stepped trench so the excavation ended at 1.2m.
