**An Historic Building Assessment**  
**(level 2 survey)**  
**at Hall Farm, 2 Main Street, Stonesby,**  
**Sproxtton, Melton, Leicestershire.**  
**NGR: SK 822 245**

Report No. 2007-026 © 2007

**An Historic Building Assessment (level 2 survey)  
at Hall Farm, 2 Main Street, Stonesby, Sproxton,  
Melton, Leicestershire. NGR: SK 822 245**

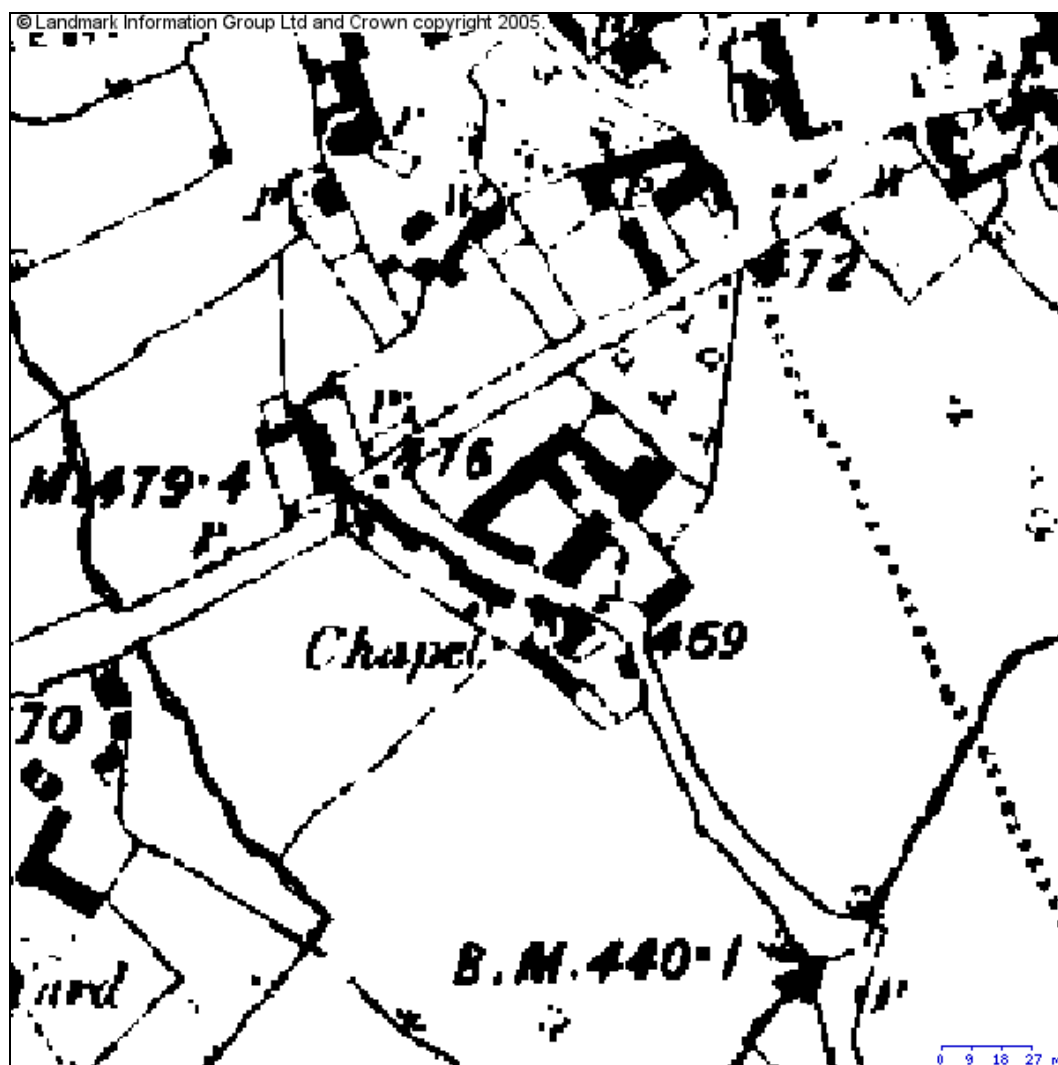
Figure 4. First edition OS map of site c.1887  
Source: Ordnance Survey, Licence number AL 10002186

The buildings under assessment are set around a large yard originally with access directly onto Chapel Lane through a blocked entrance in the southwest wall. The first edition Ordnance Survey map from c.1887 shows buildings essentially laid out in their present form although one building, since demolished, can be seen running alongside Chapel Lane up to the blocked entrance (fig 4). The Historic and Natural Environment Team, Leicestershire County Council brief also indicates that the Ordnance Surveyors plans of c.1815 may indicate that structures existed within the development area at this time which is unsurprising given the age of the farmhouse and the location within the core of the village.

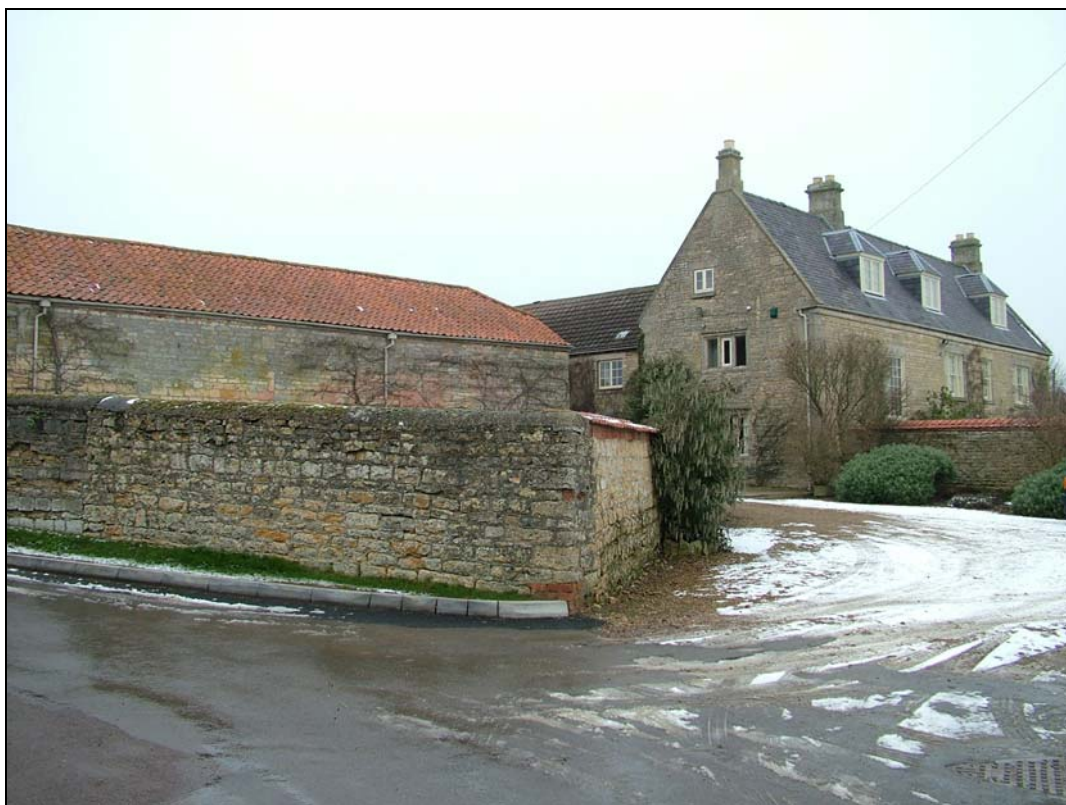
As mentioned above the barns are set around a yard with the farmhouse to the northeast (fig 3, plate 1). On the southwest side a limestone rubble-built wall which may once have formed part of a now demolished building closes off the yard from Chapel Lane. A corresponding scar from this building can also be seen on the southeast facing wall of Barn A. At the eastern end of this wall is a rebuilt section corresponding to an entrance shown on the first edition Ordnance Survey map. The yard itself has been turfed and landscaped and has a centrally placed swimming pool set within it. The northwest and southeast sides of the yard are bounded by Barns A, B, C and E. Barn C, which will be unaffected by the proposed works partially fills the northeast edge of the yard. The rest of this side is planted with a large hedge which screens the side of the farmhouse.

*Plate 1. Hall Farm viewed from south. Barn E on left hand side.*

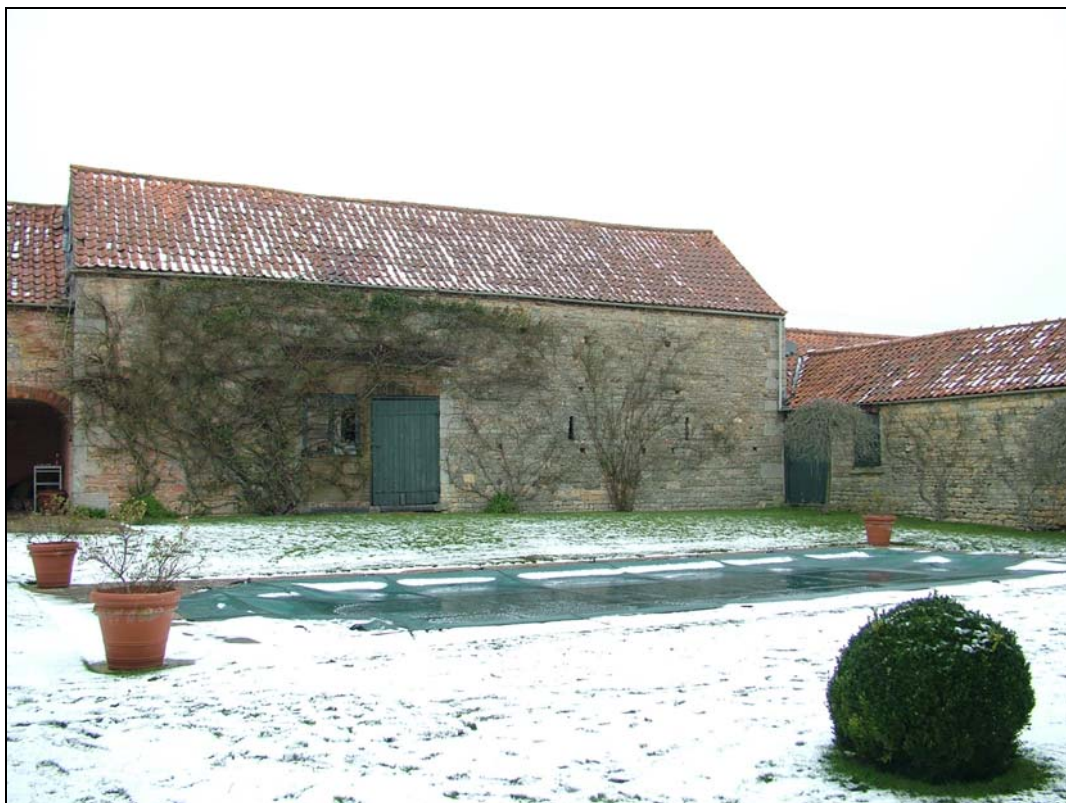
Located on the northwest edge of the yard Barn B is constructed from coursed yellowish grey limestone rubble with a gable ended pan tile roof (fig 5, plates 2 and 3). It is currently used as part of the stable facility located in the northwest area of the farm. It has large fine grained grey limestone quoins at each end on both main elevations. Barn A, another limestone and tile building, joins onto its southwestern

The southeast elevation facing onto the yard has a blocked double entrance set to the left of centre with a wooden door and a two paned window set within the blocked area. The bricks are modern and are laid on an older threshold of curved blue blocks. To the east of the doorway are two rectangular ventilation openings equally spaced up to the corner with Barn C. A number of small square holes appear to have been made into the surface of the wall around the ventilation holes possibly to hold the timbers of a temporary structure that may have been built up against it.

*Plate 2. Southeast face of Barn B.*

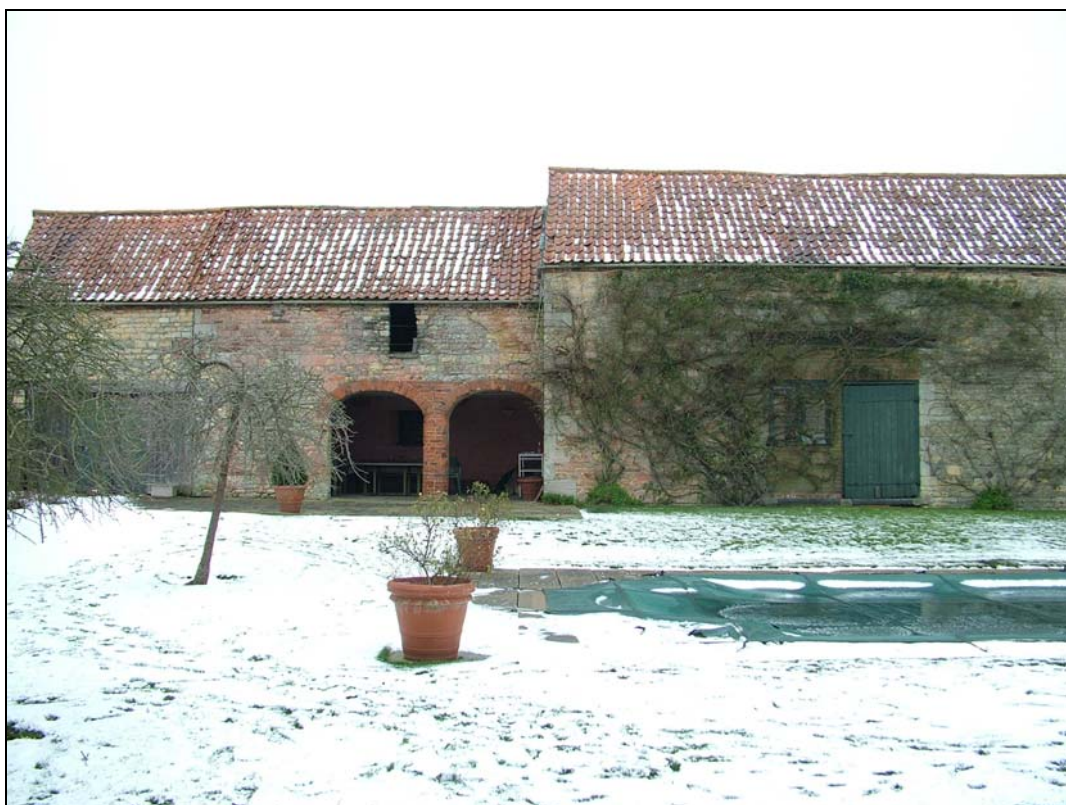
*Plate 3. Southeast face of Barn A and B*

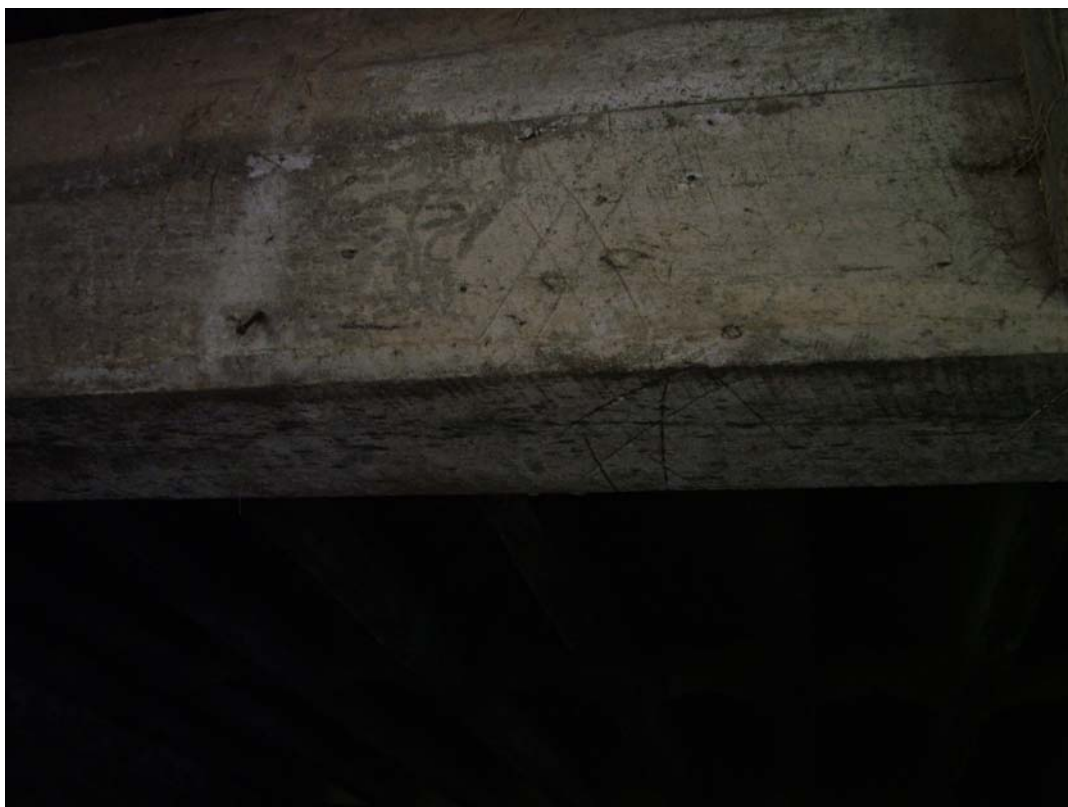
The tool marks in Barn B are worthy of note and give an insight into local beliefs and superstitions. Such apotropaic symbols were used to invoke the protection of Christ or Mary from at least the 16th century onwards (Easton 1998). Many examples can be seen across the country.

*Plate 4. Ritual marks on beam in Barn B*

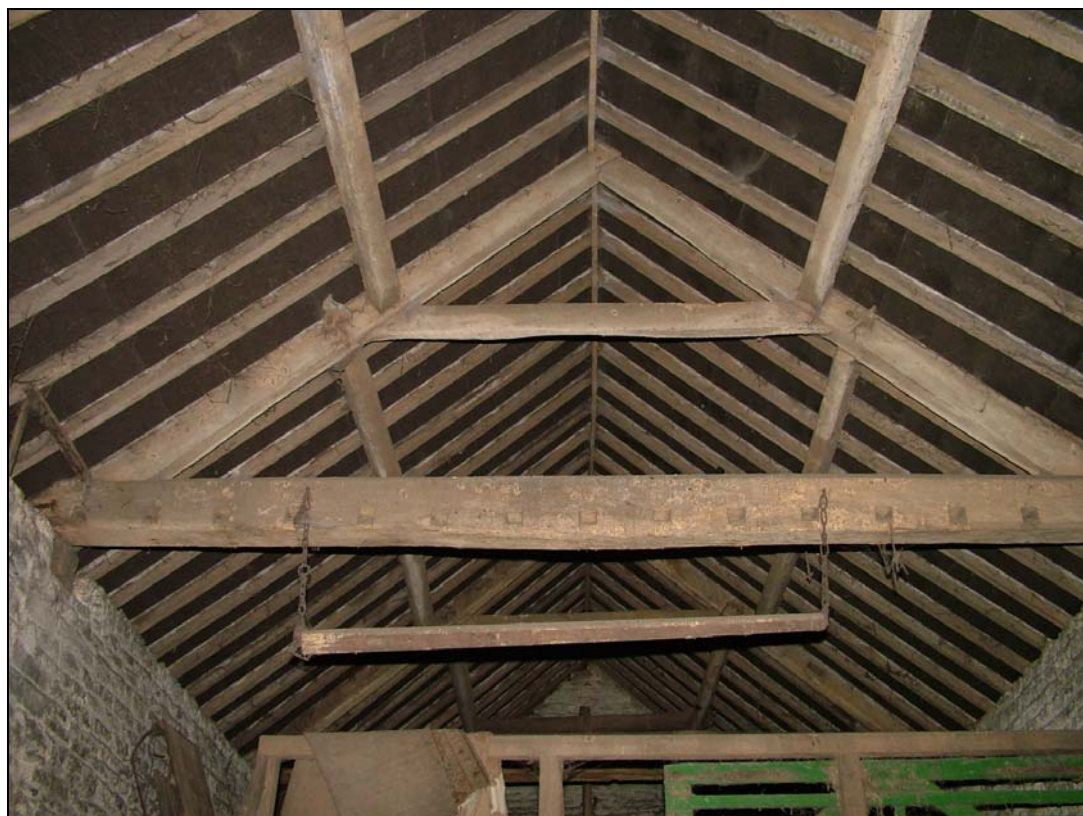
The roof structure makes use of salvaged timber for the main tie-beams shown by the many redundant mortice holes. The principal rafters are tenoned into the tie-beams at wall plate level. A smaller strainer beam or collar is tenoned into the principals as are the purlins which also have pegs through the tenon. The purlins support the common rafters which are fixed at the roof apex to a narrow ridge piece (plate 6).

*Plate 6. Roof structure of Barn B*

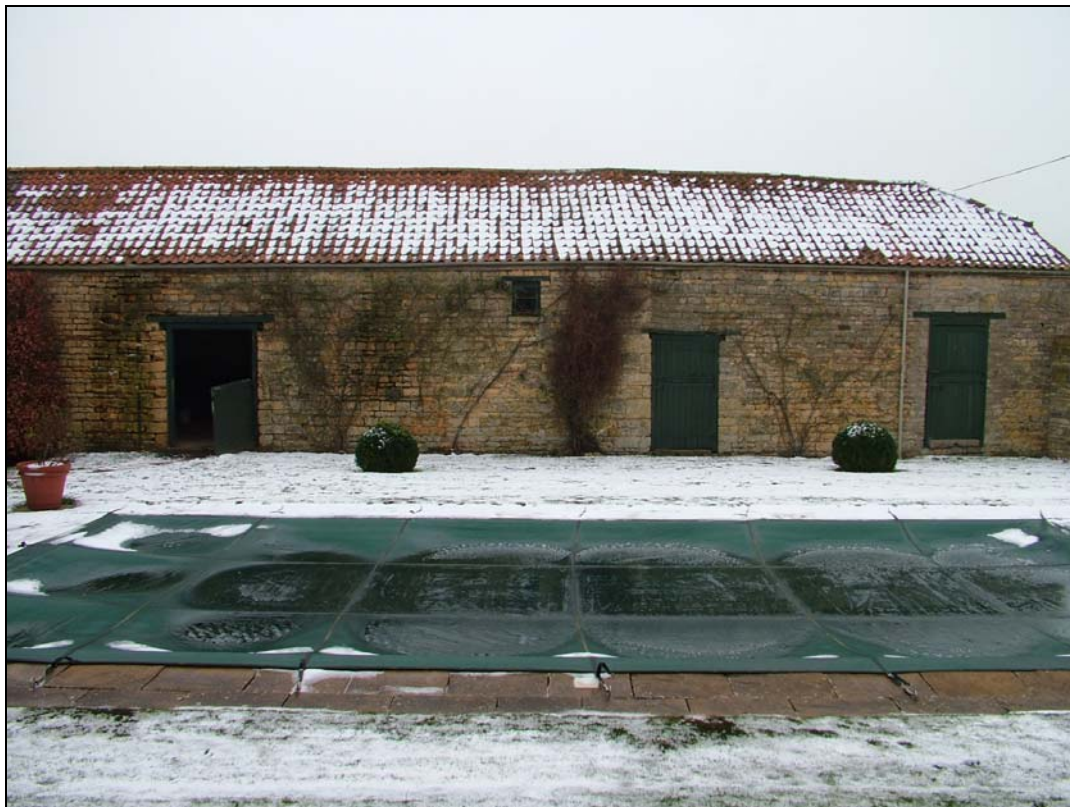
The northwest elevation has three wooden doors all of similar construction in addition to a small two paned window with a wooden sill set just below the eaves in the centre of the barn. The full height straight joint noted on the southeastern elevation can be seen leading up from the eastern side of the centre doorway indicating that the western end of the barn is likely to be a later addition.

*Plate 7. Northwest elevation of Barn E*

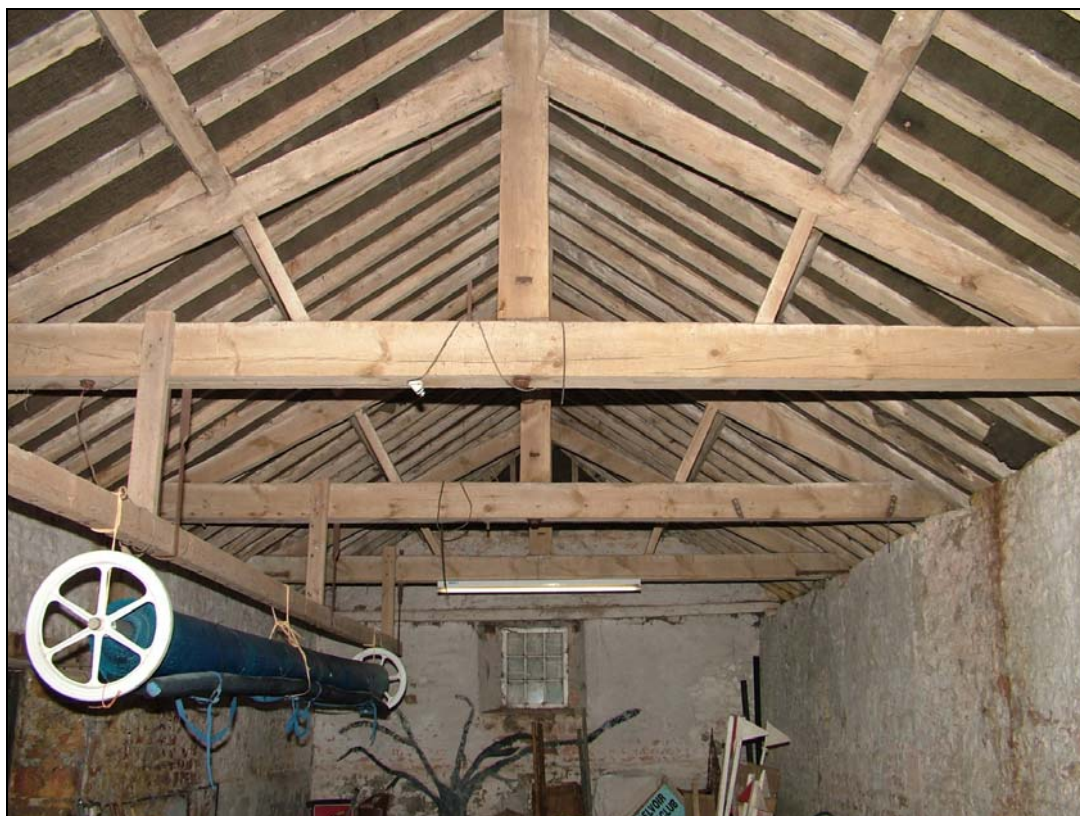
The roof in the largest section of the barn is supported on a series of suspended king post trusses. The king posts are attached through their base by bolts to the tie-beam which also supports raking struts. The principals, which do not act as common rafters, have cleats on their backs to carry the purlins and are also scarf jointed onto the king posts below the ridge line. The western end of the barn has the same structure with the ends of the purlins being set into both walls (plate 8).

*Plate 8. Roof structure of Barn E*
