An Archaeological Watching Brief At The Great Hall, Leicester Castle

ULAS Report No 2016-120

For: De Montfort University

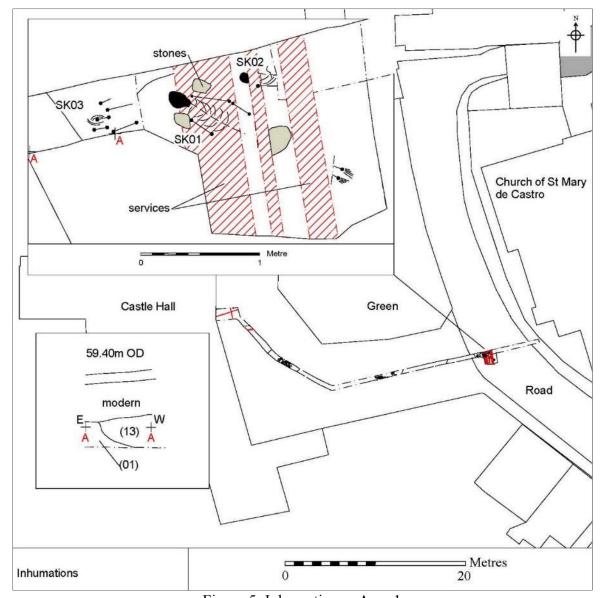
Figure 5: Inhumations - Area 1

Three well preserved (albeit truncated) inhumations were identified: two through machining and the third through subsequent hand cleaning of the initial remains. Located c.6.50m from the eastern end of the service trench and towards the graveyard of the Church of St Mary de Castro, a quantity of disarticulated human bone was also recovered from a dark brown/grey silty clay burialsoil (01) synonymous with all three burials. This deposit appeared to have been post-dated or overlain by a lighter yellow/brown silt sand (13) with common crushed mortar flecks, possibly a made ground.

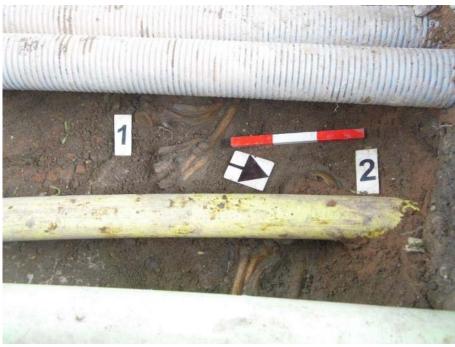
Figure 7: Skeletons (01) and (02), looking west

On confirming the articulation of Skeleton **01**, the projected area that the inhumation may have occupied was taken down, initially by machine and then by hand to the level of a gas main, to determine the extent of the burial and clean the remains. During this it was observed towards the northern baulk that the gas main had disturbed another burial. The exposed remains were cleaned and recorded but not chased to reveal their full extent, their level of 59.36m OD being below that of the current service trench depth and of existing services. The inhumation was again supine, running beneath the eastern baulk, the gas pipe having truncated the front of the

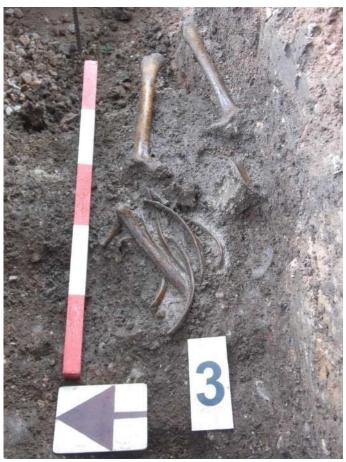
Figure 9: Skeleton (03), looking east

Following the expansion of the area around Skeleton **01**, two long bones were observed protruding out of the section created in the north-west where the line of the service trench resumed. Subsequent investigation and cleaning revealed the heavily disturbed but probably partially articulated remains of another, possibly young individual on an east-west alignment. Considering the small proportion of remains recovered, little osteological information could be obtained. Apparently supine, several of the bones had been displaced – perhaps disturbed and reburied – including both arms. The legs may have been disturbed during initial machining – a quantity of disarticulated bone was recovered from the area, both animal and human, although the latter may have been attributable to another adult individual entirely.

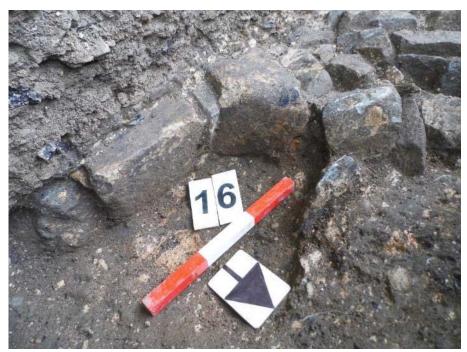
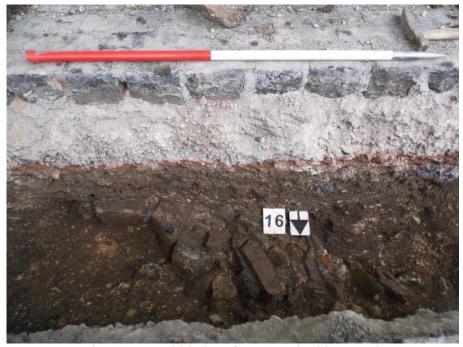
A concentration of stone, centred c.12m west of the inhumations, was investigated and interpreted as representing a cobbled surface (16), possibly incorporating mortared structural masonry remains (27). There was also a 'rubble' deposit (17) contained within a mid/dark grey/brown silty sand with crushed mortar fragments, probably representing a layer of 'made' ground (15), above (14). Roman pottery, probably residual, was recovered from the stone surface (16).

Figure 10: Cobbled surface (16), looking southwest - Area 1

Figure 11: Cobbled surface (16), looking south

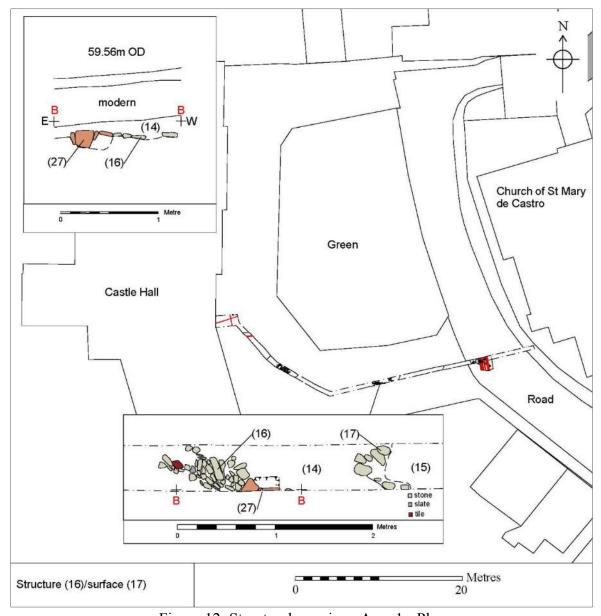
Figure 12: Structural remains - Area 1 - Plan

Structure (27) consisted of possibly reused/worked sandstone blocks bonded with a light yellow/brown mortar, with a total length of c.0.40m. This was different in character to the surface (16) on the western side which was dry bonded within a dark grey/brown silty sand (14), indistinguishable from the deposits interpreted as being made ground. The structure ran beneath the southern baulk of the narrow service trench and its interpretation as structural is no more than conjecture. Surface (16) appears to have been built up to or against this structure and over a dark grey/brown silty sand, also interpreted as representing 'made' ground, possibly lying above the burial soil (01).

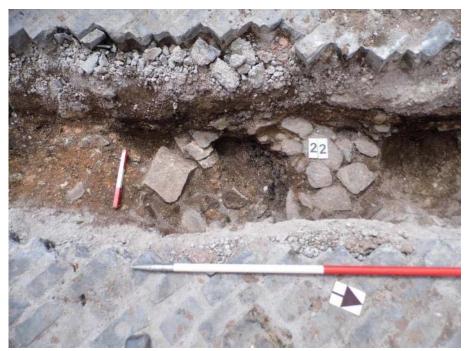
Figure 14: Possible oven feature (22), looking west

Approximately 8.0m from the north-west end of the service trench another concentration of stones was hand cleaned, recorded and interpreted as representing the remains of a possible oven feature, albeit of unclear date. Consisting of a possible masonry structural element (21) and a surface (22), overlying a layer of charcoal. The structural element (21) consisted mainly of sandstone blocks with some granite, typically $c.130 \times 110$ mm, to the south-east, possible mortar bonding between, and occasional slate laid upon, some of them. The slate comprising the surface to the north-west was typically $c.170 \times 120$ mm. The surviving structure was c.1.20m long, truncated by Pit [20] to the north-west. Containing pottery dated to 1680+AD, the slate surface (22) was seen continuing on the north-west edge of the pit.

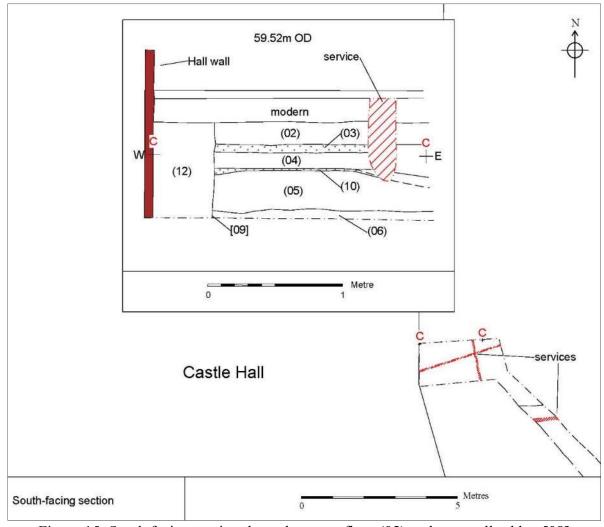
Figure 15: South facing section through mortar floor (03) and east wall robber [09]

Mortar floor (03) had a depth of c.0.06m and width of c.1.14m ending at a foundation trench to the east and truncated by a modern cut for a north-south water pipe to the west. It was constructed from light yellow/orange/brown mortar, the top being firmly compacted. It does not appear in the opposite north-facing section, the reasons for this unclear, but possibly due to the truncation of the modern east-west electricity main. It may be that the north facing section is without the original width of the porch. Mortar surface (03) was overlain by layer (02), probably made ground, c.0.18m thick, with crushed mortar and building material fragments. It was undated.

Deposit (12) consisted of mixed granite and crushed sandstone fragments in a yellow/brown sandy matrix in a straight sided cut [09], c.0.45m wide, at least c.0.70m deep and observed at the western limit of the mortar floor layers. It may represent foundation or robber material dating from the demolition of the original east wall of the Hall and subsequent construction of the present brick facade in c.1695, although no finds to support this were retrieved. Notably, this cut was not reflected in the north facing section of the service trench here, tentative supporting evidence for a termination of both the floors and the eastern wall at this location, although the extent of any disturbance from existing services could not be ascertained.

the east where it was truncated by the foundation trench [09]. A purple/grey fragmented clayey layer (05) lay beneath the lower floor, probably made ground consisting of redeposited natural. Below this, at the bottom of the excavation, a very dark grey/brown clay silt mix (06) with occasional building material fragments was difficult to interpret but may represent the fill of a pit.

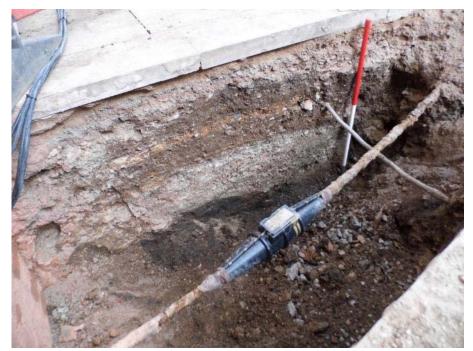
Figure 17: South facing section, looking northeast, with electricity service

An area $c.2.50 \times c.1.30$ m was excavated under controlled conditions up against the east wall of the existing hall to enable access for the services to the inside of the building and at deeper levels than the service trench itself. Two existing services – an electricity main and water pipe (Figure 17) – were unexpectedly revealed during this, thus removing the vast majority of any archaeological deposits in plan. The resulting section providing confirmation of results of previous archaeological observations (Mackie, 1994), notably evidence for a floor to a 'porch' and for the foundations for the original eastern wall of the hall.

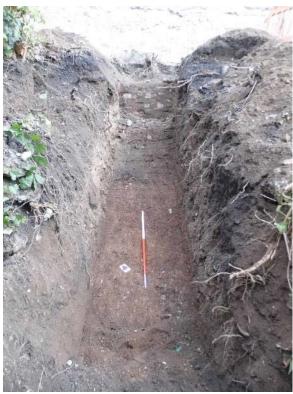
Figure 18: Trial Trench, looking north-east

The trench was stepped and excavated to a maximum depth of 1.80m to the level of natural mudstone substratum which dropped gently away to the west and the direction of the river. The sections described made ground of topsoil (c.0.45m max depth) overlying a rubble/stone/mortar layer (c.0.30m max depth), in turn above a mid-grey/brown loose loamy backfill deposit, containing fragmentary slate, stone and building material. No deposits, layers or structures of archaeological interest were observed during the investigation and, after advice from the City Planning Archaeologist, the trench was recorded, back-filled and levelled.

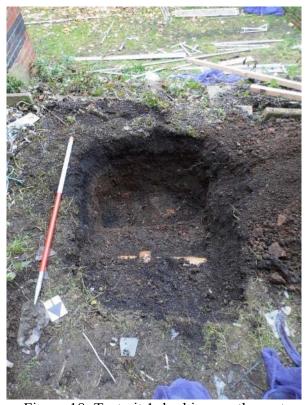
Figure 18: Test pit 1, looking south-west

A test pit, approximately $1m \times 1m$ and c.0.40m deep, was hand excavated at the request of the City Planning Archaeologist at the southern end of the terrace to the west of the hall to complement the results from the trial trench described above. Two modern service pipes were observed within a similar mid/dark grey silty sandy made ground deposit but no archaeological remains were encountered. The test pit was backfilled on completion of recording.

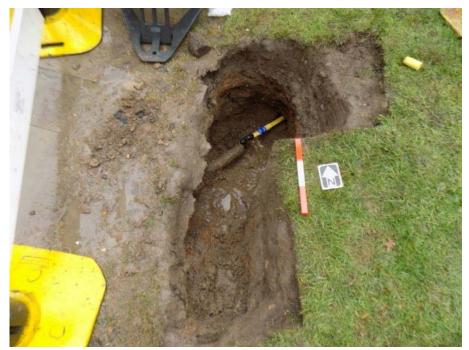
Figure 19: Test pit 2, looking north

originally instated. The pipe was located at a depth of 0.75m and was surrounded by a loose, friable mid brownish/grey sandy silt, overlain by several layers of modern made ground. The topsoil was found to be 0.20 - 0.30m thick and consisted of a smooth mid brownish/grey silty clay.

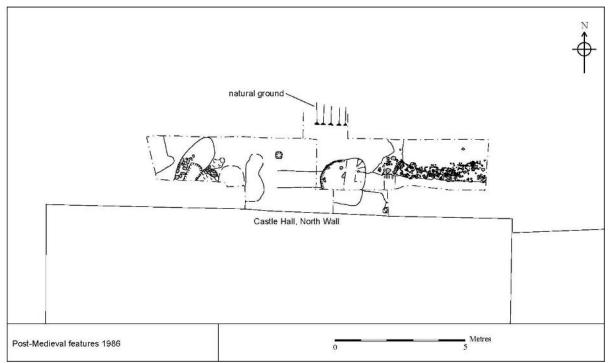
Figure 20: 1986 excavations

An external evaluation was undertaken to the immediate north of Castle Hall in 1986 by Leicestershire Archaeological Unit (LAU) as part of a research excavation following some remedial work on the roof timbers. The main objectives were to investigate whether there had been any buildings to the north of the hall. A series of layers, deposits and features dating to the post-medieval period were recorded. The resulting plan did not produce any archaeological evidence for any structures, masonry or otherwise, that may have represented ancillary buildings associated with, or extensions to, the Castle Hall. This may be significant in discussions concerning the interior layout and use of the building. Notably, c.3.4m from the northern gable wall the natural ground was observed falling away steeply, towards the River Soar.

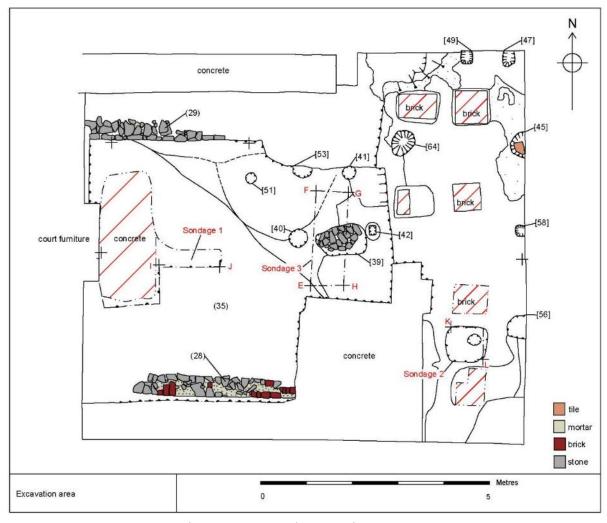
Figure 21: Internal excavations – Area 2

Considering the scheduled status of the site, three sondages were targeted in the internal area of the Castle Hall as part of a limited programme of intrusive investigation as agreed upon with Historic England and the Leicester City Planning Department. Utilising, where possible, modern disturbances, Sondage 1 was excavated up against concrete foundations for the court furniture and Sondage 2 involved the re-excavation of a previous archaeological test pit. Sondage 3 was excavated across a disturbed area of the court's interior where a compacted mortar surface had been subject to truncation and some protruding masonry debris had been identified.

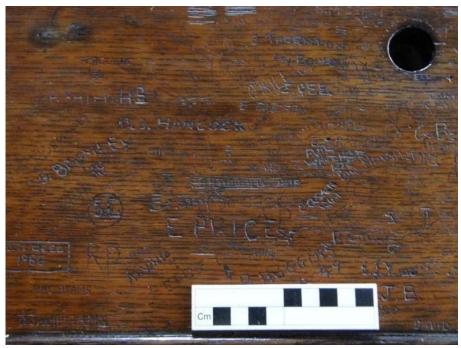
Figure 22: Court furniture graffiti

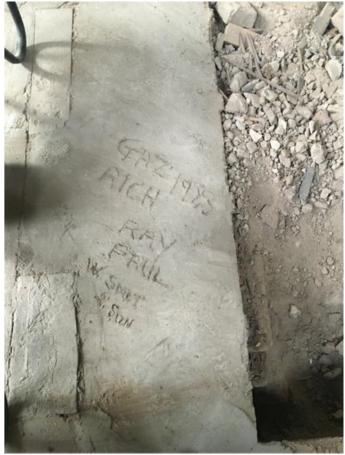
Figure 23: Modern disturbance in hall floor - Area 2

The Civil Court furniture, floorboards and wall panelling was removed under intermittent archaeological monitoring in July and August 2016 (Figure 24). A photographic record was made of the process. The floor structure included a mixture of wooden joists, floorboards, planks and some modern concrete and stone slabs. The work was postponed due to the discovery and subsequent controlled removal of some asbestos. Concrete, with names scratched into it, from the centre of the room dated it to the 1980s (Figure 23). The Judge's bench on the west side of the courtroom was left *in situ*.

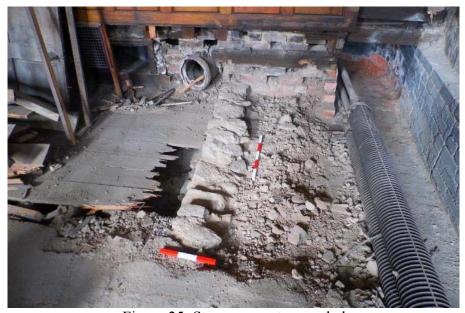
Figure 25: Stone supports revealed

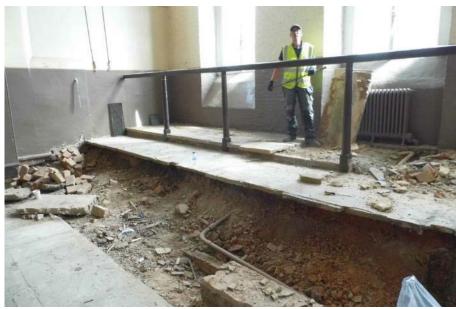
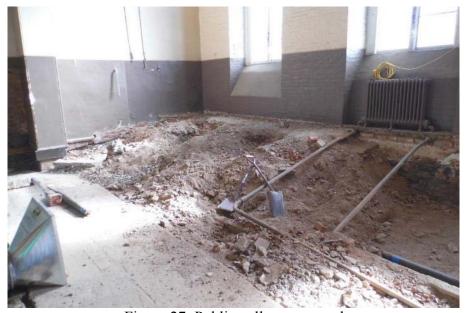
The reduction by hand of the public gallery along the eastern wall was monitored intermittently. It was composed of stone slabs above a make-up of modern brick and concrete rubble, with no indication of earlier floor layers.

Figure 26: Public gallery removal

Figure 27: Public gallery removed

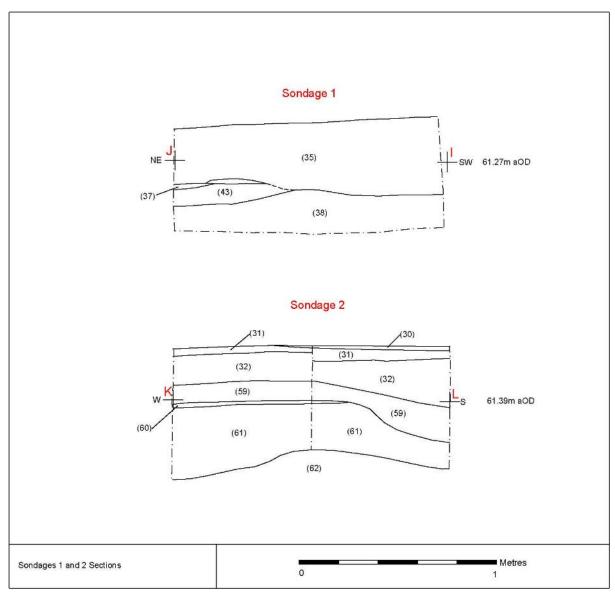
Figure 28: Sondage 1 and 2 - sections

Sondage 1 was excavated in the west of the area of investigation, up against a concrete foundation for court furniture. It was approximately $1.3 \text{m} \times 0.40 \text{m}$ and rectangular in plan. The north facing section was drawn. A loose mixed grey soil layer (35), containing pottery dating to the 12 th - 14 th century AD, was c.0.40 m deep. This overlay a light yellow crushed mortar layer (37), 0.02 m thick, possibly representing the fragmentary remains of a degraded floor at a level of 61.15 m aOD. Further grey silty sandy deposits (38) and (43) were observed underlying the mortar floor, the former of these (38) containing roughly made 12 th century AD pottery. A compacted brownish/grey clayey silt (62), observed at the base of modern intrusions in the Great Hall, was recorded at the base of this sondage but not excavated.

Rectangular Sondage 2 was located in the east aisle of the hall and involved the re-excavation of a previous archaeological test-pit between the southern two of five brick foundations supporting what was the public gallery. It measured $c.0.90m \times c.0.77m$ and was excavated down to the same compacted deposit (62) as seen in Sondage 1.

Below another mid/dark grey/brown silty sand deposit (32) comparable to (35), seen in Sondage 1, and a compacted yellow silty clay layer (59), evidence for earlier floor layers were also observed and recorded in the north, west and south sections of the sondage. A yellow/brown lime mortar surface (60), 0.02m thick, was recorded at a depth of 61.34m aOD, overlying a mixed soil layer (61) also reflecting that seen in Sondage 1.

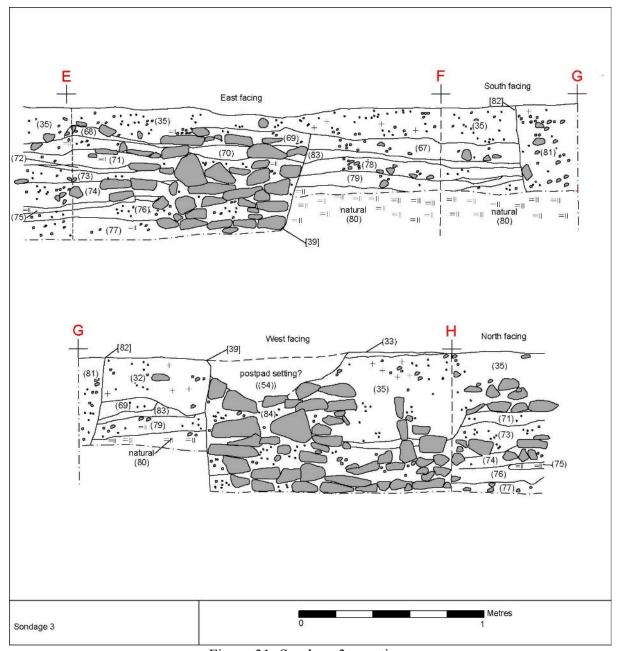
Figure 31: Sondage 3 - sections

The most informative sondage was excavated across the area of the eastern arcade post line where some disturbance in a compacted floor surface (33) was observed. The investigative slot was $c.2.10 \times c.0.70$ m, covering an area of c.1.5m². Natural red/brown clay substratum was observed at the base of this slot at a depth of 61.38m aOD.

Floor layers - A mixed loose soil deposit (35) was again observed, albeit thinning to c.0.20m, overlying possible floor deposits in this location (Figure 35). The latter survived as a layer of yellow crushed sandstone and mortar, c.0.10m thick, perhaps representing a demolition event, overlying another mortar floor (78) and possible trample layer (83). Layer (78), at 61.51m aOD and typically c.0.07m thick, consisted of yellow sand with crushed limestone and was distinct from the layer immediately above it (83), a darker grey silt, up to c.0.06m thick, with charcoal. Context (78) contained pottery dating to the 11th – 13th century AD and context (83) pottery dating to 12th – 14th century AD.

Post hole - Cut [39], over 0.60m deep, was observed in the east and west facing section of the sondage, possibly representing the original construction posthole for the eastern arcade post. Sealed by layer (35), this contained an abundance of granite packing stones and layered deposits (68) (69) (70) (71) (73) (74) (76) (77). These may represent floor and make-up layers

Post pad void - A shallow 'scoop', c.0.76m wide, c.0.20m deep and sub-rectangular in plan, observed in the west facing section of Sondage 3, would be consistent in representing the position of a padstone used to support the arcade post after it was redesigned from an earlier 'earthfast' construction. The start of the granite rich deposits immediately below may be part of this consolidation process. A very loose mid grey/brown deposit (54), containing pottery dating to 15th - 16th century AD, was removed from this.

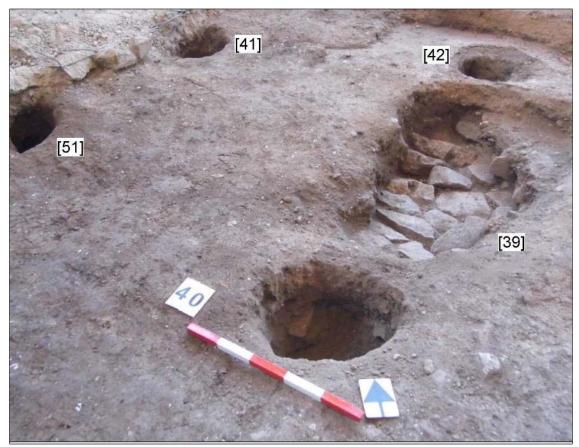
Figure 34: Postholes, looking northeast, 0.50m scale

In proximity to Sondage 3, a number of smaller postholes were excavated and recorded [40] [41] [42] [51] [53]. Postholes [40], [41] and [42] (Figure 34) with diameters from c.0.20m - c.0.40m and depths of between c.0.30m - c.0.52m may represent postholes associated with the possible removal process of the eastern aisle post. Postholes [41] and [42] were sub-circular in plan, Posthole [42] sub-rectangular. They were all recorded as containing modern rubble debris fills, not assigned a unique context number. None of them yielded datable material.

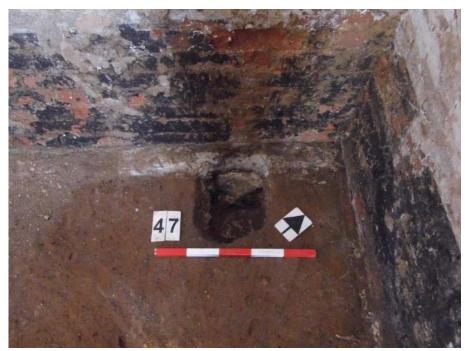
Figure 35: Posthole [47], looking northwest, 0.50m scale

Postholes [45], [47] (Figure 35), [49], [56] and [58] (Figure 21) were positioned around the internal perimeter of the hall, along the northern and eastern wall and contained fills (44) (46) (48) (55) (57) with modern inclusions and few datable finds. They were typically sub-circular in plan, ranging from c.0.21m - c.0.54m wide, but incomplete, extending beneath the line of the wall they were up against. They were between c.0.20m and c.0.28m deep. Mid brown/grey silty sand fill (44), within Posthole [45] (Figure 36), contained a notably large fragment of tile.

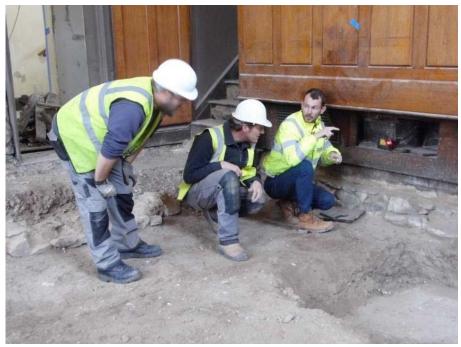
The padstone beneath one of the western aisle arcade posts located beneath the Judges bench was accessible through a small opening in the wooden panelling from the western edge of the excavation area. This was investigated in order to photograph and, using a 360° Line Laser projecting a known height from the excavation area, establish a level upon it allowing a comparison with the heights of the floor levels identified in each of the sondages and the gable end archways.

Figure 37: Levelling the western aisle padstone

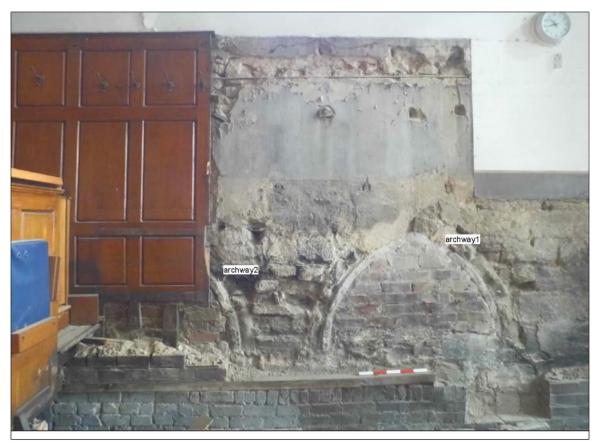
Figure 39: Doorways, partially revealed, looking north, 0.50m scale

of the doorway was obscured by the modern brick flue wall of the hall heating system. After discussions with Leicester City Council Planning Officer, the brickwork infill was removed under archaeological observation revealing a compacted mortared coarse stone infill immediately behind it (Figure 40). The date of construction and infilling of these doorways is unclear.

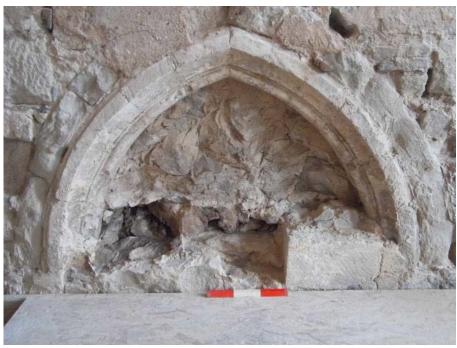
Figure 41: Archway 1 - watching brief, 0.30m scale

A watching brief visit was arranged with the developer to oversee the removal of further stone and brick infill after written agreement for the work with Leicester City Planning Department on 16th February 2017. This work began with the removal of the remaining brickwork and then the first course of lower stonework. It was discovered that this stone work was keyed into the stone backfill behind the bricks and, as such, formed part of the fabric of the Grade 1 listed building. On further advice from the Planning Officer the work was suspended and agreement reached to reinstate the affected area.

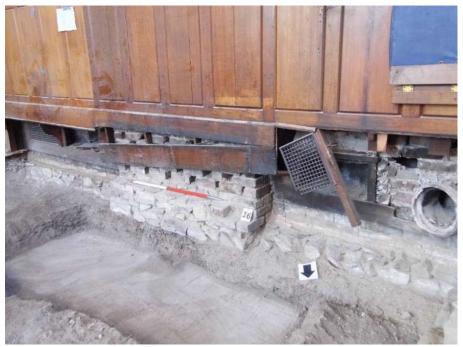
Figure 43: Stone support (36), looking southwest, 1m scale

The face of Structure (36) (Figure 43), supporting the Judge's bench, was uncovered on the western edge of the excavation area. This consisted of two courses or limestone blocks with slate and brick. The heating system for the Hall ran through and behind this.

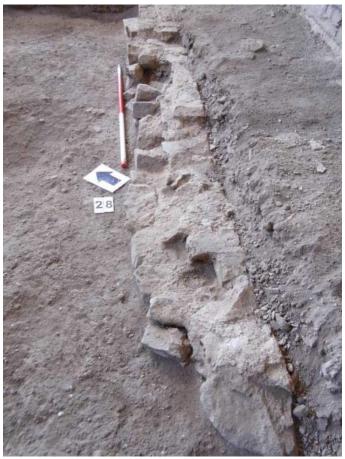
Figure 44: Stone support (28), looking northeast, 1m scale

Wall (28) (Figure 44) was located along the south edge of the excavation, extending c.3.50m on an east/west orientation. Constructed from limestone chunks and bricks bonded with mortar, it was between c.0.15m - c.0.26m in height and c.0.38m wide, rising to two rough courses. Parallel Wall (29) (Figure 45), along the northern edge of excavation, was c.3.10m long and between c.0.15m - c.0.52m wide, rising to three courses and of similar random brick, limestone and mortar bonded construction. It was connected to the north/south wall (36) supporting the *in situ* Judge's bench.

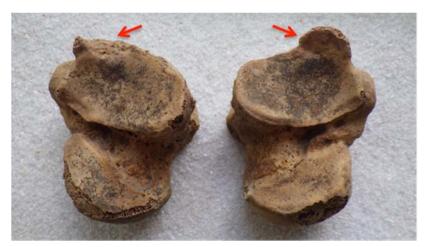
Figure 48: *Os trigonum* in both tali of Skeleton 1 (inferior view)

(Figure 48). The loose ossicle had not been recovered during excavation. On the left side the ossicle had fused to the facet of the talus, evident as a projection of the joint surface posteriorly, a subtle indentation on the inferior surface and a smooth callus-like bump on its superior surface (Figure 48).

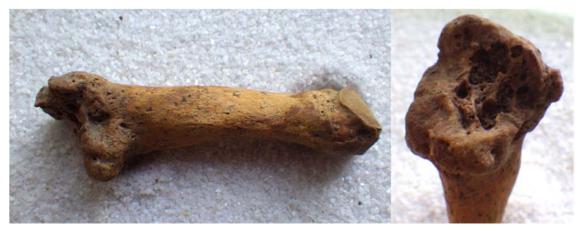
Figure 50: Fracture of the head of the right fifth metacarpal of Skeleton 1 (left – lateral view, right – distal view of head)

He also demonstrated a significant fracture of the right fifth metacarpal. The joint surface of the head (articulating with the third finger) of the fifth metacarpal had been completely destroyed so that the usual convex shape was more cup-like in appearance with a prominent projection of bone on the dorsal surface (back of the hand) (Figure 50). The joint surface was irregular and cysts had formed at the centre. There was no sign of any new bone formation, suggesting it was healed and the shaft of the fifth metacarpal had not been affected. Fractures of the metacarpal heads can either be vertical, horizontal, or oblique (Galloway 1999, 153). Based on the prominent dorsal projection seen in the metacarpal of Skeleton 1, this may have formed in response to a transverse or crush fracture to the metacarpal head, pushing the head backwards. Unfortunately, the associated proximal phalanx was not present and the left fifth metacarpal was also missing.

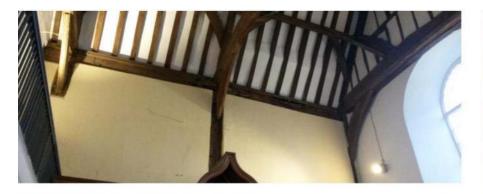
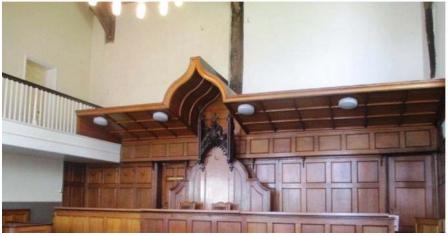
Figure 52: Western aisle arcade posts

Tree-ring samples (sample 42) from the surviving top of the truncated eastern arcade aisle post have determined a felling date of 1344 – 1369 AD, a timber previously believed to have also been felled in the 12th century. This date places the timber in the period when the Great Hall was known to be in the King's hands (1322 – 1399) and when further alterations and perhaps even complete rebuilding of the Hall took place, although this event is not supported through documentary evidence. It was also shortly after this period that both construction of a possible eastern porch was attributed and to which the floor levels identified by the excavations described here may relate. Documentary accounts illustrate these repairs in some detail. The clarification of the levels on the arcade post padstone (Figure 52) sheds light on the development of the Great Hall and requires further consideration.

Recent dendrochronological analysis and interpretation by the Nottingham Tree-Ring Dating Laboratory suggests that the earliest phase of the existing Great Hall precedes the previously cited date of 'after 1150AD'. A felling date for a timber sample (sample 41) taken from one of the western arcade posts revises this to between 1137-1162AD, confirming that the Great Hall as the oldest standing aisled building in the United Kingdom and possibly Europe. This date was corroborated by samples (CO1) taken from the detached arcade post capital currently at the Jewry Wall Museum. This phase still concurs with the Great Hall being in the ownership of Robert (le Bossu) at the time, who succeeded his father in 1118 AD and died in 1168 AD. He is generally identified as having been responsible for construction of the first stone-built hall at Leicester Castle and the lack of documentary evidence for this is countered by the architectural evidence which is typical of the latter half of the 12th century. The evidence is corroborated by the pottery finds, notably the mid -12th century Stamford ware recovered from a layer just below the possibly medieval floor level of the Hall (see above). The post-conquest period was one of consolidation on the part of the William the Conqueror who pursued a policy of constructing castles in the main towns and along important routes of communication. The origins of the fortified place at Leicester undoubtedly stems from this period along with such castles at Warwick, Nottingham, York, Lincoln, Huntington and Cambridge.

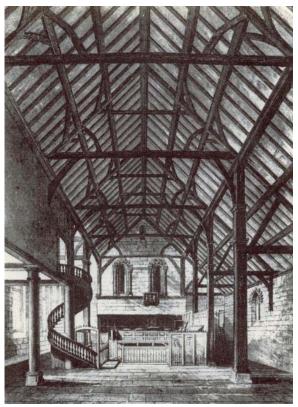
Figure 53: 1821 Hall with flagstones

The highest compacted earthen/crushed mortar floor (33) recorded in the excavations were those that the postholes cut through. This was at a height of 61.84m aOD and may represent the final floor level when the padstones were still visible and before the final alterations had taken place. At the Great Hall of Oakham Castle, the lower of two levels of flagstone floors is believed to represent the original floor, allowing the moulded bases of the columns to be visible. It would be reasonable to suppose that the floor in the Great Hall of Leicester Castle at some point was of similar construction although no archaeological evidence for this survives (Figure 53).

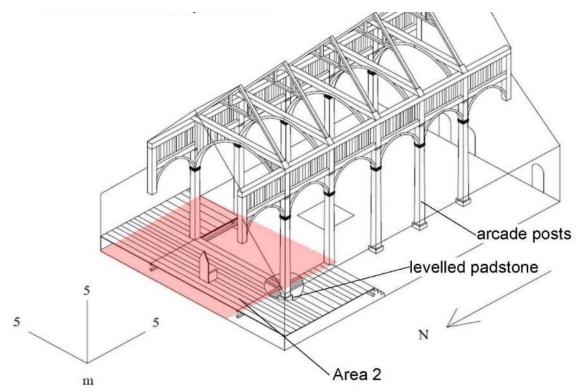
Figure 55: Reconstruction showing position of arcade post

There is evidence that one phase of alterations may have involved the shortening of the arcade posts and insertion of supporting postpads, raising these above earlier floor levels (78) (60) (37) (Figure 54) (Figure 55) The date of this event is unclear. It may have been part of the documented 1377-78 repairs and alterations when, along with the porch, the roof was covered with slates, a screen was erected and an oriel window added, or as late as 1522, when the castle was surveyed by the Royal Commission and the roof of the Great Hall replaced. The reason for the work may have been the deterioration of the lower ends of the earthfast timber posts. The event is reinforced with archaeological evidence from Sondage 3; the possibly backfilled original east arcade posthole [39] is cut deeper than 61.10m aOD and the possible base of the 'postpad/padstone' void (no context number) was at a level of 61.63m aOD, comparable to the base of the *in situ*, albeit shortened western aisle padstone (61.73m aOD) accessible beneath the judges bench. Pottery dating to the 15th – 16th century AD from the material within the postpad void (54) support this interpretation. The bases of the remaining arcade posts, observation and measurement of which would add to this information, are inaccessible.
