Archaeological Attendance and Recording  
during groundworks at  
Flores House, 34D High Street, Oakham, Rutland, LE15 6AL

ULAS Report No 2018-143

## **Archaeological Attendance and Recording during Groundworks at Flores House, 34D High Street, Oakham, Rutland, LE15 6AL NGR: SK 86073 08727**

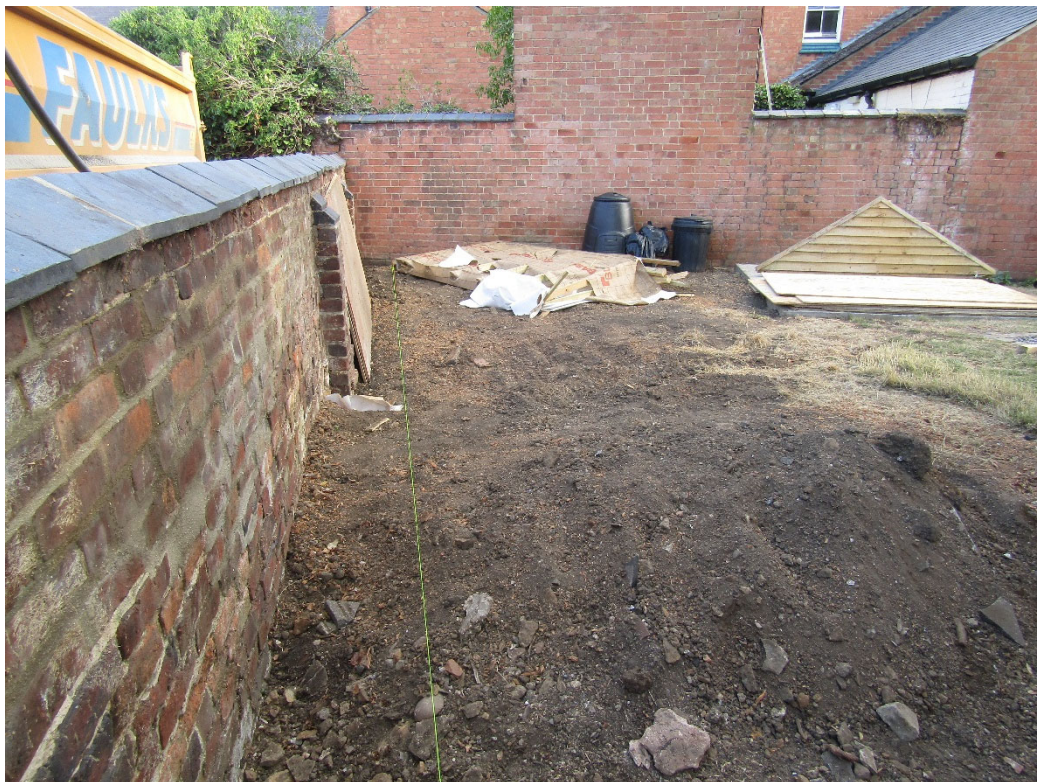
Figure 4: Area prior to excavation looking north. Visible in the photograph is the existing concrete shed base to be removed.

In the north-east corner of the area to be excavated was an old concrete shed base and hard-core footing (Figs 8 and 9). It was planned that this would be broken and removed at a later date without excavating beyond the depth of the made ground.

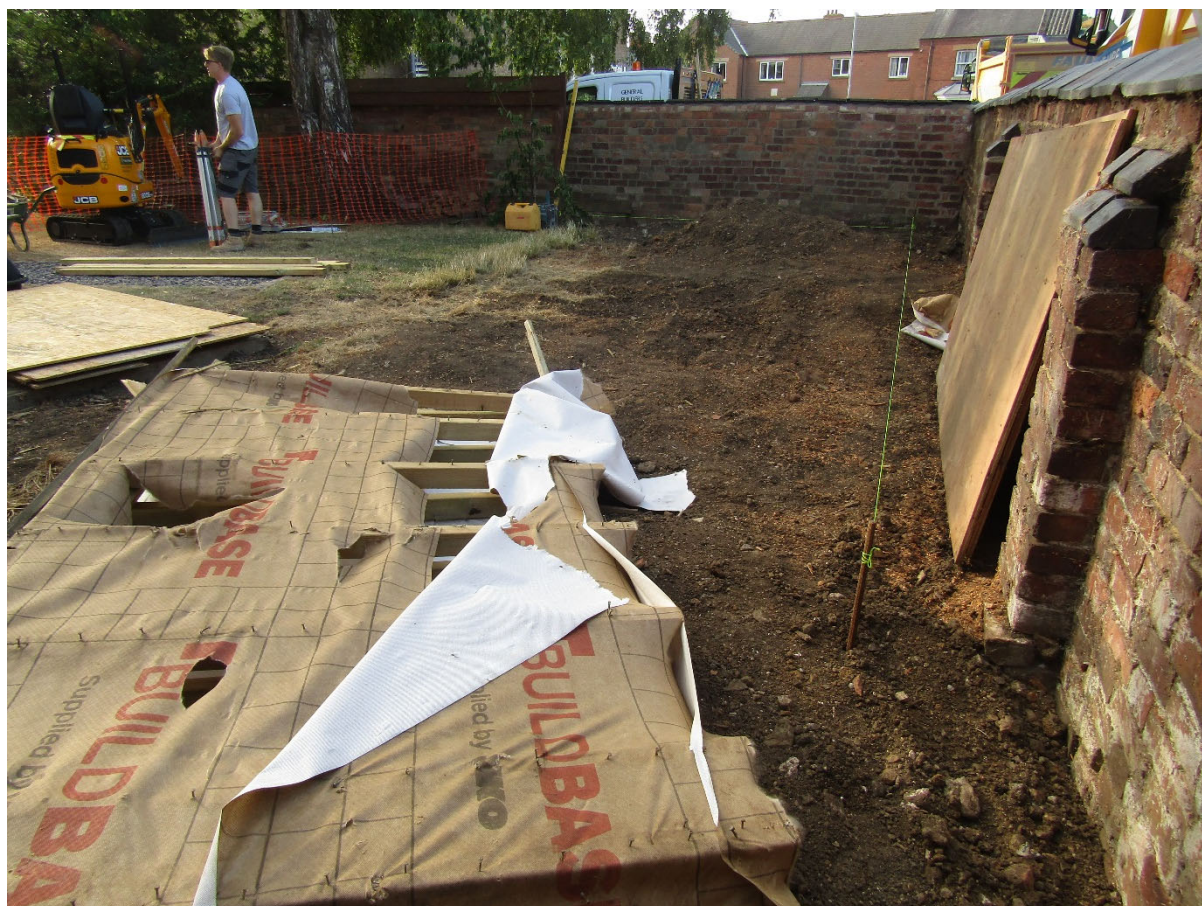
Figure 5: Area prior to excavation looking south

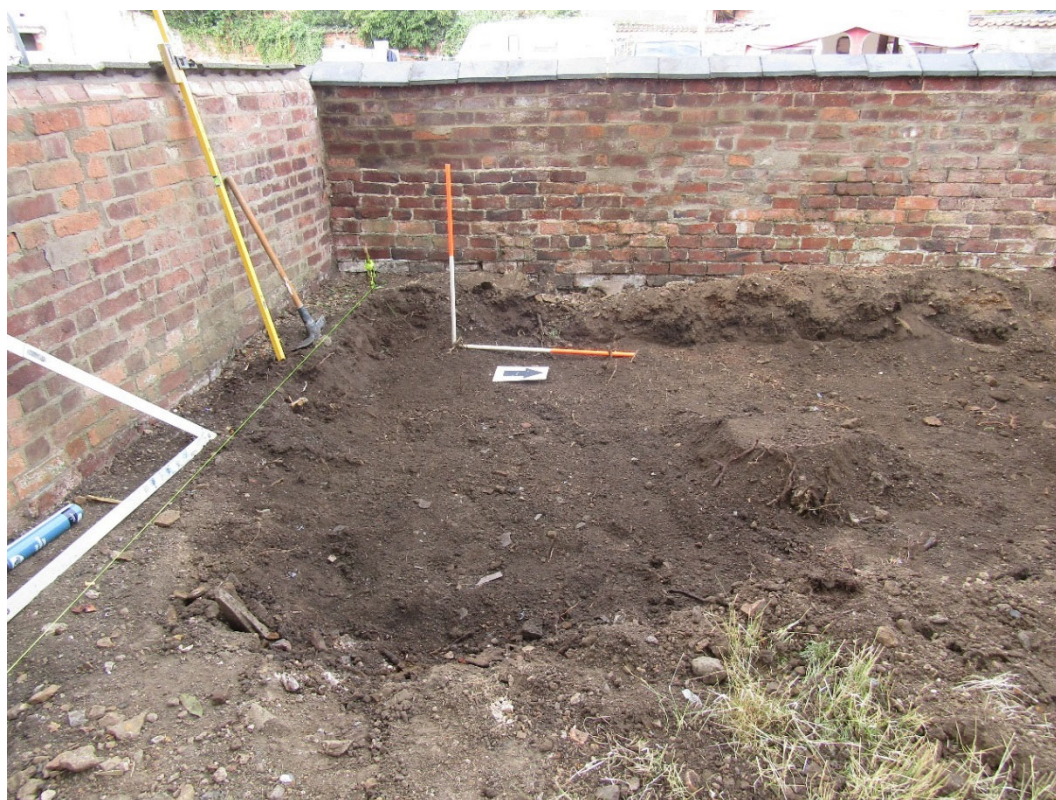
Figure 6: South western corner post excavation. Photograph shows the location of a buried tree stump. Scale 1.0m.

The area earmarked for the construction of the garden building had been heavily truncated by the removal of at least two trees and the buried stump of another. The ground had also been disturbed in the past to bury a small quantity of asbestos sheeting which was discovered during excavation. There was a range of modern debris mixed with the heavily disturbed topsoil including bricks and plastic objects. The subsoil was not reached or disturbed during the excavation.

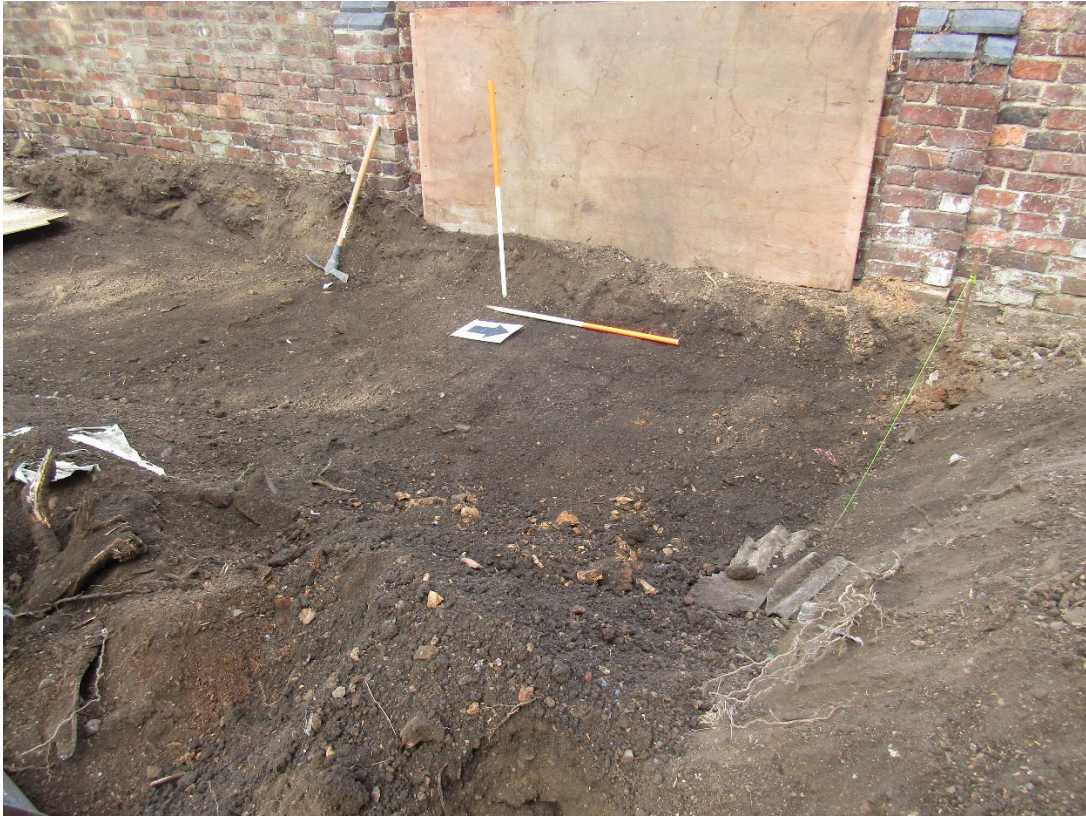
Figure 7: North western corner post excavation. Scale 1.0m

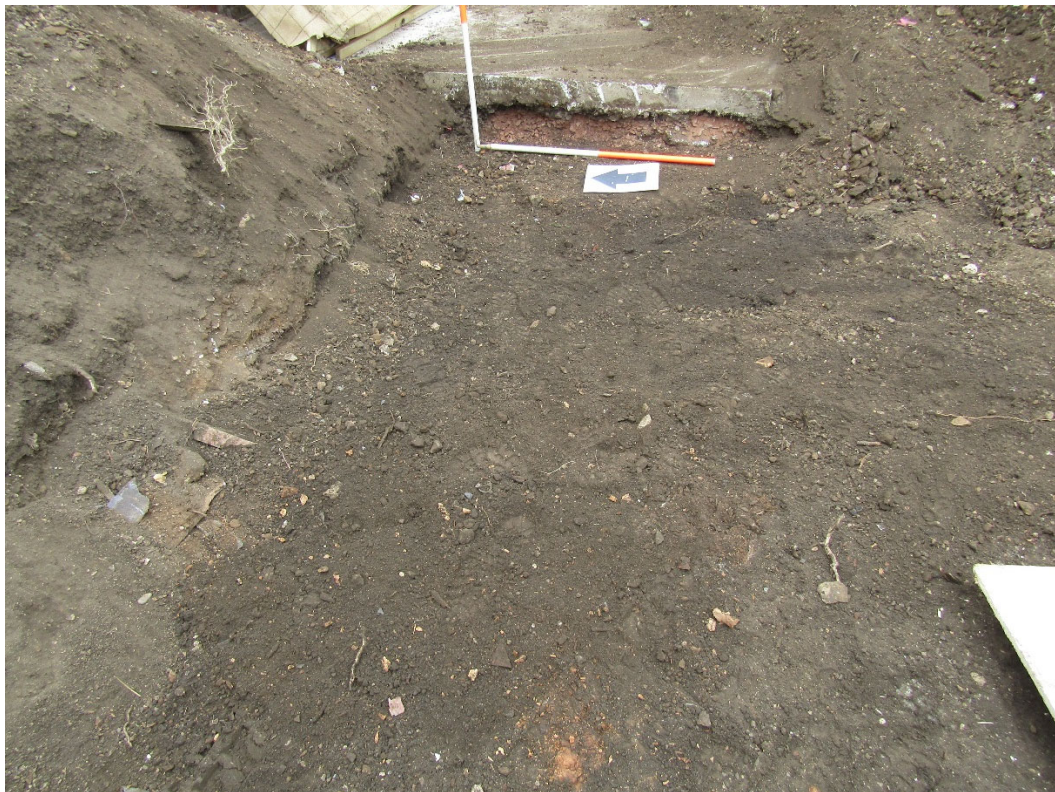
Figure 8: Part of the north eastern corner post excavation looking east. Photograph shows the existing concrete shed base and its hard-core footing which will be removed to the same depth as the rest of the area. Scale 1.0m.

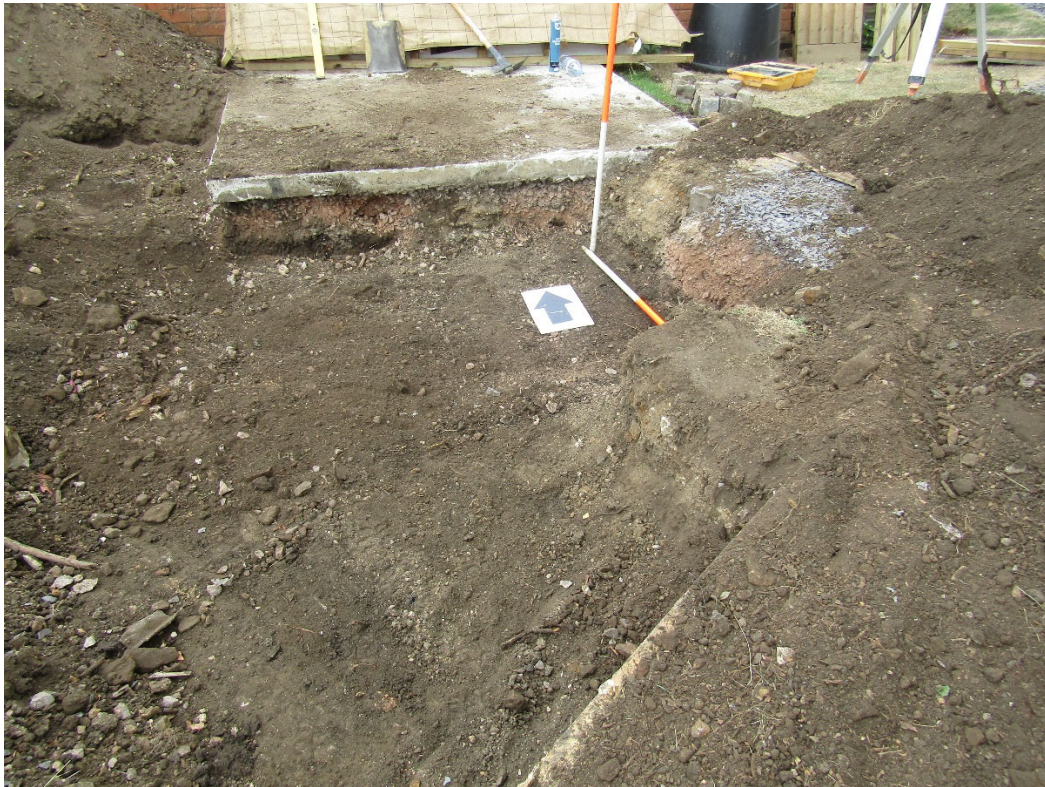
Figure 9: Remaining part of the north eastern corner post excavation looking north. Photograph shows the existing concrete shed base and its hard-core footing which will be removed to the same depth as the rest of the area. Scale 1.0m

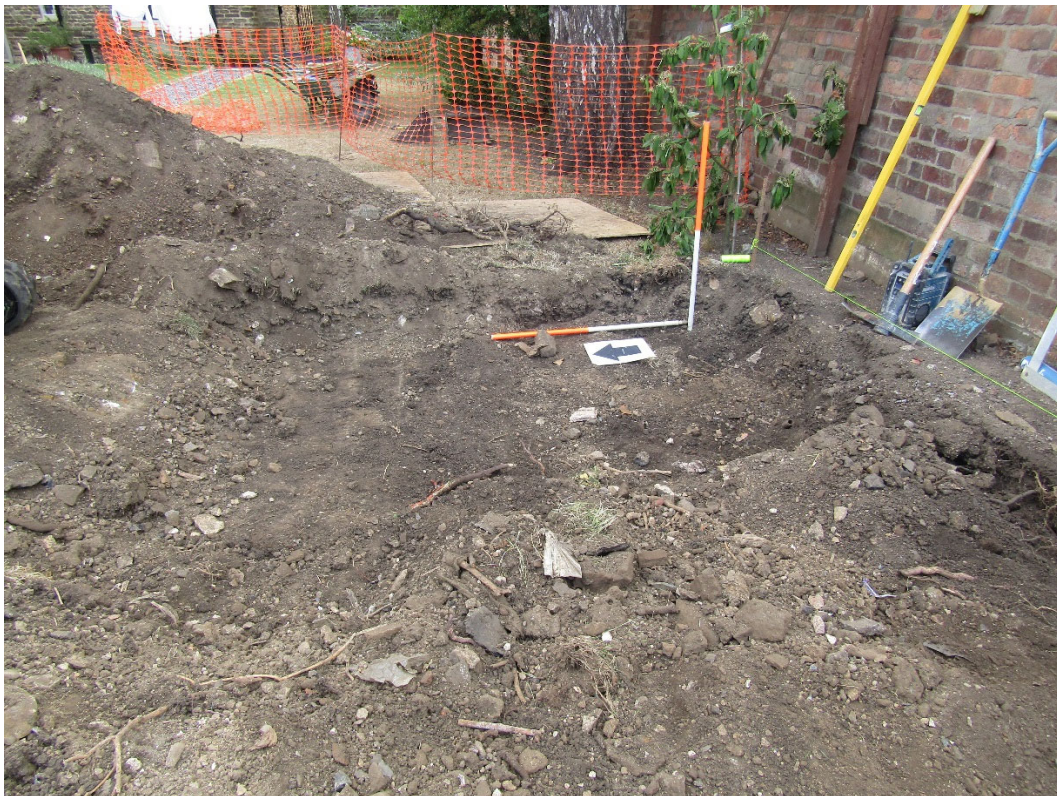
Figure 10: South eastern corner post excavation looking east. Scale 1.0m
