**An Archaeological Evaluation of Land at Church Farm, Seaton, Rutland
(NGR SP 903 981)**

Jennifer Hayward

An Archaeological Evaluation of Land at Church Farm, Seaton, Rutland (NGR SK 903 981)

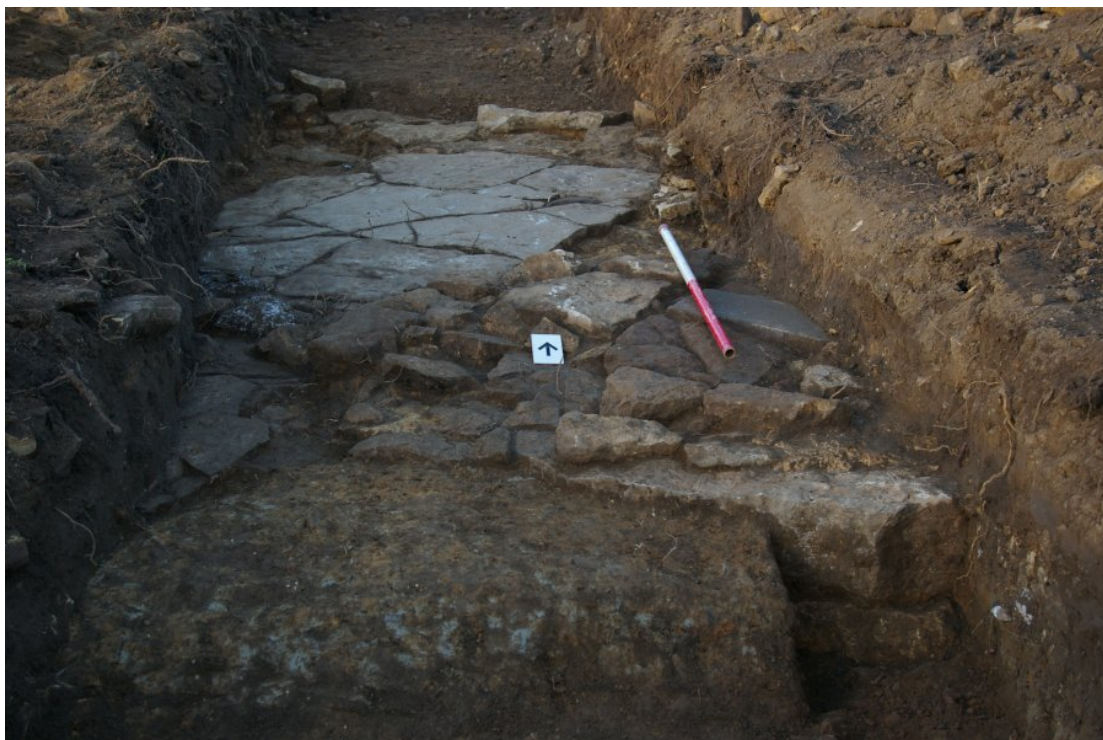
These walls appear to be of dry-stone construction, having little evidence of mortar bonding; however, a small quantity of yellow, sandy, mortar-like material was noted in the core of the far south-eastern wall. A double-walled dry stone wall is constructed with two faces of stones, usually with a core filled with smaller stones; however it was also common to use sand or earth in the core or “hearting” of double-walled dry stone walls, when they were used for domestic structures, in order to reduce draughts (http://en.wikipedia.org/wiki/Dry-stone_wall#Dry_stone_buildings; DSWA 2004: 112).

Figure 5 – View of building remains, showing small hand-excavated slot to the south-east that revealed a second course of iron-stone foundations

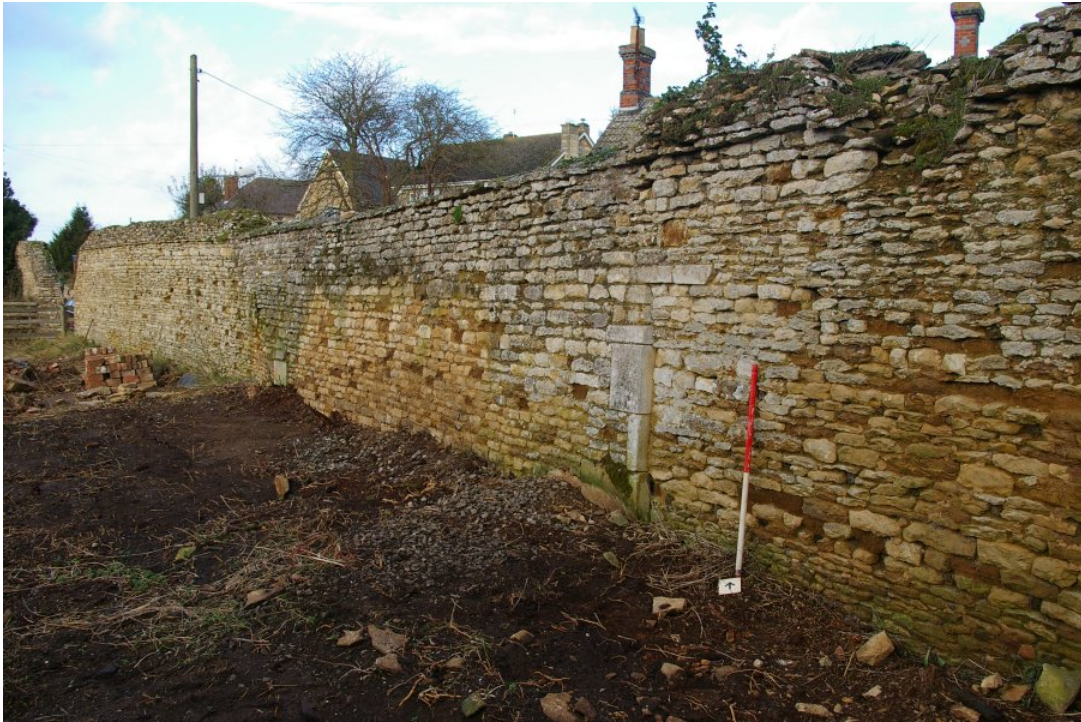
No evidence for earlier buildings on the site had been noted during the desk-based assessment or the building survey. However, a rapid survey of the high wall surrounding the farm found evidence of stoned-up doorways, as well as some interesting areas of stonework, including evidence for well constructed buildings with granite quoins (see figures 6, 7 and 8). The walls are bonded with a yellow sand mortar very similar to that associated with the building foundations in trench 6. These buildings clearly pre-date the construction of the current iron-stone buildings at Church Farm.

Figure 6 – Evidence for earlier building within surrounding wall of Church Farm, looking north from within grounds of Church Farm.

The earlier buildings evidenced in the boundary wall show that the terracing of Church Farm occurred after their demolition. A row of granite stones was visible at the base of the wall on the churchyard side, shown in figure 7 (partially obscured by plants), indicating that this would have been the outer face of the wall. On the western side of the wall (Church Farm side) the ground level has been cut away to form the southern terrace on which a U-shaped range of iron-stone barns is constructed. This

indicates that the buildings evident within the wall went out of use prior to the construction of these barns.

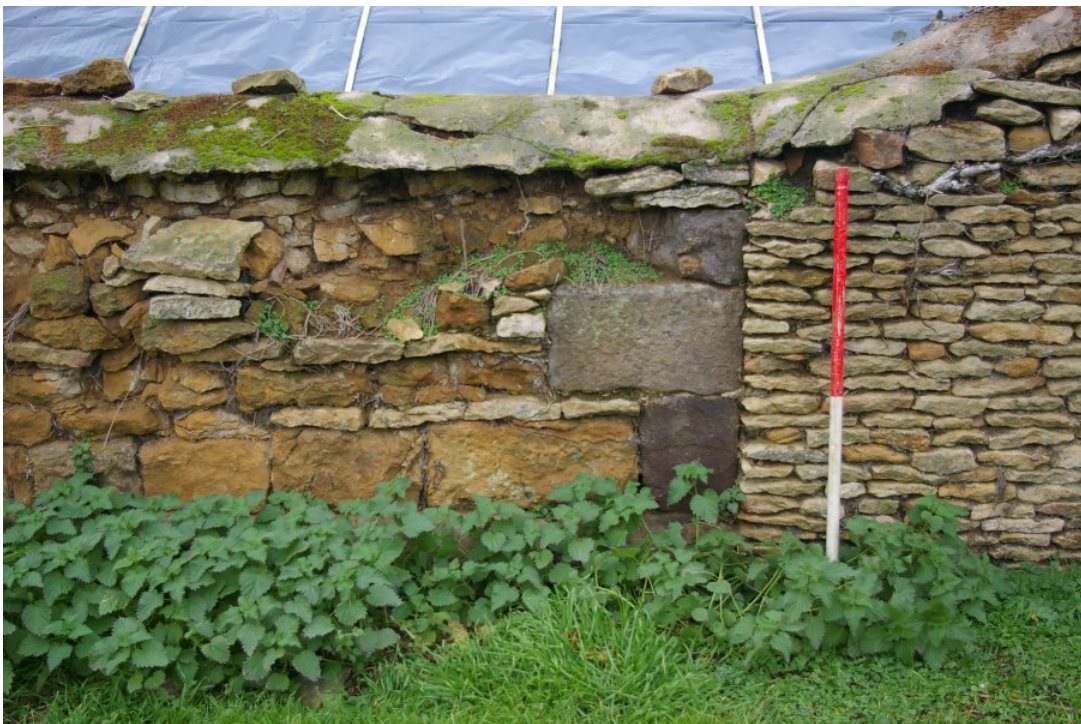
Figure 7 – Evidence for earlier building within surrounding wall of Church Farm, taken looking east from within the churchyard.

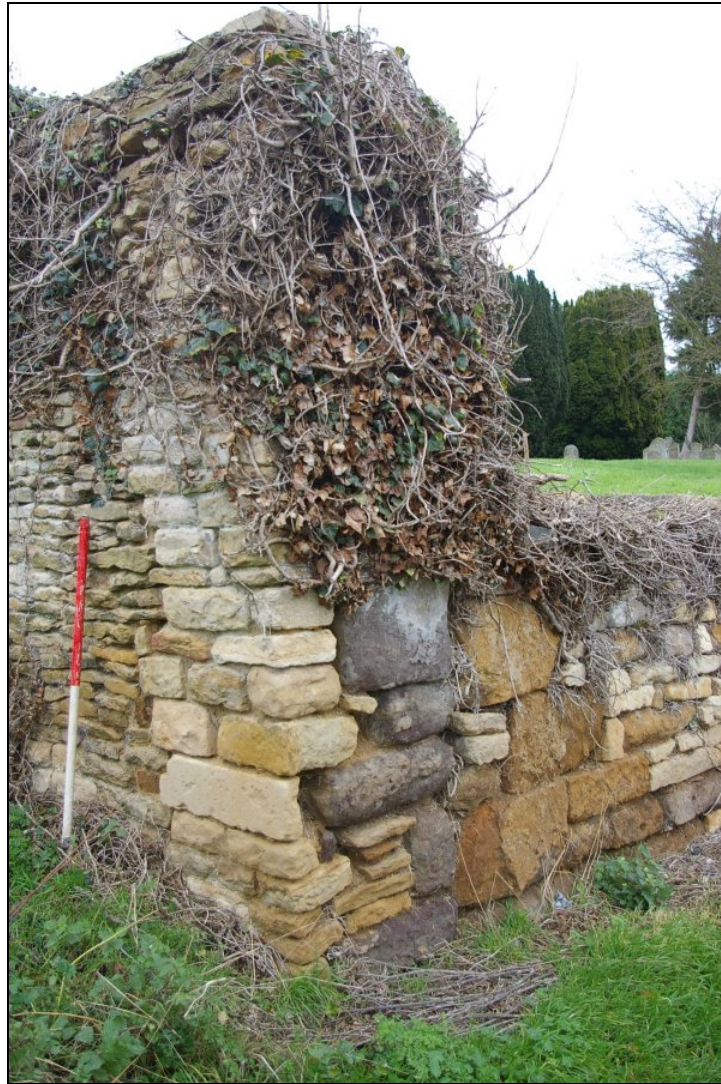
Figure 8 – Evidence for earlier building within boundary wall of Church Farm and All Hallows Church, looking north-east from Church Lane
