**An Archaeological Evaluation at  
Leicester Abbey:  
Third Season, Summer 2002**

**University of Leicester**

**Archaeological Services**

*ULAS Report Number 2004-065*

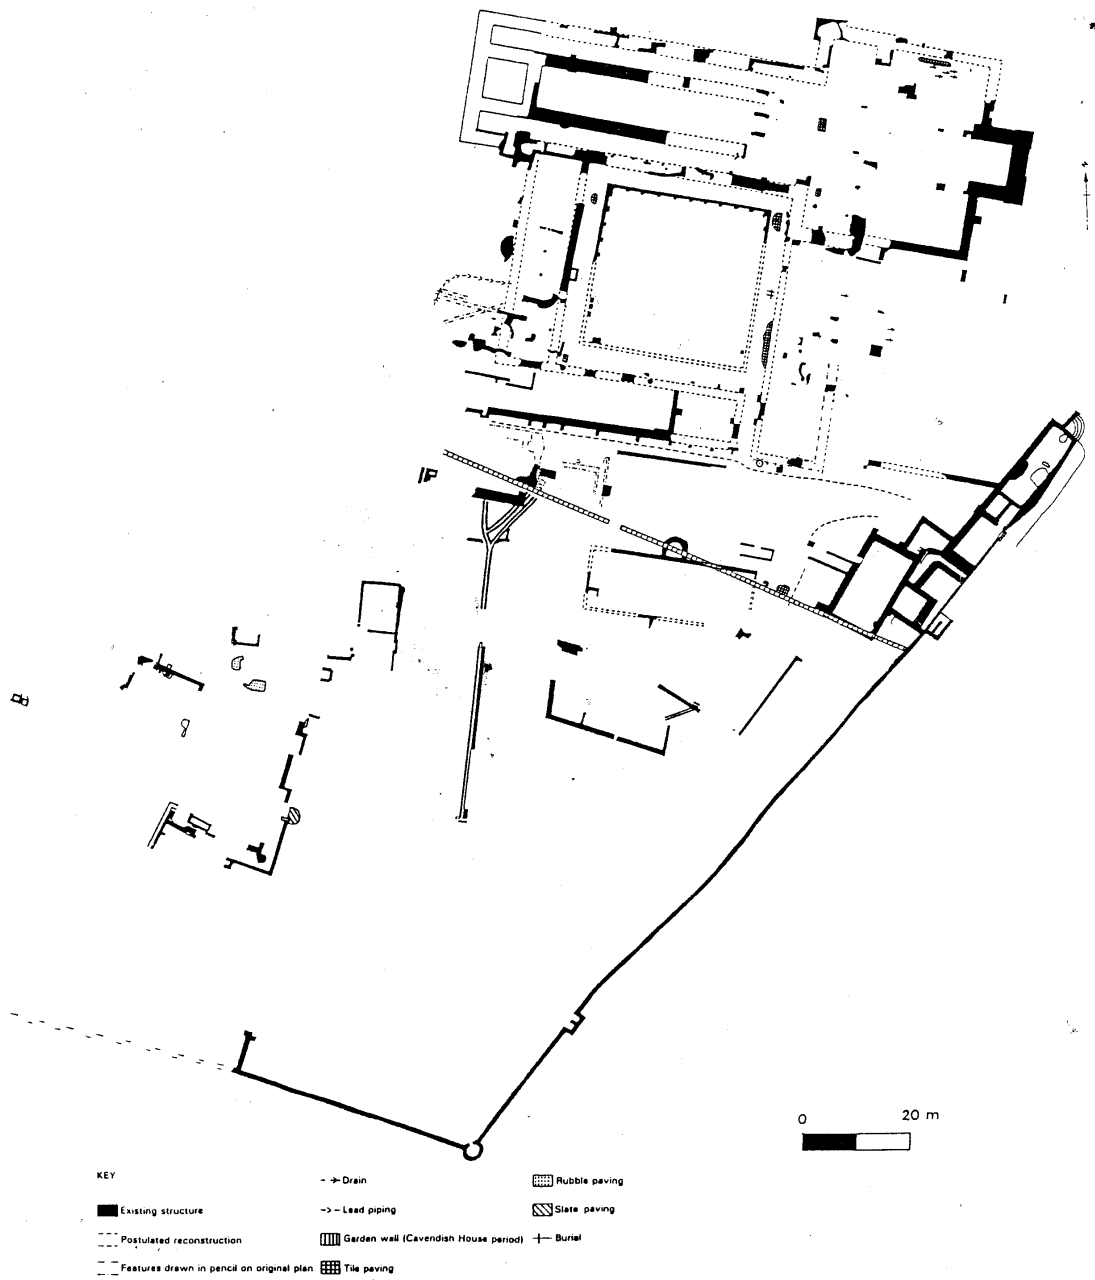
Figure 4

15. Composite plan of the results of Bedingfield's excavations (Leics. Museums).

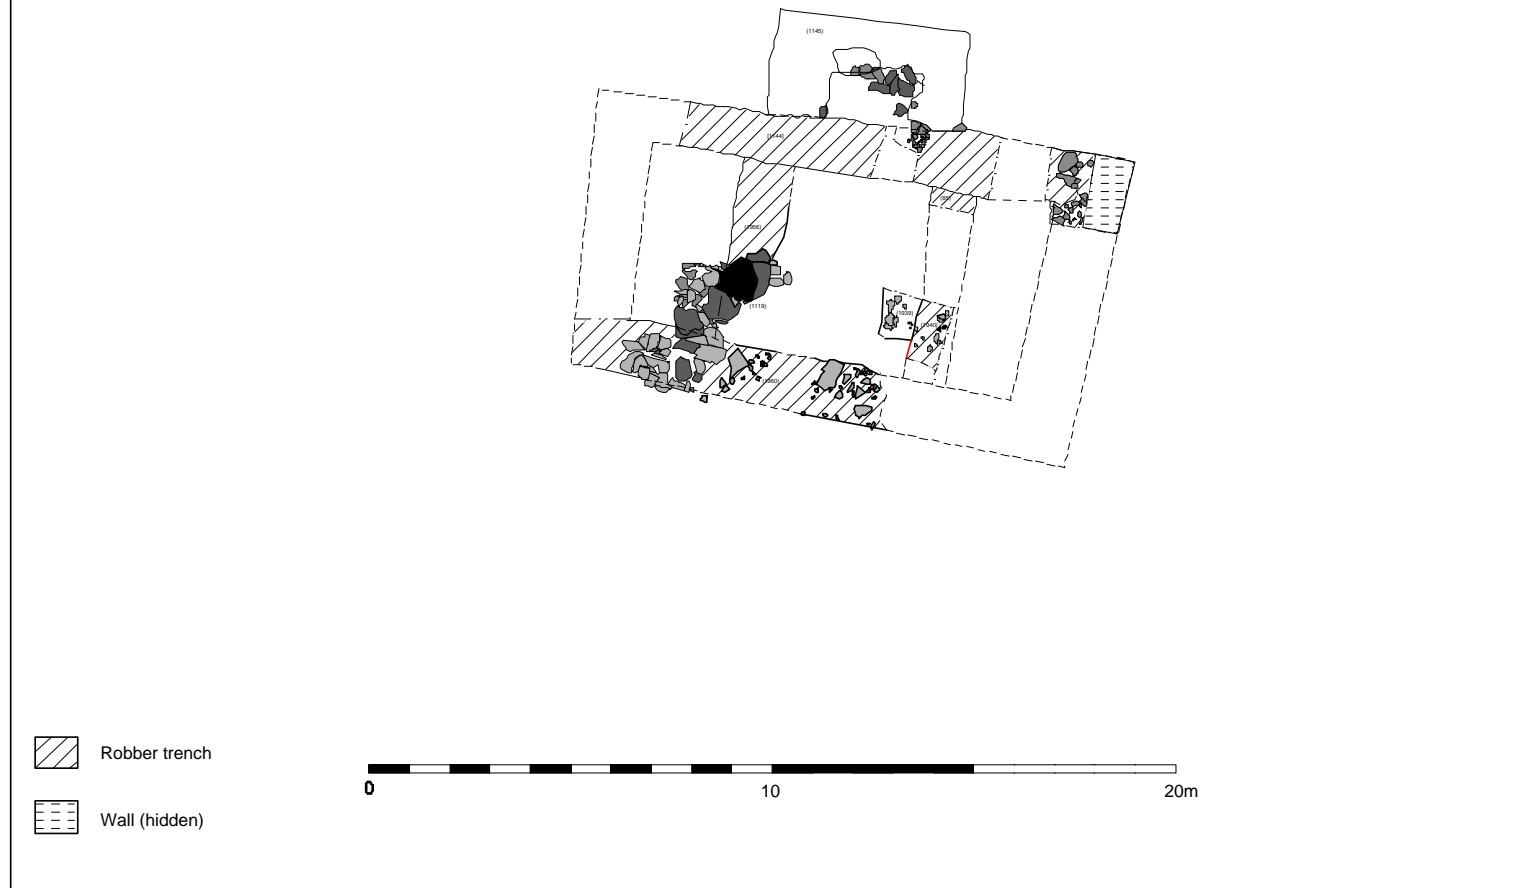
Fig. 10: Phase 1 gatehouse: preliminary interpretation of plan

#### 4.1 Trench 19 (Figures 9, 10. Plates 1-3)

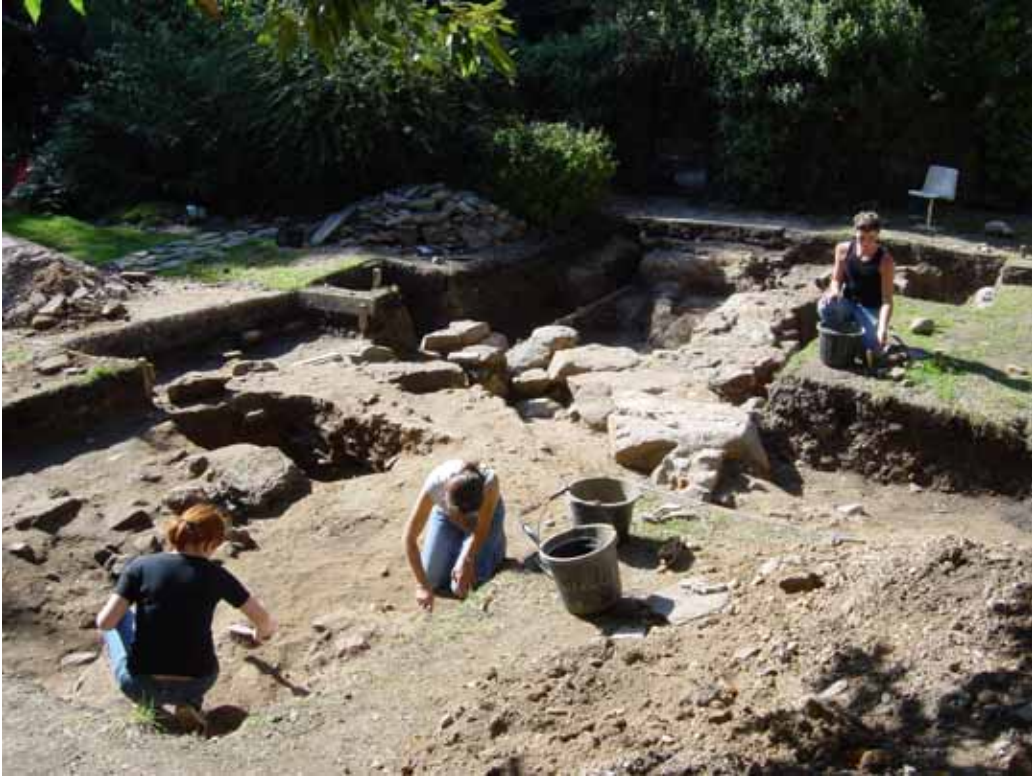
**Plate 1** : Students excavating remains of the medieval gatehouse in Trench 19  
(Looking south west)

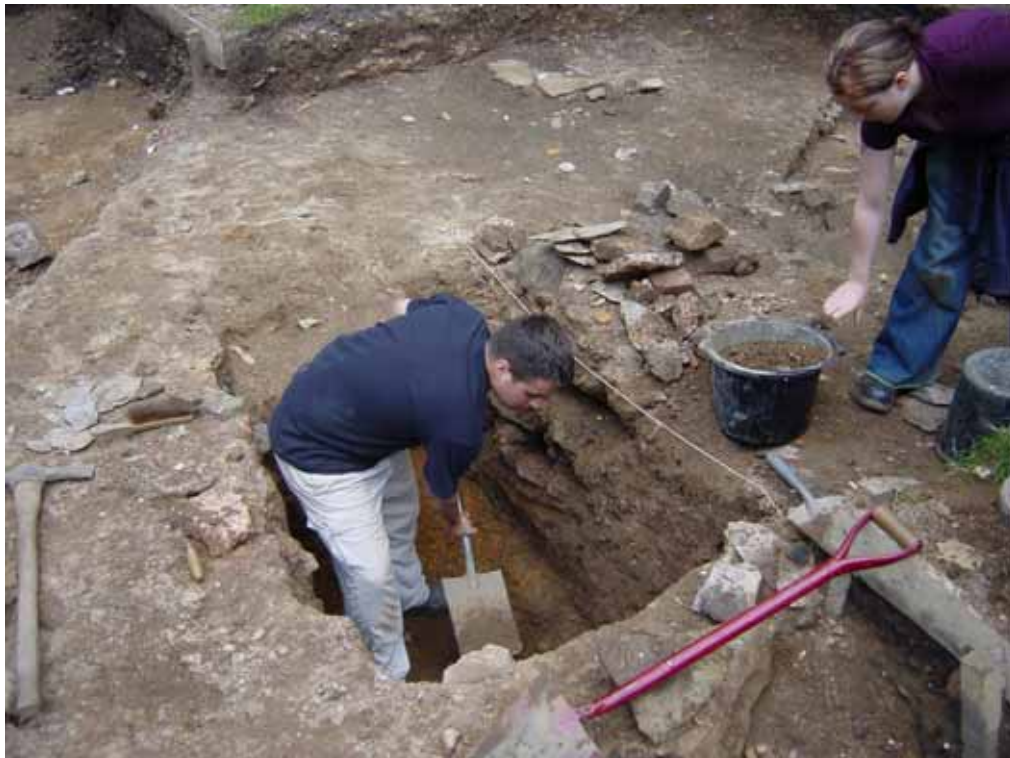
**Plate 2** : Students excavating a slot through robber trench [1961] in the medieval gatehouse.

The extensive robbing of wall (1992) and robber trench [1961] suggest that it belongs to an earlier phase than (1119), and is possibly the south wall of the original gatehouse, probably removed in the later medieval period when the gatehouse was extended to the south and furnished with polygonal corner towers. The objection to this interpretation is that a fragment of wall footings (1992) survives at the crossing point with (1119), whereas one might expect it to have been destroyed when (1119) was constructed. Possible explanations for this are as follows:

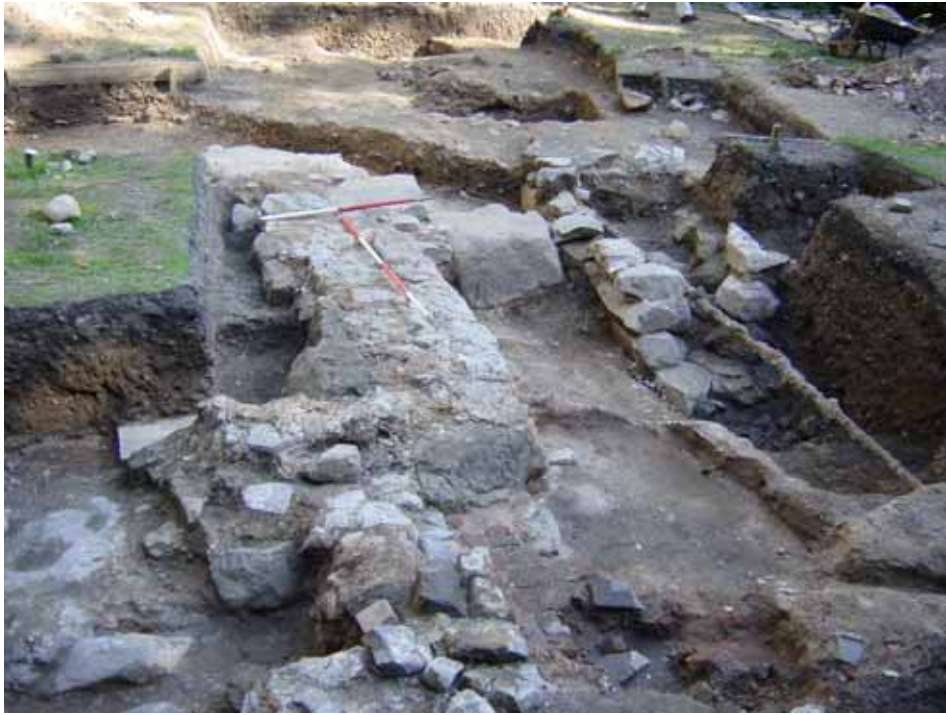
**Plate 3** : Remains of the medieval gatehouse looking east. In the foreground the brick and stonework relates to walls from the post civil war phase and later farm buildings.

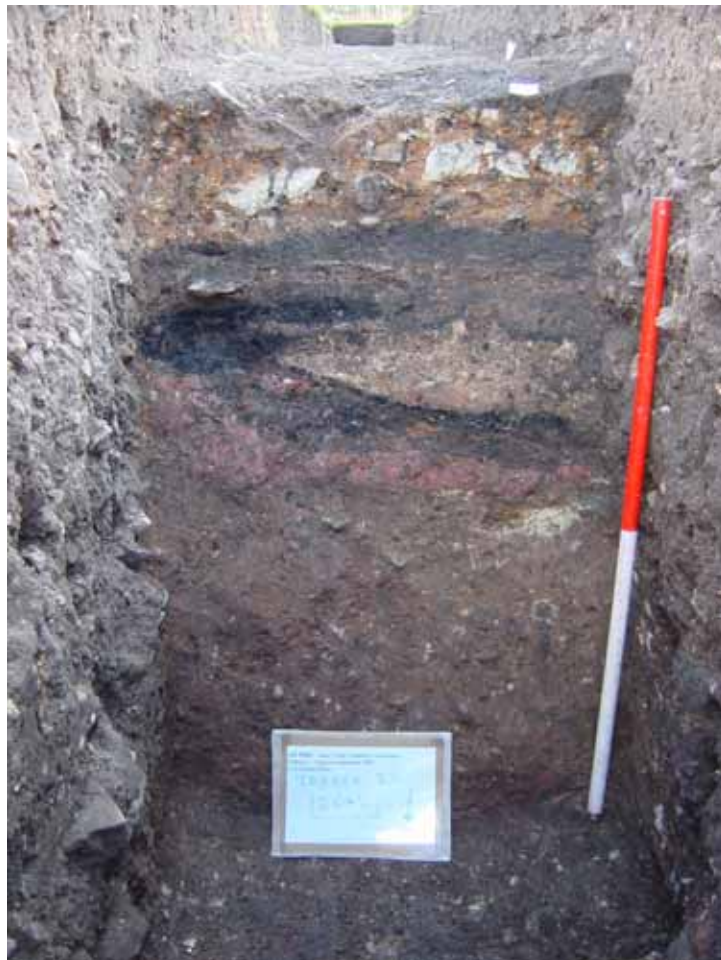
**Plate 4** : Section showing depth of surviving archaeological stratification in the kitchen area, including demolition and former floor layers.

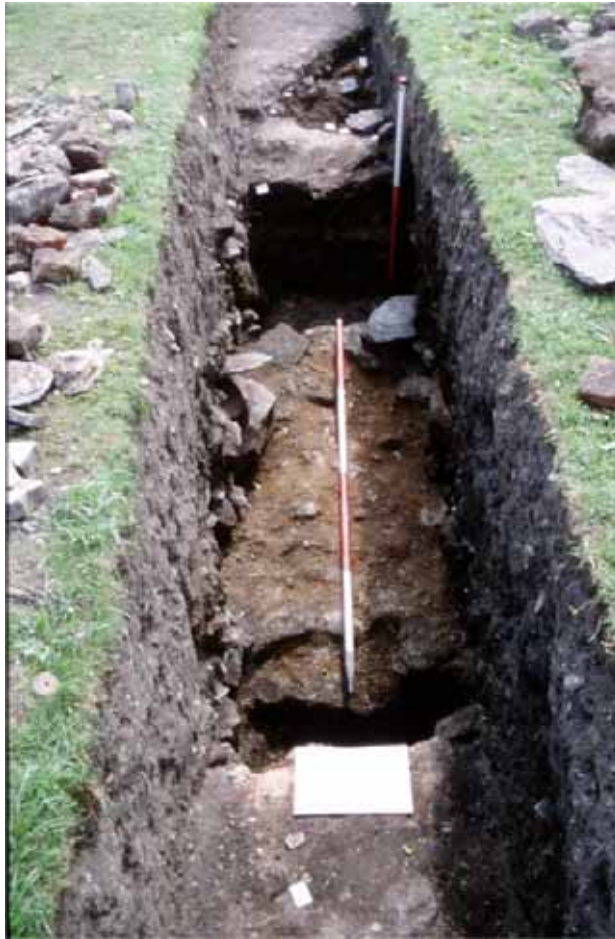
**Plate 5 :** Exposed section of the north wall of the kitchen (2043), previously revealed by Bedingfield in the 1930s, but not included in the reconstruction.

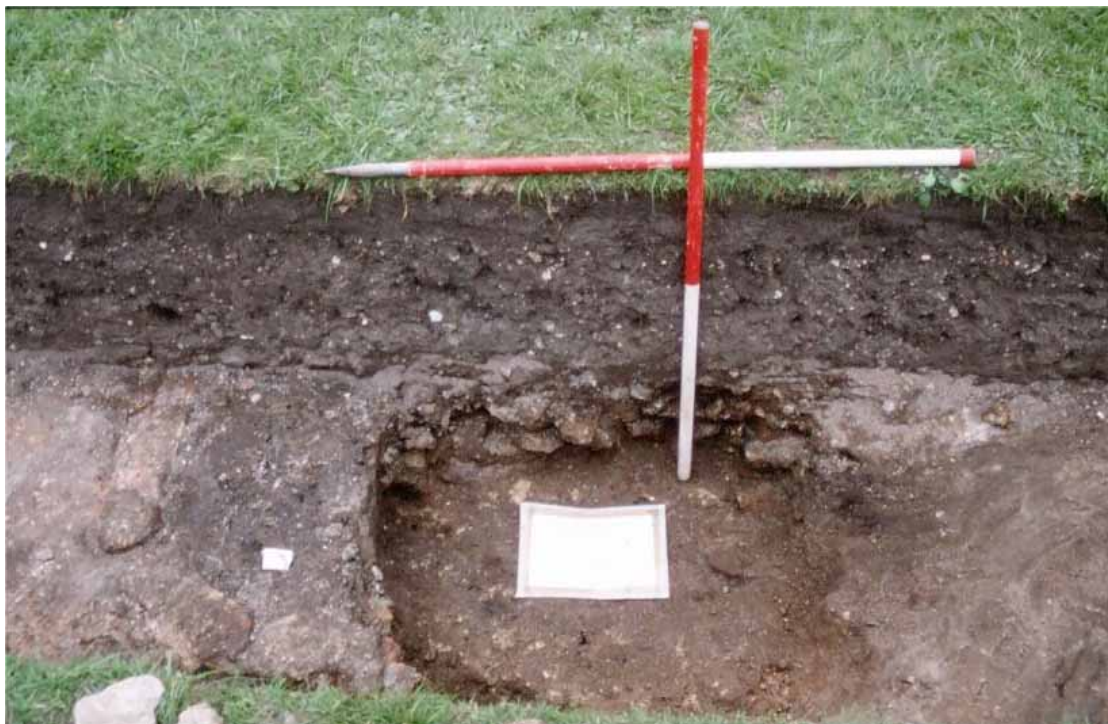
**Plate 6 :** Remains of an oven (2028), exposed in the kitchen area.

The knobbed stem of a goblet, in the form of an inverted baluster, and dating from the mid 16th or the 17th centuries, was recovered from the backfill of the oven, context (2009), together with the Midland Yellow ware pottery vessel noted above. Willmott comments, 'The majority of high quality 16th century drinking vessels found on monastic sites can be attributed to occupation on the site after the dissolution', (Willmott 2002, 21, plate 7, fig.156.10.2). A Victorian glass bead occurred in context (1941).
