**Archaeological attendance and
recording during groundworks at
St. Thomas More RC Church,
Glenwood Avenue,
Wollaton, Nottingham
(SK 52030 39472)**

ULAS Report No 2018-184
©2018

Planning application No. 16/02298/PFUL3

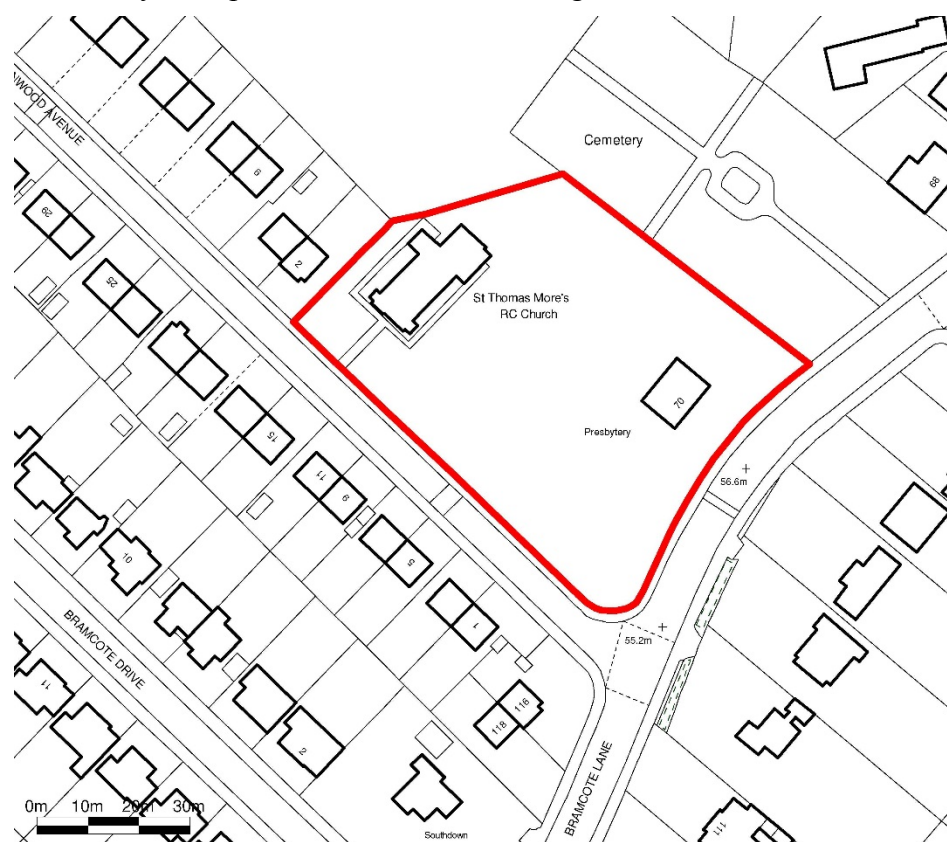
Figure 2: Location of proposed development area. Plan provided by developer

The town of Wollaton lies around 4 miles west of the City of Nottingham (Fig. 1). St. Thomas More Roman Catholic Church lies on the north-eastern side of Glenwood Avenue, with the car park and grass lying adjacent to the south-east along the junction with Bramcote Lane (Fig. 2).

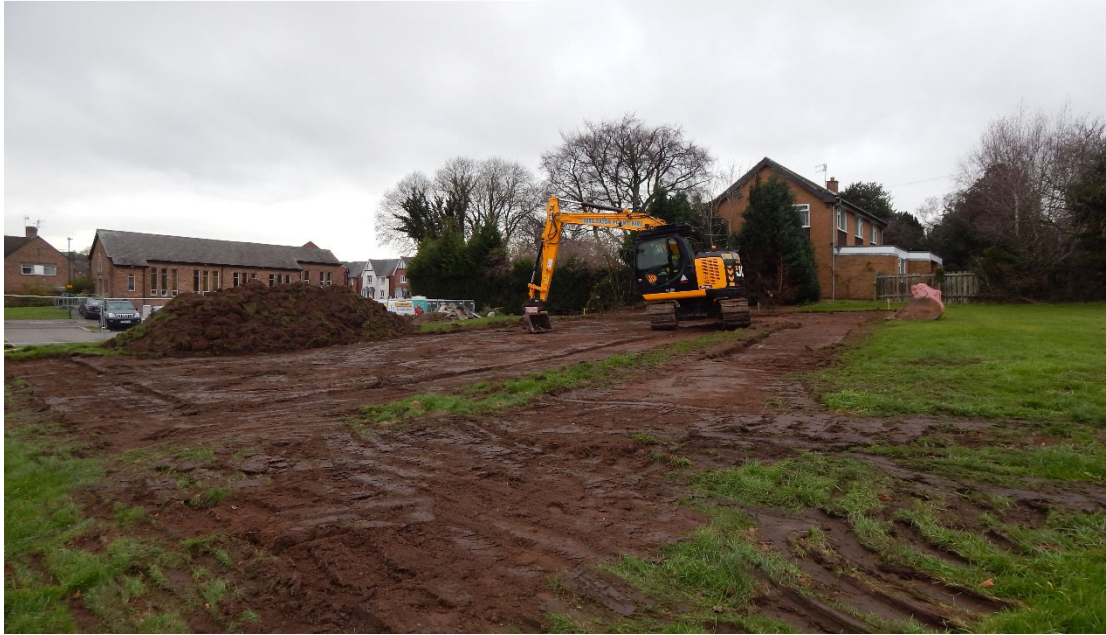
Figure 4: Work in progress, looking north

The work was carried out by a large tracked excavator fitted with a flat bladed ditching bucket. The spoil was removed using a front-tip dumper (Fig. 4).

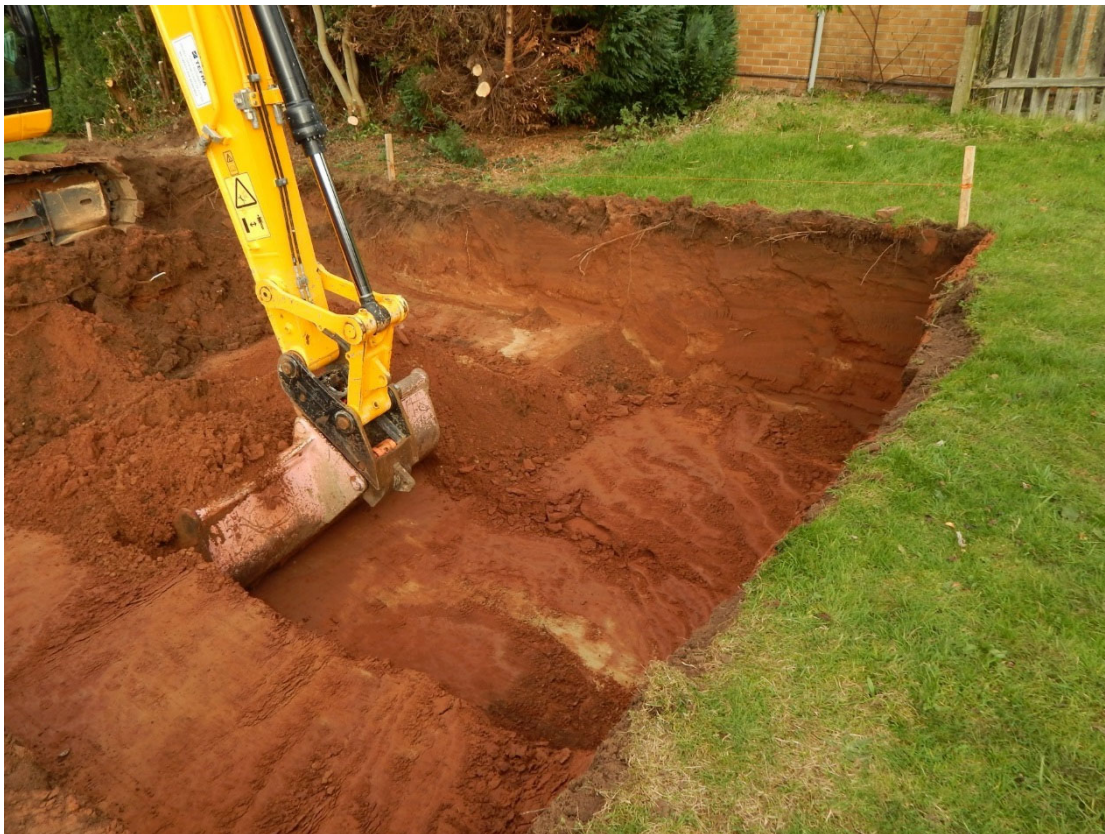
Figure 6: Work in progress on full depth dig, north-east corner

The area was then stripped to the finished reduced level starting in the eastern corner of the site and moving slowly to the north-west and then south-west (Fig. 6). Across most of the site the sequence consisted of 0.20m of topsoil over 0.10m of subsoil down to the aforementioned sand and sandstone. With the land falling substantially from south-east to north-west the depth of the dig in the north-west corner was around 1.4m deep down to around 0.70m at the western end. No features were seen within the excavated areas.

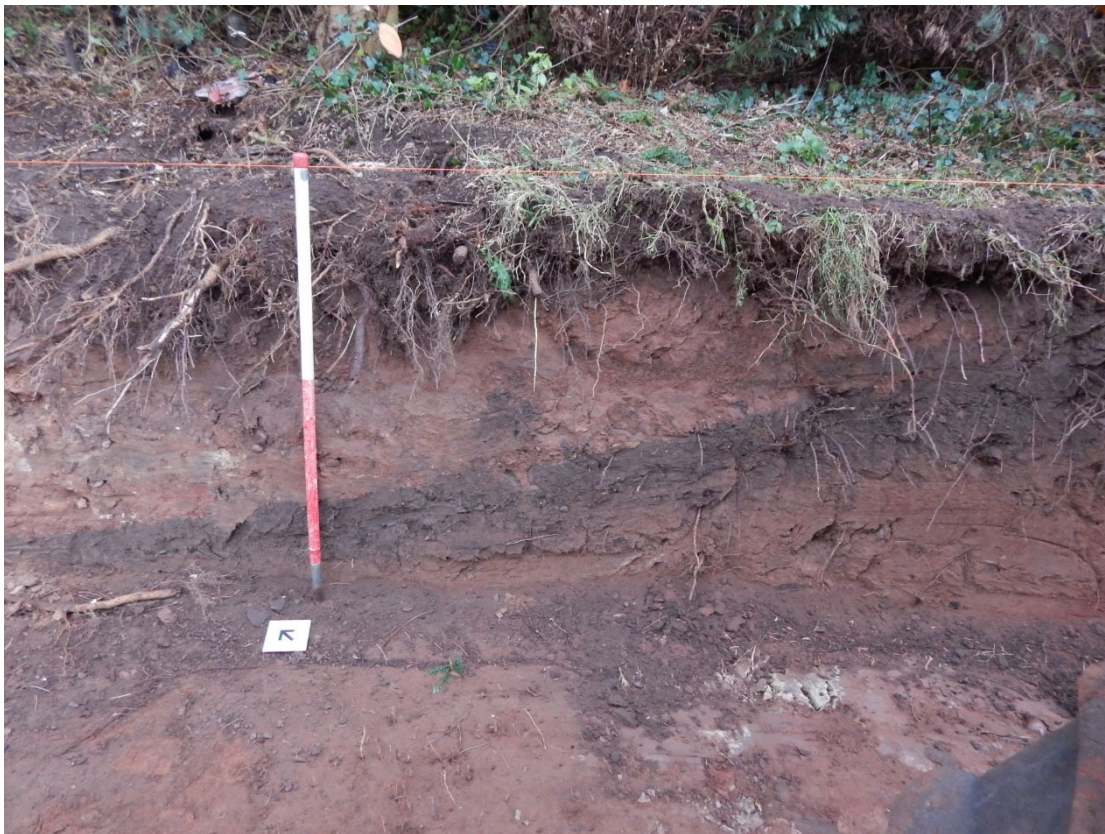
Figure 8: Tip line visible in south-west facing section of excavation

Along the north-eastern edge of the site the full section across the site could be seen. At the western end this consisted of 0.70m of mixed made-up ground and topsoil down to the base. Around 10m from the eastern end of the section a tip line could be identified showing that the deep topsoil was mainly infill of a steep hollow here, possibly associated with the construction of the nearby presbytery and the garden to the rear, of which this section formed the southern extent. Under the mixed topsoil lay a buried topsoil layer over red sandstone (Fig. 8).

At the north-eastern end of the site where the area met the adjacent land of the presbytery, the section created here revealed redeposited mixed topsoil and made-up ground lying over an earlier topsoil layer, most likely representing disturbance of the natural land surface from when the presbytery building was constructed and the adjacent gardens landscaped.

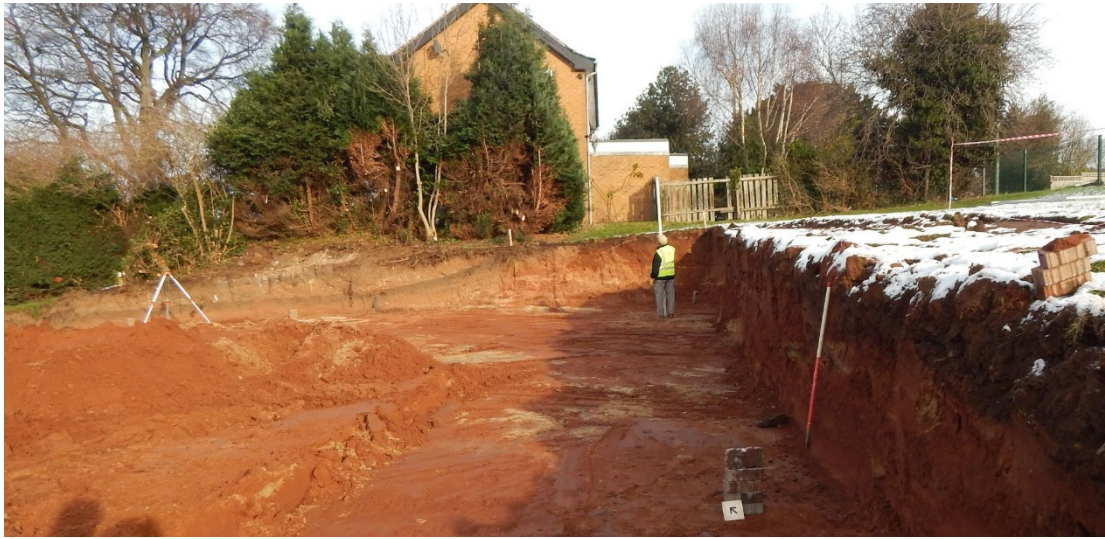
Figure 9: Excavations almost complete, looking north-east

By the visit of 12th December the area was almost completely stripped down to the required formation level. No further inspections were made. No archaeological features or artefacts associated with archaeological features were discovered during the archaeological attendance.
