**An Archaeological Impact Assessment
of
The City Rooms,
Hotel Street,
Leicester
SK 585 043**

Planning Application 2003/0917

**University of Leicester
Archaeological Services**

Report No. 2004/202 ©TRP/ULAS 2004

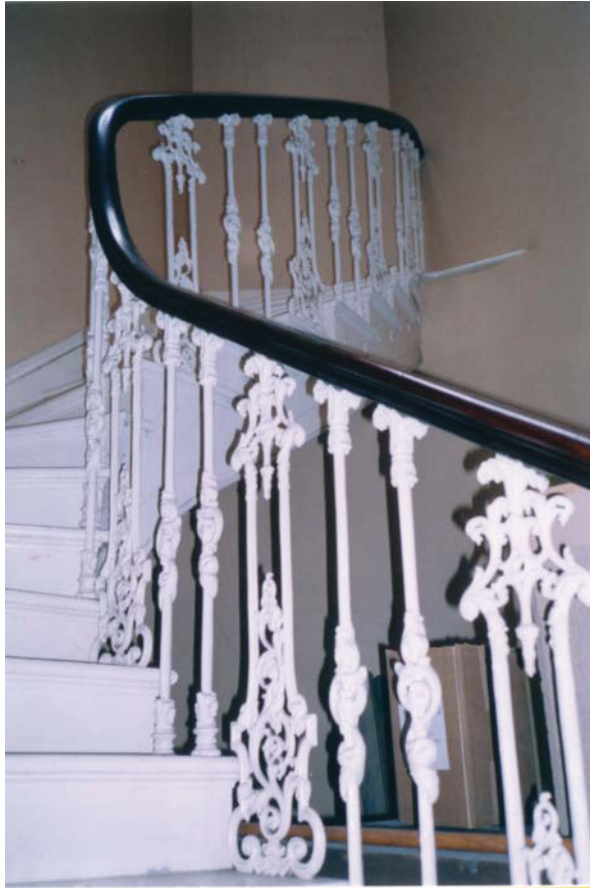
After Johnson's death in 1814 the Leicester based architect, Joshua Harrison is believed to have been responsible for a series of extensions to the original building, c.1817-18, particularly the Market Place extension which is joined to the main building by a single storey link notable for its Tuscan columns *in antis*. The 1st edition of the 25inch Ordnance Survey map of Leicester, (1888)² shows the two extensions onto Market Place South and Horsefair Street, though by that date the Horsefair Street extension had become the County Police Office. Internally residual evidence of the link between the original Assembly Rooms and the Horsefair Street extension is most aptly expressed by a fine, free-standing, staircase with cast-iron balusters which sweeps upwards from a lobby area on the south-east side of the building coming to an abrupt halt against a solid wall, (*see Plate 1*).

Plate 1 Cast iron balustrade with moulded handrail rising from Ground floor lobby area to blocked doorway at First Floor Level

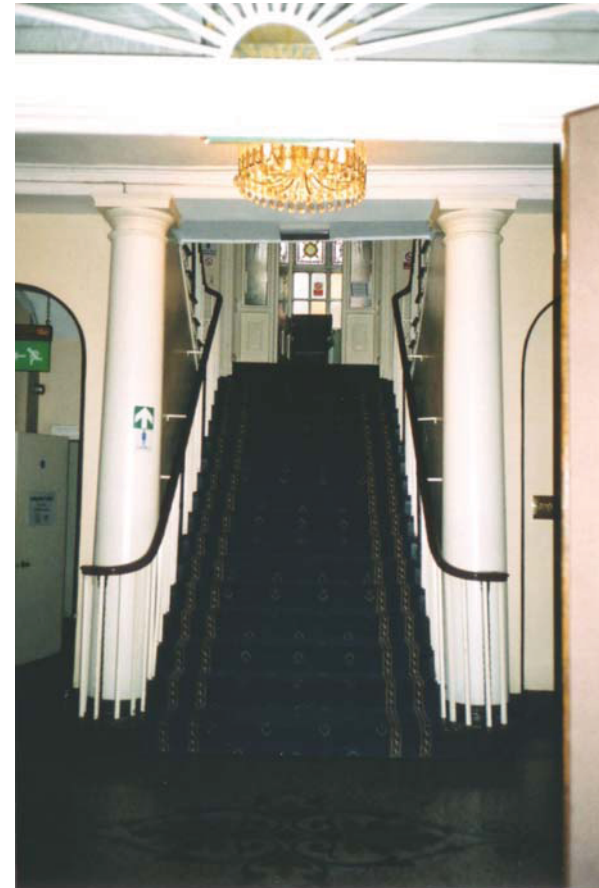
Plate 2 Main staircase rising from Entrance Hall to mezzanine level where an office was installed in the late 19th century

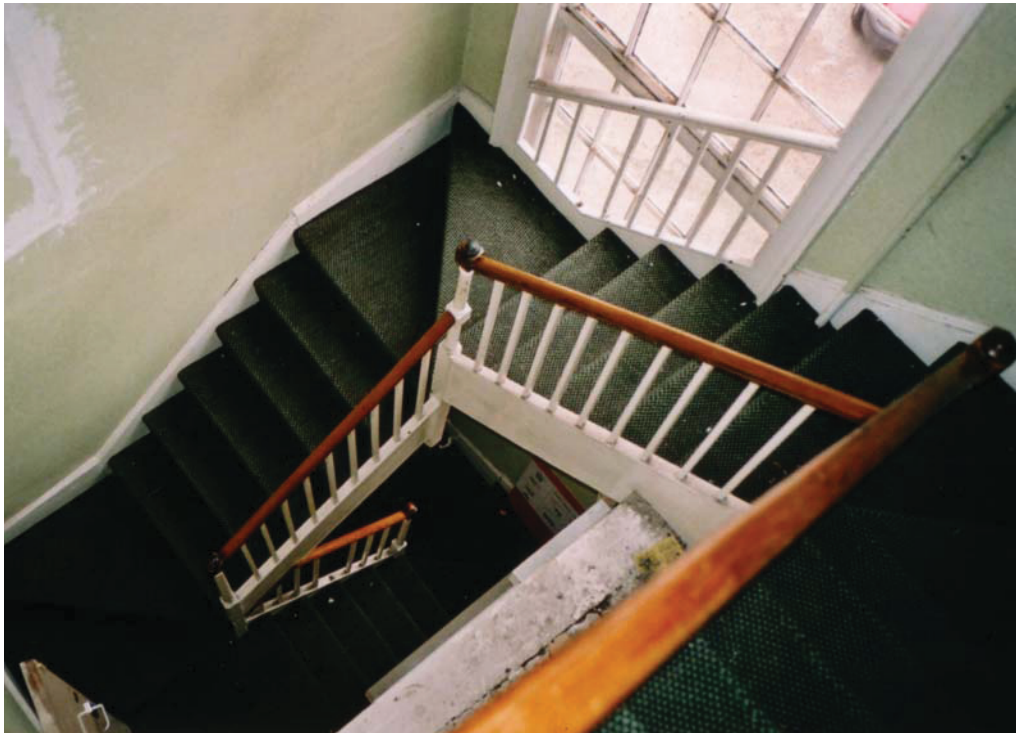
Plate 3 Service staircase rising from ground to second floor, showing stick balusters with block and turned newel posts, and part of the large sash window that lights this flight of stairs.

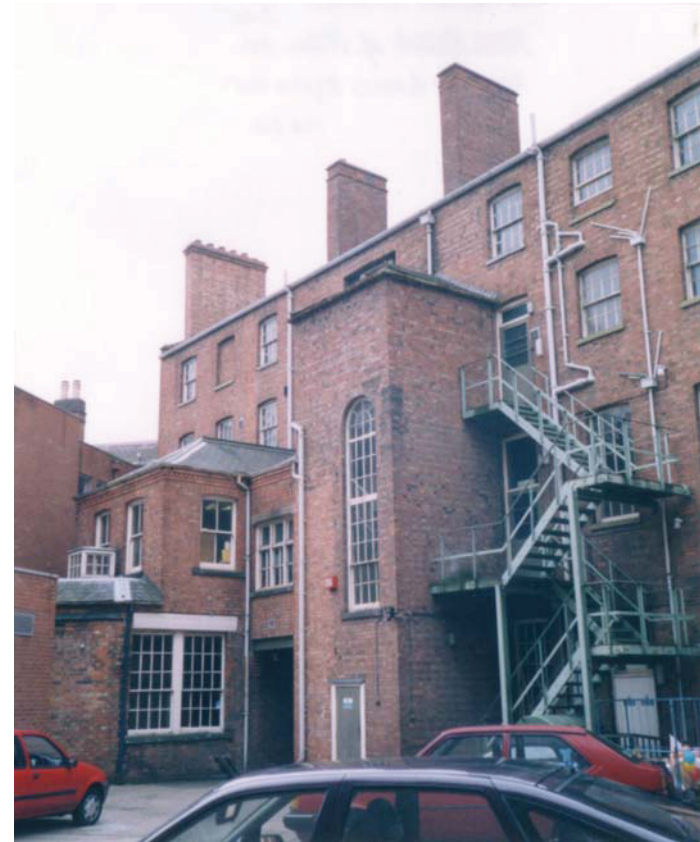
All other interiors are believed to have been executed by *Joshua Harrison* in 1817-18, when the Leicestershire Magistrates Office first acquired the property. While the small office suite with stained-glass panels situated at a mezzanine level, forming a landing at the top of the initial flight stairs of the main staircase, (*see Plate 2*), is part of a later series of 19th- or very early 20th-century works introduced when Leicestershire County Council owned the property. A ‘service’ staircase, with a block and turned newel, simple moulded handrail and stick balusters, rises through the building from ground to second floor level at the rear, i.e., south-east elevation, (*see Plate 3*). This stair, which is set in its own, separate tower, is lit by the three part sash-window with semi-circular head seen at the rear of the property. The rear elevation also shows an array of sash windows that largely represent the ‘service’ elevation of the original Hotel proposal, (*see Plate 4*), and the later additional block now forming the Kitchens and mezzanine Office

Plate 4 Rear view of the City Rooms showing the brick outshoot for the service staircase with deep sash window and later brick outshoot additions for the kitchen block and mezzanine office. Also shows the array of sash windows on this elevation.

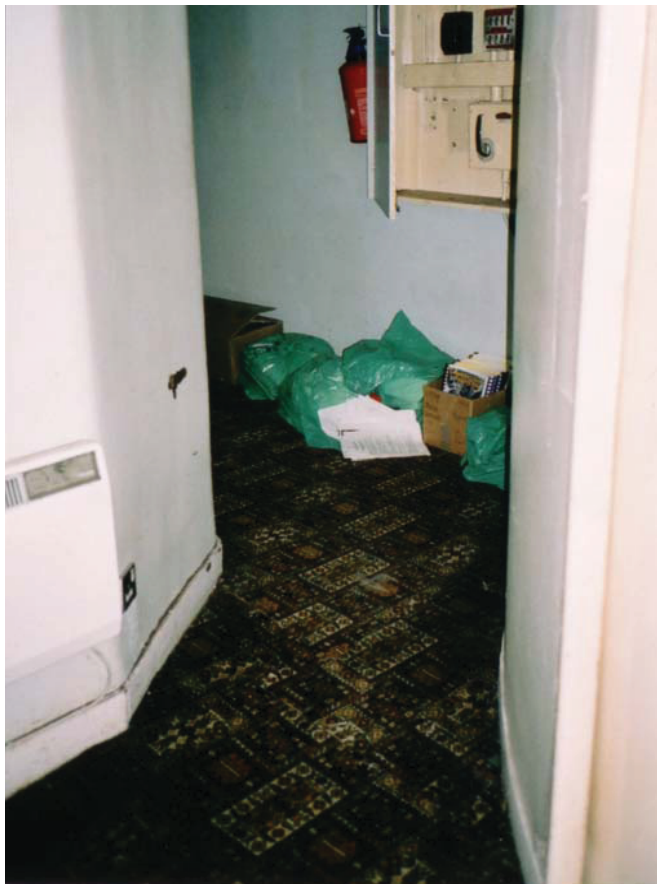
Access to the second floor level is solely by means of the rear, ‘service’ stairs that rise from the Ground Floor to a narrow landing at second floor level, the reduced amount of space available at this point being governed by the rear of the semi-circular, orchestra balcony and its access door, (see Plate 5). The rooms on this level all face east and are serviced by a corridor running the full length of the building that has the inner wall of the ballroom along its north-west side.

Plate 5 Second floor corridor at point where the Fire Door is to be installed. The curved section on the extreme right is the partitioning of the orchestra balcony.

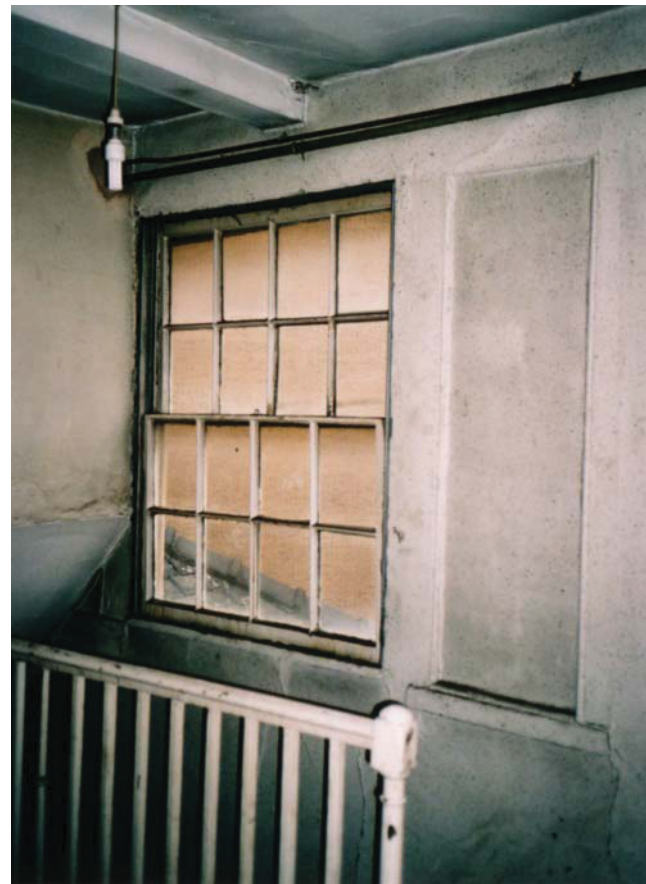
sash window which was originally part of a tripartite arrangement. The narrow side of one part of the window, now blocked, can be seen by the head of the stairs, (*see Plate 6*), the other blocked section is now concealed by a store cupboard containing a hot water cylinder. The rooms at this level all face east and are serviced by a corridor running the full length of the building, on the west side of the corridor there is continuous run of partitioning concealing much of the coving structure of the ballroom ceiling.

Plate 6 Detail of two parts of the tripartite window set at the head of the staircase rising from second to third floor. The eight-over-eight sash window is the central feature and the section to the right originally had a narrower four-over-four fixed window, now blocked.

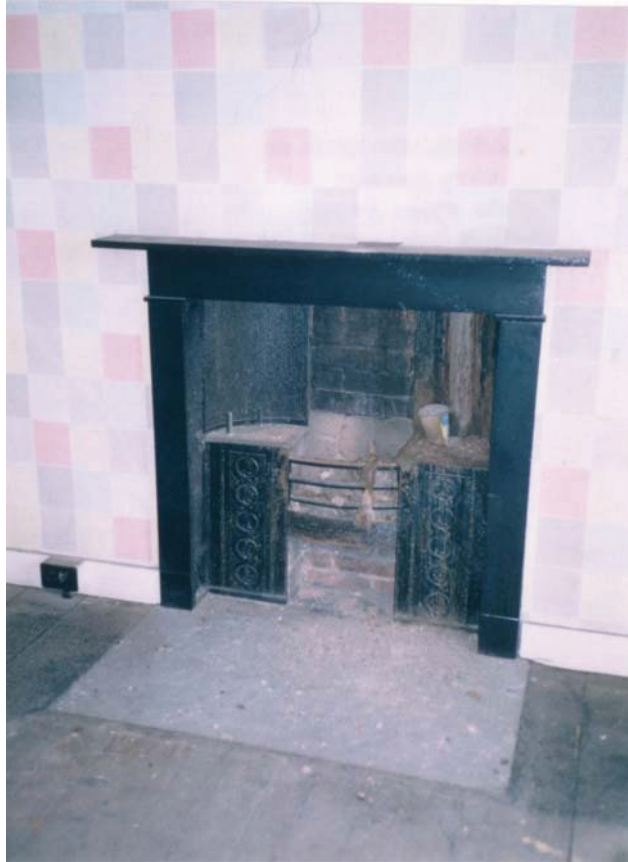
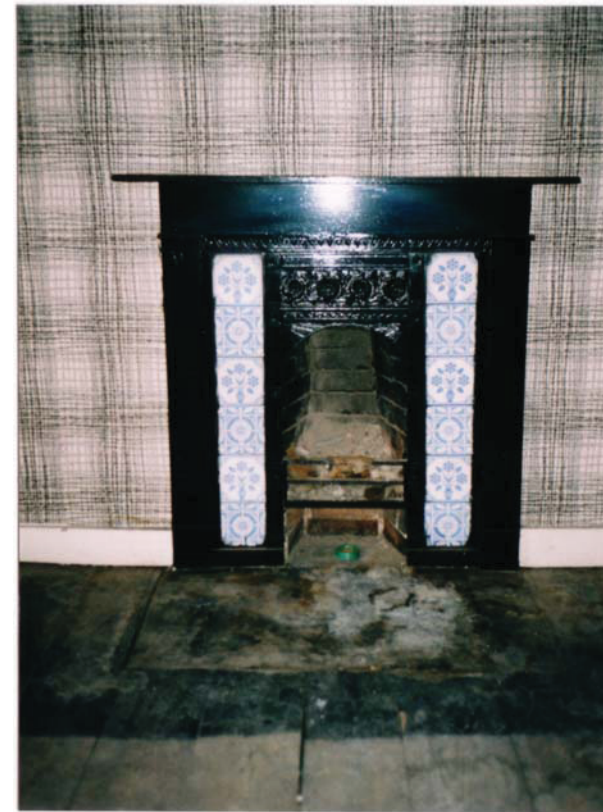
The rooms on the east side of the building contain a series of original cast-iron fireplaces with relief cast surrounds characteristic of the period 1840-1880, (*see Plates 7 and 8*). It would appear there were originally four rooms on each of the second and third floors, two rooms being located on either side of the central lobby area. On both floors plaster partitions had been installed between the two rooms in the north-east corner of the building and a bathroom installed. This feature was not repeated on the south-east corner on either floor. The variety of bathroom fixtures

Plate 7 and Plate 8. Two chamber fireplaces retained in the upper floor rooms, the earlier fireplaces with elevated grate and side panels (see left) is probably *c.* 1840, the other fireplace (right), with decorated draught control hood and transfer blue tiled surround is probably *c.* 1860/70
