**An Archaeological Evaluation at
Forge Field to the rear of 5 Market Place,
Billesdon, Leicestershire.
*NGR: SK 718 028***

Andrew Hyam
May 2005

*Planning Application Ref: 04/1486FUL
Client: Sandhurst Builders Ltd, on behalf of
Mr and Mrs G. Jeffery*

Report No. 2005-065 © 2005

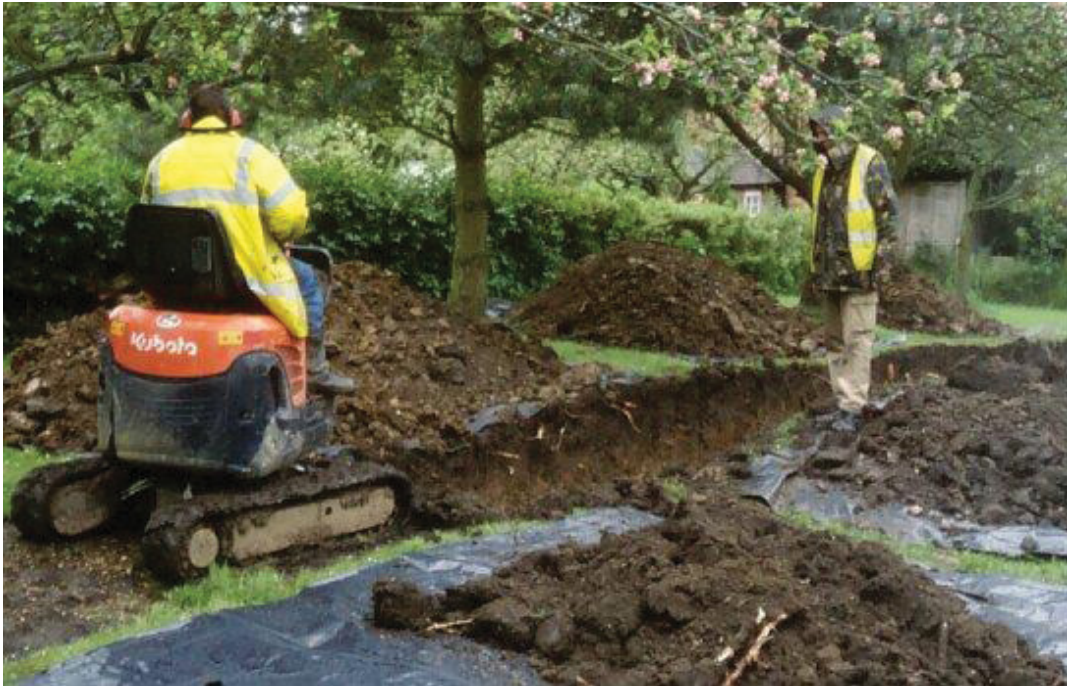
Plate 1 excavation of Trench 1. The earthwork can be seen rising and falling in the far section.

Very little evidence for the cause of the earthworks could be seen that would link it with any medieval activity. The interface between the subsoil and natural substrata dipped down slightly along with a corresponding rise in the thickness of the topsoil half way along the trench but no features could be seen cutting into the natural. The dip seen in the ground level (plate 1) was simply a thickening of the topsoil depth.

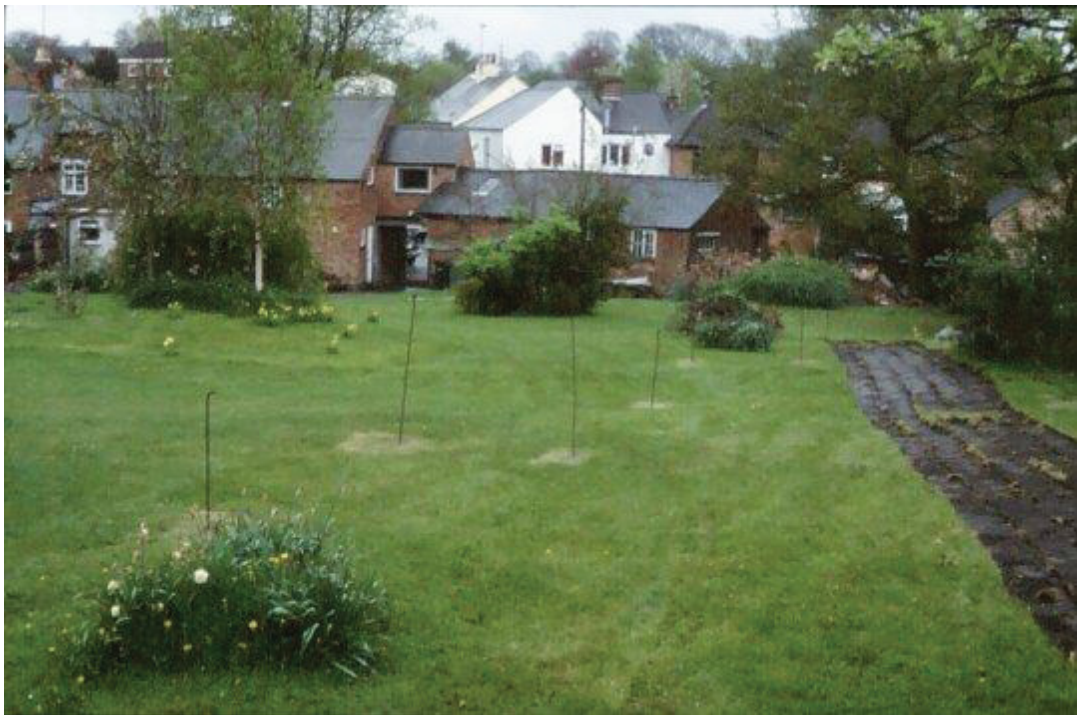
Plate 2. De-turfed area of Trench 2 looking south east.

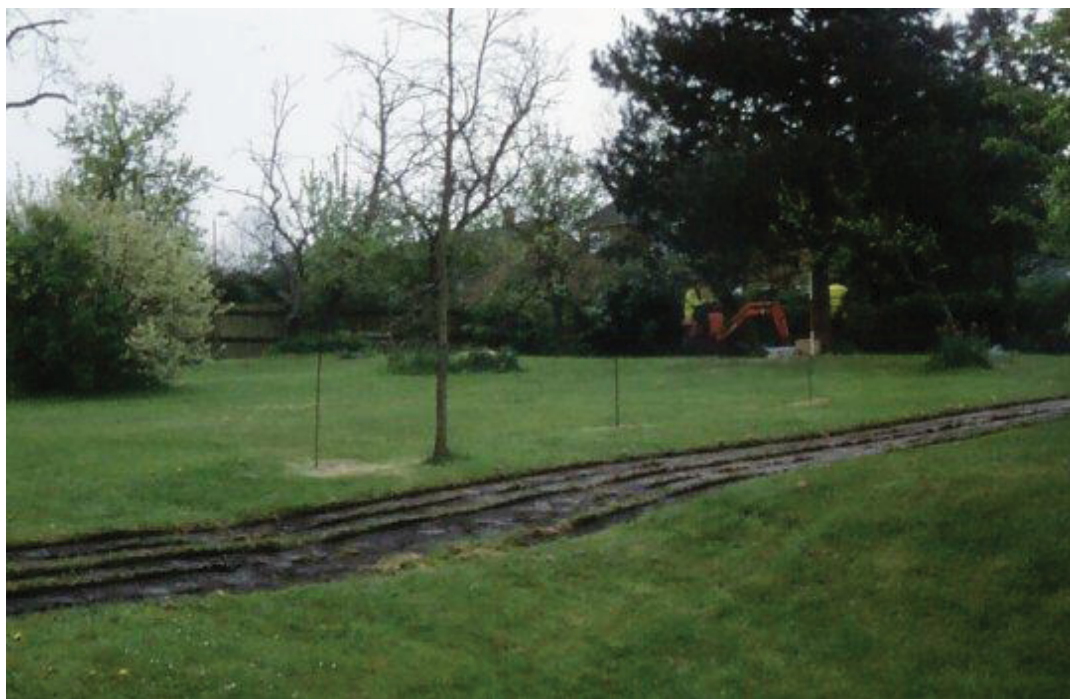
Plate 3. Trench 3 prior to excavation. The earthwork depression created by 19th century clay extraction pit.

A number of features were observed in this trench including the edge of a clay pit that was excavated to serve the 19th century local brick-making industry. The excavated edge of the pit coincided exactly with the earthwork observed before the commencement of this evaluation work (plate 3). The fill was a dark brown mixed

silty-clay with lots of brick and slate fragments. The location of this clay pit was already known about by the owner and this excavation served to confirm this.
