**An archaeological watching brief during the
excavation of foundation trenches at land to the
rear of Quorn Conservative club, Nursery Lane,
Quorn, Leicestershire (SK 562 166)**

University of Leicester Archaeological Services

Report no 2005/053

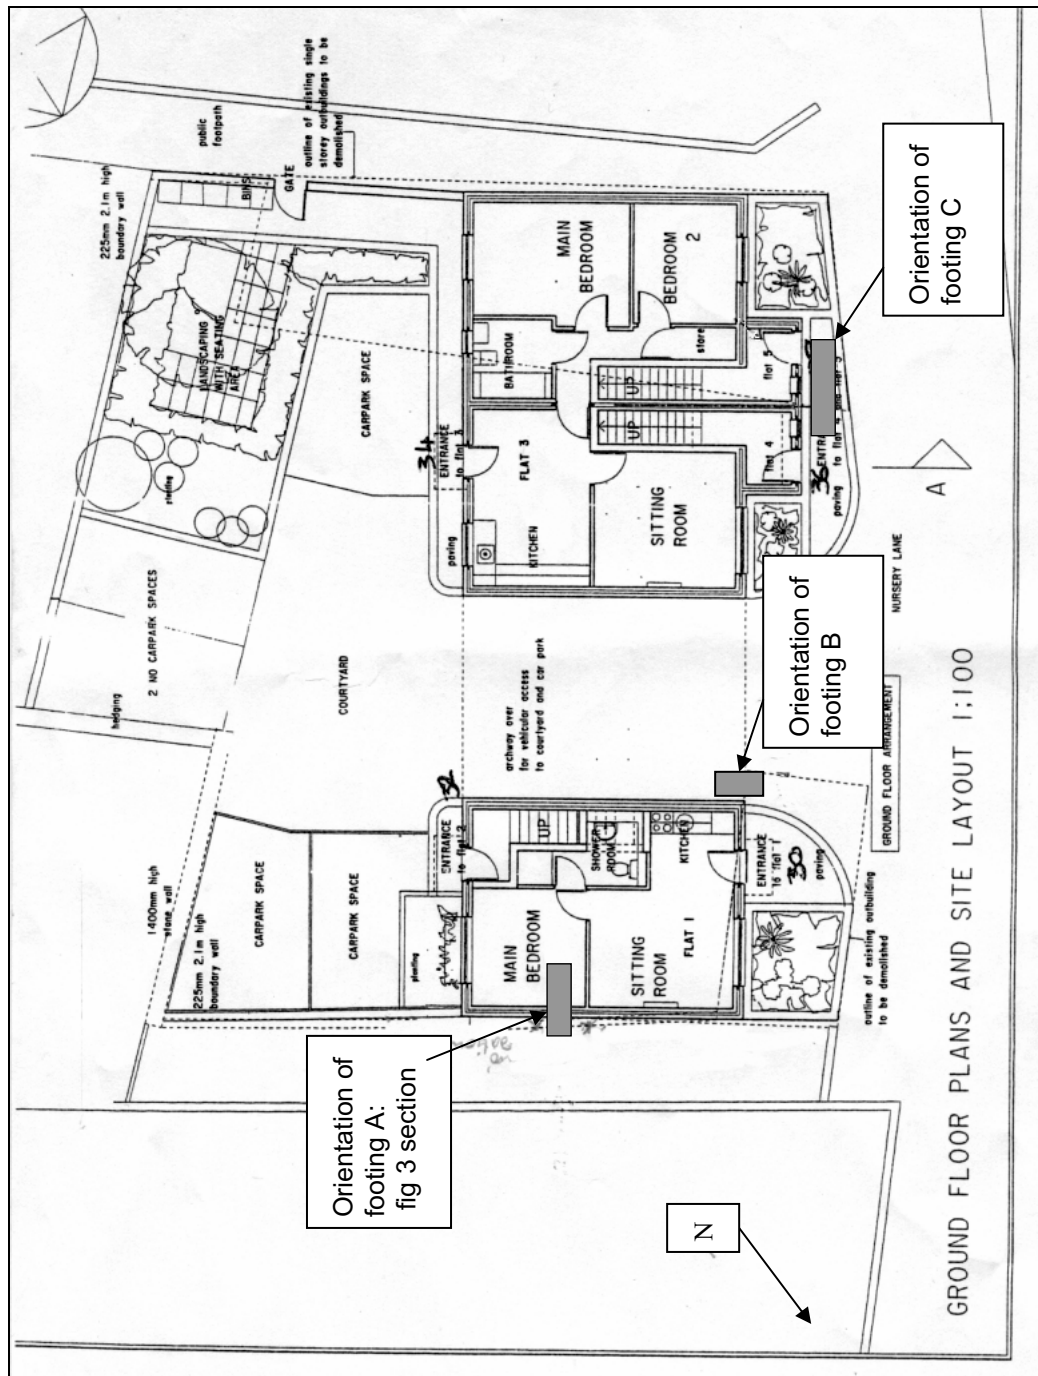
Fig 2

B and C on fig 2. Footing A was the most substantial, and crossed the foundation trench at a right angle, as far as could be told, parallel to the Nursery Lane frontage; footing B could be a return of the same structure. Only one edge of footing C was visible. Footing A was a mixture of chunks of chalk/lime mortar, clinker, and clay soil with granite masonry, more bonding than masonry: in general the footings were not of high constructional quality. Nevertheless, footing A included several large, properly dressed, granite blocks up to 45cms in length. Presumably these were a re-use of material as several fragments of brick or tile were also present, making a construction date of 18th or 19th century likely.

Layout of new development, with position of wall footings

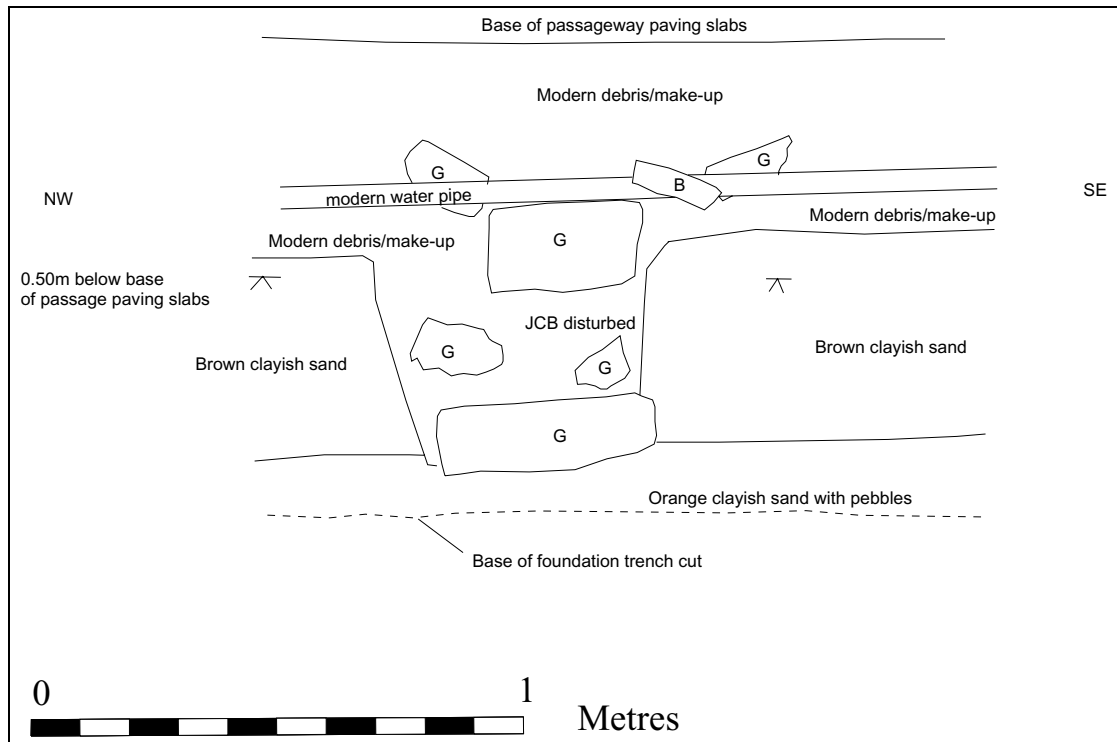
Fig 3 Section through footing A

G = granite, B = brick
