**An Archaeological Watching Brief
During ground-works at
Foxton Inclined Plane,
Leicestershire
(SP 69230 89590)**

British Waterways

ULAS Report No. 2006-102 ©2006

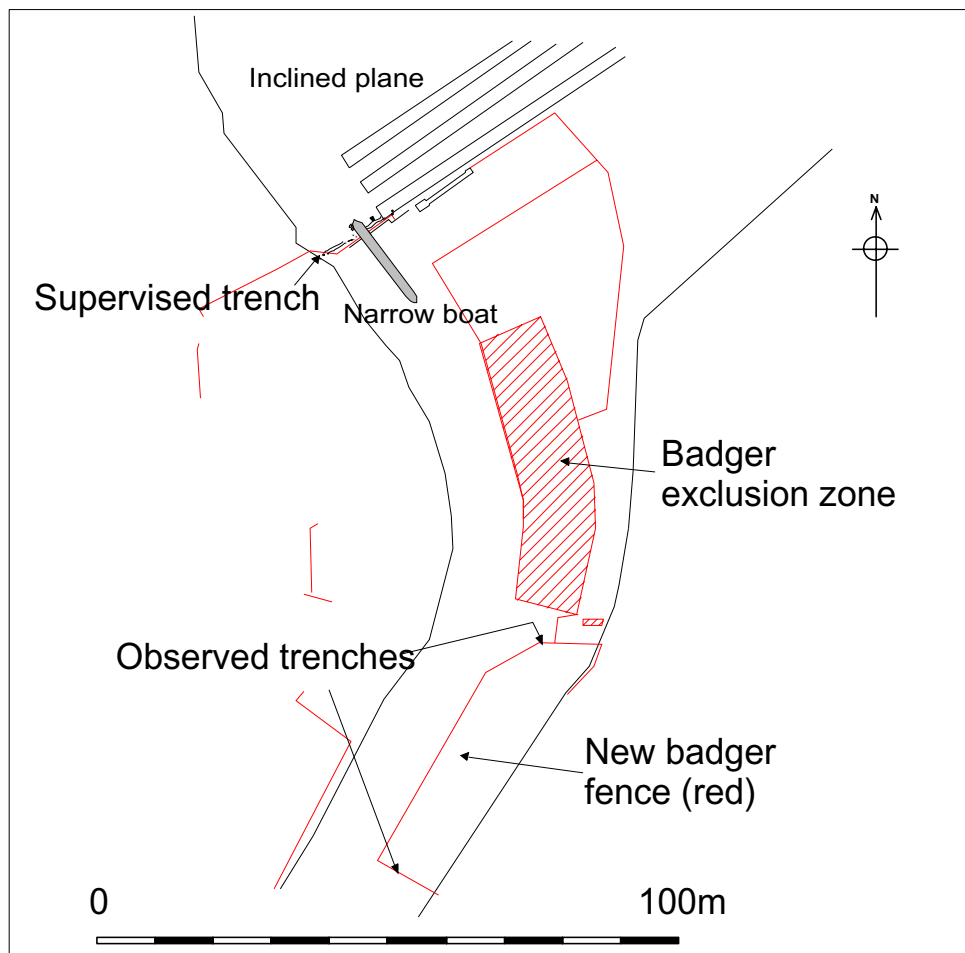
Figure 3: Plan of upper arm of plane showing areas observed during watching brief

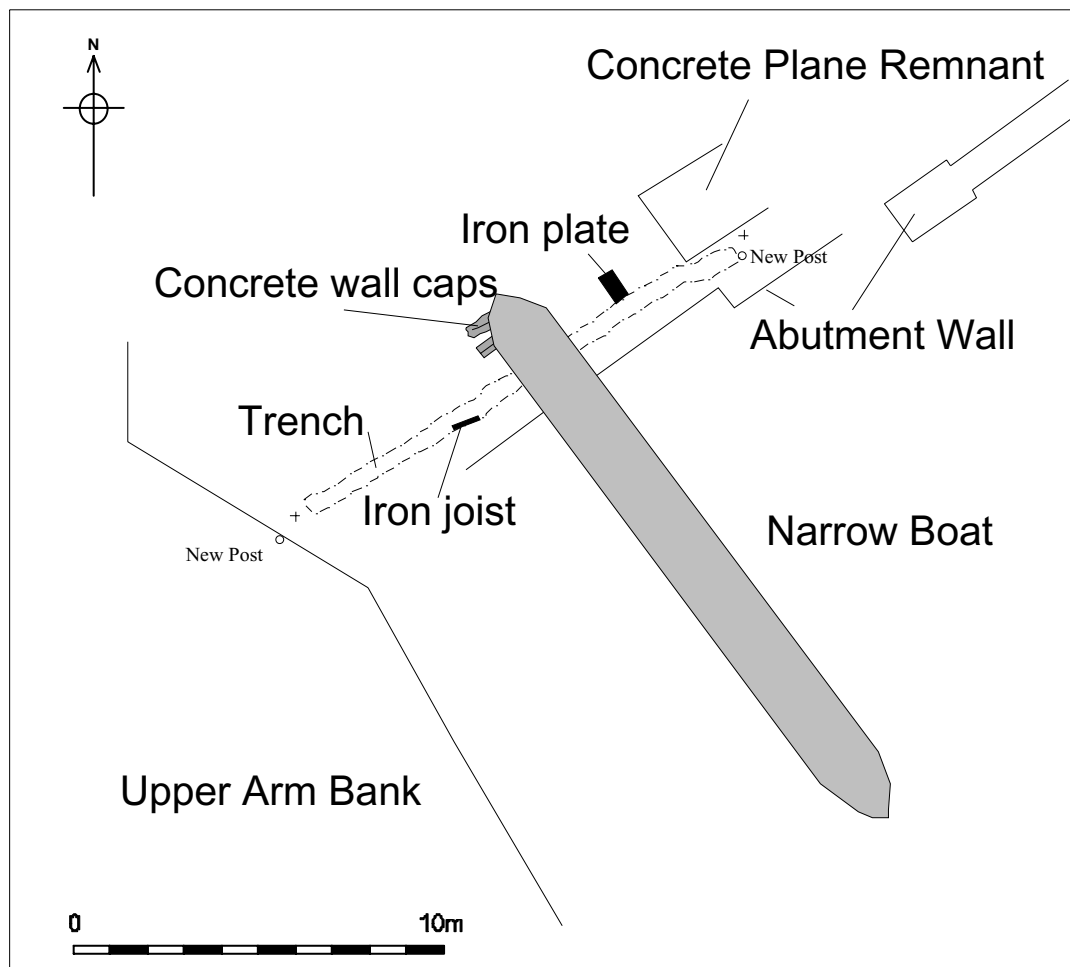
The trench was excavated between 0.2m and 1m from the edge of the abutment wall and no foundations for the brick abutment were found during the watching brief.

Figure 4: Detail of north western end of upper arm, showing trench plan

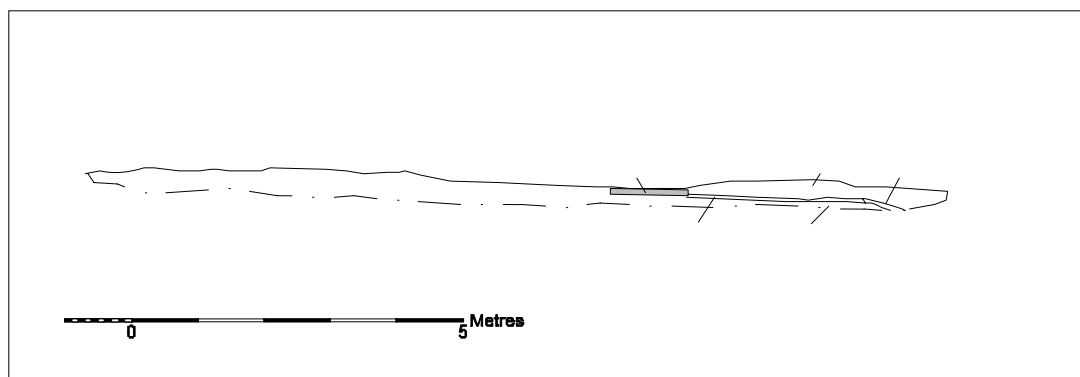
was a fairly loose mid-grey silty clay loam, containing chunks of brick and other broken ceramic building material. The bricks were red or blue and were four and a half inches deep. A more compacted clayey soil could be seen at the base of the trench. At the western end of the trench the excavation was slightly deeper and this exposed a layer of grey clay overlying a greyish yellow clay, which could be seen clearly in section.

Figure 5: North west facing section of trench, showing features

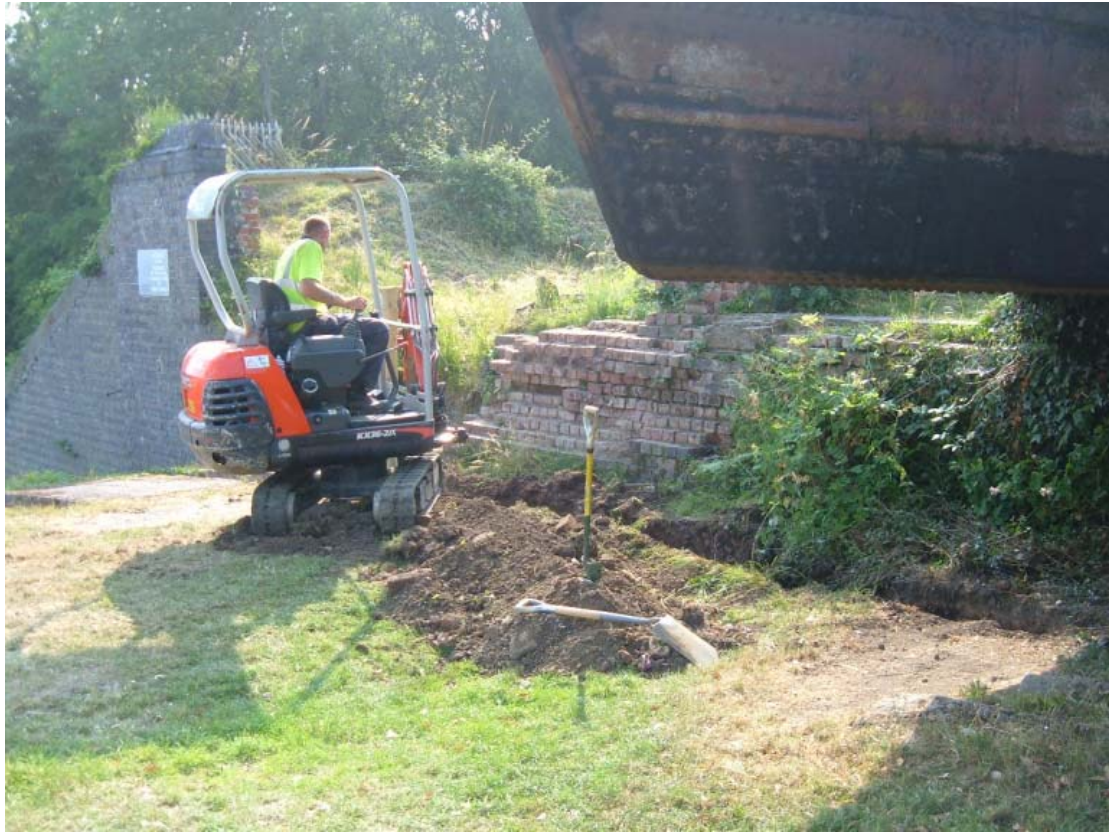
The trench close to the abutment wall at the end of the upper arm of the Inclined Plane was situated far enough away from the wall not to expose any of the foundations of this structure. The wall has sustained some wear and erosion over the years and remnants of this decay were in evidence within the trench, including bricks and rubble and fragments of mortar.

Plate 1: Work in progress on badger fence close to abutment wall, looking southeast

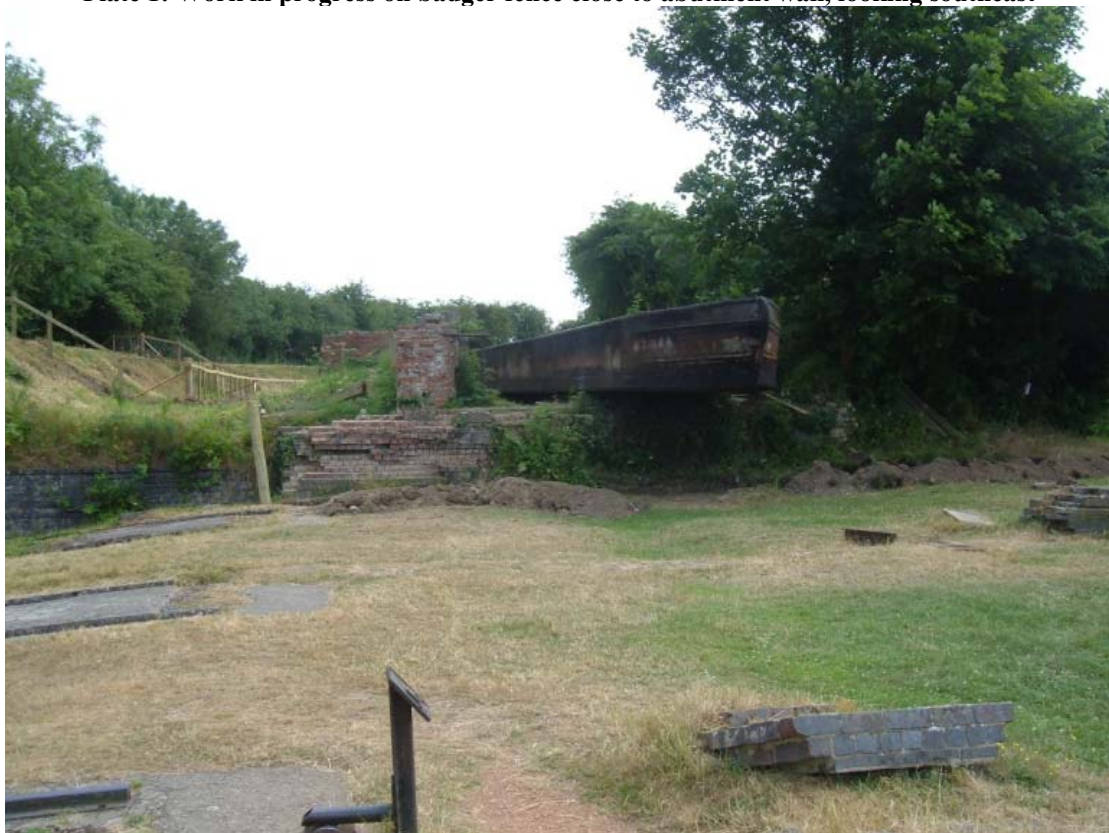
Plate 2: Completed trench on upper arm, showing top section of incline and narrow boat, looking south

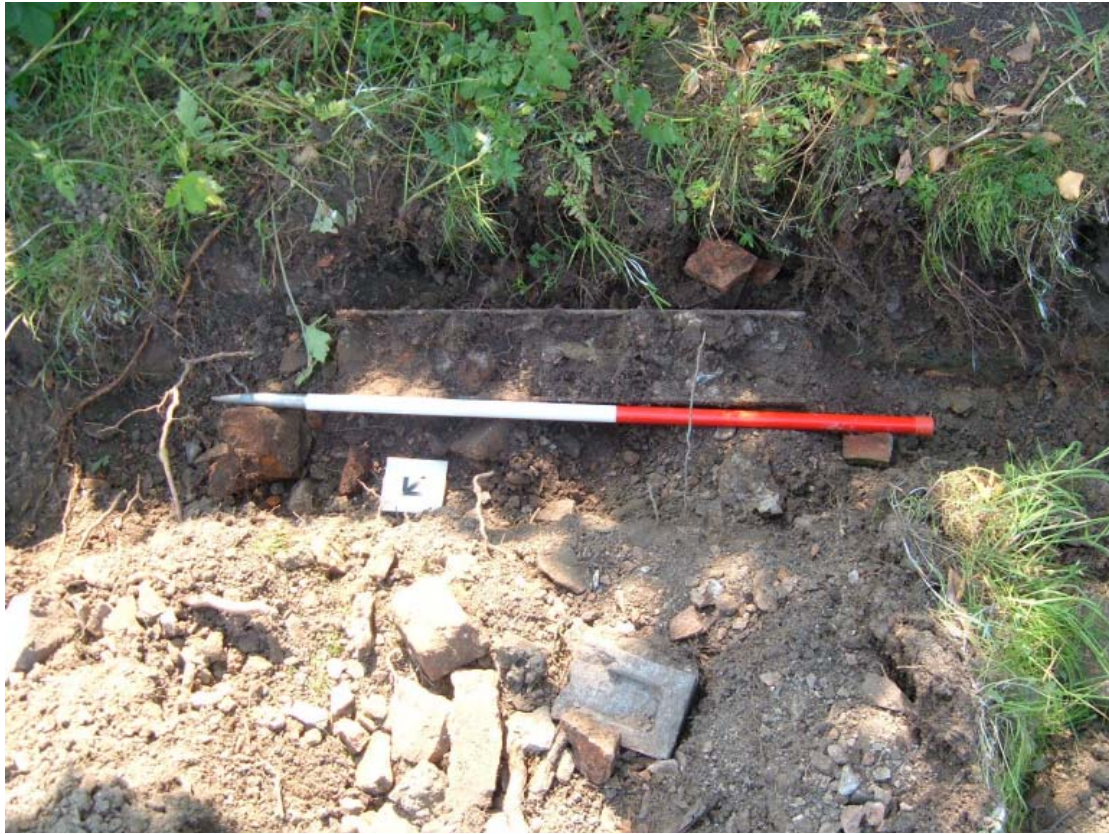
During the excavation two pieces of iron were recovered from the trench. One was a flat section of iron plate, which measured 1.2m x 0.38m x 0.1m with two 0.1m holes drilled into its surface along one edge. The other was a section of an iron channel, which measured 0.78m x 0.08m x 0.15m and was 'c'-shaped in cross section, with a large bolt fixed through its mid-section. The flat plate lay close to the surface at the edge of the trench, the joist section was just partially embedded into the southern section of the trench. Both fragments appeared to have been cut with an acetylene torch.

The iron channel fragment does not appear to have been part of the known structure and its exact function is not known.

Plate 3: North facing section of trench, showing iron channel fragment in situ, looking south

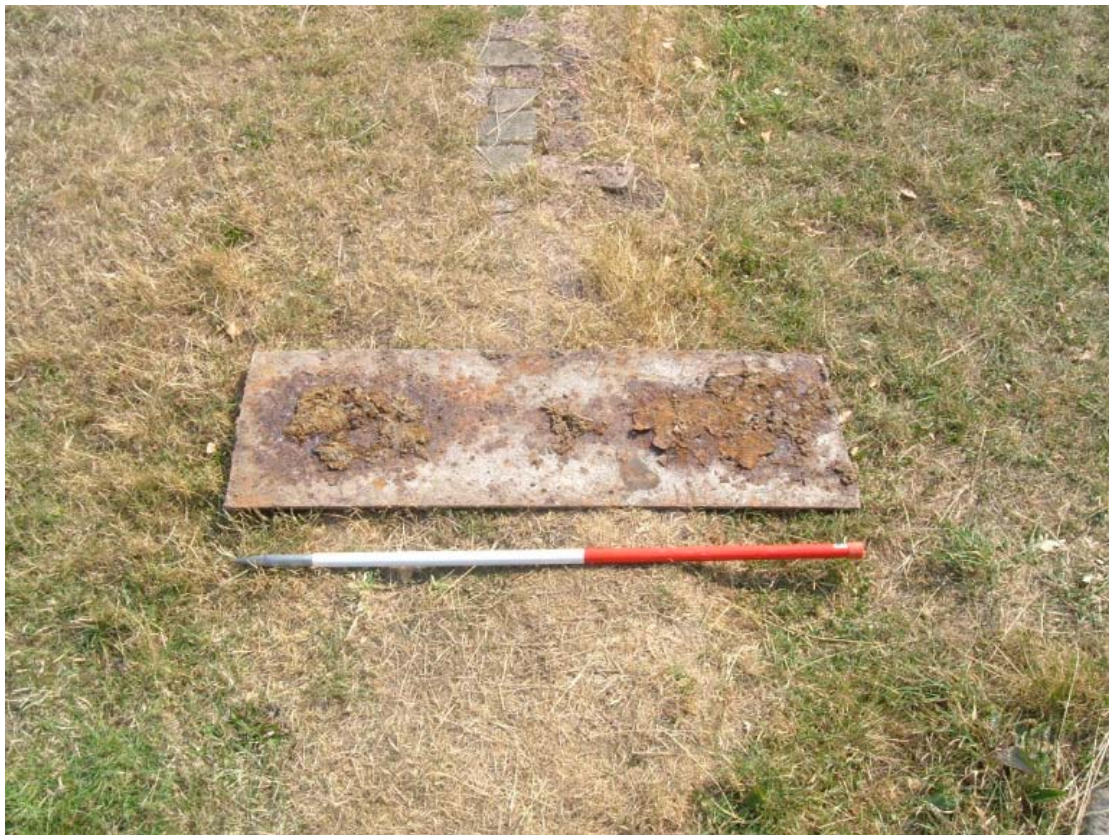
The pieces of iron discovered within the trench were not easily identifiable. The iron plate may have been part of the iron caissons that were used to carry the boats through the incline. All large metal structures on the plane would have been cut up in the 1920s, this may have been a small segment that was left behind during the salvage work.

Plate 4: Section of iron plate found close to trench

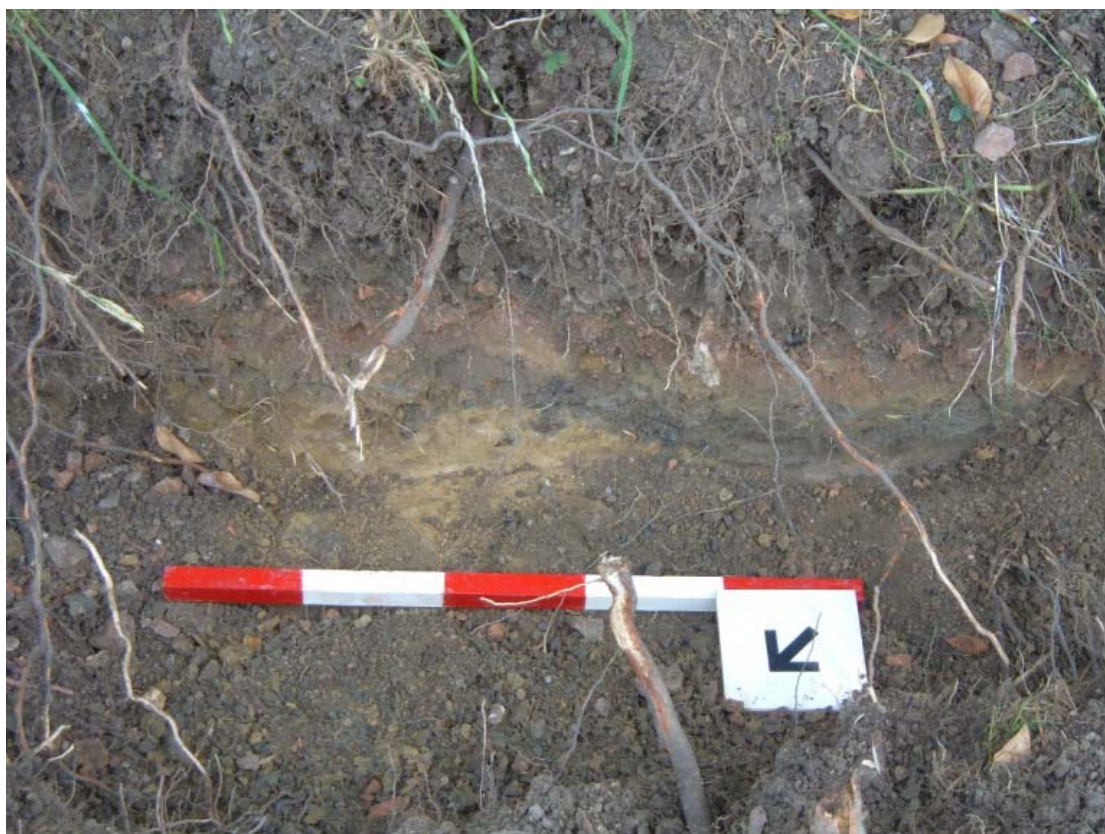
Plate 5: Western end of north facing section of trench, showing clay layer, looking south

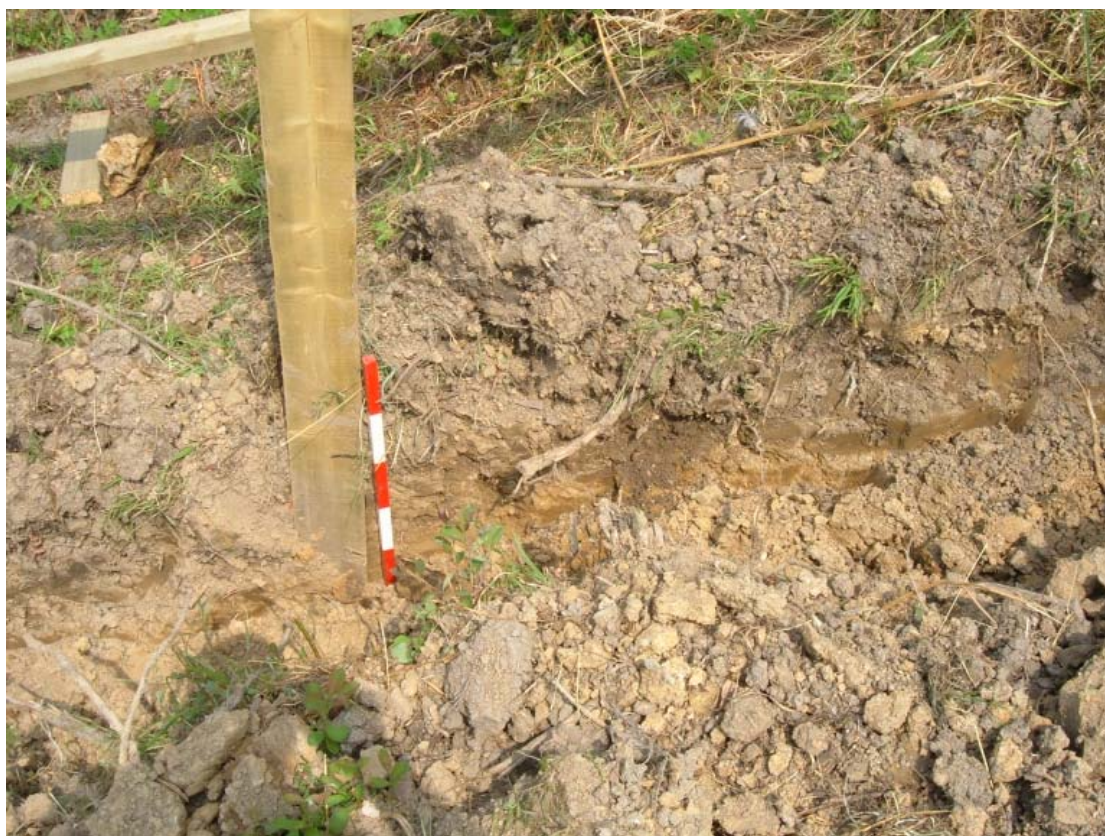
Sections of the trenches along the dry upper arm were also investigated for evidence of bank construction techniques. These sections showed that the bank mainly consisted of compacted yellow or red clay, probably reddened by heating, covered with a layer of dark grey loamy topsoil (Fig 7).

Examination of the trenches in the areas around the dry upper arm showed that the banks were made out of burnt clay as suggested by the monument descriptions.

Plate 7: South facing section of badger fence trench on dry upper arm of canal, showing burnt clay made ground, looking north east
