A Photographic Survey Of the Old Baptist Chapel, Loddington Lane, Belton-in-Rutland, Rutland (NGR SK 8172 0151).

A Photographic Survey of the Old Baptist Chapel, Loddington Lane, Belton-in-Rutland, Rutland (NGR SK 8172 0151).

Summary

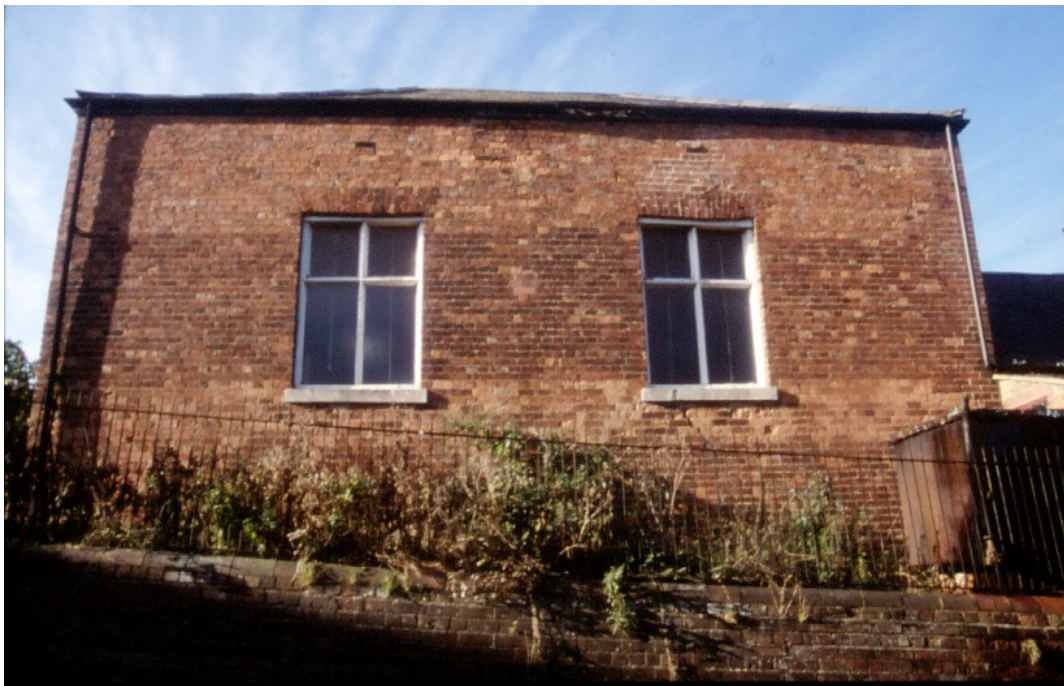
Colour Plate 4 Right Wall, Showing Changes in Brickwork.

The Chapel itself (*Colour Plate 1*) consists of a single storey rectangular Chapel house of red brick with a hipped roof of apparently Welsh slate. There is a smaller schoolroom at the rear of the Chapel onto which a brick built lean-to has been added. There are clearly different types of brickwork within the build, most notably the top eighteen courses of the right wall; probably as a result of being built by subscription and using whatever materials were available.

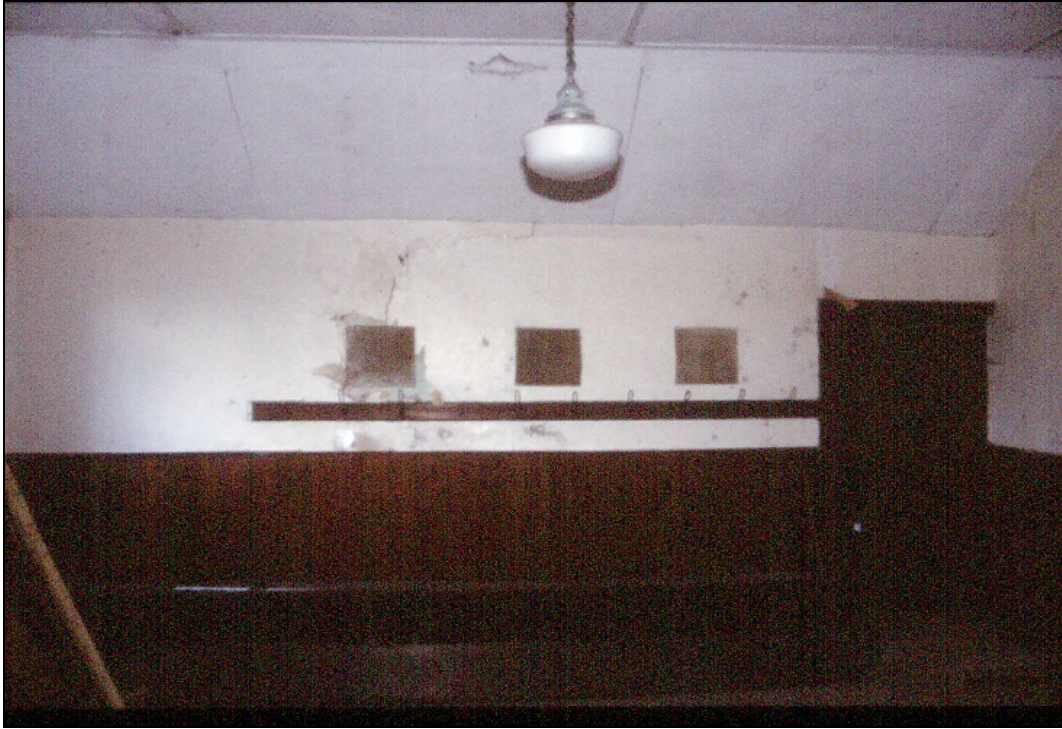
Colour Plate 5 Dedication Plaques in the Schoolroom

Entry to the schoolroom is via a door to the right of the pulpit; the floor level within schoolroom is approximately 500mm lower than the Chapel House. The room is dominated by a modern oil-fired stove on the front wall, there is no mention of this in the minute book, but it is probably a 1980s addition. On the right wall there are three sandstone dedication plaques (*Colour Plate 2*), inscribed left to right with “*THIS STONE WAS LAID BY ^{RV} REYNOLDS OF LEIGHFIELD OCT 21 1889, E. CORBY AND SON J.E CORBY*” and “*THIS STONE WAS LAID BY A. PEARSON OF UPPINGHAM OCT 21 1889*”.

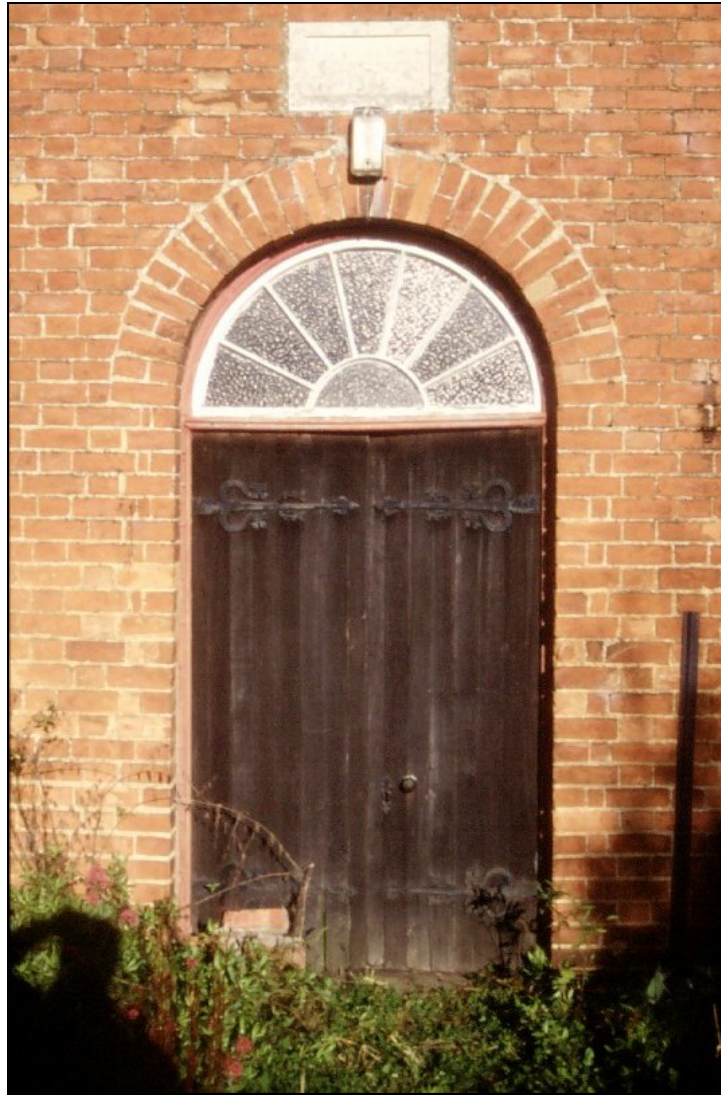
Colour Plate 6 Front Door

The Chapel house (*Room 1*) has six timber framed windows, two on the front wall and two each on the left and right walls, the sills have been plated with hammered tin, probably in an attempt to prevent the further decay of the timber originals below. Entry is via a central door on the front wall, above which is a Thomas Thomas arch (*Colour Plate 3*), over this is a date stone of local sandstone, inscribed *Baptist Chapel Erected 1843*. The date stone was not in place when the Chapel was photographed in 1910 (*Black & White 1*) and must, therefore, be a twentieth century addition.

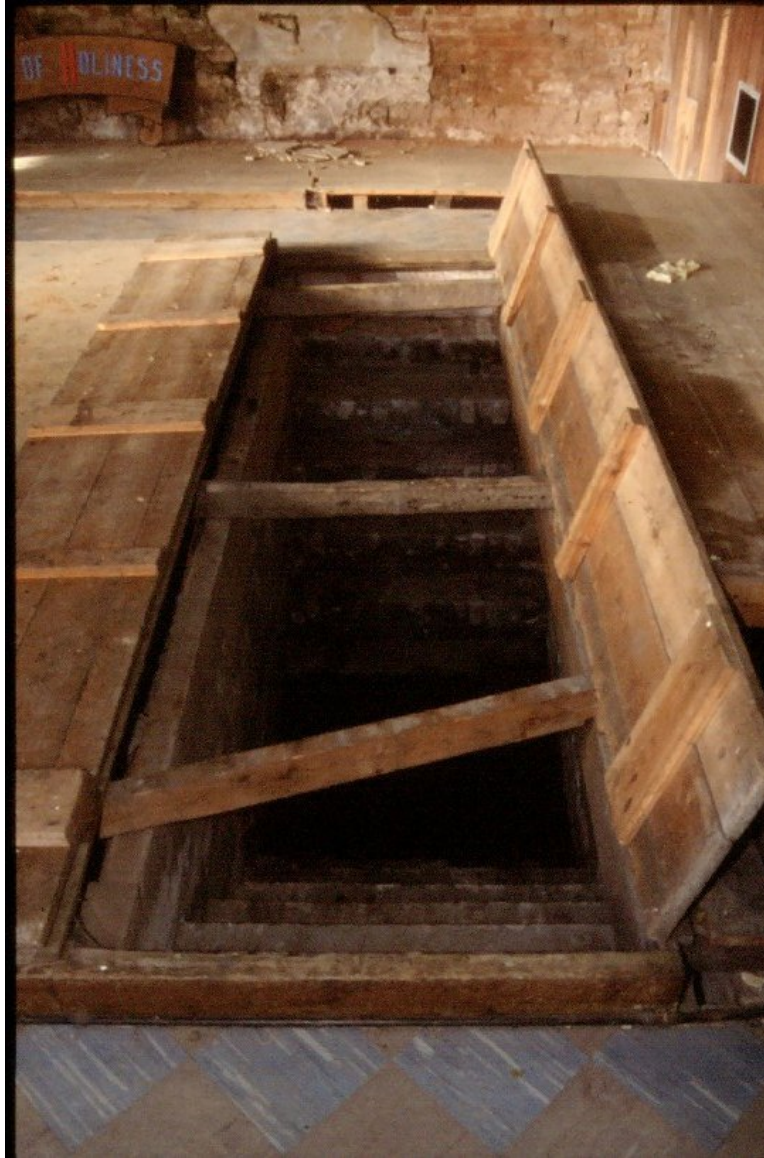
Colour Plate 7 The Baptistry

Internally there has been much alteration and very little of the original fixtures remain; within the Chapel House both the pews and the pulpit have been stripped out, but the outline of the pews are visible on the remaining wall panelling on the right wall (*Colour Plate 5*). The Baptistry, however, is still open (*Colour Plate 4*) and there is a small cast iron stove on the right wall, the flue of which can also be seen on the 1910 photograph.
