**Archaeological Attendance and  
Recording during Groundworks at  
Avenue D and Avenue E  
Sneinton Market,  
Nottingham**

**NGR: SK 58046 3990**

ULAS Report No. 2019-074  
©2019

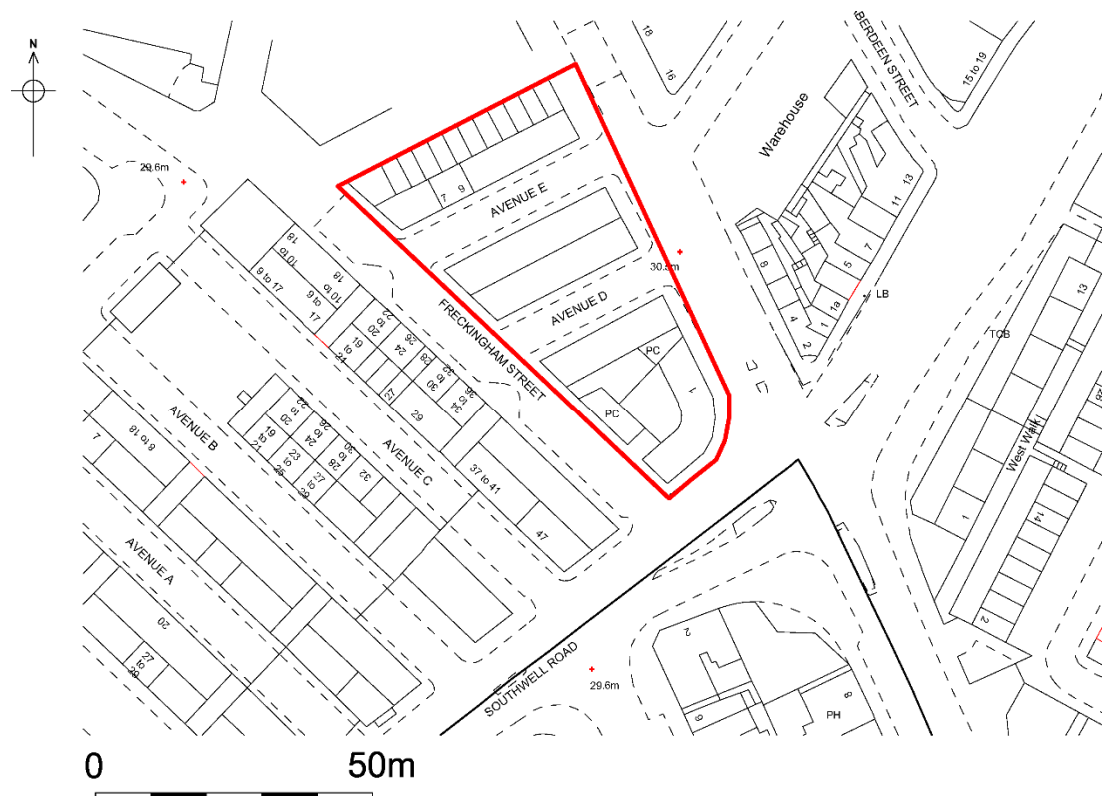
Figure 2 Plan of proposed development area  
Site outlined in red

The proposed development is located at the north-eastern edge of Nottingham city centre, on the eastern side of Sneinton Market between Freckingham Street, to the west, and Bath Street, to the east. Parallel streets known as Avenues D and E run from south-west to north-east and divide the development area into three blocks (Figs 1 and 2).

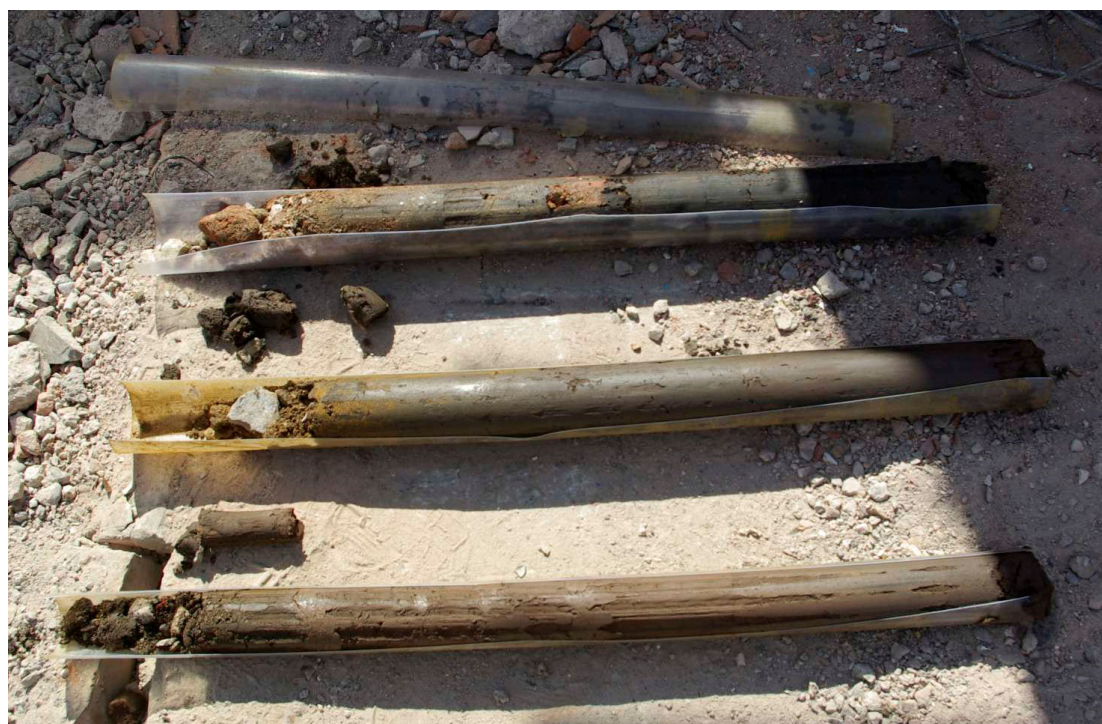
Figure 4 Core samples from Borehole 101  
1 metre long tubes. Highest level at top left, deepest sample bottom right

Borehole 101 was placed within the footprint of the partially demolished south-eastern building. The hand-dug top of the hole exposed a 0.5m thick layer of building and demolition rubble mixed with sandy layers. Beneath this was a layer of made ground consisting of dark brown sandy clay which gradually became lighter in hue the deeper the core sample went (Fig. 4). Fragments of brick and some glass were recovered throughout and even down to 4m below ground level.
