**An Archaeological Attendance and Recording
During Groundworks at 75 Church Gate,
Leicester, LE1 3AN**

ULAS Report No. 2019-081
©2019

For: GNK Investors and Asset Management

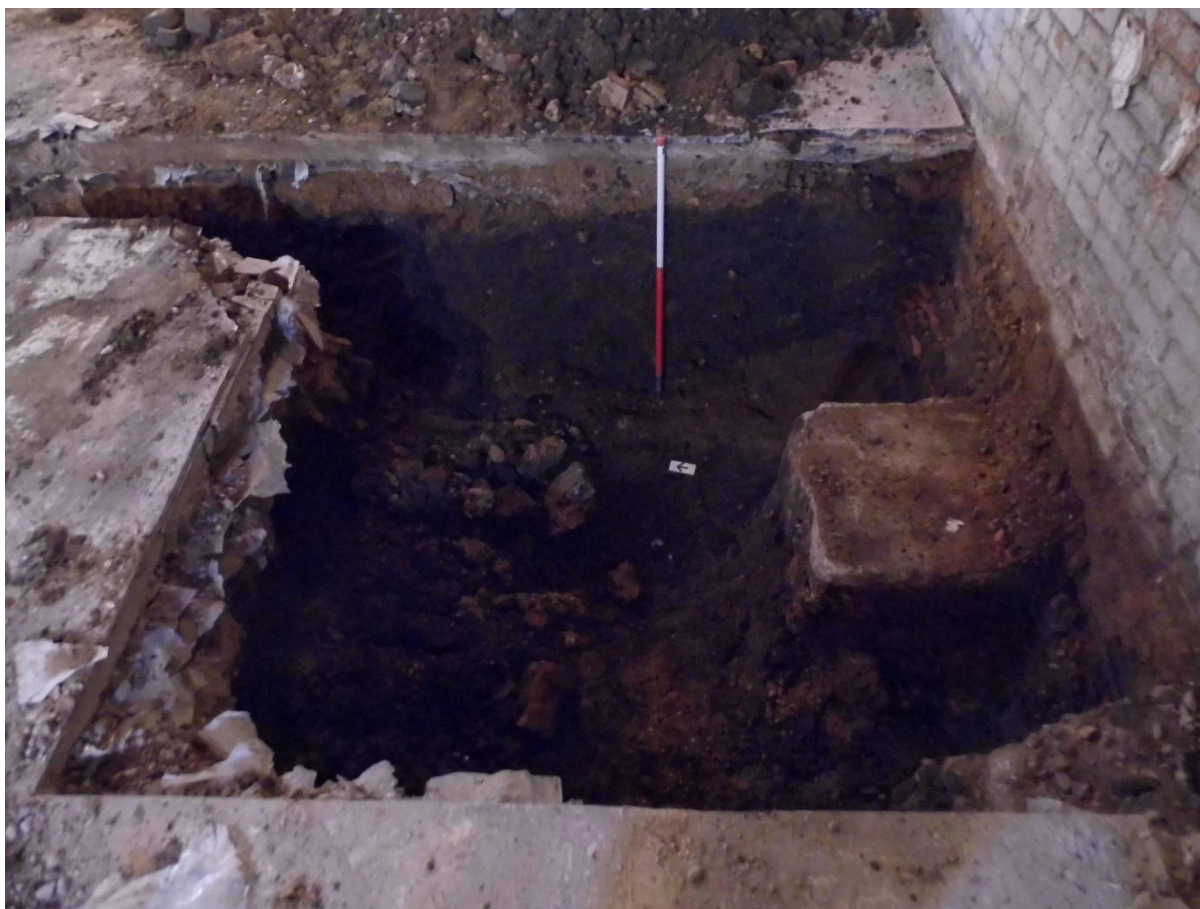
Figure 4: Deposits encountered in the lift shaft area showing the concrete block against the building wall.

rubble. The edge of a drain was found in the south-western corner of the lift shaft and a concrete block measuring 0.66m² by more than 0.7m deep was found against the southern wall of the building (see Figure 4).

Beneath the modern concrete and hard-core was a 0.7m thick layer of loamy sandy silt that was coloured dark blackish-grey. This deposit resembled a topsoil and contained small stones with

fragments of modern porcelain which were not retained. This layer was overlaying a mid-brownish-yellow coloured sandy silt which contained a few small rounded pebbles. This deposit was not dug into and it is unclear whether it represents the archaeological horizon.

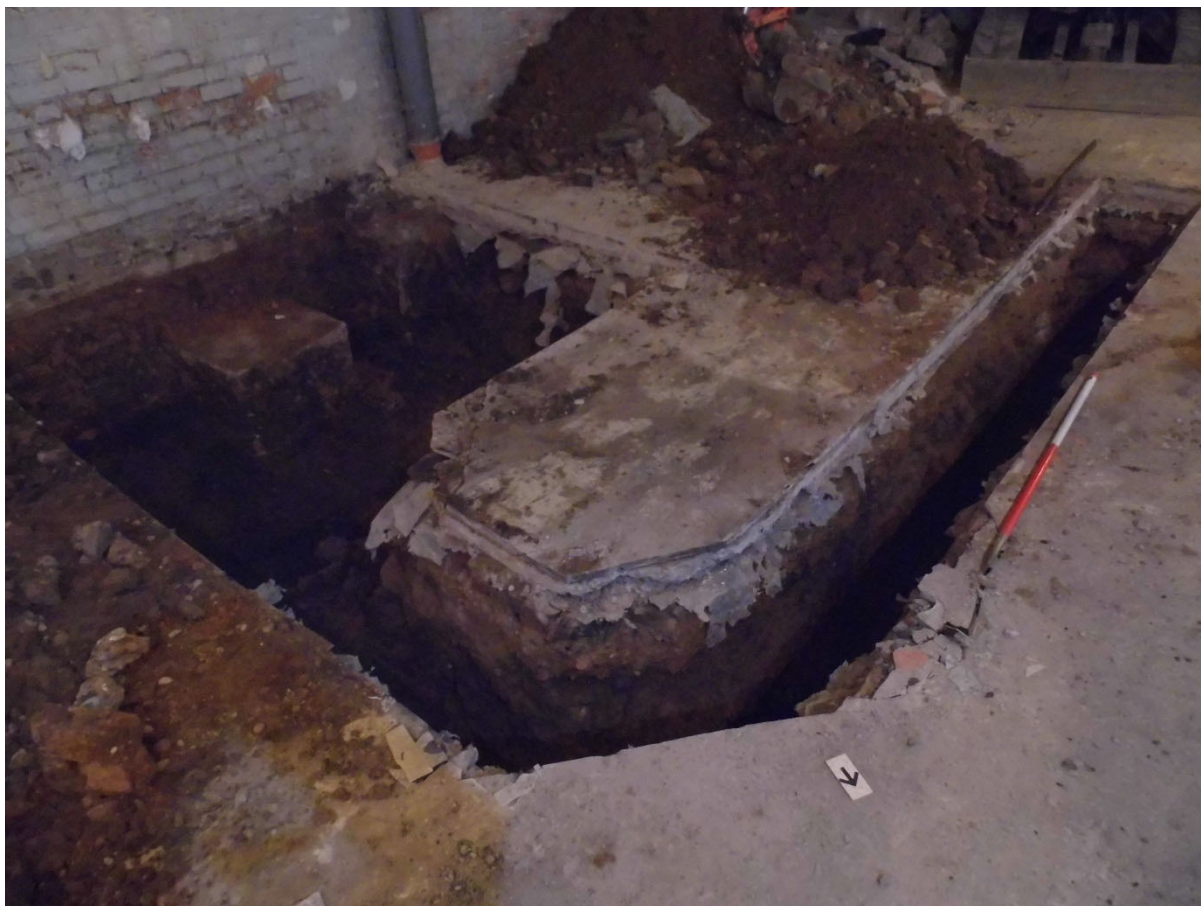
Figure 5: The excavated lift shaft and trench for the wall footing.

Next to the lift shaft a 4.5m long by 0.5m wide trench orientated east to west was dug for the construction of a wall. The eastern end turned to the south and joined to the north-eastern corner of the lift shaft (see Figure 5). The trench was also dug to a depth of 1.1m and an electrical cable was found in the western end. Beneath the modern layers the same dark blackish-grey coloured loamy sandy silt found in the lift shaft continued throughout the trench. No features were identified in either the trench or the lift shaft area although the rim of a glazed hollow ware vessel dating to 1650-1750 (D. Sawday pers. comm.) was recovered during the groundwork.

The work performed at 75 Church Gate found no archaeological features during the groundworks. Beneath the modern building a 0.7m-thick layer of loamy sandy silt was found which appeared to represent topsoil. Modern pottery was found in this layer and the unstratified post-medieval pottery is likely to have originated from it. The site is located to the east of the Roman and medieval town and the thick topsoil layer may have accumulated throughout the post-medieval and modern periods. It is not known whether the layer of sandy silt found beneath it represents an archaeological horizon.
