**An Archaeological Watching Brief at the
Thring Centre, Uppingham School,
Uppingham, Rutland.**

NGR: SP 86545 99783

ULAS Report No. 2019-091

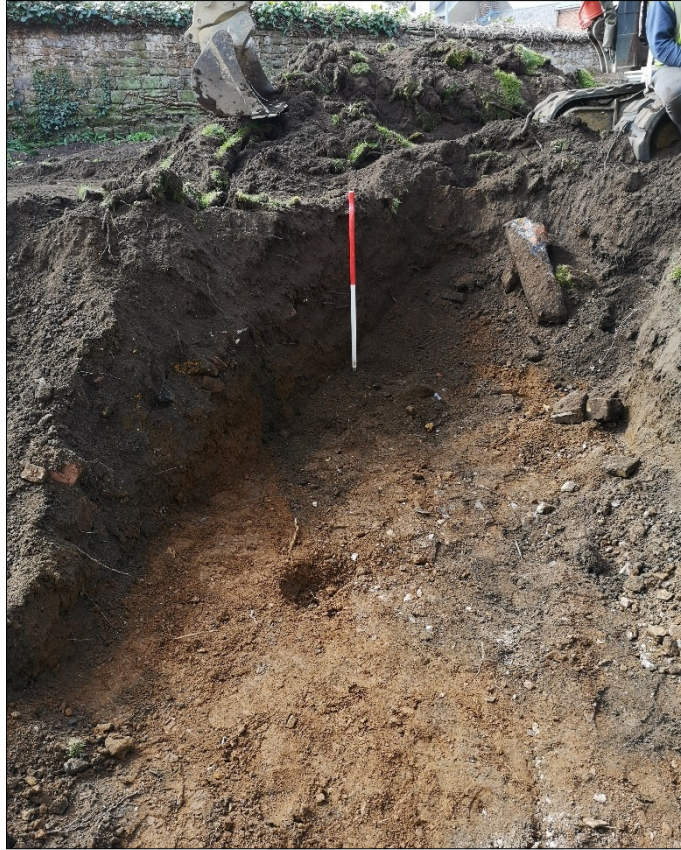
Figure 7: Trench 1 during excavation, looking west

This trench ran broadly north-west to south-east in from the east edge of the bank. The trench indicated that the bank here was made-up ground with frequent early modern material, and additionally cut by a large pit feature which also produced much modern material. The pit could be seen to be cutting the subsoil. At the base of the trench, broadly at formation depth level, both subsoil and below, natural, were observed. This suggested that any earlier, cut features might also be affected by the groundworks. No earlier features were exposed in the trench however, although the large modern pit cut took up most of the floor of the excavated trench and would have truncated any earlier features. The garden soil context (10) was a dark brown grey stony sandy loam. This was very loose with frequent root disturbance from the fruit trees that stood here until recently. The subsoil below this was an orangey brown stony clay. The natural was similar but was a brighter, orange ironstone-rich gravelly clay.

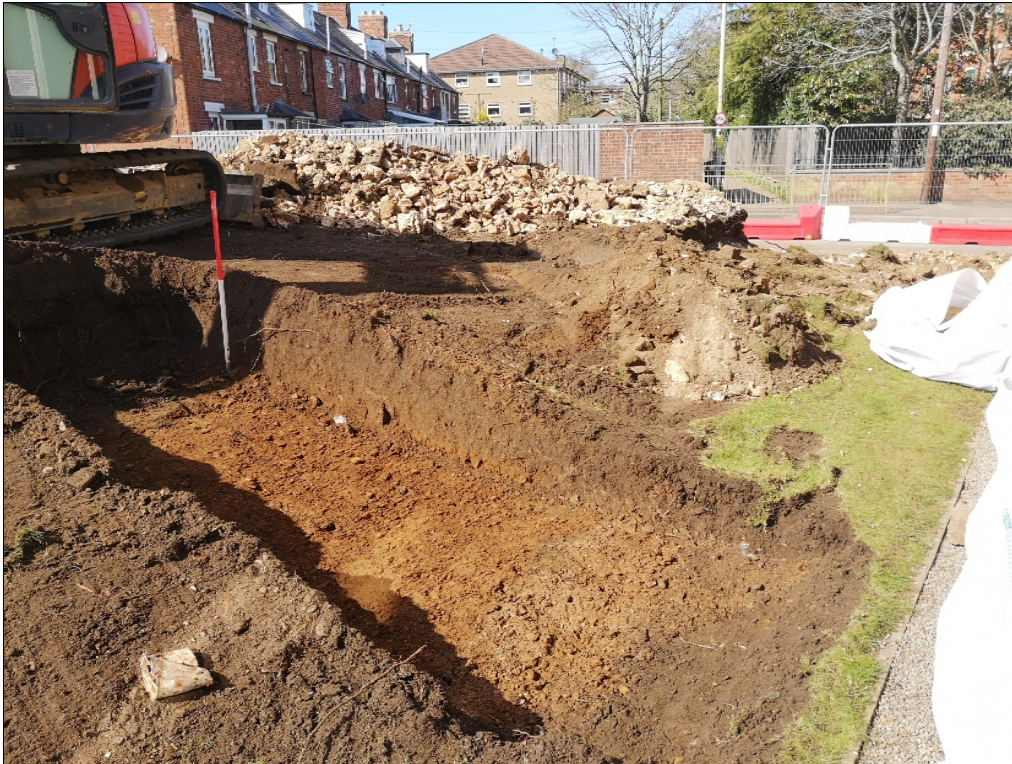
Figure 8: Trench 2 looking north

Trench 2 ran east-west. It exposed a similar sequence as Trench 1. Here the bank was not as high, being reflected by the 'topsoil' context (10) depth being 0.5m as opposed to 0.7m. No features were exposed at the lower level i.e. at the natural interface.

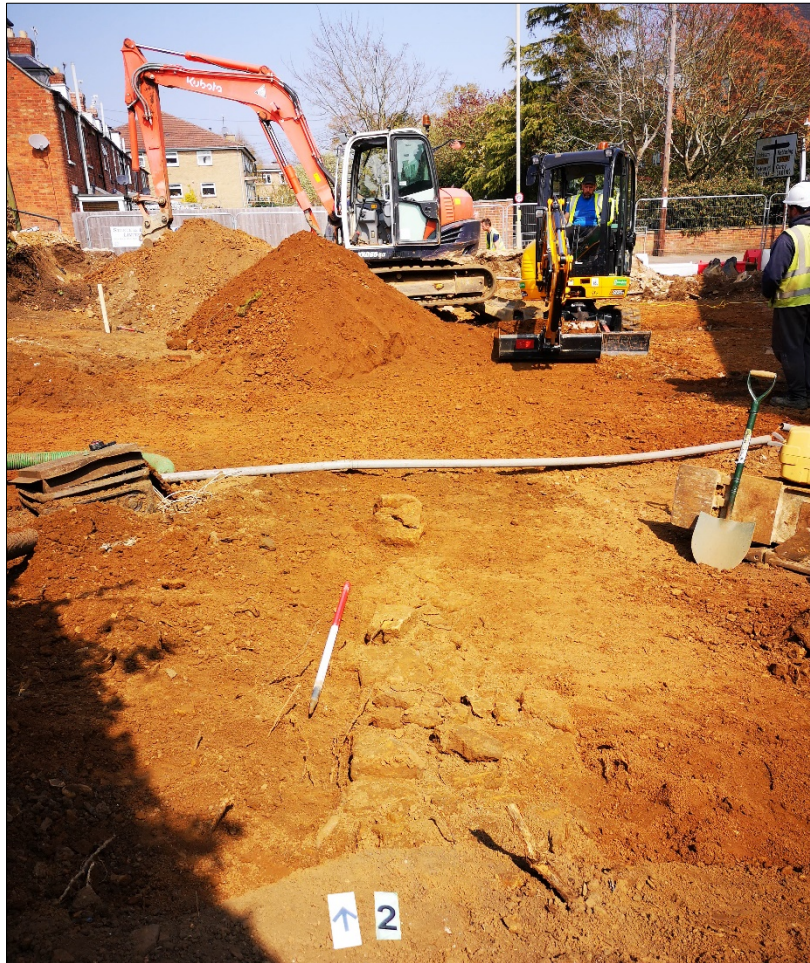
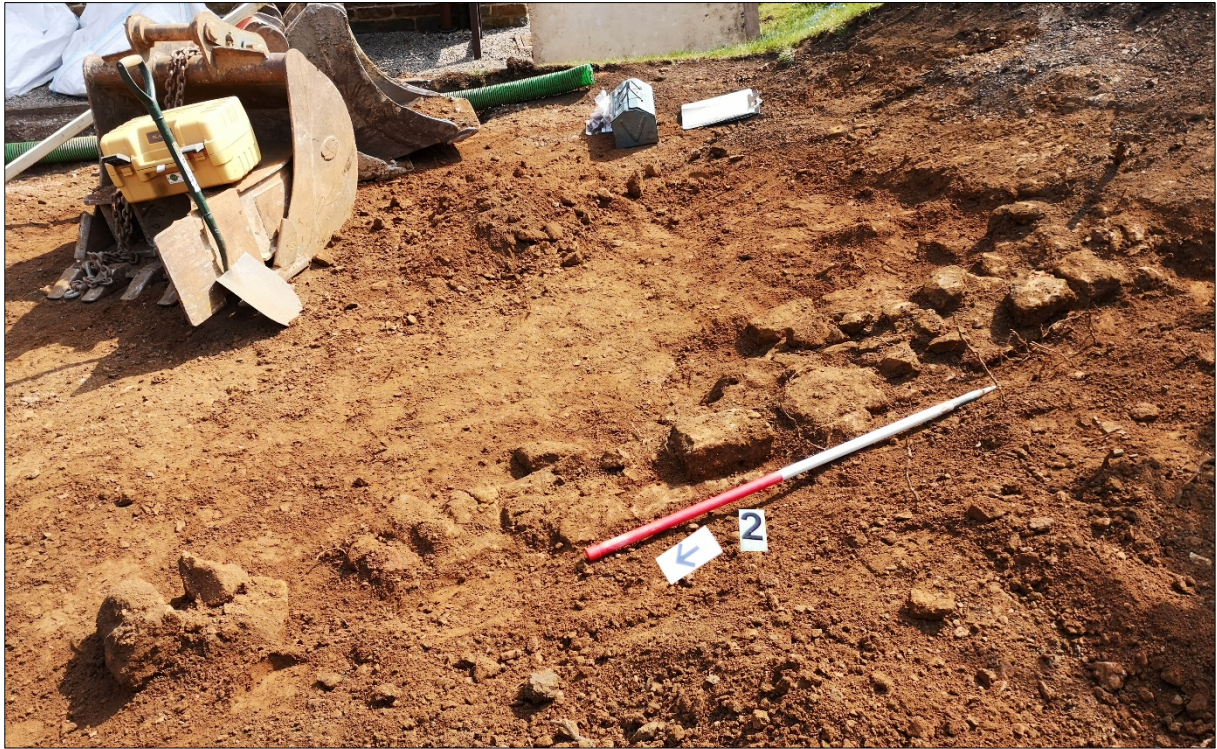
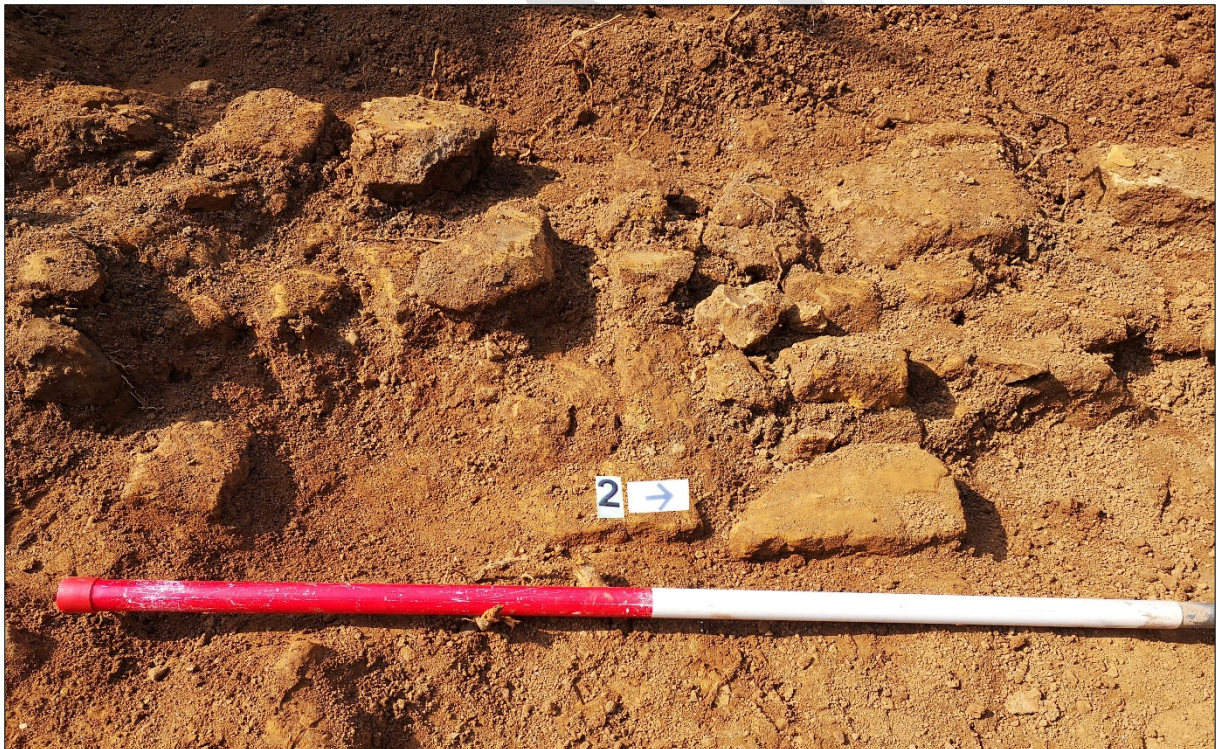
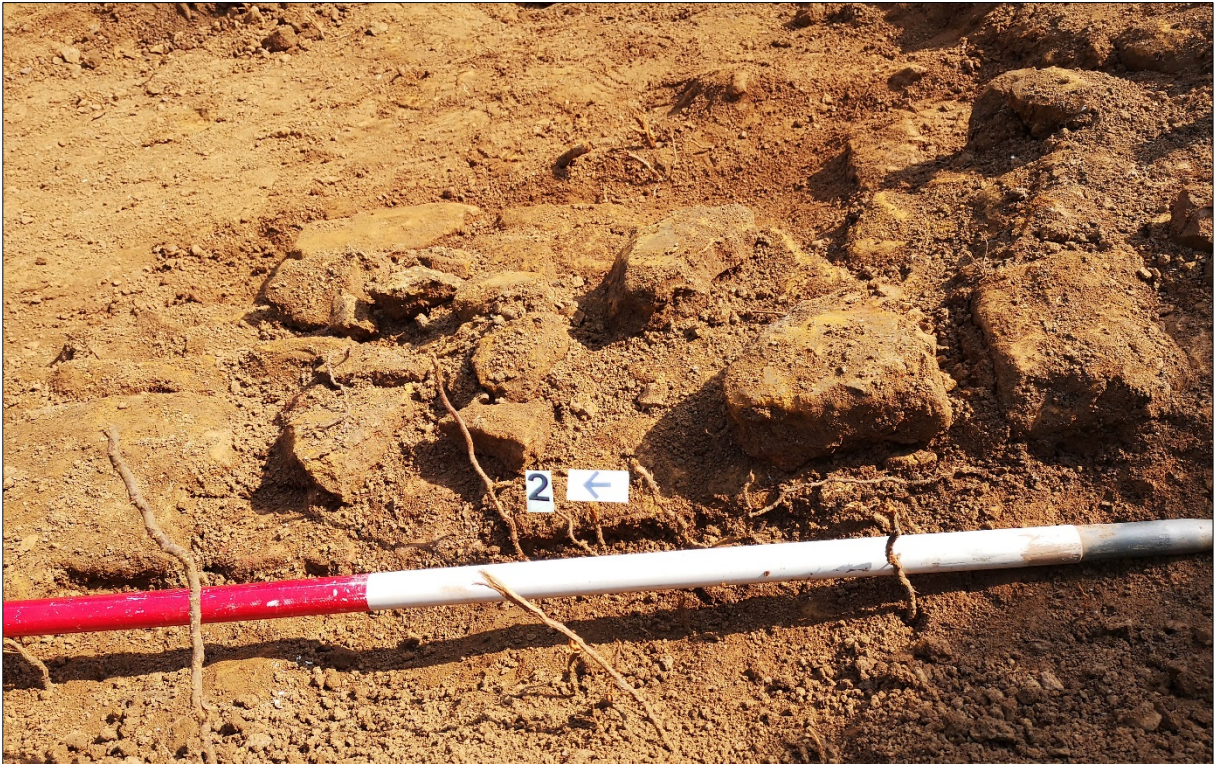
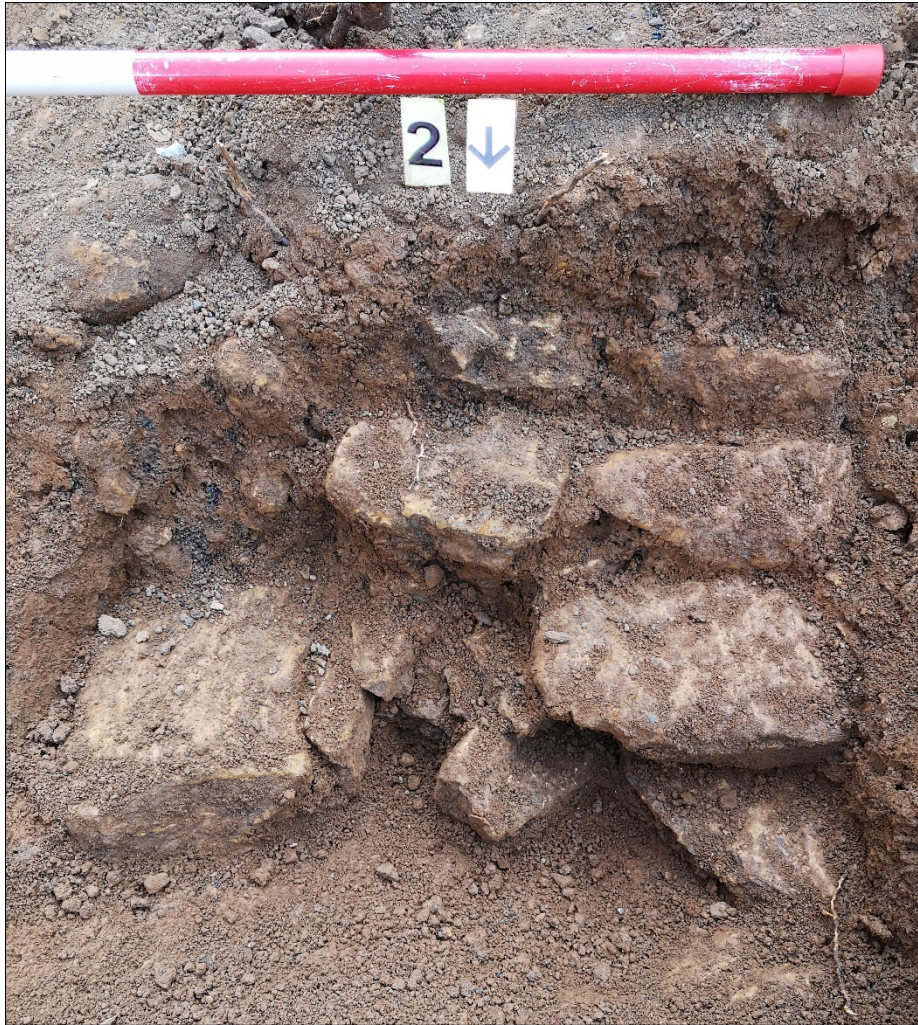
At the south of the stripped area, running slightly west of north-south for a distance of 3.1m in length was wall-line (2) [8], located on Figure 5. This wall comprised a 0.6m-wide structure, with both east and west sides being faced (Figure 9 - Figure 12). The structure was only observed cutting natural and only at the base of the subsoil, not from higher up. Three courses survived, with the stonework consisting of ironstone rubble slabs up to 0.3x0.2x0.1m across and bonded with an orangey-brown clay. Below, the footings were a single course of material, very similar in make-up but consisting of smaller stone (0.1x0.1x0.1m). At the south of the stripped area the wall continued into this baulk (see Figure 13), and it is likely that it originally butted-up to the main wall two metres to the south. If the wall had continued northwards it would have lined-up with the east edge of the entrance through the main wall on the frontage, this entrance surviving only as quoins on the external face of the wall (see title page photograph). It could be that wall (2) then originally formed a structure separating the garden area to the west from the rest of the manorial enclosure. There is some support for this view, as the outer wall is of a different build here to than to the east, for example being castellated on the capping (Coward 2019). The former entrance on the frontage of North Street West would have entered into this small western enclosure. Unfortunately, the frontage area had been very badly disturbed by more modern remedial work (see below), so no definite continuation could be identified. Some rubble was however identified dumped in this area. The western of the two quoin lines also had part of a wall-line surviving against the interior face (see Coward 2018, Fig. 20). The indication, in the absence of any direct dating evidence, is that wall (2) is broadly

contemporary with the other manorial structures, and thus perhaps as early as 17th century in date, if not a later alteration as is proposed for other structures elsewhere on site.

Figure 9: Wall (2) looking north, after initial cleaning

Figure 10: Wall (2) looking south-east, after initial cleaning

Figure 11: Wall (2) looking west, showing east face

Figure 12: Wall (2) looking east, showing west face

Figure 13: Wall (2) looking south, showing section through structure.

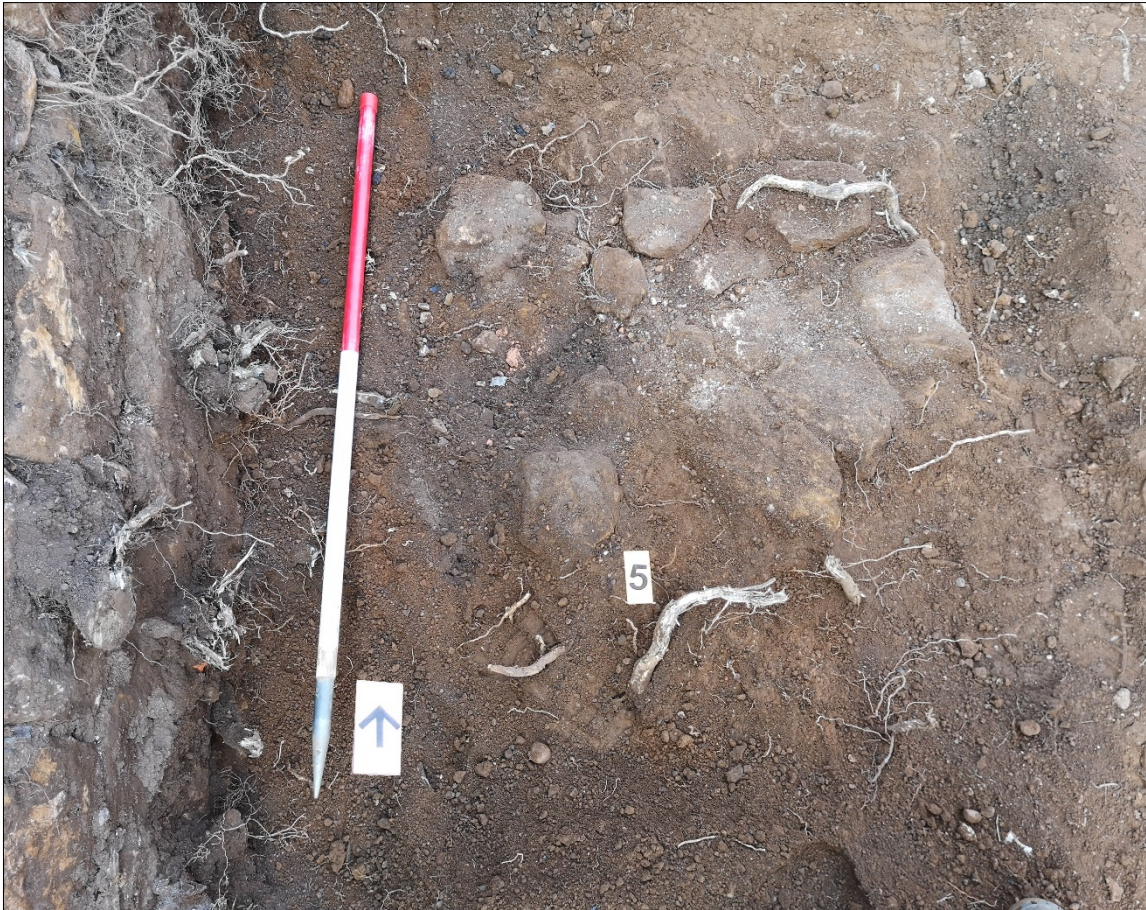
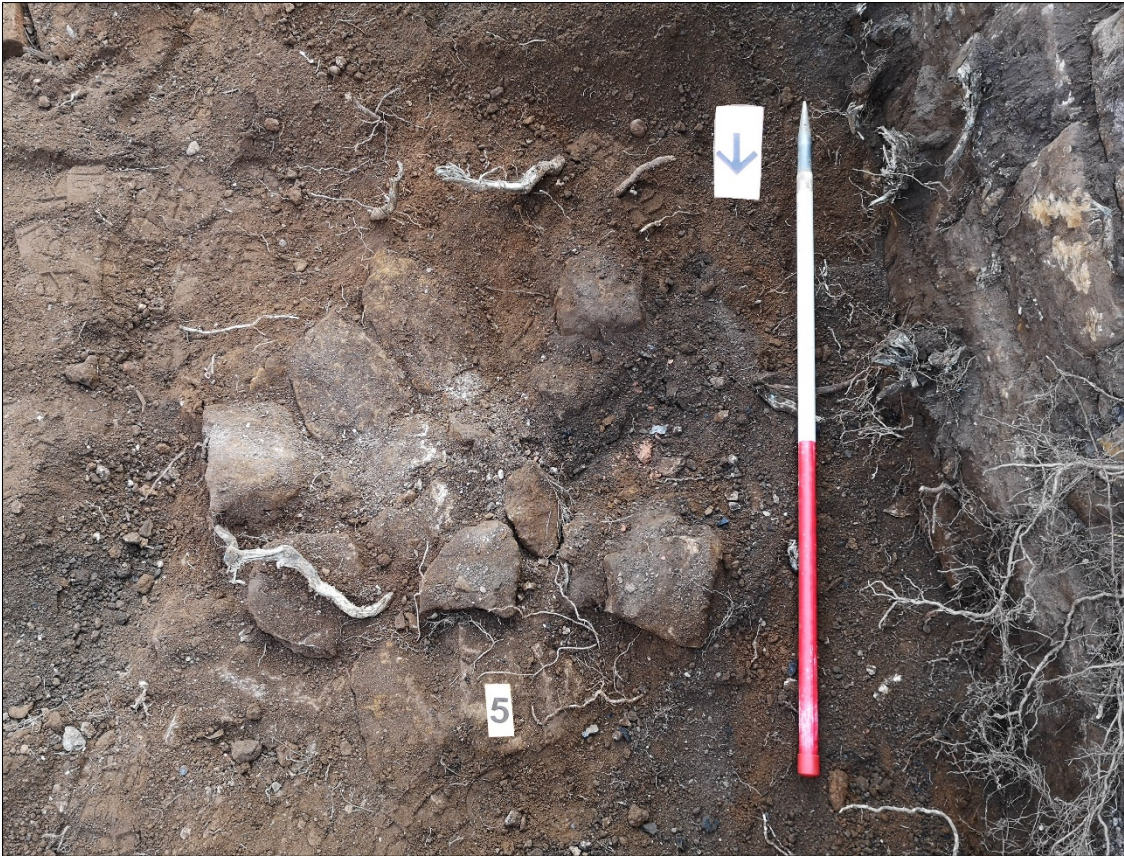
To the north-west, wall lines (5) and (6) were identified. These were perpendicular to the listed precinct wall (1), and 2.1m apart (centre to centre). Wall (5) survived for a length of 0.8m long (east-west) 0.6m wide. The wall consisted of two courses of ironstone slabs up to 0.25x0.2x0.05m across, with the stones arranged so the outer faces were regular. It is not clear that they were bonded, and additionally the upper surface of the structure was quite flat, suggesting it may have been a 'dwarf' wall perhaps to support a timber structure. North of this, wall line (6) was similar, one metre long (east-west) 0.35m wide and consisted of two courses of ironstone, slabs up to 0.3x0.2x0.1m with a total depth of 0.3m. Unlike wall (5) this butted up against the precinct wall. Much modern material was identified in this area, and both these wall-lines cut the subsoil, suggesting a relatively recent date. From the garden soil here, context (10), a fine clay pipe bowl was recovered, this being of 19th-century date. Wall (6) corresponds closely with the north wall of a C-shaped structure seen on the first edition Ordnance Survey map (of the 1880s), as shown in Figure 5. This was a rectangular structure, c.4m north-south by 3m east-west, and was probably a potting shed or similar.

Figure 14: Wall (5) looking north, listed precinct wall to left.

Figure 15: Wall (5) looking south, listed precinct wall to right.

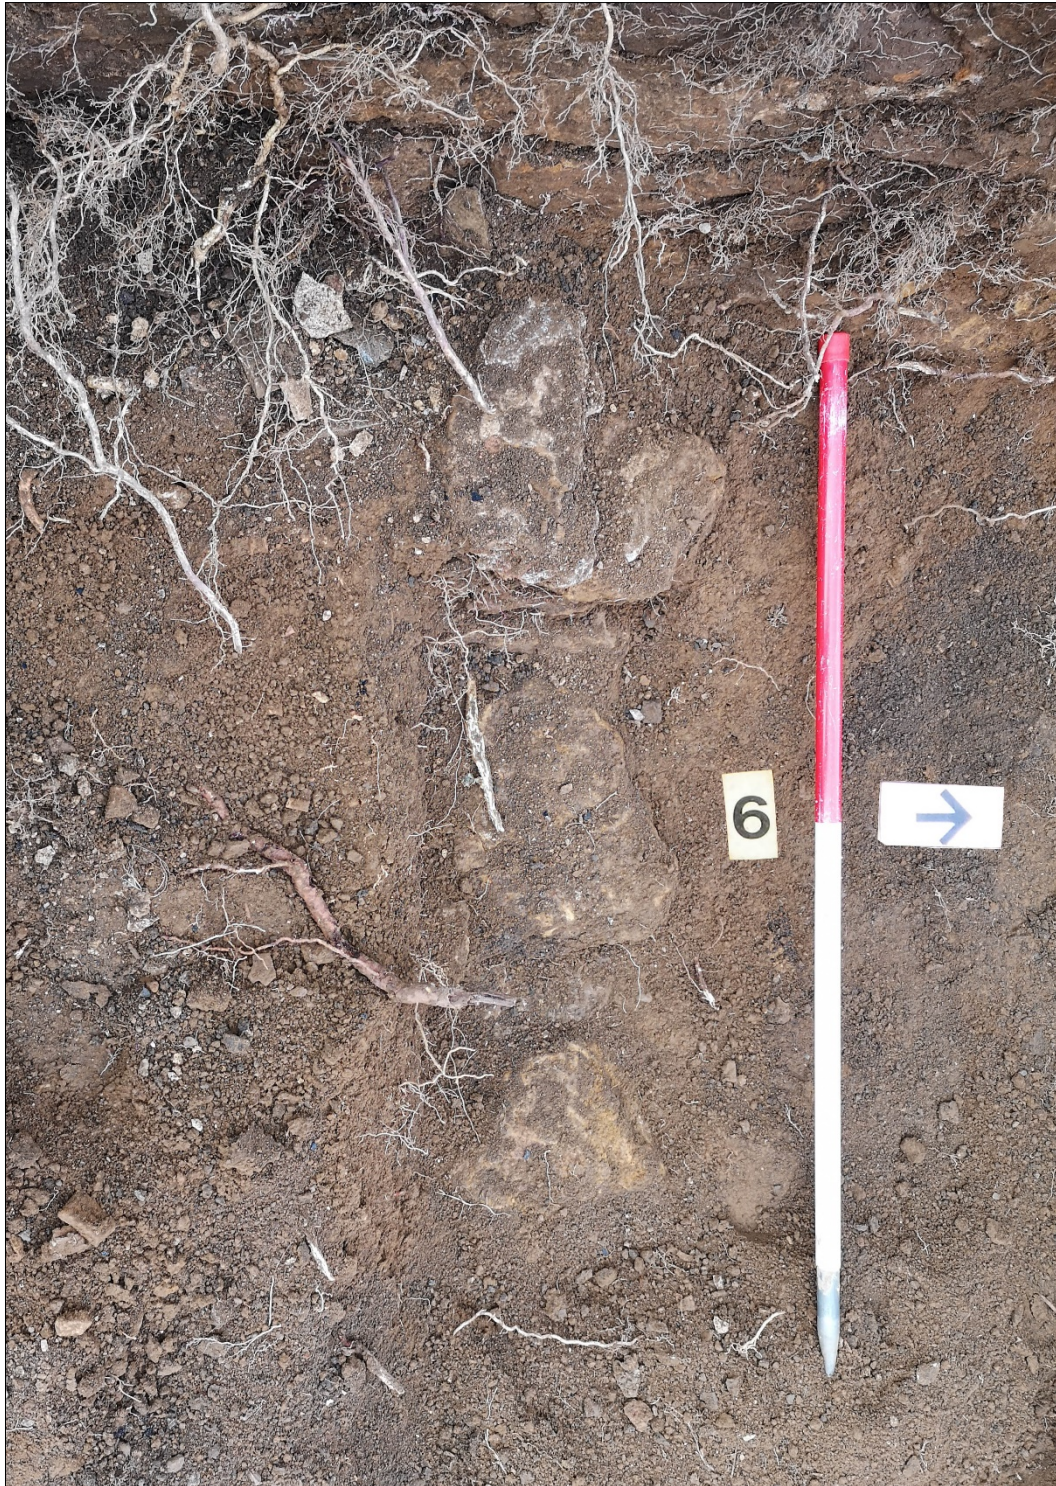
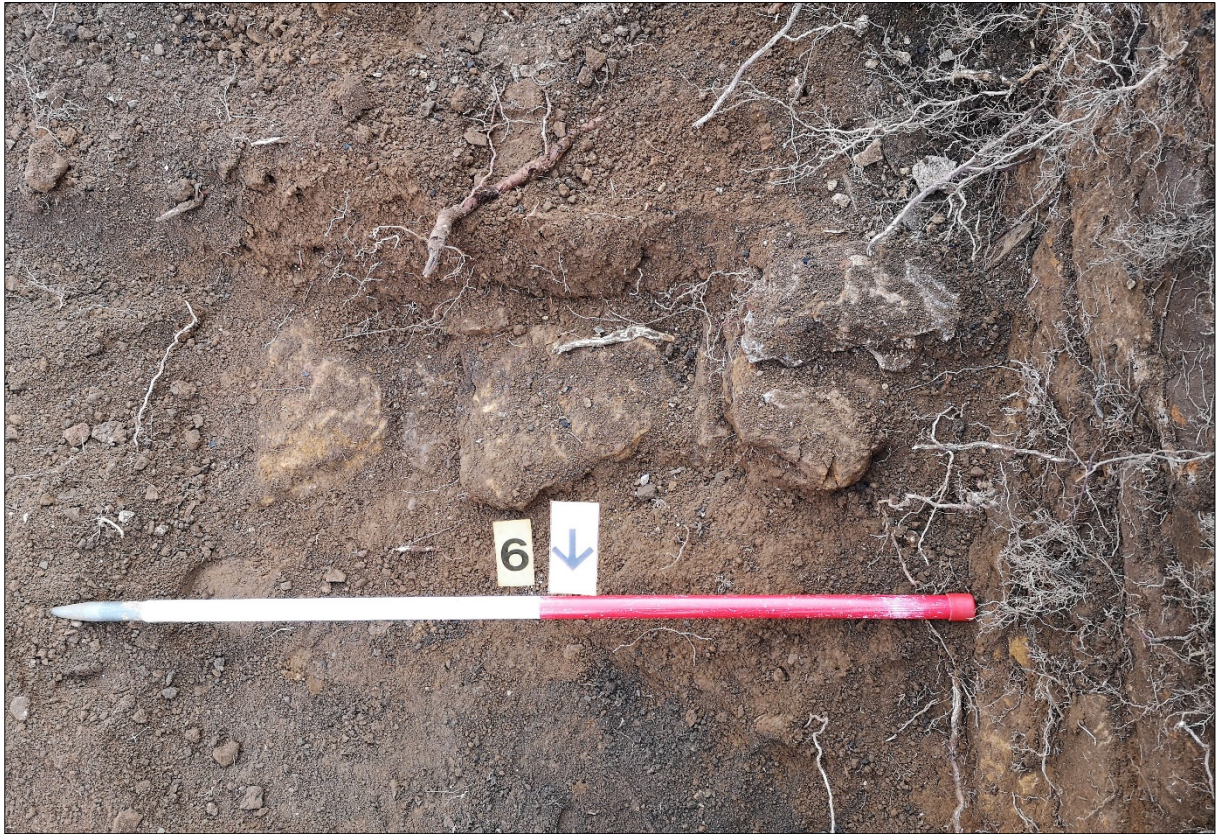
Figure 16: Wall (6), west at top, listed precinct wall at top.

Figure 17: Wall (6) looking south, listed precinct wall to right.

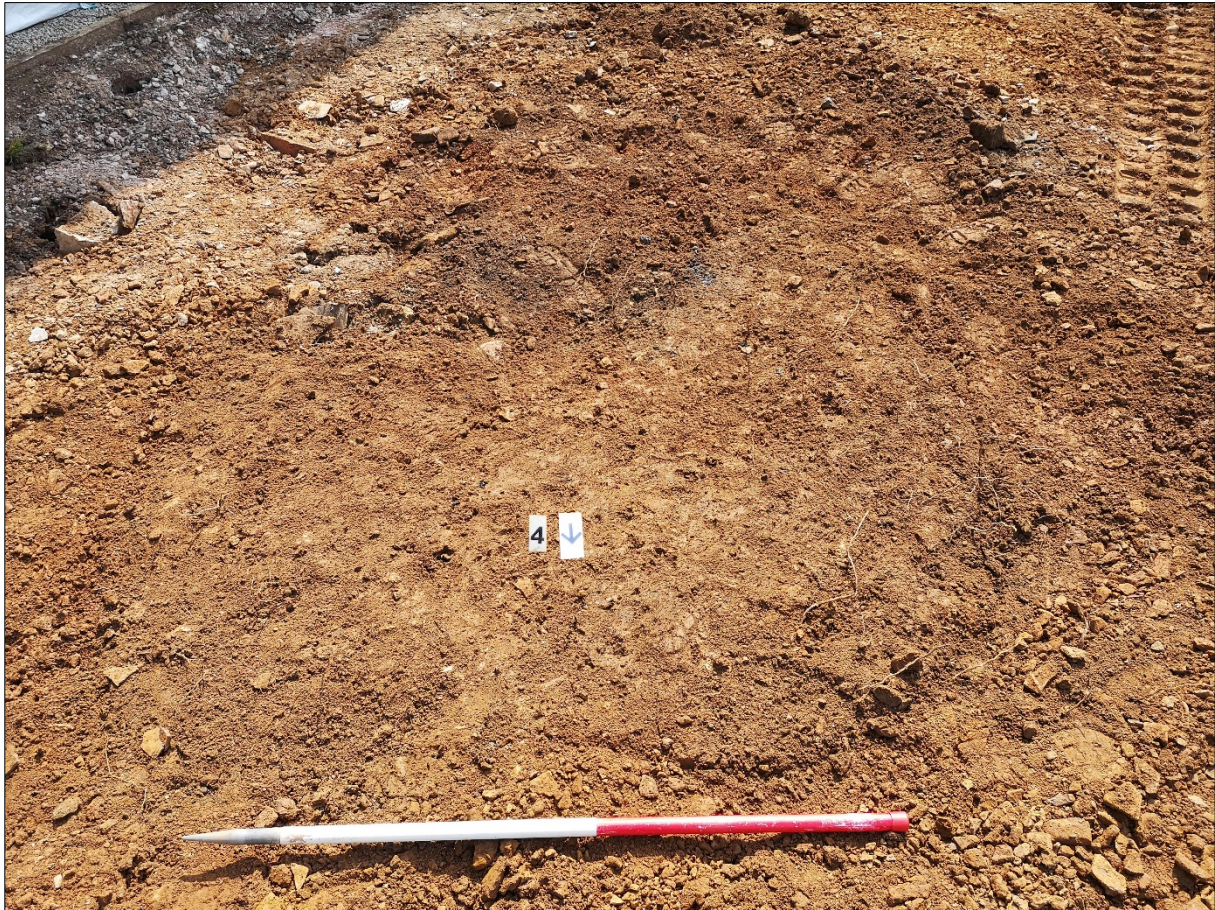
Figure 18: Pit [4] looking south, prior to sample excavation.

Pit (3) [4] was located in the north-east of the stripped area. It was sub-rectangular in plan, 2m east-west by 1.8m north-south. The feature was cutting natural, 0.15m deep with a shallow profile and had soil fill (3) consisting of a brown to grey clayey sand, with flecks of ironstone. The feature produced some 17th-18th finds and also more modern material including pottery, glass and ceramic building materials.

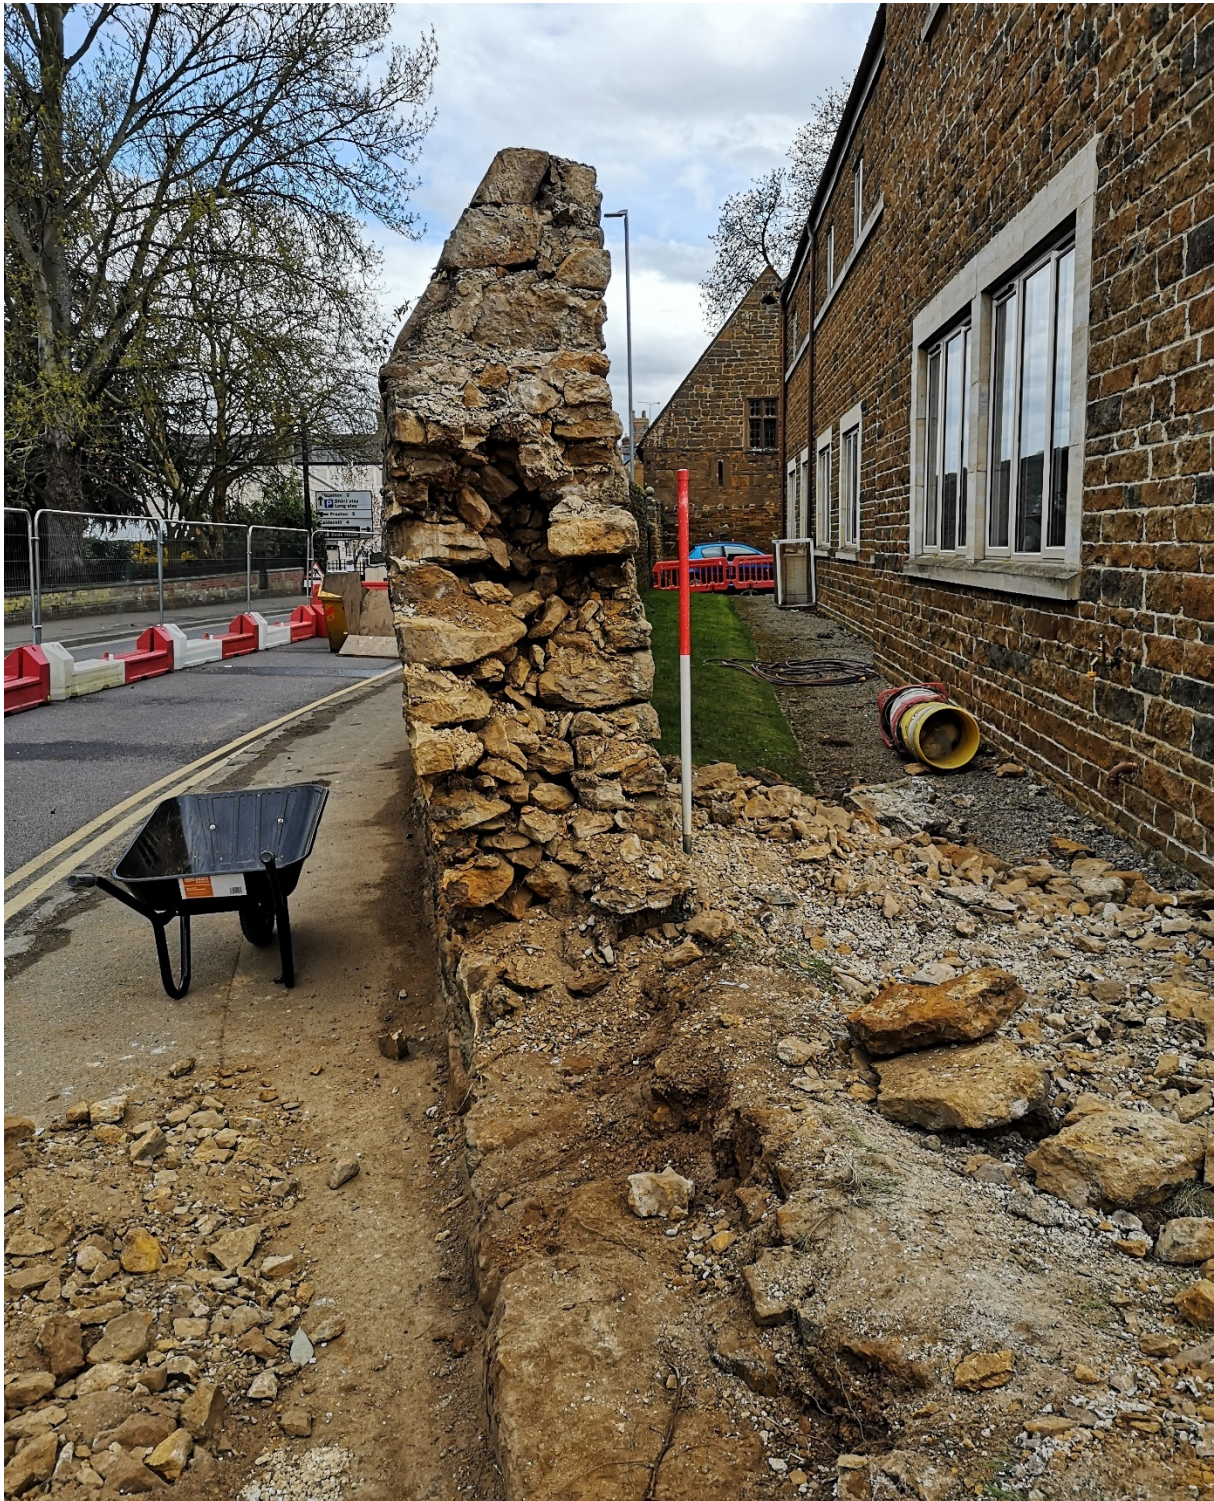
Figure 19: Wall (1) looking east, showing rubble core, mortared upper level, footings.

During the works, ongoing records were made of the wall as it was taken down. The information reported here is in addition to the Historic Building Survey carried out prior to groundworks (Coward 2019). The freestanding part of the wall could be seen to have a loose rubble core with many voids over the majority of the observed length (Figure 19). The void-like nature may be due to settlement of the infill – being directly adjacent to a road would exacerbate this. The rubble core consisted of ironstone fragments that were considerably smaller than the facing stones. As can be seen, the upper part of the structure, where the wall tapered, was mortared with a lime mortar. This difference may indicate that this upper level was a rebuild or addition.

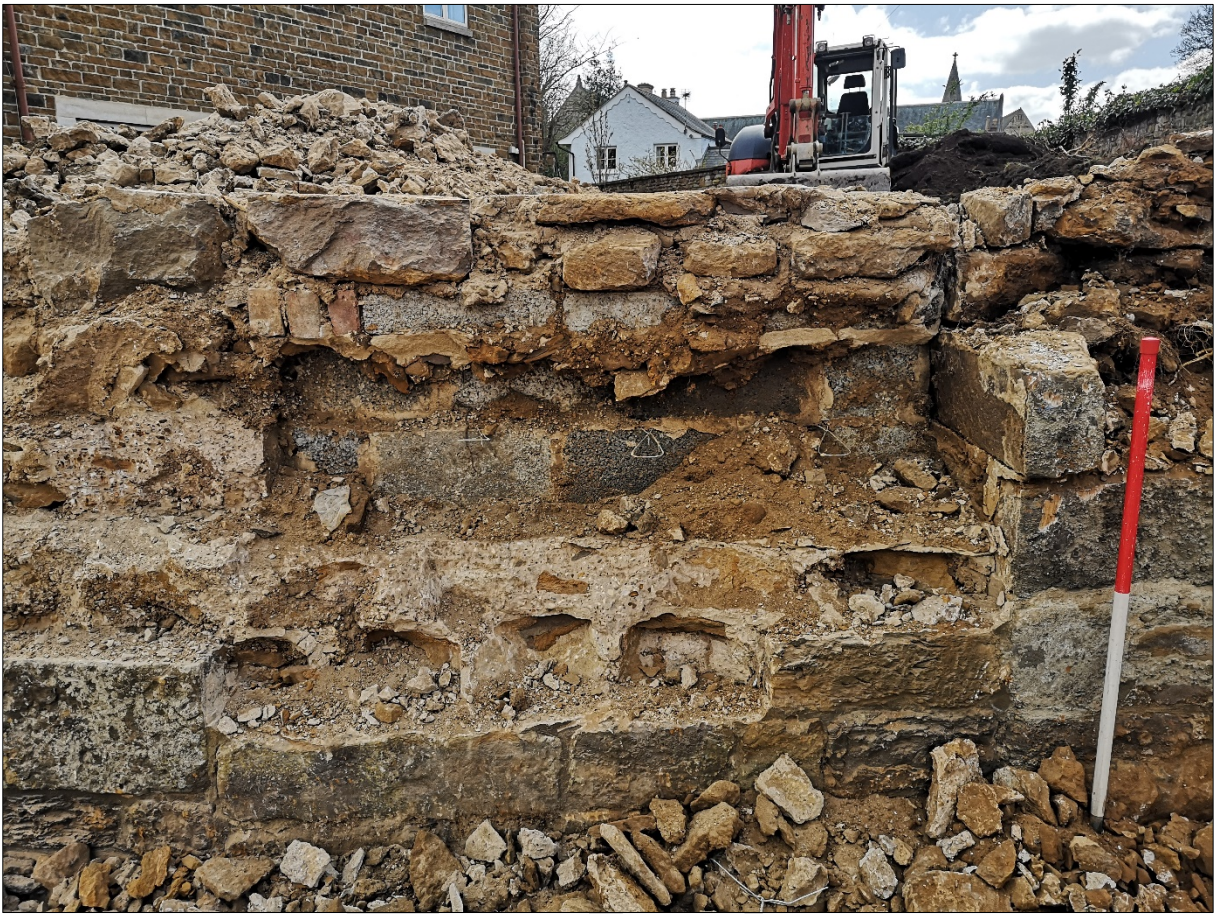
Figure 20: Wall (1) looking south, showing modern infilling.

In the area of the blocked entrance, where large quoins were still visible, on removal it was clear that this part of the wall has been rebuilt or infilled in recent times, with concrete blockwork visible within the structure (Figure 20). What is also clear is that a large section of the wall had been rebuilt, or re-mortared, with a hard cement mortar in the main section (Figure 21)

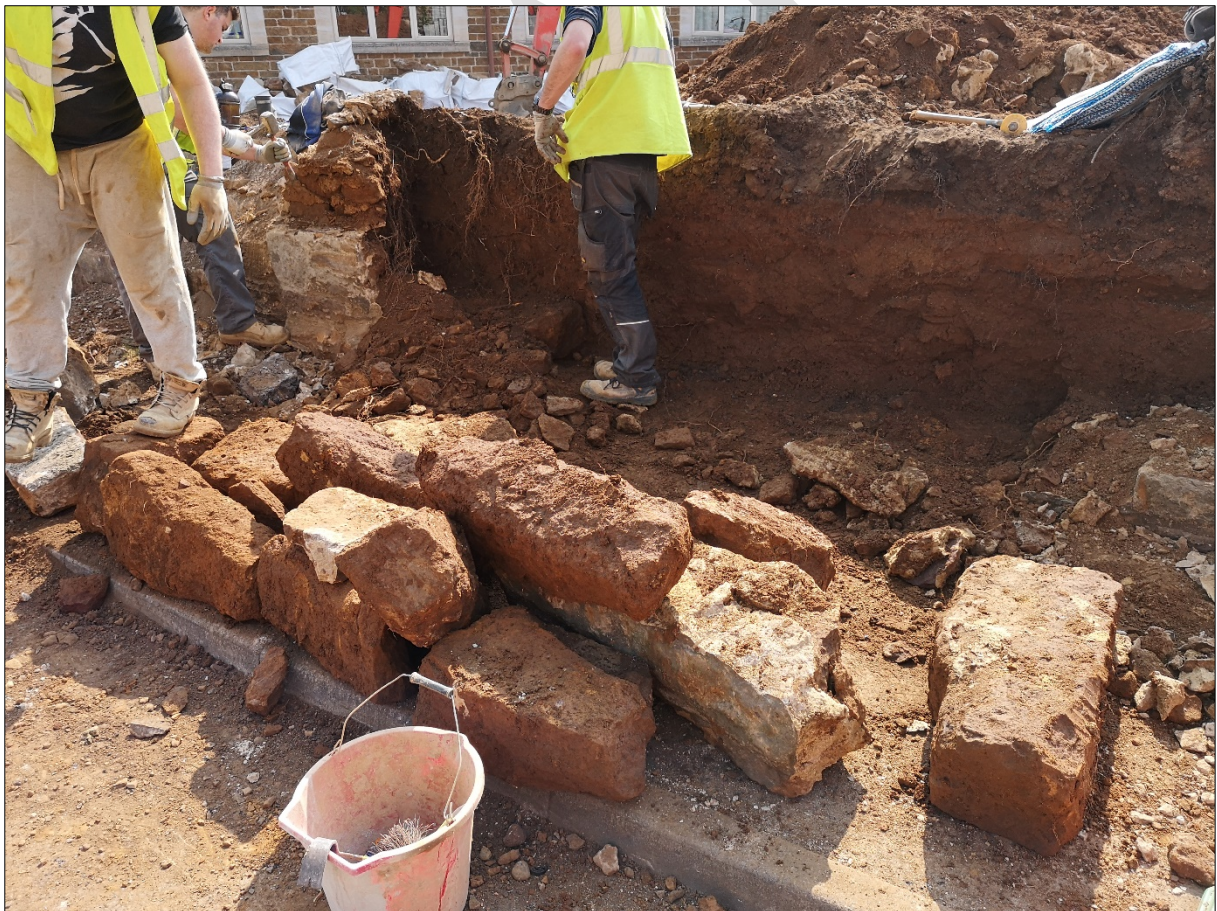
Figure 22: Footings being removed, looking south.

The footings of the wall where probably original consisted of large ashlar ironstone blocks, some up to 0.8m long and 0.4x0.3m across. The footings were a single course, mostly two blocks wide, and producing a footing width of c.0.8m, wider than the upstanding wall which was 0.6m wide (Figure 22). The footing on the internal side of the wall was absent in places, with this part of the wall resting on the natural ground which was a firm ironstone-rich gravel (Figure 23). That the footing was stepped out on the external side, and in fact was left in situ in one area as it was beyond the line of the wall suggests that the wall may have previously been

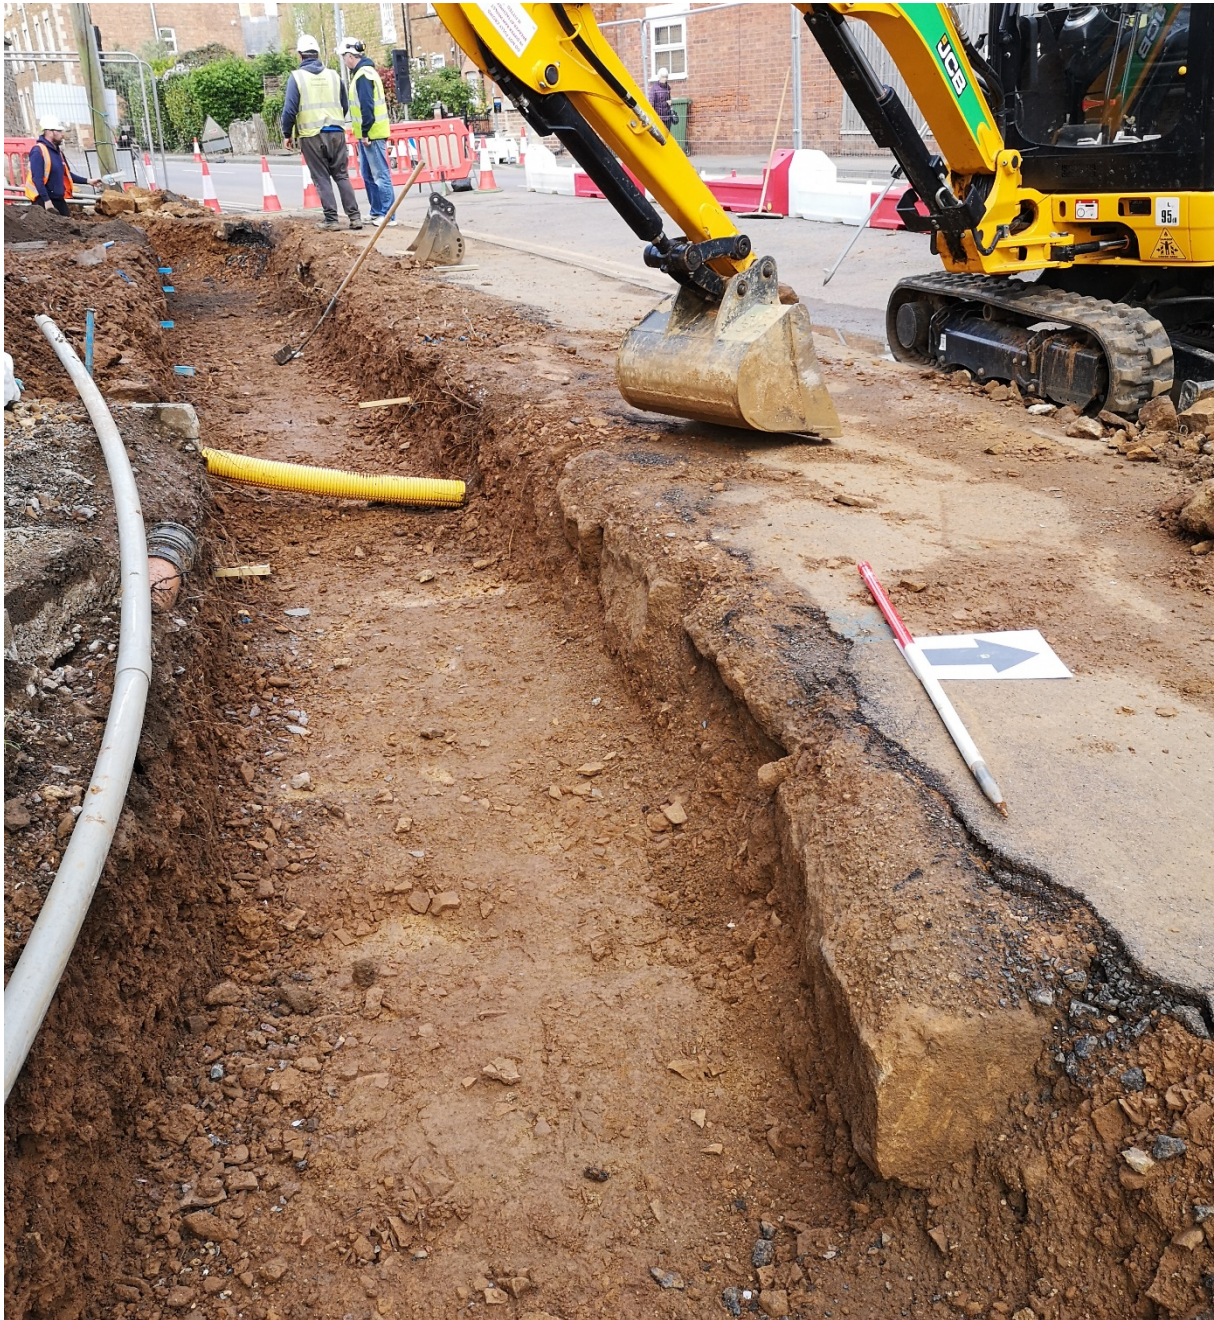
Figure 24: New footings trench after excavation. Also shows original footings beyond the line of the wall (right).

rebuilt on a more southerly alignment, with the original footings left in situ (Figure 24). Beyond the wall, it is unclear what the original ground level was, because the external area is low and clearly modern (pavement), and the internal area is the reworked garden soil, context (10).
