An Archaeological Watching Brief on land adjacent to 32 Stockerston Road, Uppingham, Rutland. NGR: SP863 997

Summary

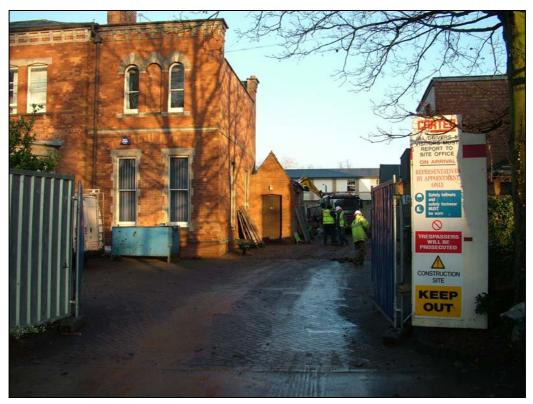
Plate 1. Development site viewed from Stockerston Road. No. 32 on left, theatre building on right, small outhouse to be removed.

Although not situated within the core of the town, the development site is within the historic settlement core and within the area of strip development along the main routes leaving the town (plate 1). Because of this it was considered that the works would be likely to expose any surviving medieval or post medieval archaeology.

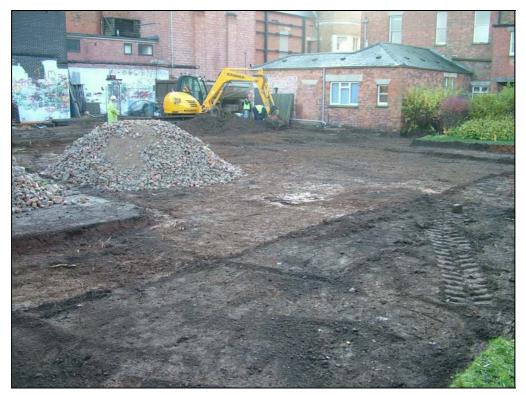
Plate 2. Site viewed from northwest. Topsoil partially removed. Location of demolished outbuildings shown by whitewash on theatre walls.

The foundations of the outhouse buildings which had recently been demolished appeared to be relatively shallow with fairly poor quality brickwork. The size of the bricks were of 19th or 20th century date. The foundation outline corresponds with the outline shown on the map in figure 3 and continues from the north eastern

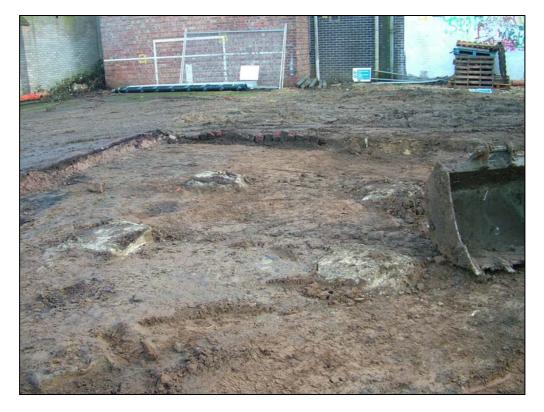
Plate 3.Truncated concrete posts and associated disturbance. Some tarmac surface still to be removed.

The subsoil strip revealed the presence of a back-filled garden pond along the centre of the western boundary. The pond cut into the natural substrate but was reasonably modern as a plastic sheet liner was found beneath it. 10.7m from the northern boundary were the remains of four truncated concrete posts with some disturbance around them (plate 3). It is not clear what function these served but the proximity to the demolished outhouses suggests perhaps a base for an oil tank or similar object.
