**A Photographic Survey at The Canal Basin, Derby Road/Bridge Street,
Loughborough, Leicestershire. NGR SK 5334 1996.**

Gerwyn Richards

University of Leicester Archaeological Services were commissioned by Metz Architects Ltd & William Davies Ltd to undertake a photographic survey at Loughborough Wharf, Bridge Street/Derby Road, Loughborough, Leicestershire. The photographic survey recorded the 19th and 20th century industrial and canal side buildings prior to their demolition.

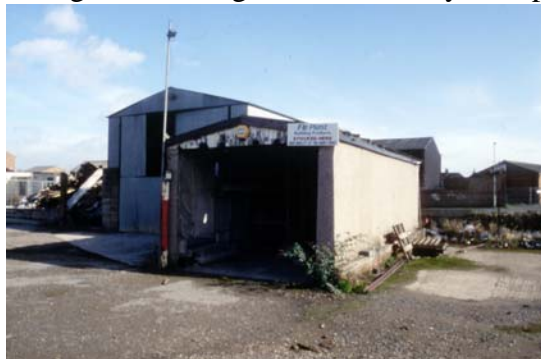
Figure 2 Building 1.

Building 1 is a pre-fabricated garage type building, measuring 0.9m by 0.35m. The structure itself is steel framed clad in concrete panels with a pink pebble dashed finish built on red brick plinth. The roof is corrugated asbestos cement sheets; there is vehicle access at the front of the building and pedestrian access to the rear. Internally, there is nothing of significance to record. This type of pre-fabricated garage has been common for the past thirty years, both for domestic and commercial use; therefore, dating the building more accurately is impossible.

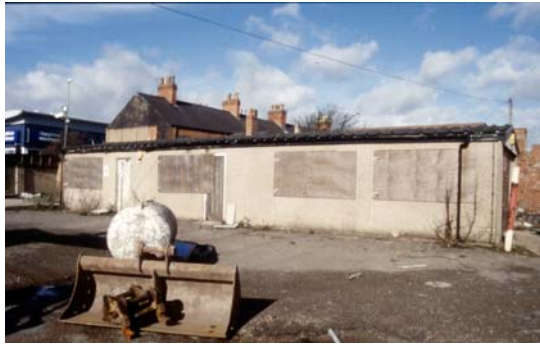
Figure 3 Building 2.

Building 2 is another pre-fabricated concrete building, although this time a larger workshop/commercial unit measuring 15.5m by 5m. Once again the structure is a steel frame, clad in concrete panels with a pink pebble dashed finish; the roof is corrugated asbestos cement sheets. There is vehicle access on the right hand gable end and two pedestrian entrances; one on the left hand gable end, towards the rear of the building and the second towards the left on the front wall. There are four steel framed windows, which had been over boarded at the time of the survey.

Internally the building has been divided into three rooms; the two rooms to the left of the building are currently in use as mess rooms, while the larger room to the right appears to be a workshop/ general store room.

As with building 1, this type of pre-fabricated building has been common for the past thirty years and more accurate dating is impossible. They are both; however, good examples of late 20th century mass produced architecture.

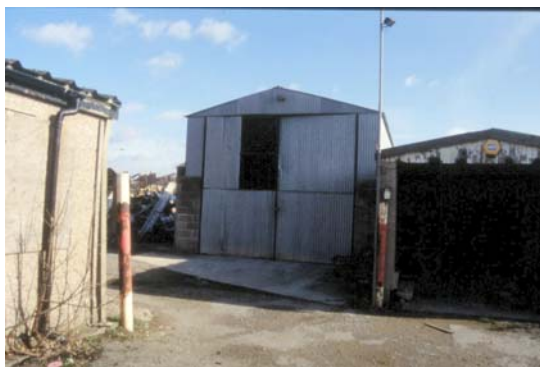
Figure 4 Building 3.

Building 3 is a steel framed structure, approximately 8.5m by 6m in size. It is half height breeze block walls and corrugated galvanized sheets; the roof is also of corrugated galvanized sheets. This building is not recorded on the most recent Ordnance Survey map of the proposed development area and is therefore, likely to be very recent in date.

The building is of very little architectural significance but again it is a good example of late 20th century mass produced architecture.

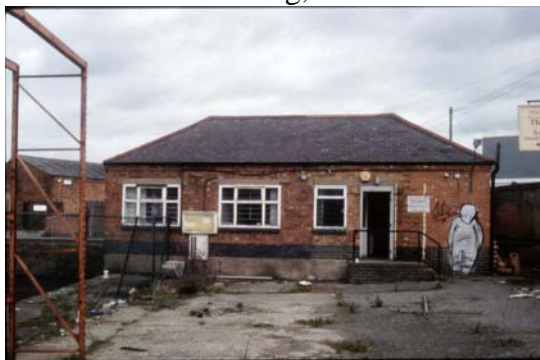
Figure 5 Building 7.

The final building within this part of the proposed development area is also the most significant. Building 7 was originally built as the pump house to supply water for the adjacent power station in 1904. The building itself is a single storey red brick building with a hipped roof of Welsh slate and red terracotta ridge tiles and a deep blue brick plinth, originally five courses deep, measuring 5m by 12.5m. The building is much altered both internally and externally; it appears to have been extended by approximately 4m to the left with, the blue brick plinth on this extension is 10 courses deep. Other than the extension, there has been little alteration to the exterior of the building, which still reflects its late Victorian utilitarian origins.

There are three timber framed windows and a pedestrian door on the front wall; the two windows to the left are likely to be original while the third and the door are later additions. There is another smaller timber framed window on the left hand gable and evidence of two bricked up windows on the rear wall. All the windows have blue splayed header brick sills.

There is a quaint jettied external chimney breast on the left gable over the canal basin; all internal evidence of the fireplace has been lost.

Internally the building is much altered and is currently being used as offices; there is nothing of the original form or function of the building visible and nothing of architectural significance remains.

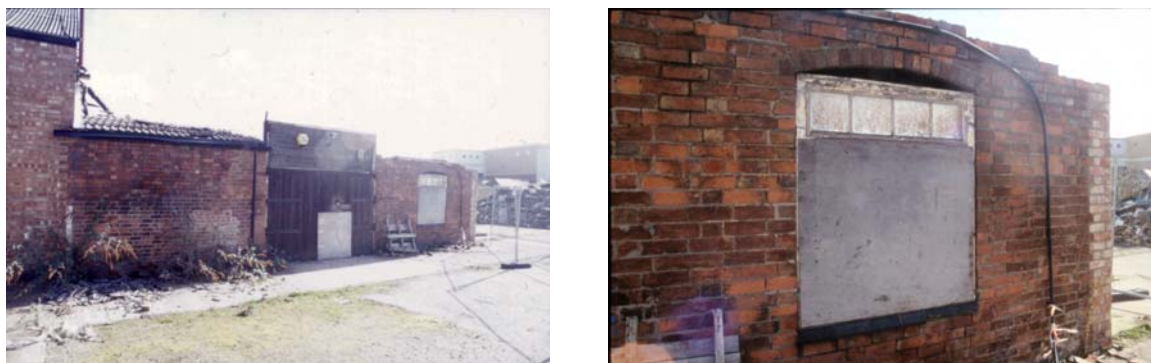
Figure 6 Two Views of Building 4.

Buildings 4, 5 & 6 are the more significant buildings within the proposed development area representing the last vestiges of the sites canal heritage. Building 4 is the earliest building, however extensive fire damage and subsequent partial demolition means that by the time this survey was carried out, very little of the building remained. The only substantial remains are the front wall and part of the rear wall facing the canal basin; the remaining architectural details are most visible in the front wall. The construction is of 9 by 2 ¾ inch red brick in a Flemish Bond with a blue brick damp proof course. There is a single surviving sixteen pane cast iron windows, with a central four light opening, probably original, on the front wall; there is an identical surviving window on the rear wall also. Both windows have blue splayed stretcher brick sills and cambered arches above.

Access is via a central full height double door and there is a pedestrian door on the rear wall facing the canal. As a result of the fire there are no interior features remaining; there are however rails still visible in the floor and an unusual angled protrusion in the right hand gable wall containing a blocked up fireplace, providing a glimpse of the buildings past. What little remains of the roof is clad with concrete tiles, obviously modern replacements.

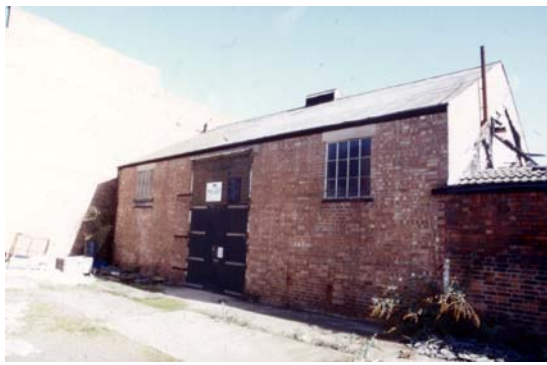
Figure 7 Building 5.

Building 5 is by far the largest of the buildings within the proposed development area, measuring 14m by 11m. The building is of Fletton brick in a Flemish Bond and corrugated asbestos cement sheets. Access is via a central full height double door, there two steel framed twelve pane windows immediately below eaves height. Being a warehouse, internally there is nothing of architectural significance. The roof is a soft wood Queen Post with Raking Struts construction.

The building has all the characteristics of a World War II era utilitarian building and undoubtedly dates from this era.

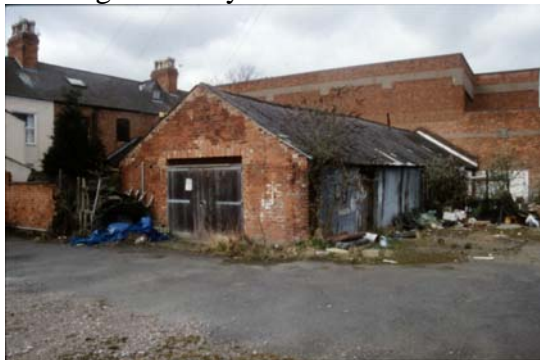
Figure 8 Building 6.

The final building within this part of the proposed development area is building 6; it is located immediately to the rear gardens of 25 to 35 (odd) Derby Road. It is a single story brick built building, currently in use as Exile Ironworks. Structurally the building is of 9 by 3 inch red bricks in a Flemish Bond, although the northernmost bay is of a smaller 9 by 2 ¾ inch red bricks.

As with the other buildings the roof is of corrugated asbestos cement sheets. The building appears to have originally been an open fronted structure with the wall plate supported on bullnose brick piers; this has now been bricked up in the right hand bays and the left hand bays are clad in corrugated galvanised sheets. Vehicle access is via a double door on the left hand gable, this appears to be a recent insert, there is evidence of a blocked up window or door to the left of the double door. There is also a pedestrian door in the front wall into the right hand bay. Internally there are two partitions creating one large bay to the left and two smaller connected bays to the right. The roof construction is a softwood kingpost with a bolted connection to the cross beam.

Although much altered the building appears to mainly late 19th century in date.

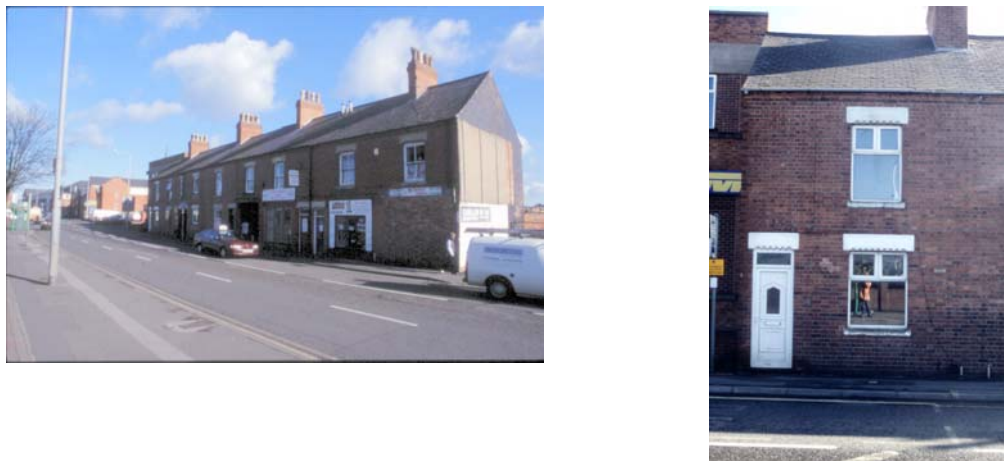
Figure 9 General View & Detailed View of Derby Road Frontage.

The final group of buildings within the proposed development is 25 to 35 (odd) Derby Road, a group of 6 brick built late Victorian terraced houses. The houses are all red brick in a Flemish Bond on the front walls and no identifiable bond on the rear wall, not an uncommon practice at this time as the rear of the property was not easily seen. The roofs all appear to be the original Welsh Slate. There is a covered cart entrance between numbers 27 and 29, providing access to the rear yard and buildings 4, 5 & 6 and a second covered pedestrian entrance between numbers 31 and 33.

All the houses have identical features such as the eaves, sandstone lintels and sills, chimneys capped with Crown Chimney pots and moulded bricks. This detail suggests that these houses were of a slightly higher status when new, a status since lost. There are a number of minor alterations and differences including the addition of UPVC windows and doors to a number of the properties, but on the whole the houses are in an as original condition.

Internally the houses are all much altered, although the basic lay out of two ground floor rooms, two first floor rooms and an attic room are the same and original. Most have had two storied rear extensions added housing kitchens and bathrooms at some stage. There are a number of original features surviving in a number of the houses including decorative plaster work, there was evidence that the original cast iron fireplaces had only recently been removed upstairs and a number of possibly original sash windows survived on the rear of the properties.

Numbers 25 and 27 have had their ground floors converted into shops, causing considerable change to the original floor plan. Both have also had much larger rear extensions added.
