**A Photographic Survey of the Former Shepshed Hosiery Company Factory,
Sullington Road, Shepshed, Leicestershire (NGR SK 4795 1895).**

University of Leicester Archaeological Services undertook a photographic survey of the former Shepshed Hosiery Factory Sullington Road, Shepshed, Leicestershire. The complex includes a range of typical midland industrial buildings dating from the late 19th to the late 20th century. The survey was commissioned by Corporate Architecture and Prime Life Ltd. The archive will be held by Leicestershire County Council, Heritage Services.

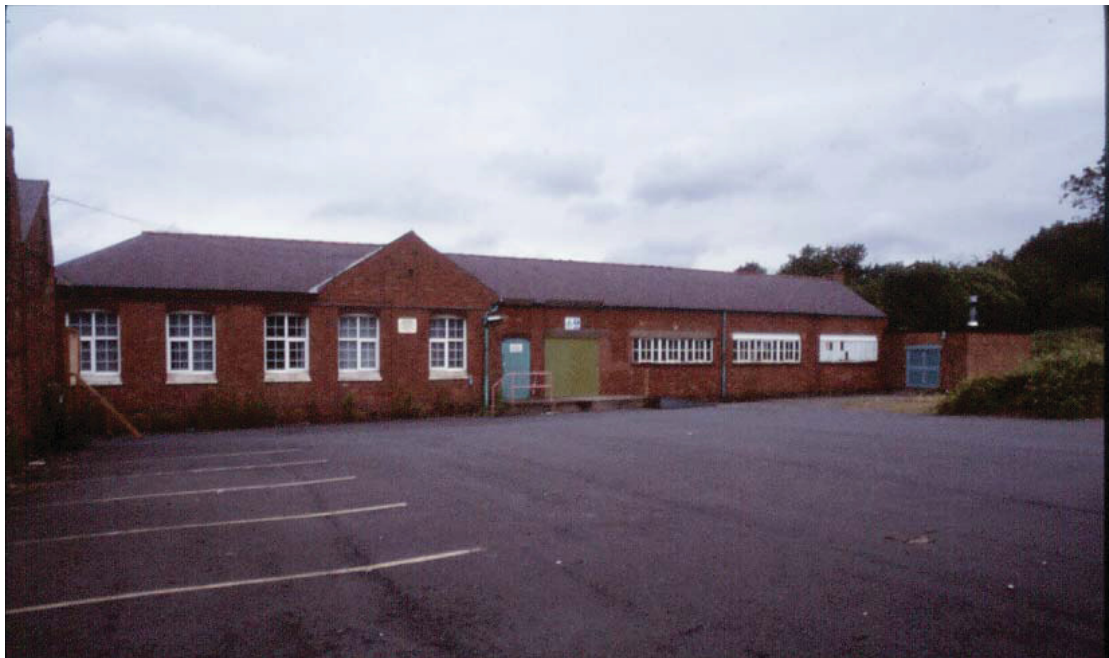
Colour Plate 1 Building 1, Southwest Facing Elevation.

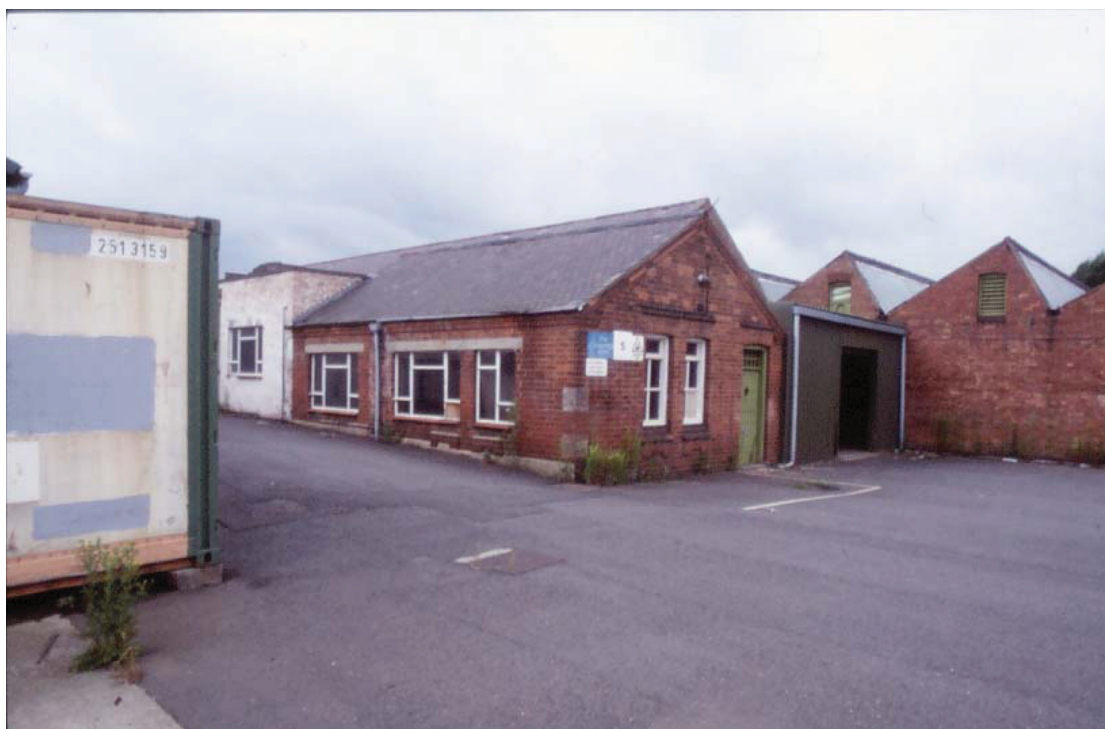
The majority of the main buildings currently occupying the site probably relate to the late 20th century rebuilding, mainly during the early 1960s. They consist almost exclusively of brick and imported Welsh slate; some of the buildings have corrugated asbestos north light roofs, internal roof construction is of both timber king post design and steel trusses. There are fragments of the earlier buildings surviving on site, most notably building 1, which dates from the early part of the 20th century (Colour Plate 1) and a small room on the northernmost gable end of building 2 (Bay 4) which has apparently remained largely unaltered (Colour Plate 2).

Colour Plate 2 Room on North Westernmost Gable of Building 2/Bay 4.

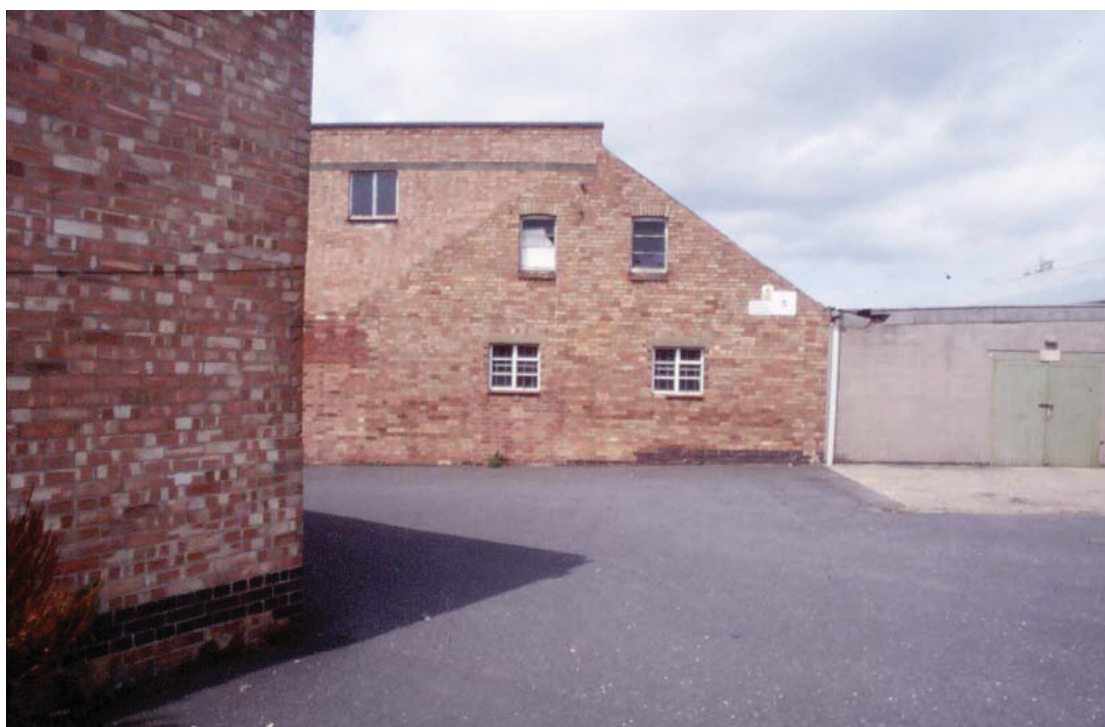
The only remains of the earliest phase of building which first appears on the 1903 Ordnance Survey is the southernmost gable end of building 2 (Bay 4). The interior of this gable has been re-skinned in modern breeze-blocks, leaving no interior detail visible (Colour Plate 3).

Colour Plate 3 Gable End of Earliest Phase of Building.
