An Archaeological Evaluation on land at Rugby Road Lutterworth Leicestershire, LE17 4HB

NGR: SP 545 839

ULAS Report Number: 2019-128

An archaeological field evaluation on land at Rugby Road, Lutterworth, Leicestershire (SP 545 839)

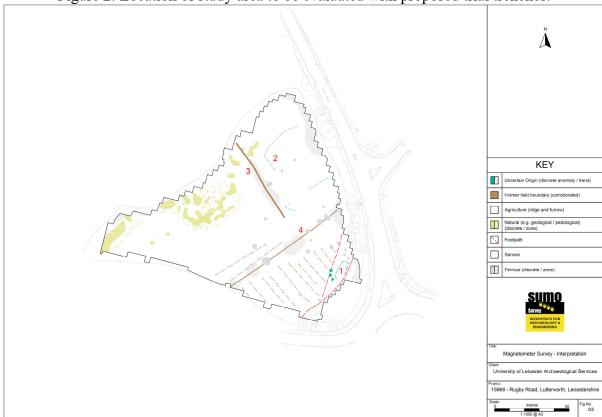
Figure 3: Plan showing results of geophysical survey (after Davies 2019)

Geophysical survey carried out in 2019 as part of the evaluation recorded no magnetic responses that could be interpreted as being of significant archaeological interest.

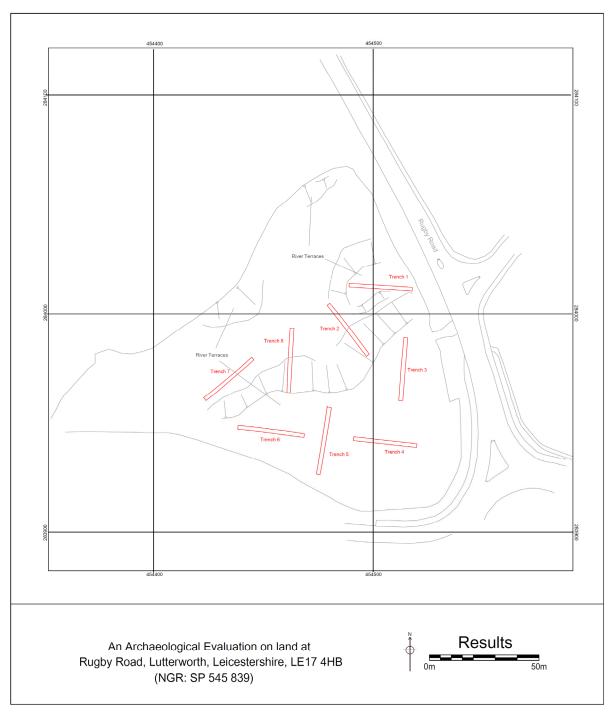
Figure 5: Location of trial trenches

Eight trenches were excavated within the development area (Fig. 5).

No archaeological finds or deposits were located within any of the trenches. The natural substratum was generally reached after around 0.25m-0.50m of topsoil and subsoil had been removed. The only features revealed were field drains observed within four trenches (2, 3 4 and 6). The field drains were typically orientated east to west and comprised ceramic pipes or bricks and granite rubble.

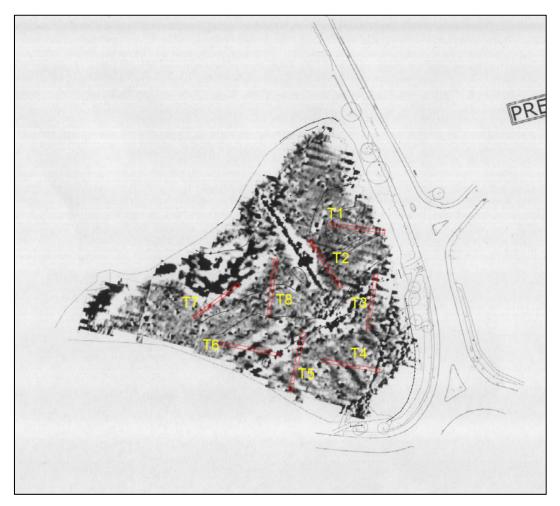
Figure 6 Excavated trenches overlying geophysical results.

The archaeological evaluation by trial trenching revealed no evidence for archaeological features or finds within the any of the trenches, apart from an east-west post-medieval boundary ditch revealed within trenches 3, 5 and 6, and medieval ridge and furrow visible in trenches 3, 4, and 5. There was no evidence of any other features in the trenches and other potential anomalies located by the geophysical survey were most likely geological in nature.

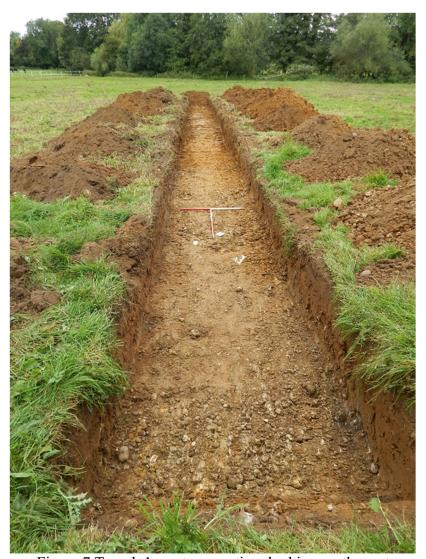
Figure 7 Trench 1, post excavation, looking north-west

OD Height: 105.45m	(SE) 0m	5m	10m	15m	20m	25m	28m (NW)
Topsoil Depth	0.20m	0.20m	0.20m	0.20m	0.20m	0.20m	0.20m
Subsoil Depth	0.30m	0.20m	0.35m	0.40m	0.35m	0.25m	0.25m
Depth of Natural	0.50m	0.40m	0.55m	0.60m	0.55m	0.45m	0.45m
Base of Trench	0.60m	0.45m	0.65m	0.65m	0.60m	0.50m	0.50m

This trench was located within the north-east corner of the proposed development and targeted a moderately sloping earth platform (Figs 5 and 7). No archaeological finds or deposits were located within this trench. The natural substratum was generally reached after around 0.40m-0.60m of topsoil and subsoil had been removed. The only features revealed gradual undulating natural clays and gravels.

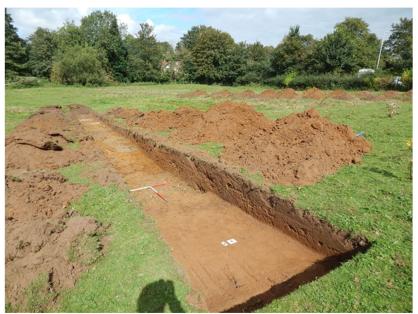
Figure 8 Trench 2, post excavation, looking north-east

OD Height: 105.64m	(S) 0m	5m	10m	15m	20m	25m	29m (N)
Topsoil Depth	0.20m	0.20m	0.20m	0.20m	0.20m	0.20m	0.20m
Subsoil Depth	0.25m	0.55m	0.30m	0.25m	0.20m	-	-
Depth of Natural	-	0.75m	0.50m	0.45m	0.40m	-	-
Base of Trench	0.45m	0.75m	0.55m	0.45m	0.40m	0.20m	0.20m

Trench 2 was situated in the north-east corner of the site and was orientated north to south. It had targeted a surface that comprised terrace or platform, which sloped downward from north to south and extended into a level flood plain area (Figs 5 and 8). This trench revealed at the base a sloping natural comprising brown grey sands and gravels, which were sealed under 0.55m subsoil or post glacial colluvial deposit. The northernmost end of the trench was level and natural was truncated by several land drains laid in lattice pattern and sealed under a subsoil that measured 0.20m deep. A modern water pipe had truncated the southern end of the trench. No archaeological features were identified.

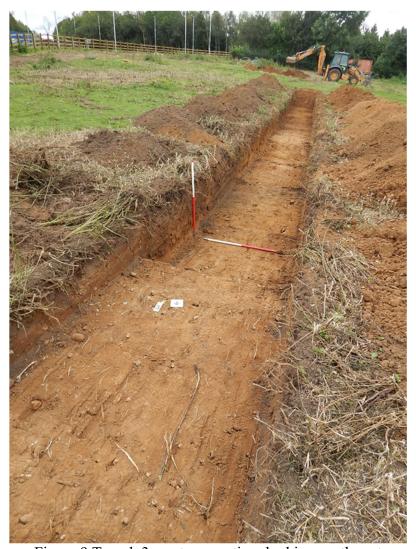
Figure 9 Trench 3, post excavation, looking south east

OD Height: 107.92m	(NE) 0m	5m	10m	15m	20m	25m	29m (SW)
Topsoil Depth	0.20m	0.20m	0.20m	0.20m	0.20m	0.20m	0.20m
Subsoil Depth	-	0.40m	0.40m	0.40m	0.40m	0.50m	0.60m
Depth of Natural	-	0.75m	0.50m	0.45m	0.40m	0.70m	0.80m
Base of Trench	0.30m	0.80m	0.80m	0.70m	0.75m	0.80m	0.90m

Trench 3 was placed towards the east end of the proposed development area and targeted both a level area and geophysical anomalies, that were thought to be medieval ridge and furrow and a post-medieval boundary ditch (Figs 5 and 6). Excavation of the trench revealed natural sands and gravels at base of the trench that sloped gradual downwards south to north (Fig 9). Overlying was deep subsoil that measured between 0.40m and 0.60m deep, which was thought to be a post-glacial colluvial deposit. Towards the southern half of the trench ridge and furrow

features were only visible as moderate undulating features within the topsoil. The northern half of the trench contained a backfilled boundary ditch and the occasional modern pottery retrieved and recorded before it was discarded. A modern water pipe had truncated the northern end of the trench.

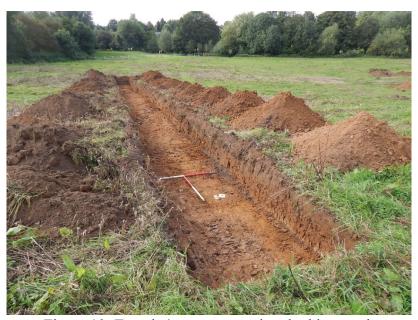
Figure 10: Trench 4, post excavation, looking north

OD Height: 109.55m	(S) 0m	5m	10m	15m	20m	25m	31m (N)
Topsoil Depth	0.20m	0.20m	0.20m	0.20m	0.20m	0.20m	0.20m
Subsoil Depth	0.25m	0.30m	0.30	0.30m	0.30	0.35m	0.40m
Depth of Natural	0.45m	0.50m	0.50m	0.50m	0.50m	0.55m	0.60m
Base of Trench	0.60m	0.55m	0.50m	0.50m	0.60m	0.60m	0.70m

This trench was located within the southern half of the site and targeted a flat area with geophysical anomalies thought to be medieval ridge and furrow (Figs 5 and 6). Following the removal of the overburden it was clear that no archaeological remains occupied the trench (Fig. 10). The natural at the base of the trench comprised sands and gravels and sloped gradual downwards south to north. The remnants of the medieval ridge and furrow field system were visible as moderate undulating features within the topsoil.

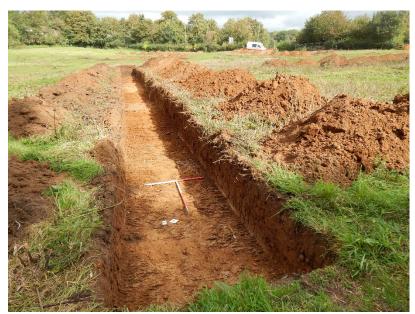
Figure 11: Trench 5, post excavation, looking north-east

OD Height: 107.51m	(W) 0m	5m	10m	15m	20m	25m	30m (E)
Topsoil Depth	0.20m	0.20m	0.20m	0.20m	0.20m	0.20m	0.20m
Subsoil Depth	0.30m	0.45m	0.50m	0.45m	0.45m	0.30m	0.20m
Depth of Natural	0.50m	0.65m	0.70m	0.65m	0.65m	0.50m	0.40m
Base of Trench	0.65m	0.80m	0.85m	0.85m	0.80m	0.70m	0.60m

Trench 5 had been placed towards the south-west corner of the development area and had targeted an area of geophysical anomalies thought to be medieval ridge and furrow and a post-medieval boundary ditch (Figs 5 and 6). Excavation of the trench revealed natural sands and gravels mixed with clay at base of the trench (Fig. 11). The natural sloped gradually downwards from south to north and was overlain by a deep post-glacial colluvial deposit or hill wash that measured between 0.30m and 0.50m deep. This trench did contain ridge and furrow but it was only visible as moderate undulating features within the topsoil, whilst a modern boundary ditch was seen at the northern end of the trench.

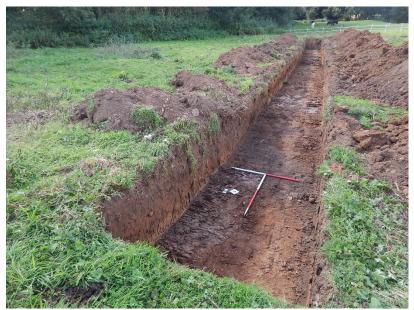
Figure 12: Trench 6, post-excavation, looking north-west

OD Height: 106.06m	(SE) 0m	5m	10m	15m	20m	25m	30m (NW)
Topsoil Depth	0.30m	0.30m	0.20m	0.20m	0.30m	0.30m	0.30m
Subsoil Depth	0.30m	-	0.45m	0.20m	0.40m	0.30	0.50m
Depth of Natural	0.60m	-	0.65m	0.50m	0.70m	0.60m	0.80m
Base of Trench	0.80m	0.70m	0.80m	0.70m	0.90m	0.75m	0.90m

Trench 6 was placed towards the north-west corner of the site and targeted an area of geophysical anomalies thought to be a boundary ditch (Figs 5 and 6). This trench had targeted what appeared to be a moderate sloping earth platform but excavations of the trench revealed natural brown sands and gravels that sloped downwards from south to north (Fig 12). Overlying was a post-glacial colluvial deposit that measured 0.30m deep at the southern end of the trench and 0.50m at the northern end. A potential feature was seen towards the centre of the trench which on investigation revealed a natural feature. At the southern end of the trench a modern boundary ditch was visible.

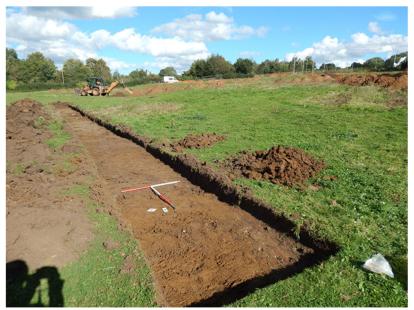
Figure 13 Trench 7, post excavation, looking east

OD Height: 103.38m	(W) 0m	5m	10m	15m	20m	25m	29m (E)
Topsoil Depth	0.20m	0.20m	0.20m	0.20m	0.20m	0.20m	0.20m
Subsoil Depth	0.05m	0.053m	0.10m	0.10m	0.10m	0.15m	0.1 0m
Depth of Natural	0.25m	0.25m	0.30m	0.30m	0.30m	0.35m	0.300m
Base of Trench	0.25m	0.25m	0.30m	0.30m	0.30m	0.35	0.30m

This trench targeted a blank geophysical area on the north-west corner of the field and a flat flood plain area (Figs 5 and 6). Excavations revealed a natural grey silty clay with several ceramic pipe field drains laid in a lattice pattern (Fig. 13). The trench contained little or no subsoil which suggests possible landscaping activity or natural erosion. No archaeological features were revealed with in the trench.

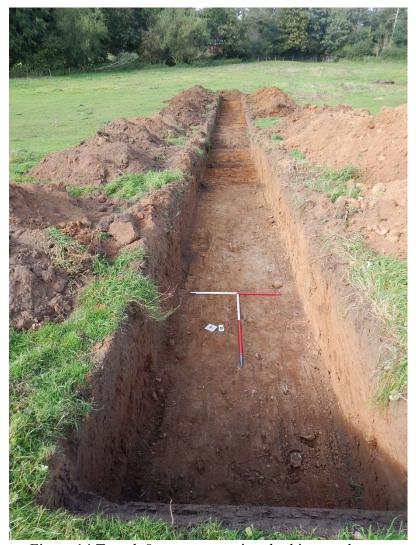
Figure 14 Trench 8, post excavation, looking north-east

OD Height: 103.64m	(SW) 0m	5m	10m	15m	20m	25m	32m (NE)
Topsoil Depth	0.20m	0.20m	0.20m	0.20m	0.20m	0.20m	0.20m
Subsoil Depth	0.70m	0.50m	0.50m	-	0.40m	0.50m	-
Depth of Natural	0.90m	0.70m	0.70m	-	0.60m	0.70m	-
Base of Trench	0.92m	0.80m	0.80m	0.20m	0.70m	0.85m	0.20m

Trench 8 had been placed towards the centre of the development area and had a sloping earth platform or terrace (Fig 5 and 6). Excavation of the trench revealed natural sands and gravels

mixed with clay at base of the trench (Fig. 14). The natural that sloped gradually downwards from south to north was overlain by a deep colluvial deposit or hill wash that measured between 0.40m and 0.70m. The northernmost end of the trench was flat and natural was truncated by several land drains. No archaeological feature were visible.
