**An Archaeological Evaluation at Hall Farm, Main Street, Sutton Cheney
Leicestershire, CV13 0AJ**

NGR: SK 41730 00360

**ULAS Report No 2019-133 v3
© ULAS 2019**

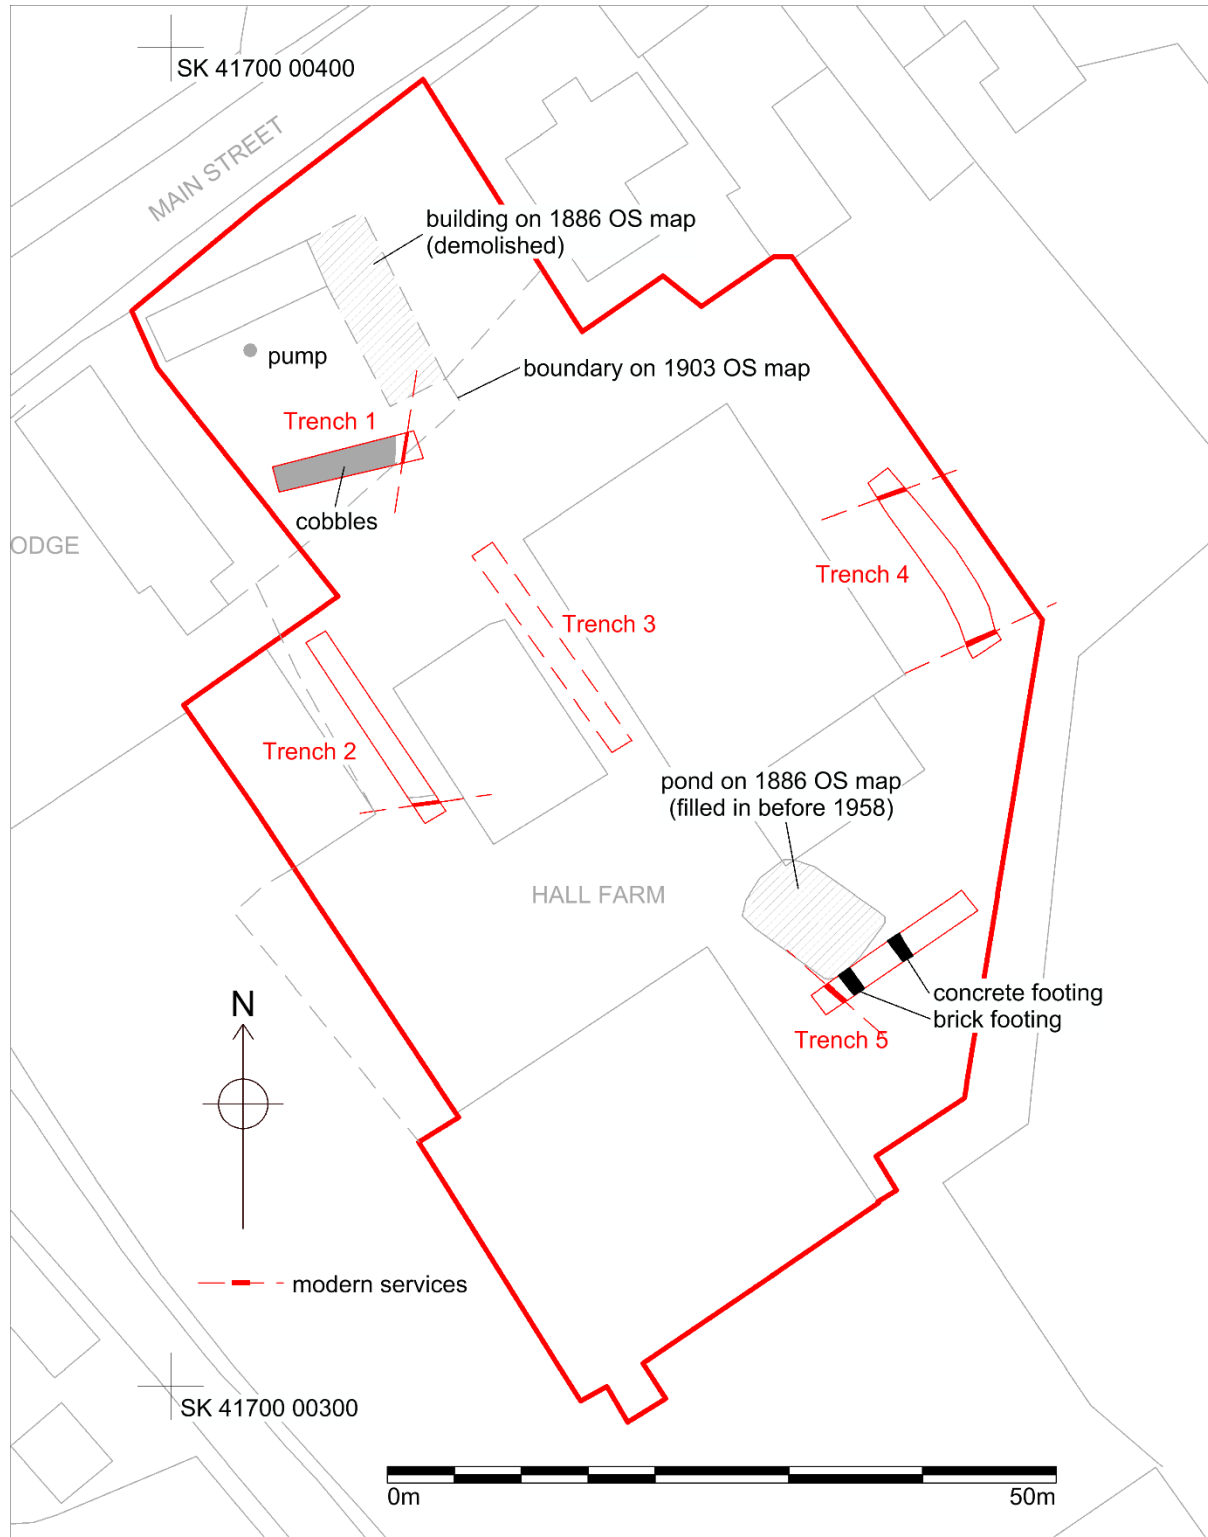
Figure 3: Location of trenches showing archaeological features, modern services and pertinent information from 1st & 2nd edition 1:2500 Ordnance Survey maps (1886 & 1903).

A total of 4 trenches was excavated within the development area (Figure 3). This meant 95.4 sq m of trenching was completed, comprising a 3.2% sample of the site.

On the Main Street frontage, the cobbled surface in Trench 1 probably relates to a small enclosed yard area associated with an L-shaped building and pump shown on the 1st edition 1:2500 Ordnance Survey map of 1886. This appears to be a small 19th-century farmyard or service yard to the east of Ivy Lodge, itself a late 18th / early 19th-century building with possible earlier elements (Andrew Hyam pers. comm.). Ordnance Survey maps show that part of the L-shaped building was demolished sometime between 1966 and 1983 and this may account for the large quantity of brick rubble found on top of the cobbled surface in Trench 1. Pottery from the surface gave it a *terminus post quem* of the late 19th / 20th century and it is probably contemporary with the L-shaped building, which also appears to be of 19th-century date, rather than the earlier house to the west. Subsoil was not present beneath the surface, which rested directly on the natural substratum, and it is unlikely that earlier stratified deposits survived in this area although deeper intrusive features, if present, might remain relatively intact.

To the south, maps show that much of the present farmyard covered ground which was formerly field, probably pasture, until the late 20th century. This is reflected in the soil sequence in Trenches 2 and 4 which both revealed undisturbed subsoil with a diffuse interface with the natural substratum. This suggests that the soil formed naturally and had seen very little disturbance. Topsoil was missing from these trenches, having been previously removed when hardcore and gravel was laid to create the farmyard. Neither trench produced evidence of archaeological activity in the vicinity.

A similar soil sequence was observed at the east end of Trench 5, at the southern end of the site, but most of the trench crossed a large waterlogged ‘hollow’ which coincides with the southern edge of a rectangular pond depicted on Ordnance Survey maps from 1886 to 1929. The pond was backfilled with soil containing 20th-century pottery and building material. This is consistent with map evidence which indicates that the pond was filled in sometime between 1929 and 1958. The brick and concrete footings in Trench 5 cannot be directly equated with any building on Ordnance Survey maps. However, they clearly post-dated the backfilling of the pond and must, therefore, be of later 20th-century date and are probably associated with the farmyard which was built in the 1970s/80s.

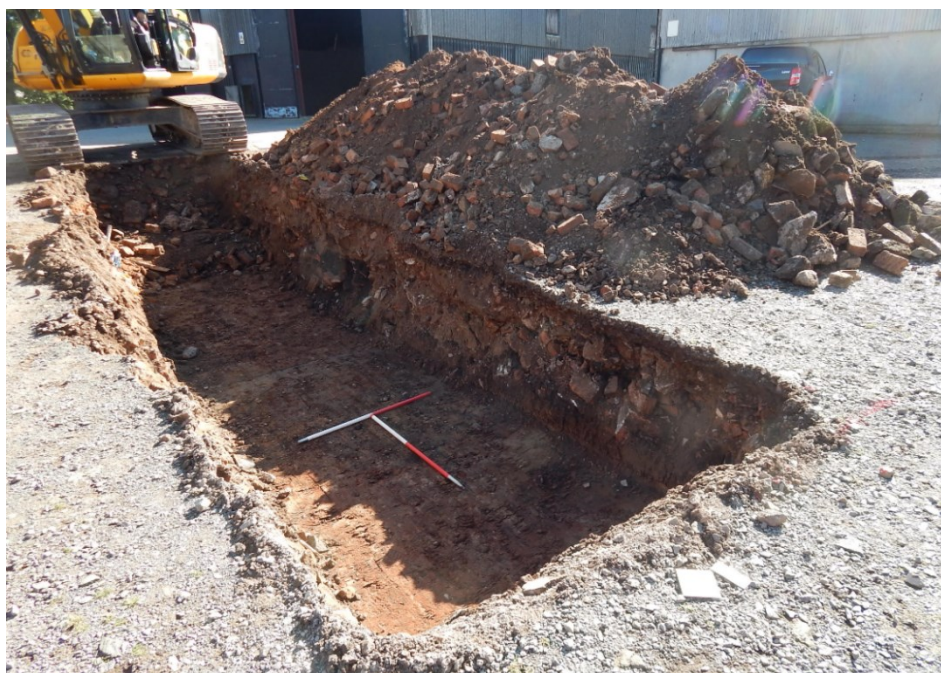
Figure 4: Trench 1, post excavation, looking east

Trench 1 was located toward the north end of the site, c.20m south of Main Street, and was broadly orientated west to east. Ground gently sloped down across the trench area from 118.6m aOD in the east to 118m aOD in the west. Modern gravel farmyard surface (c.0.2m thick) and made ground comprising a layer of modern brick rubble up to 0.6m thick was removed exposing a cobbled surface (c.0.2m thick) overlying natural substratum (Figure 4). The surface covered the western two-thirds of the trench and contained late 19th/20th-century pottery (spotted dated on site and not retained). The natural substratum, mottled red clay with patches of sand and gravel, was observed

at c.117.8m aOD at the west end of the trench. At the east end, the cobbles and natural were truncated by a service cable. No other archaeological features or deposits were visible.

The brick rubble may have come from the demolition of part of a brick farm building immediately north of the trench, dismantled in the 1970s or 80s, but this is by no means certain and it could be imported made ground. The cobbled surface presumably relates to an earlier phase of the farmyard. When it was first laid is unclear but it was presumed to be of 19th-century date.

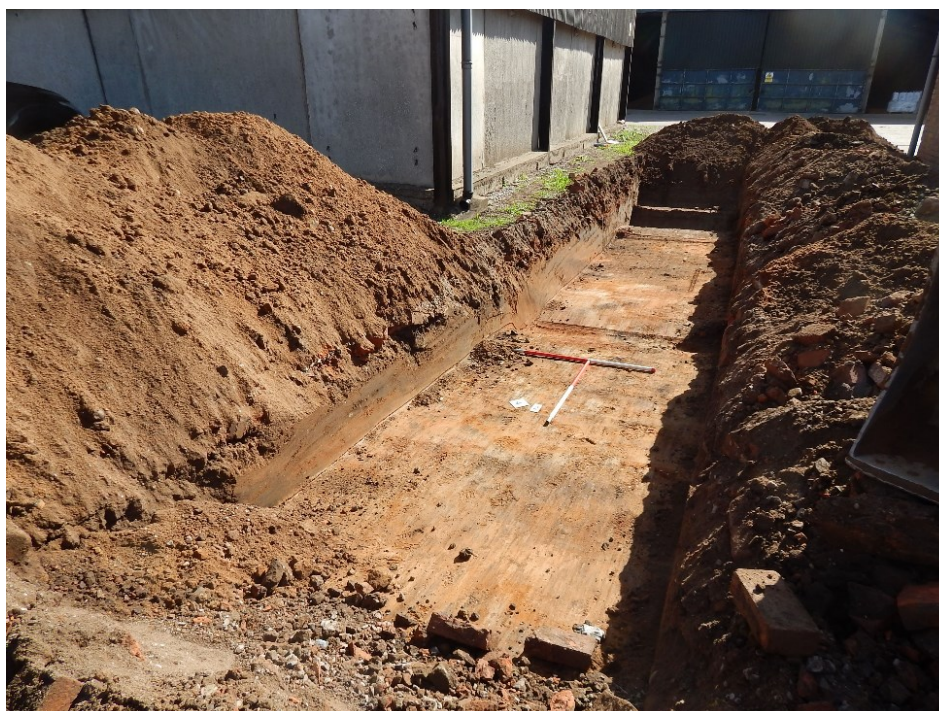
Figure 5: Trench 2, post excavation, looking south-east

Trench 2 was located on the west side of the site, 12m south of Trench 1 and was placed between a workshop and a barn broadly orientated south-east to north-west on level ground at 118.40m OD. Modern gravel farmyard surface (c.0.1m thick) and made ground comprising a layer of modern brick rubble up to 0.3m thick was removed exposing subsoil (up to 0.5m thick) overlying natural substratum (Figure 5). The subsoil, which thickened from c.0.3m in the north to c.0.5m in the south, was dark greyish-brown sandy clay mixed with pebbles. The natural substratum, mottled yellowish-orange and brown sand with gravel patches, was observed

between *c.* 117.5m aOD towards the south end of the trench and *c.* 117.8m at the north. At the south end of the trench, the natural was truncated by a service cable. No other archaeological features or deposits were visible.

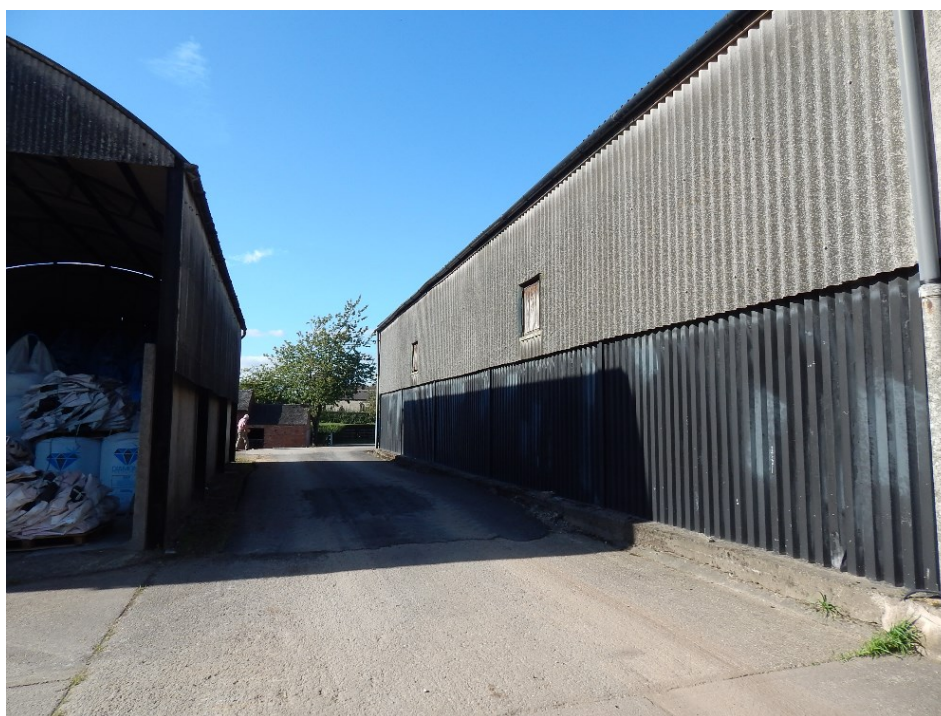
Figure 6 Location of proposed Trench 3, looking north.

Trench 3 was to be located at the centre of the site between two barns (Figure 3 & Figure 6). However, due to site constraints (confined space, deep concrete surfaces and the possible presence of an electricity cable) it was agreed with the consultants TEP and the Senior Planning Archaeologist for Leicester County Council that this trench would not be excavated.

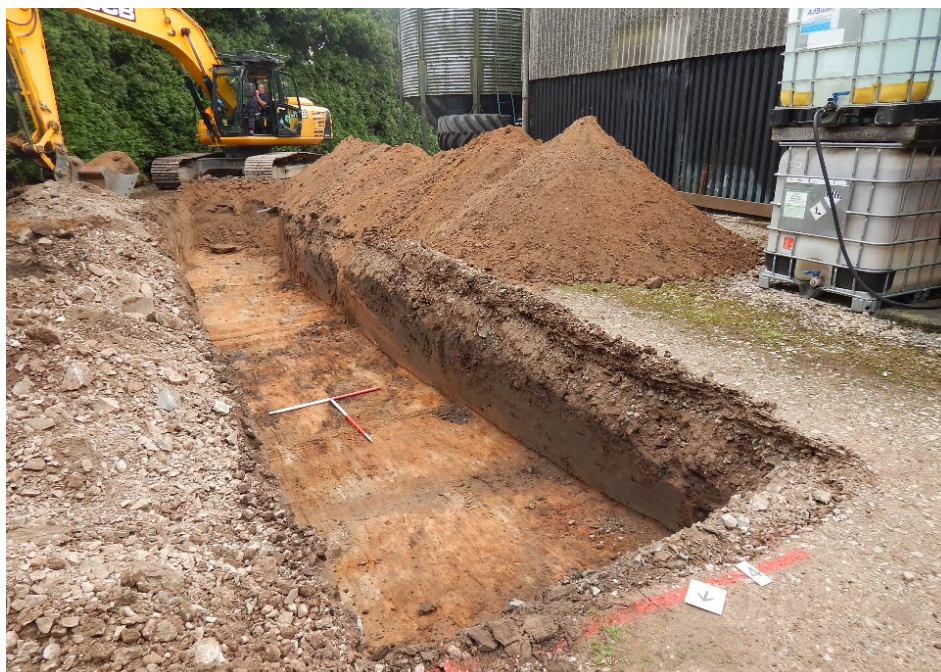
Figure 7: Trench 4, post excavation, looking south.

Trench 4 was located on the east side of the site east of a large barn, broadly orientated north-west to south-east, on level ground at 118.9m aOD. Modern gravel farmyard surface and brick rubble hardcore (*c.* 0.4m thick) was removed exposing subsoil (up to *c.* 0.65m thick) overlying natural substratum (Figure 7). The subsoil was dark greyish-brown sandy clay mixed with pebbles. The natural substratum, mixed pale orangeish-brown sandy-clay and orangeish-brown

sand mixed with frequent pebbles, was observed at *c.*117.9m aOD. At the south end of the trench, the presence of a service drain meant that ground was not excavated down to natural. At the north end of the trench a modern land drain was observed. No other archaeological features or deposits were visible.

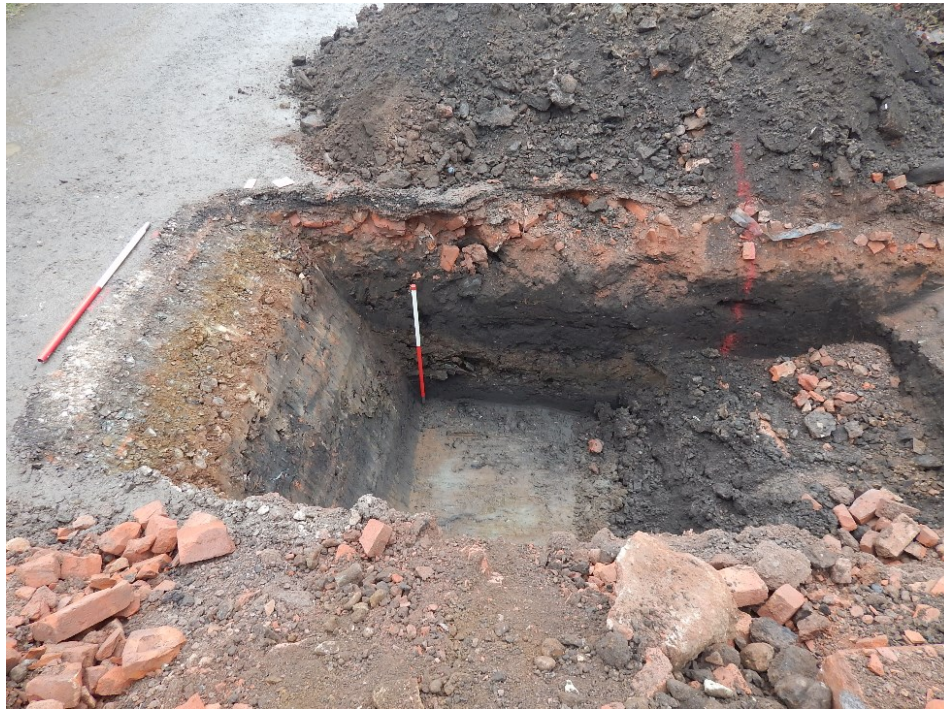
Trench 5 was located on the south side between two barns, broadly orientated south-west to north-east, on level ground at 118.5m aOD. Modern gravel farmyard surface and brick rubble hardcore (*c.*0.3m thick) was removed exposing dark greyish-brown topsoil (up to 0.5m thick) overlying dark greyish-brown sandy-clay (up to 0.9m thick) mixed with occasional pebbles, brick and tile. These soils appeared to fill in a large hollow crossing much of the trench, probably a pond shown on editions of Ordnance Survey maps between 1886 and 1929 but absent from an edition of 1958. The lower sandy-clay fill of the pond contained late 19th/20th-century pottery (spotted dated on site and not retained). The natural substratum, mixed pale orangeish-brown sandy-clay and orangeish-brown sand and gravel, was observed at 117.2m aOD to the east outside the 'pond' and 116.8m aOD beneath the 'pond'. The water table appeared to have been reached here, as water seeped into the trench at this low lying point.

Figure 8: Trench 5, west end post excavation, looking north-west showing dark soils backfilling a 'pond'. The unmachined area to the right contains a modern service pipe.

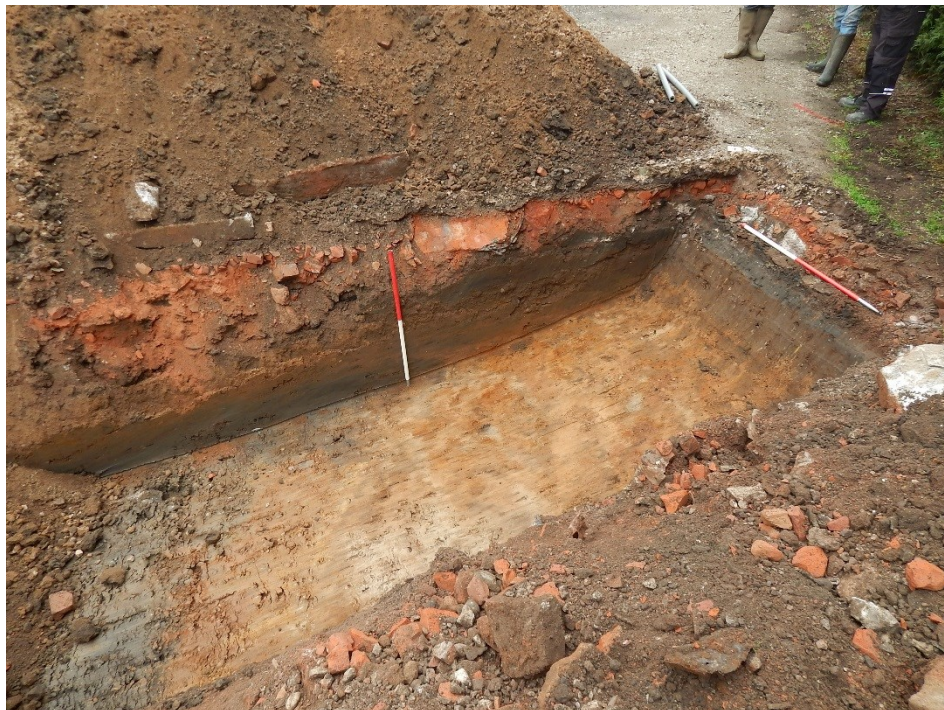
Figure 9: Trench 5, east end post excavation, looking north-west. The pond edge can be seen on the left edge of the image.
