**An Archaeological Investigation in  
advance of the installation of a  
Welcoming Christ Statue at Launde  
Abbey, Launde Road, Launde,  
Leicestershire LE7 9XB**

**NGR: SK 79706 04365**

ULAS Report No. 2019-142  
©2019

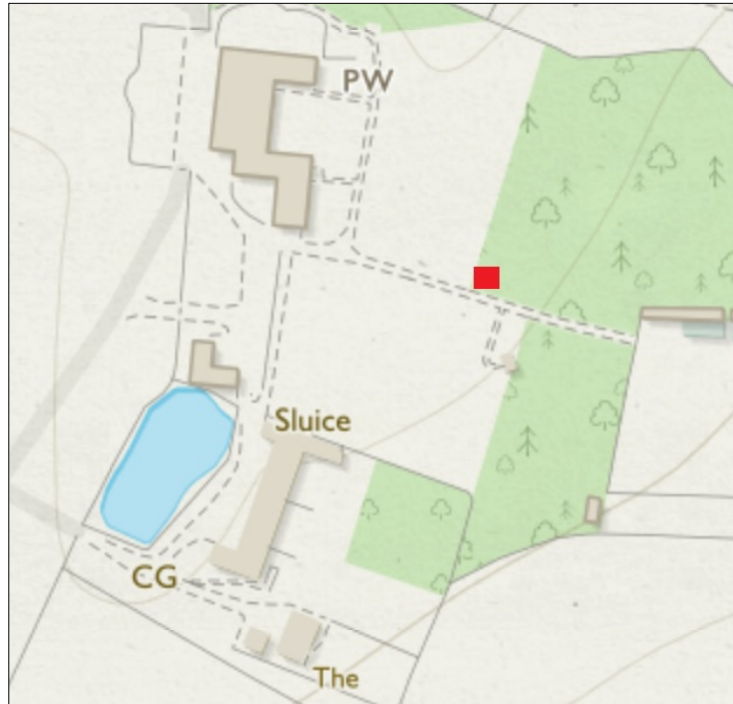
**Figure 2.**

**Location of site of excavation to the east south east of the main house outlined in red**

The proposed development area, to the east south east of the mansion house, lies at a height of approximately 148m aOD. The surrounding area is currently laid out as terraced lawns and the proposed site of the statue on the higher terrace alongside a path leading east to a walled garden (Fig. 2) and (Fig.3).

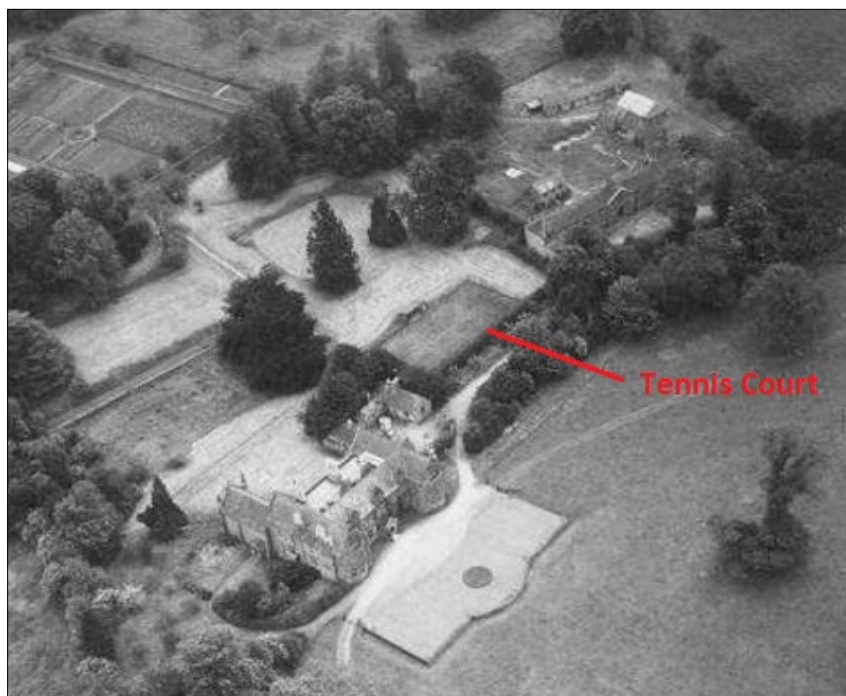
**Figure 7.**  
Aerial photograph taken in the 1940's showing the terraced lawns and tennis court (Blaxland and Roenisch 2008)

The historical background to the gardens was researched by the Leicestershire and Rutland Gardens Trust (Blaxland and Roenisch 2008). At the time of the Augustinian Priory there were a number of fishponds pre-dating the private residential use of the house. One of these ponds is thought to have become a sunken garden established in the 19<sup>th</sup> Century, with steps to the centre and a fountain to the southern end (Fig 5). The ‘parterres’ on this east side of the house are thought to be early post medieval to late post medieval (MLE23453). A parterre is a formal garden constructed on levels, consisting of plant beds, usually in symmetrical patterns, separated and connected by gravel or turf paths. The borders of the plant beds are often hedged and the interiors planted with flowers or filled with gravel. These beds were possibly lawned in the late 19<sup>th</sup> Century as records suggest a lawn was established for playing croquet, possibly on the terrace above the sunken garden. A tennis court was also established on a lower terrace, visible on the 1931 Ordnance Survey map (Fig. 6) and the aerial photograph taken around 1945 (Fig.7)

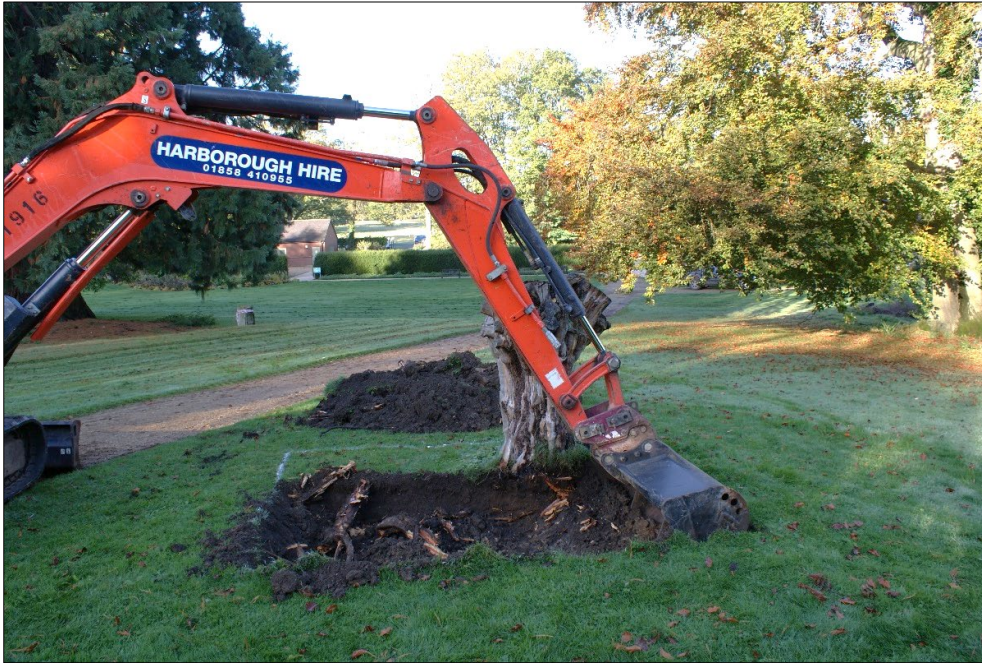
**Figure 9.**

The top soil was stripped around the base of the tree stump to an average depth of 0.30m (Fig. 8). Substantial tree roots ran across the area of excavation and machine excavation continued in spits into a subsoil of approximately 0.15m. The base of the root ball was reached at approximately 0.5m and the stump removed (Fig. 9). Some fragments of ceramic building material were amongst the root ball presumably from prior landscaping or planting. The top soil was comprised of a mid to dark greyish brown clayey silt with gravel and flint and ironstone fragments. The sub soil was a light greyish brown silty clay with rare pebbles and ironstone fragments. The natural ground

**Photograph of machine stripping of topsoil looking south east**

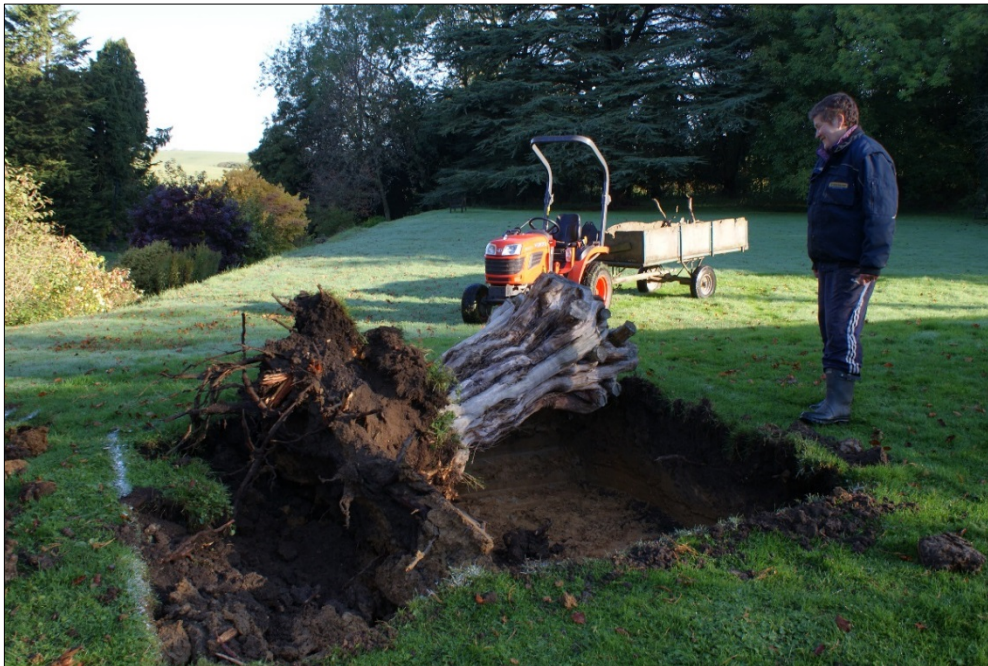
**Figure 10.**

was a mid to light orange brown sandy clay with frequent ironstone and sandstone pieces. To achieve a level base variable depths were reached in to the natural clay of 0.90m to the east and 0.70m to the west (Fig. 10). No archaeological features or deposits were observed during this excavation.

**Photograph of removal of tree stump at depth of subsoil looking north**

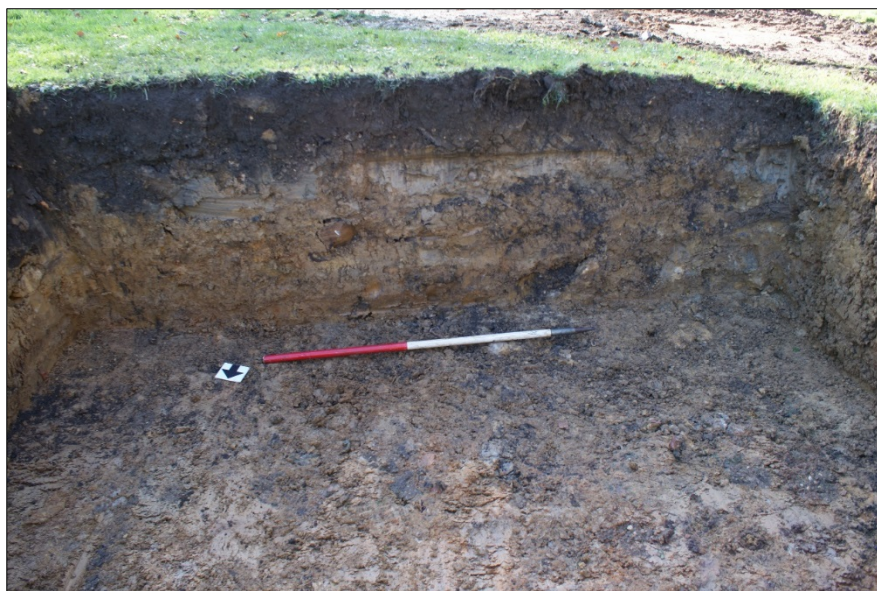
**Figure 11.**

**Photograph of north facing section at the end of excavation**

Excavation of the foundation pit for the statue revealed no archaeological features or deposits. The diminishing level of topsoil to the west and fragments of building material within may point to the post medieval period of landscaping and terracing of the garden.
