**Archaeological Attendance and
Recording during Groundworks at the
Deepings School, Park Road,
Deeping St. James,
Peterborough,
PE6 8NF**

ULAS Report No. 2019-147
©2019

**Archaeological Attendance and Recording at
Deepings School,
Deeping St. James, Peterborough,
PE6 8NF**

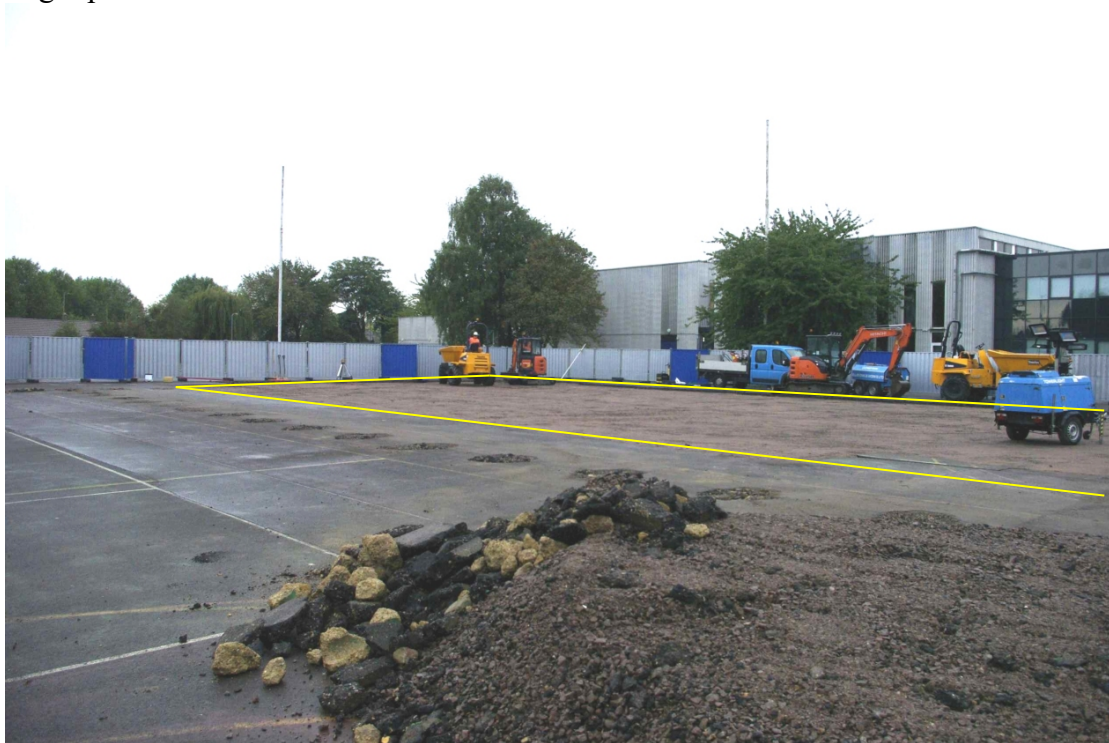
Prior to commencement of the archaeological work the tarmac surface of the former playground area had been removed to reveal a level surface of compacted mill waste (Fig. 5). Across the whole site the tarmac had a thickness of between 0.08 and 0.1m. This provided an ideal surface on which to work and run vehicles so that the mill waste was then left in-situ and the post pads were excavated through it.

Figure 5 Site after removal of tarmac and prior to excavation of pads
Looking south-west. Area highlighted by yellow line

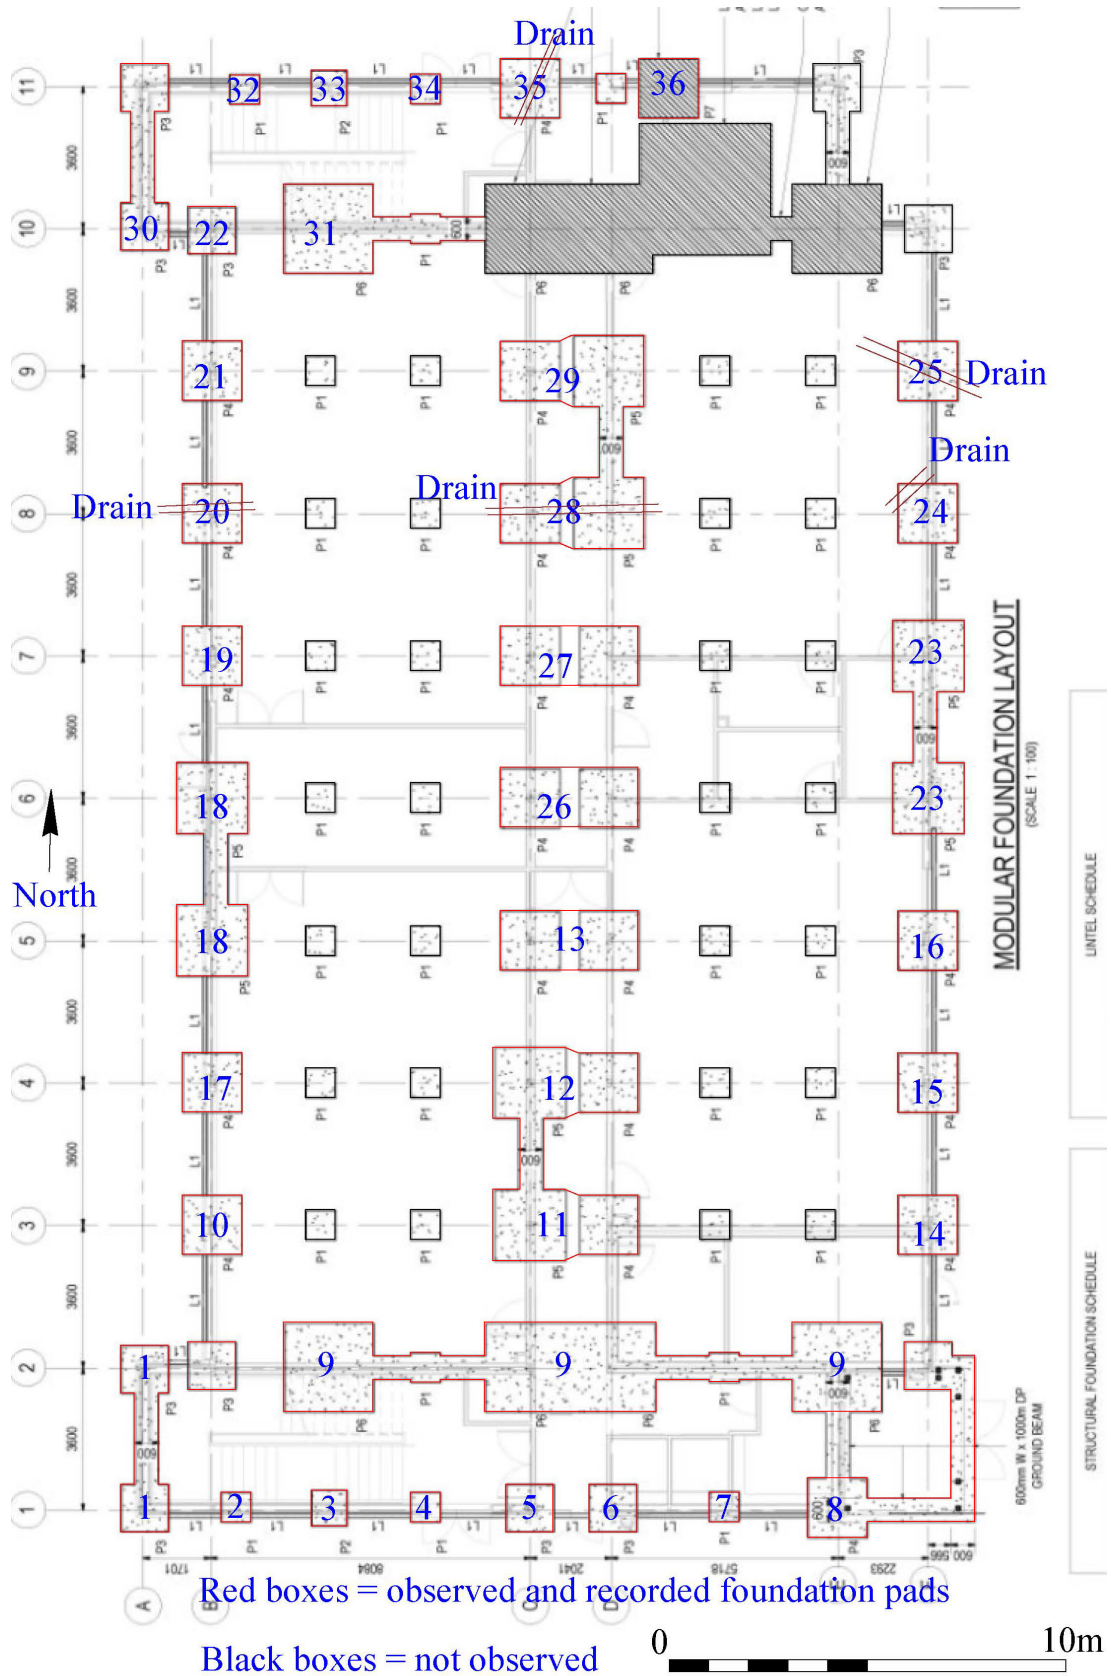
For the purposes of this report the post pads were numbered in the order of their excavation. The numbers do not relate to any identification given by the contractor (Fig. 6). Each pad was excavated in spits down to a maximum depth of 1.2m below current ground level. Removal of the mill waste beneath the tarmac revealed a hard layer of compacted dark brown silty clay pressed into a made stone bedding layer. This compact silty clay gave the impression that this area may have functioned as the construction site car park whilst the school was being constructed (Fig. 7).

A total of 36 post pads were observed across the site. The post pad plan included four rows of smaller pads measuring 750mm by 750mm (see Fig. 6). After consultation with the client it was decided that, due to the total absence of archaeological material across the site, these would not be observed. Any linear archaeological features which may have been present within the site would have been visible in the excavations for the larger pads and none were seen.

Figure 6 Observed post pads
 Numbers relate to their order of excavation and do not relate to any construction related references

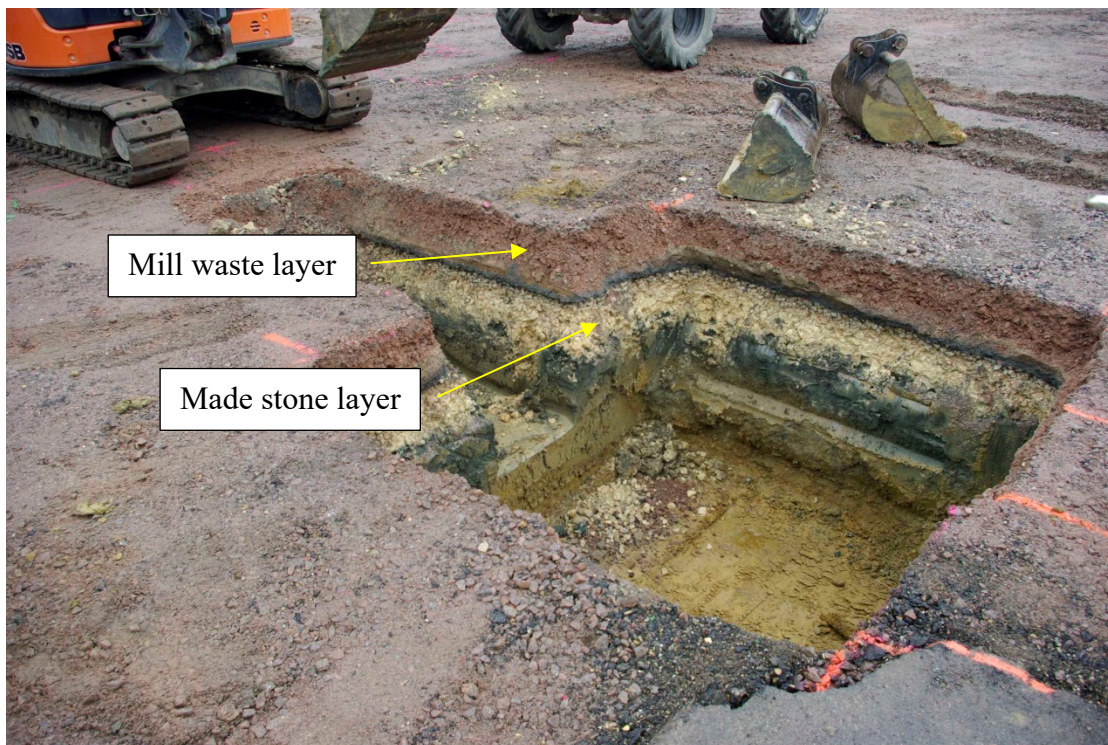
Figure 8 West end of post pad number 9 during excavation
Looking south-east

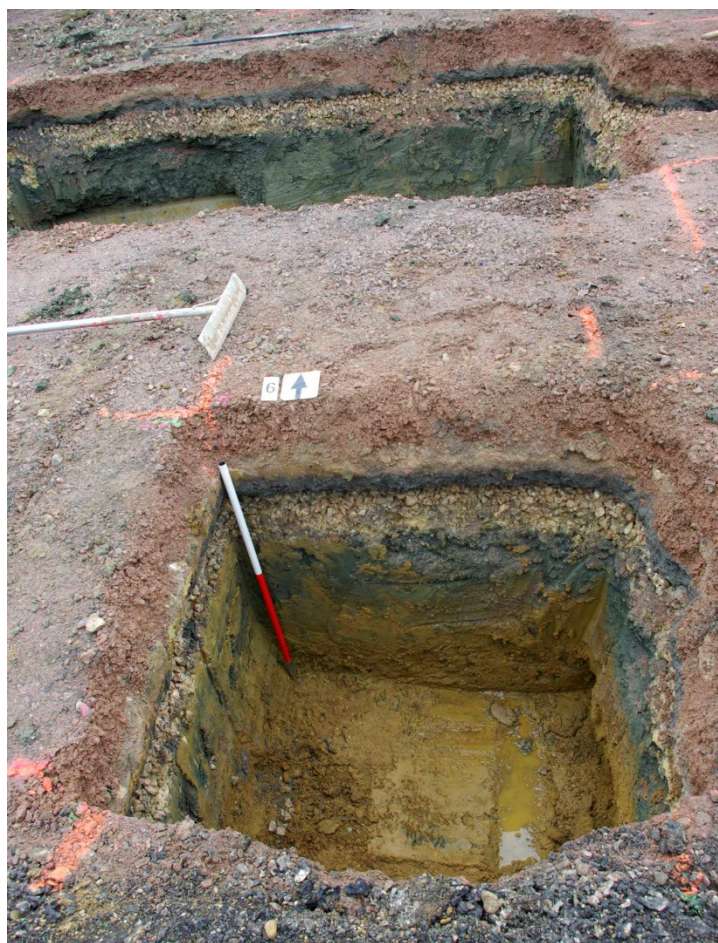
Figure 9 Post pad 6
Looking north. 1m scale. Post pad 9 at top of picture

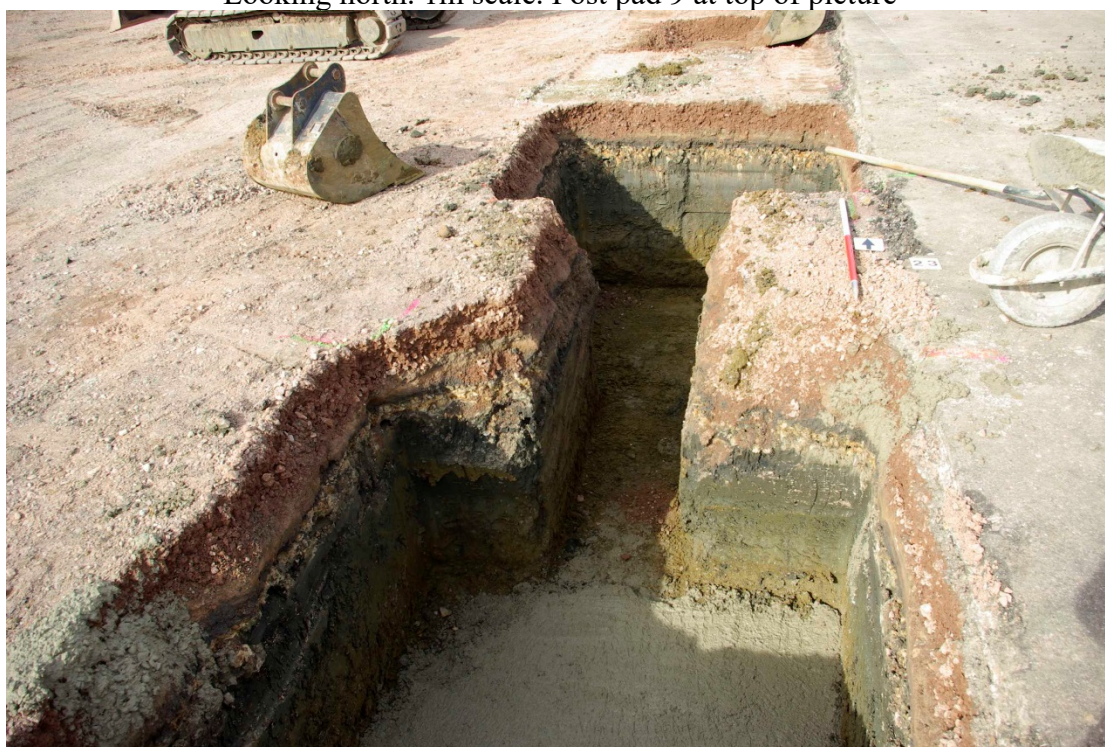
Figure 10 Post pad 23
Looking north. 1m scale

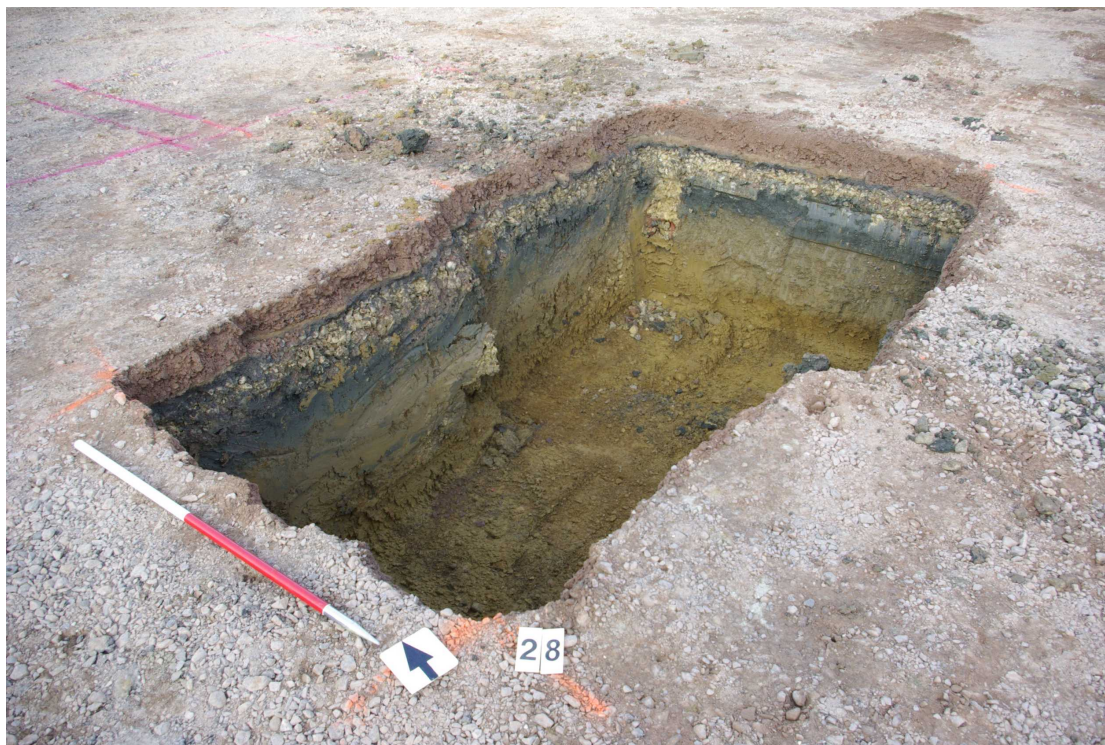
The natural substratum consisted of a dark grey sandy clay with patches and areas of light yellowish brown sandy clay within it. Patches of sandy gravel were also observed within the lighter sandy clay. A number of ceramic land drains were observed cutting into the top of the natural. The backfill within the drain cuts consisted of the stone bedding layer material seen across the site which indicates that the drains were laid at the same time.

Figure 11 Post pad 28
Looking north-east. 1m scale. Note land drain in top corner
