**Archaeological Attendance and
Observation during test-pitting at
St. Martin's Park, Barnack Road,
Stamford,
Lincolnshire,**

ULAS Report No. 2019-155
©2019

For: Burghley Land Ltd

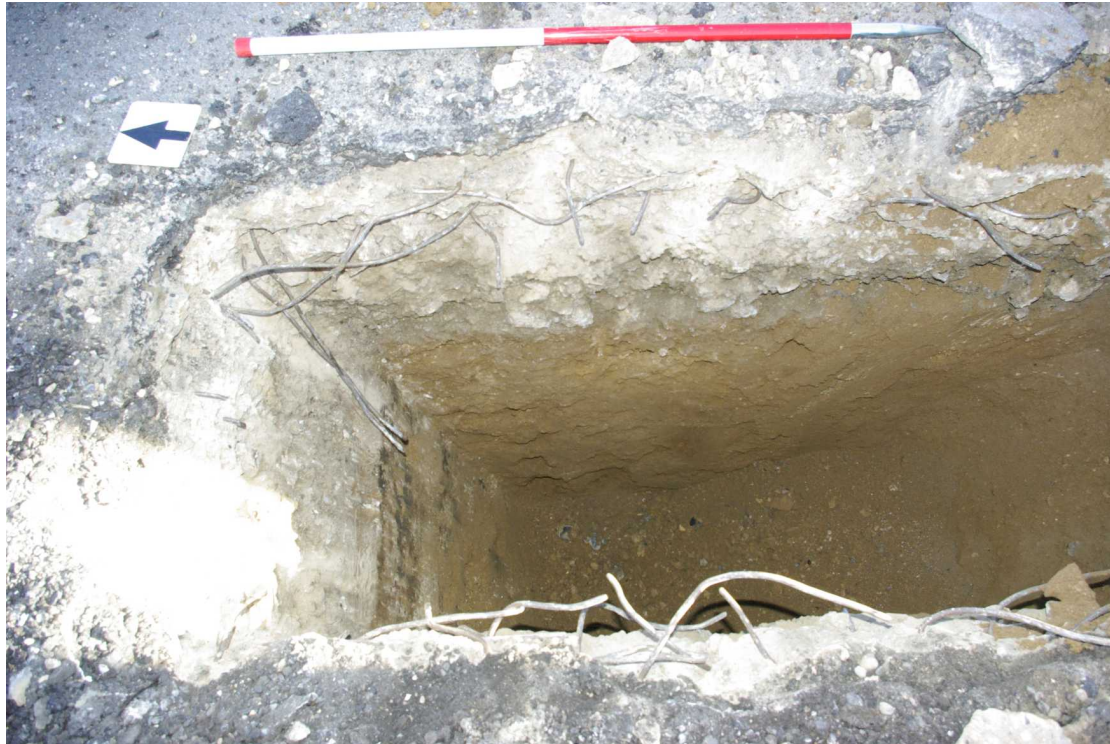
TP101 was placed in the north-east corner of the main car park. A total thickness of 0.6m of tarmac, reinforced concrete and made bedding was removed. Beneath this a mid-orange brown clayish silty sand layer of natural substratum was exposed which extended to 1m below current ground level. Below this was a similar layer but with increasing amounts of small limestone fragments and sandy gravel. The test pit was excavated down to 2m below current ground level by which time the natural substratum consisted almost entirely of sand and gravel (Fig. 6).

No topsoil or subsoil was seen in this pit nor were any archaeological features or deposits seen.

Figure 6 Test pit TP101 fully excavated
Looking east. 1m scale

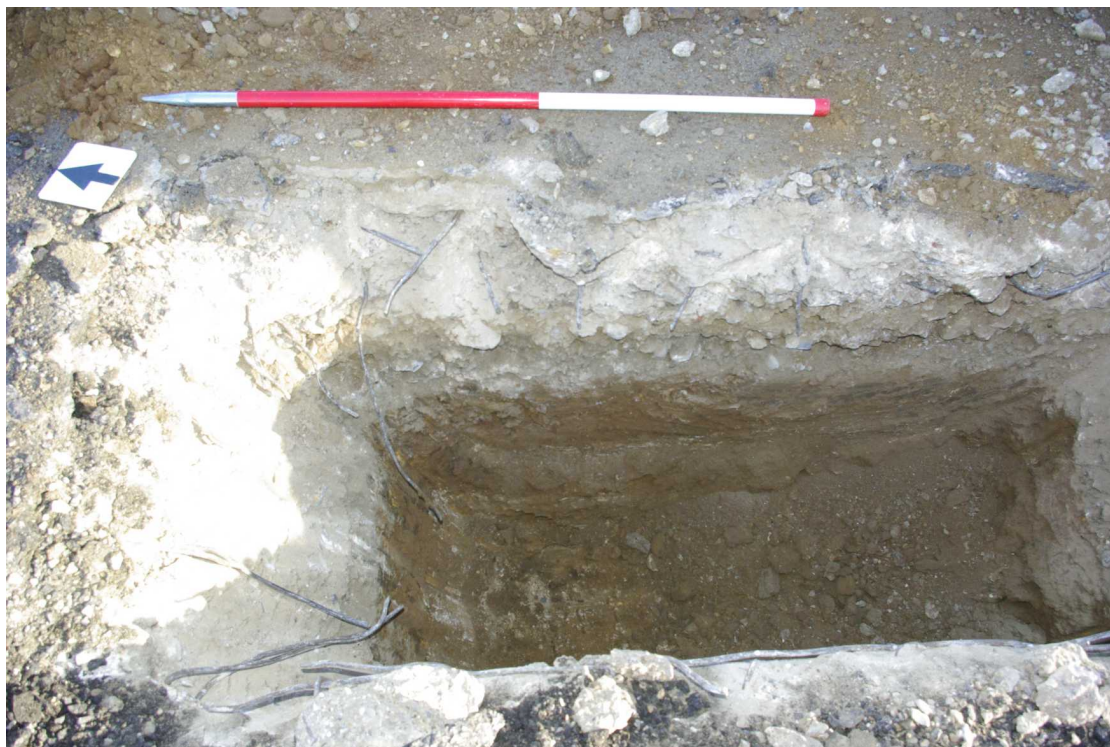
TP102 was placed in the south-eastern corner of the main car park. As with TP101 0.6m of tarmac, reinforced concrete and bedding material was removed to expose the natural substratum. The natural consisted of the same mid-orange brown clayish silty sand as seen in TP101. However, at a depth of 0.9m below current ground level the natural had changed to a brighter orange-brown sandy gravel deposit. Excavation stopped at 1.25m below ground level with sandy gravel being seen down to the base of the pit (Fig. 7).

No topsoil or subsoil was seen in this pit nor were any archaeological features or deposits seen.

Figure 7 TP102 fully excavated
Looking east. 1m scale

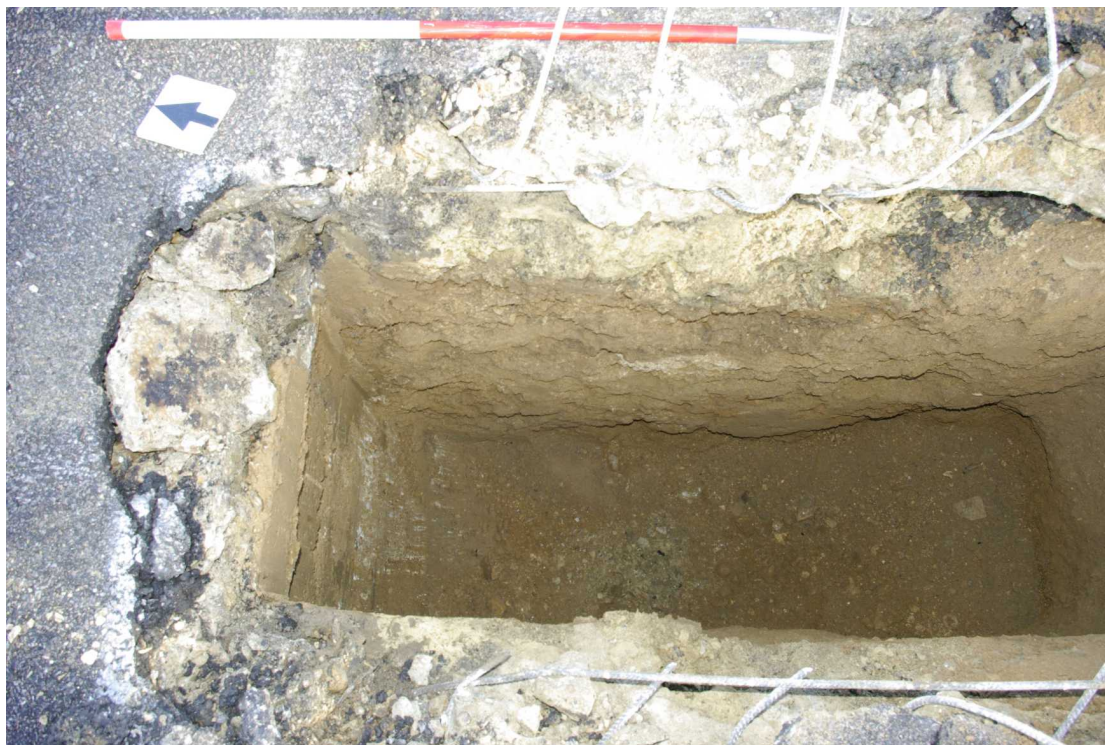
TP103 was located on the western side of the main car park close to the row of houses near the centre of the site on Barnack Road. Only 0.45m of tarmac, reinforced concrete and bedding material were observed in this pit. Beneath this was a 0.15m layer of silty clay which might be alluvial material and which covered a mid-orange brown silty sand and gravel natural substratum which extended to the base of the pit at 1.9m below current ground level (Fig. 8).

No topsoil or subsoil was seen in this pit nor were any archaeological features or deposits seen.

Figure 8 TP103 fully excavated
Looking east. 1m scale

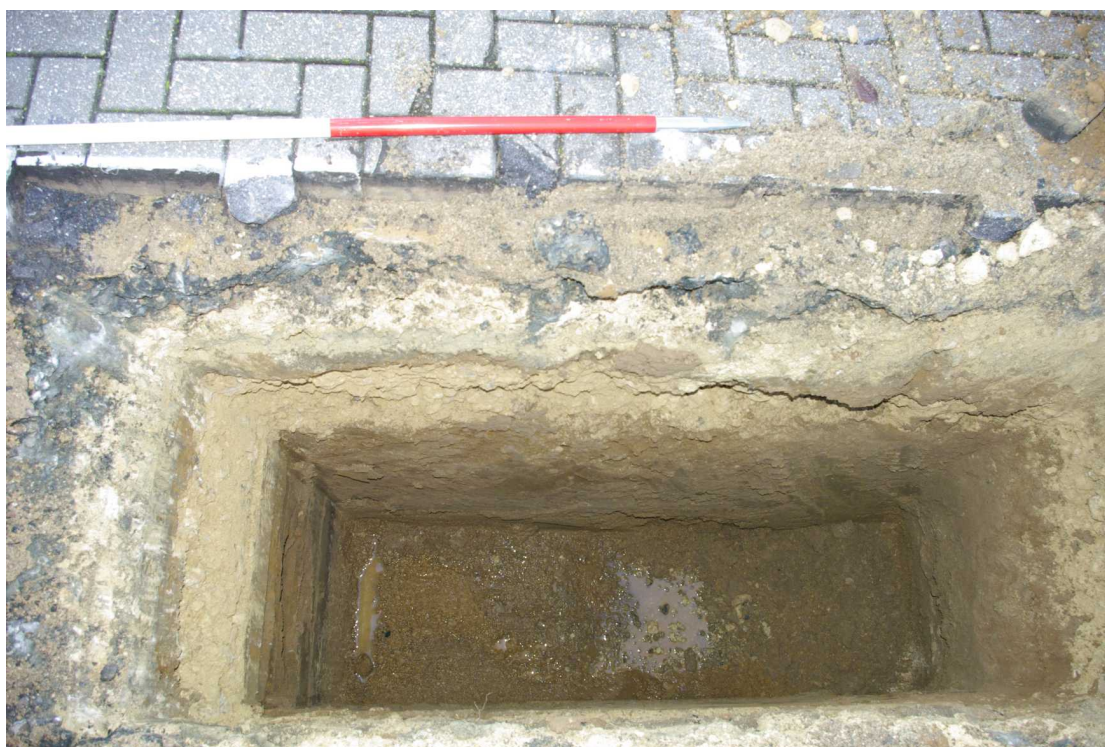
TP104 was placed in the north-eastern corner of the SKDC site. A 0.45m thick layer of block paving and partially concreted bedding layer were removed to expose a thin layer of disturbed clayish sand down to 0.55m below current ground level. This disturbed layer covered a 0.3m layer of stoned made-ground down to 0.85m below ground level. Beneath this was the same mid-orange brown clayish silty sand as seen in TP101 and TP102 which continued down to 1.75m below ground level below which was sand and gravel. Excavation stopped at 2.05 below ground level with sand and gravel still being encountered all the way to the base of the pit (Fig. 9).

No topsoil or subsoil was seen in this pit nor were any archaeological features or deposits seen.

Figure 9 TP104 fully excavated
Looking north. 1m scale

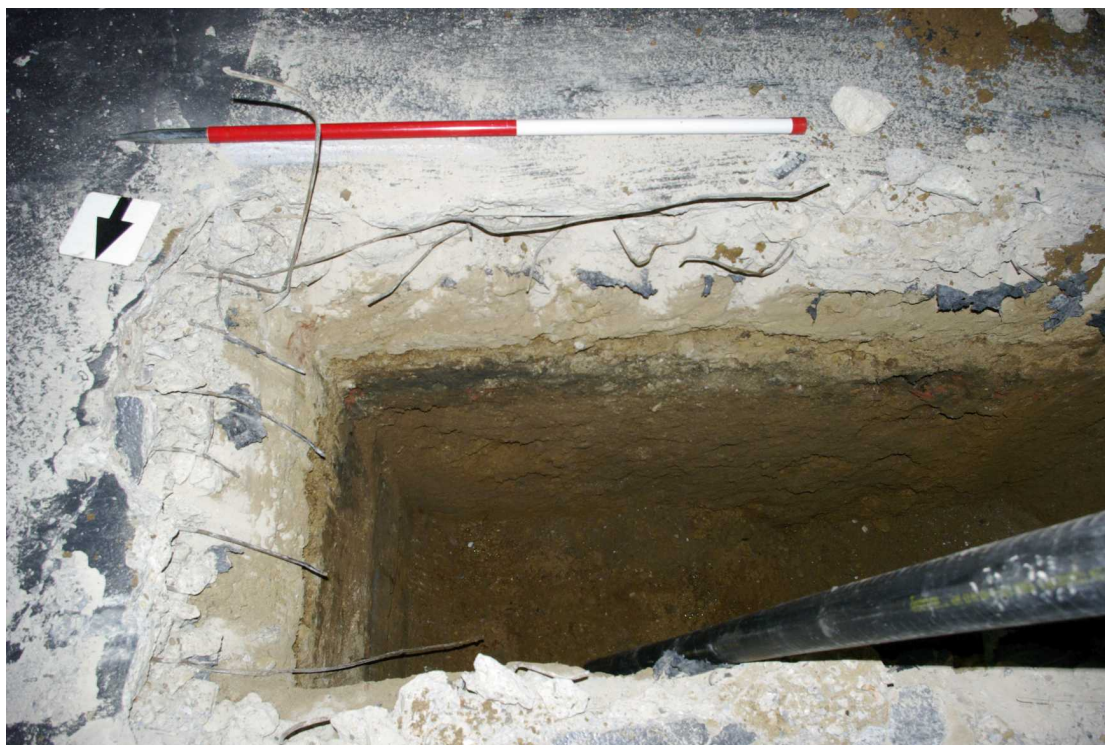
TP105 was placed within Building 5. 0.45m of reinforced concrete floor and bedding were removed to expose a mid-brown silty sand with some gravel within it. An unglazed ceramic drain ran through this layer which extended to 0.55m below current ground level. It was not clear if this layer was a remnant of disturbed subsoil or a trampled deposit created when the building was erected. Beneath this was clean sand and gravel extending down to the base of the pit at 1.5m below current ground level.

No topsoil or subsoil was seen in this pit nor were any archaeological features or deposits seen. A number of large machine pits were observed across this building indicating that, once the buildings are demolished, some areas will have been badly disturbed.

Figure 10 TP105 fully excavated
Looking south. 1m scale

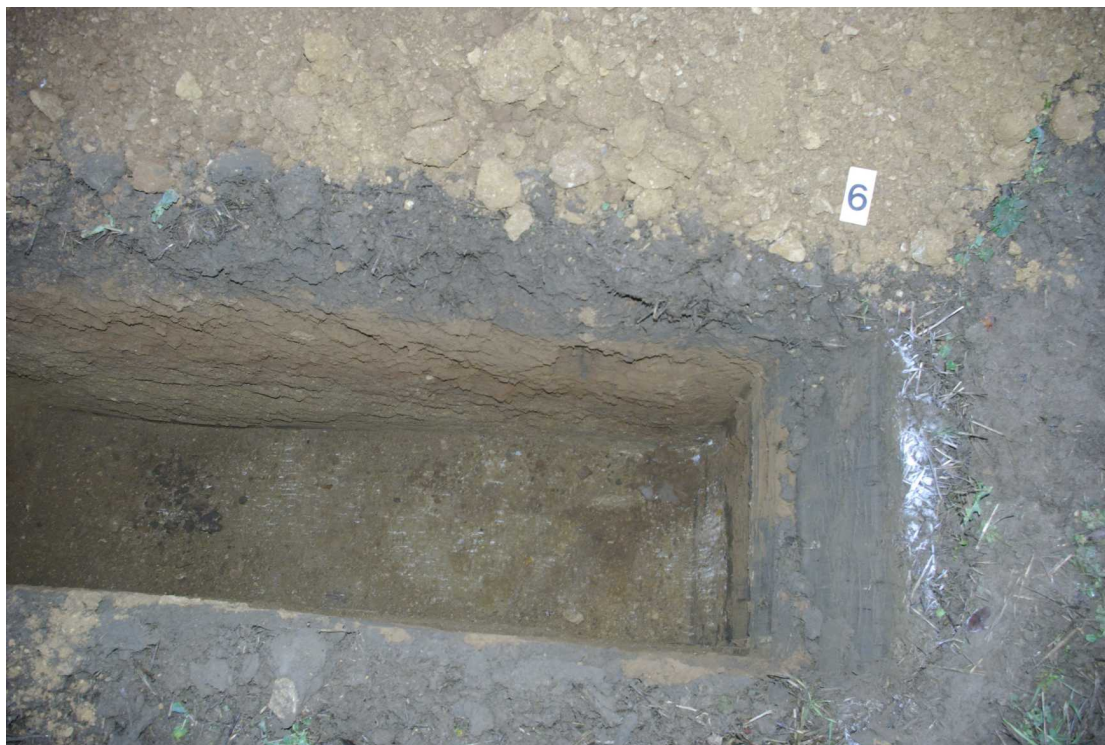
TP106 was located close to the gateway onto Barnack Road along the southern edge of the BLL field. The topsoil and subsoil consisted of a mid-grey brown silty clay and sand with a combined depth of 0.4m. Beneath this was the mid-orange brown clayish silty sand natural substratum seen in the SKDC test pits which extended down to 0.75m below current ground level. Sand and gravel was seen from this level down to the base of the pit at 1.3m below ground level (Fig. 11).

Figure 11 TP106 fully excavated
Looking south

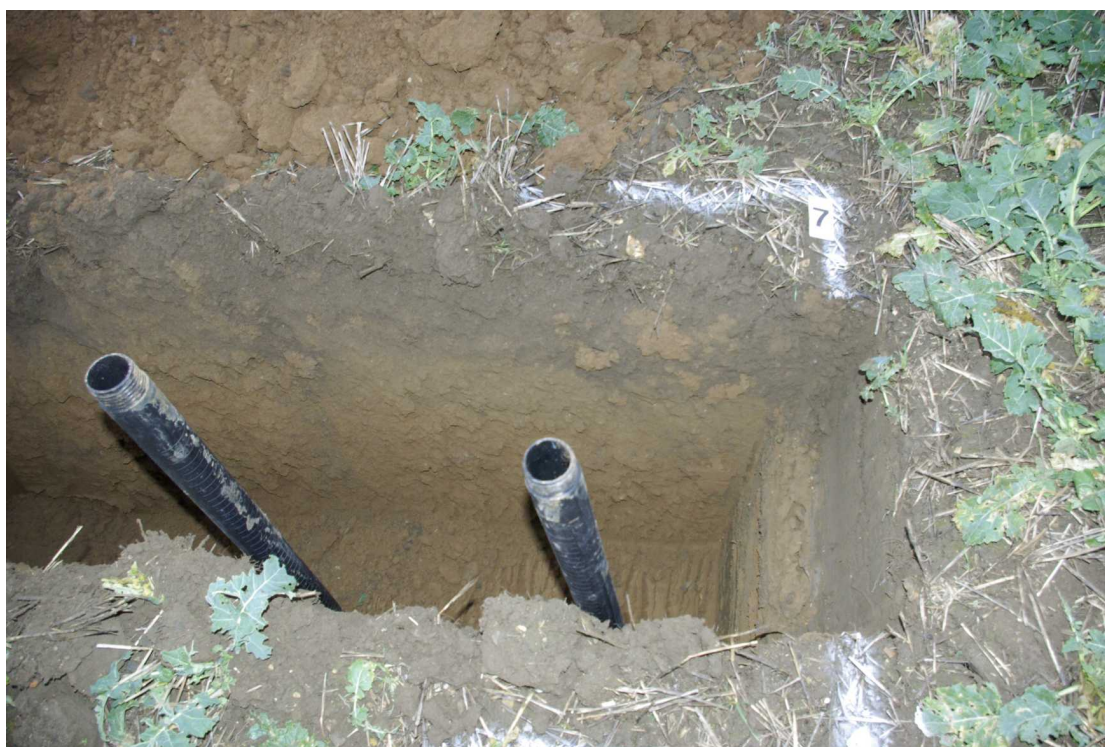
TP107 was placed close to the north-eastern corner of the BLL field. 0.4m of topsoil and subsoil were removed to expose a red-brown clayish silty sand natural substratum which was slightly darker in hue than previous test pits. This layer extended down to the base of the pit at 1.1m below current ground level (Fig. 12).

Figure 12 TP107 fully excavated
Looking south

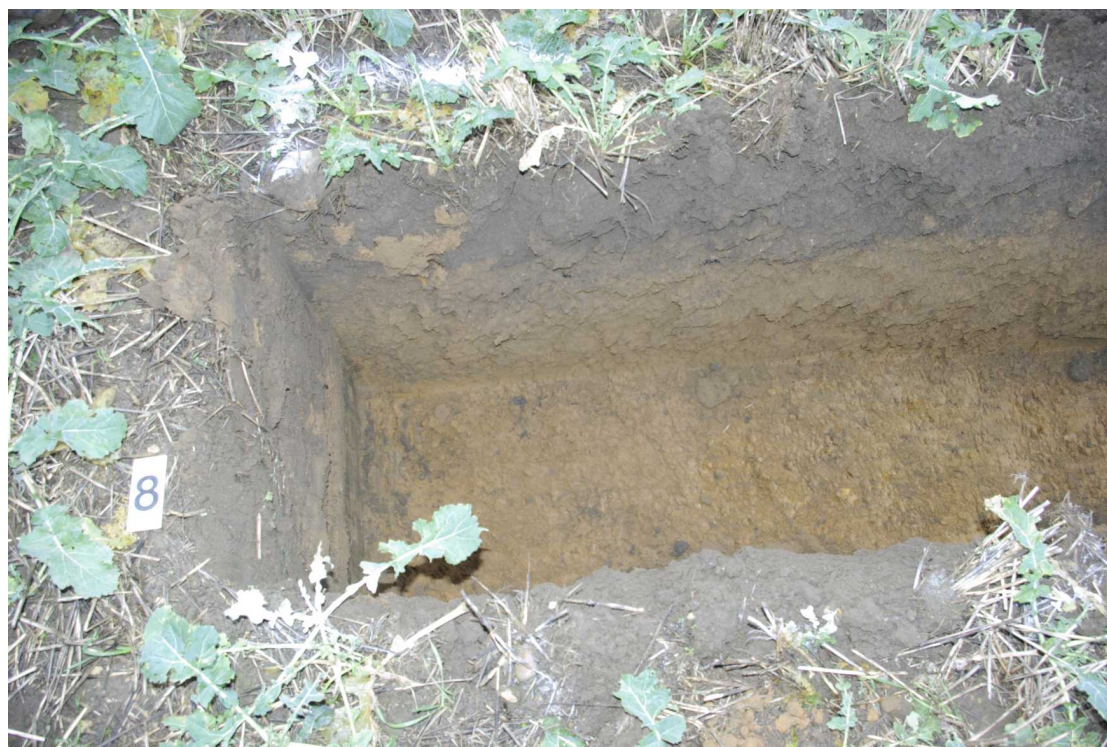
TP108 was located on the western side of the BLL field. Topsoil and subsoil with a combined thickness of 0.35m were removed to expose the mid-orange brown clayish silty sand natural substratum. This continued down to the base of the pit at 0.8m below current ground level.

Figure 13 TP108 fully excavated
 Looking south-west
