Archaeological Observation, Investigation, Recording, Analysis and Publication of Works at Home Farm House, Back Lane, East Farndon, Northamptonshire, LE16 9SE.

NGR: SP 7181 8521

ULAS Report Number: 2020-055

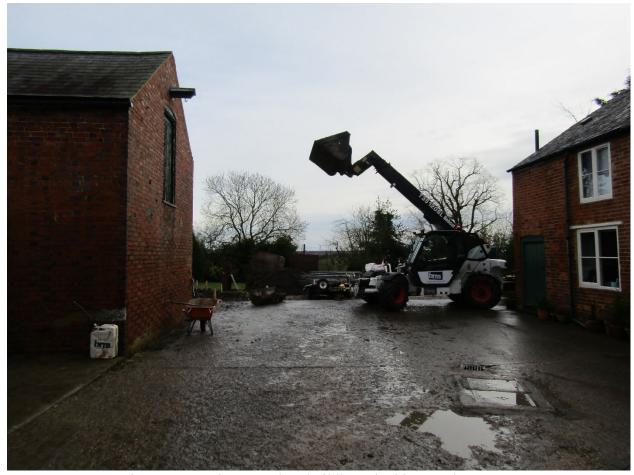
Home Farm House is Grade II listed (UID 1054028) and is a mid-18th century building with 19th century alterations. Associated outbuildings lie to the north of a central courtyard and were

used by the farm until the late 1990s. The farmhouse and outbuildings have since been used for domestic purposes and for storage (Fig 3).

Figure 3: Farmhouse and outbuildings, looking north-east.

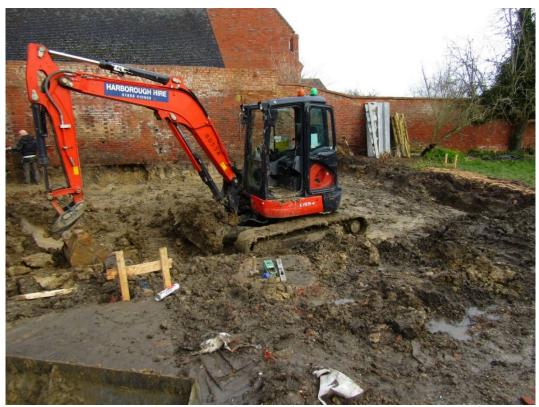
The small rectangular area of the proposed extension, measuring 2.45m by 3.80m, was initially stripped using a flat-bladed bucket of 1m width over a portion of lawn and a narrow 1m wide gravel path close to the rear of the building (Fig. 5). This exposed a porous membrane below the gravel above a dark garden soil (silty clay) across the area. The initial strip removed around 0.30m of turf and topsoil.

Figure 4: Extension area stripped of hard standing, looking north

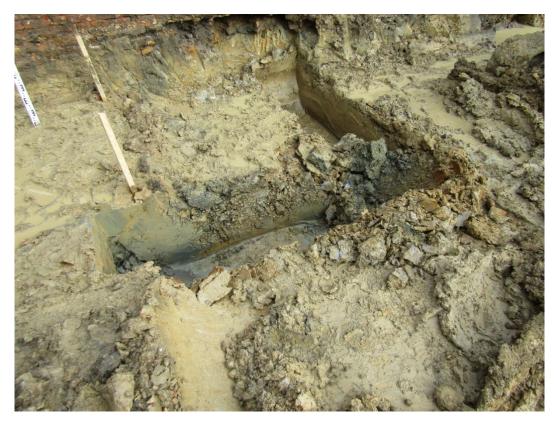
Subsequently the foundation trenches across the site were excavated using a 0.60m wide flat-bladed bucket to around 0.056-0.65m depth. The sequence across the site comprised around 0.10-0.19m dark mixed subsoil containing charcoal and some modern brick and tile fragments over 0.50m-0.60m of natural substrata – a yellowish grey stony clay, which became greyer in colour towards the base.

Figure 5: Foundation trenches at the north-west end of site looking north (For scale Trench is 0.65m wide, 2.80m long)

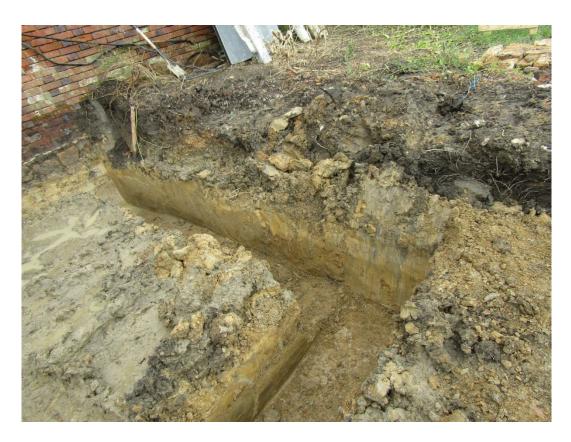
Figure 6: Foundation trenches at the north- east end of the site looking north.

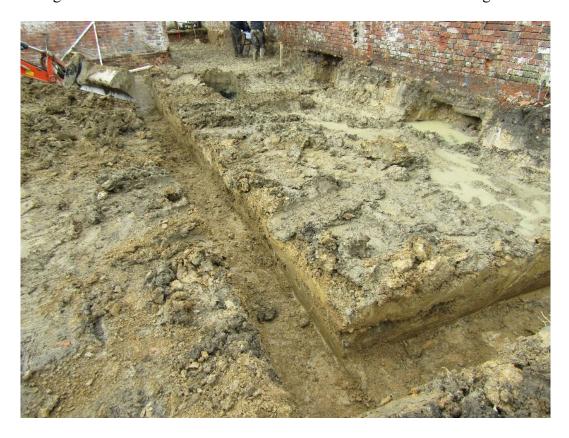
Figure 7: Foundation trenches at the centre of the site looking west

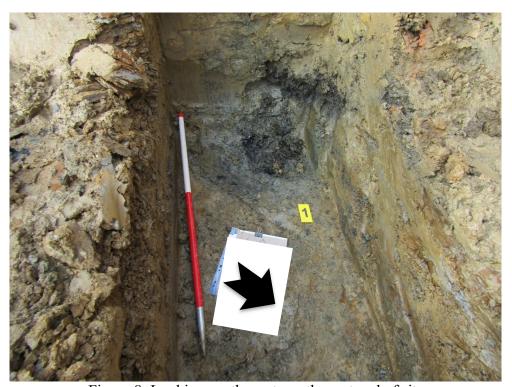
The only features identified were a modern pit filled with dark grey clay and organic leaves and twigs, with a fragment of modern tile at the north-west end of the site (Fig. 8). A further possible modern disturbance in the subsoil was identified to the east with oil seeping into the section (Fig. 9)

Figure 8: Looking south west, north-west end of site

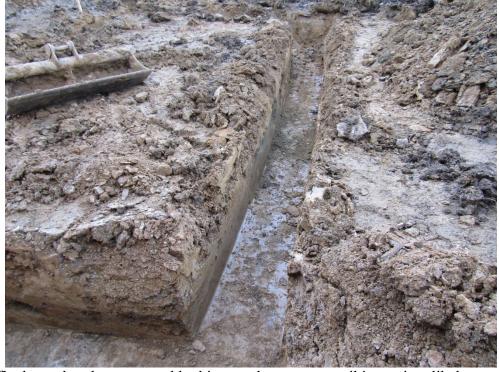
Figure 9: final trench to be excavated looking north-east, some oil in section, likely seeping in from the old farmyard above.
