**An Archaeological Field Evaluation on land adjacent to 41A Main Street, Medbourne, Leicestershire.**

**NGR: SP 80089 93389**

**ULAS Report No.2021-004**

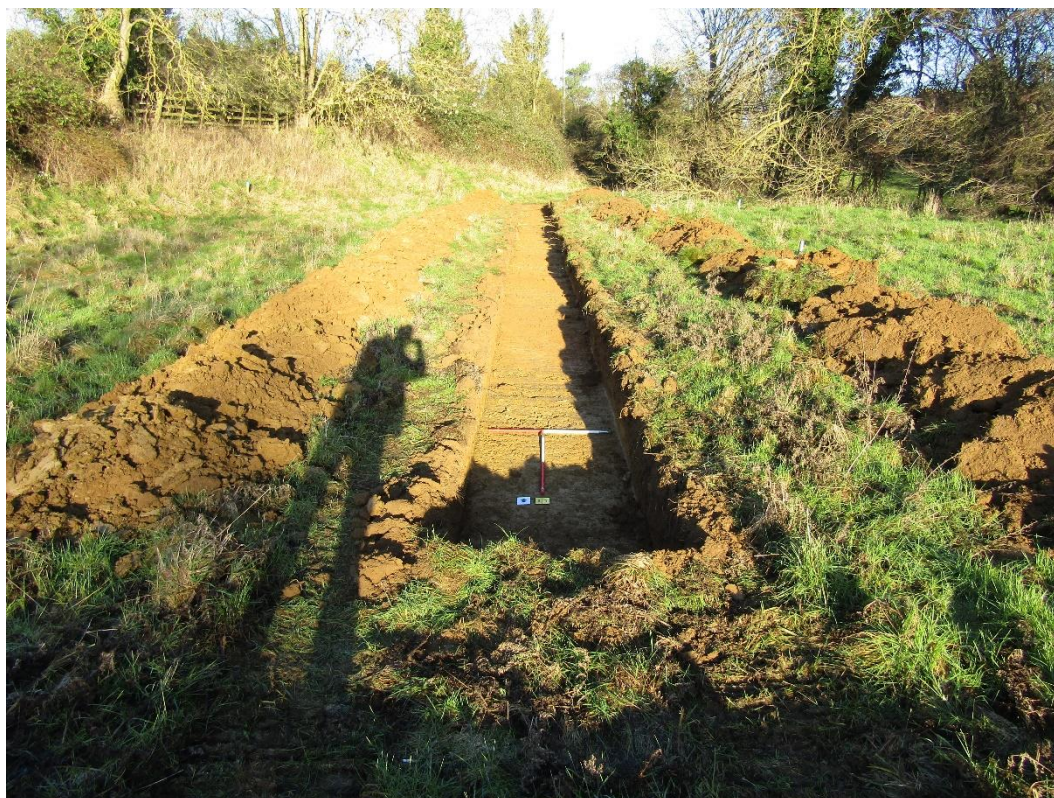
Figure 5: Trench 1. Looking north.

Trench 1 was positioned to target the northernmost of the proposed dwellings, oriented northwest-southeast and located in the northern corner of the development site between Main Street and the site boundary. Excavation of the trench revealed a series of five linear features identified as furrows running east-west. The remains of their corresponding ridges were still visible at ground level and so they were not excavated (Fig. 5). A modern land drain was also recorded within the trench.

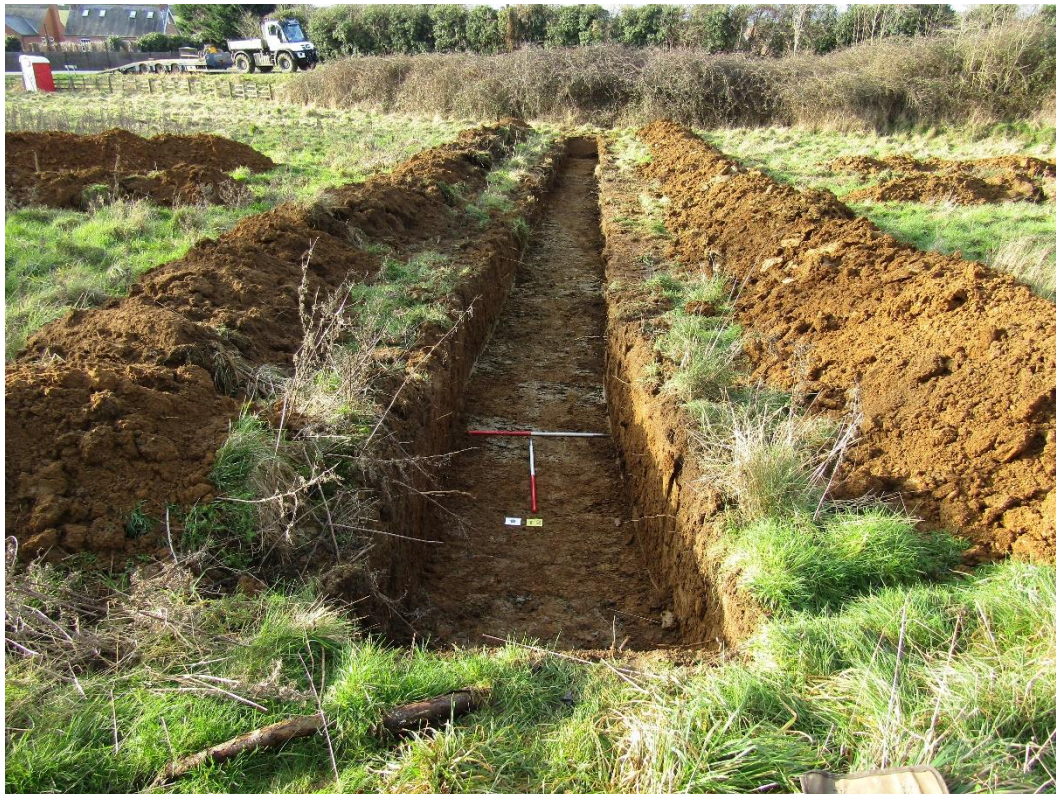
Figure 6: Trench 2. Looking west.

Trench 2 was oriented east-west below the southern extent of trench one, and located to target the access road to plots one and two and, part of the building footprint of plot 2. Excavation of the trench revealed the remains of two furrows running diagonally across the trench. The

easternmost extent of the trench was situated on the slope present across the eastern boundary of the development site, and revealed that the slope was likely the result of upcast from the adjacent railway cutting and comprised what appeared to be a large quantity of subsoil. A previous geotechnical pit was also identified in this area of the trench.

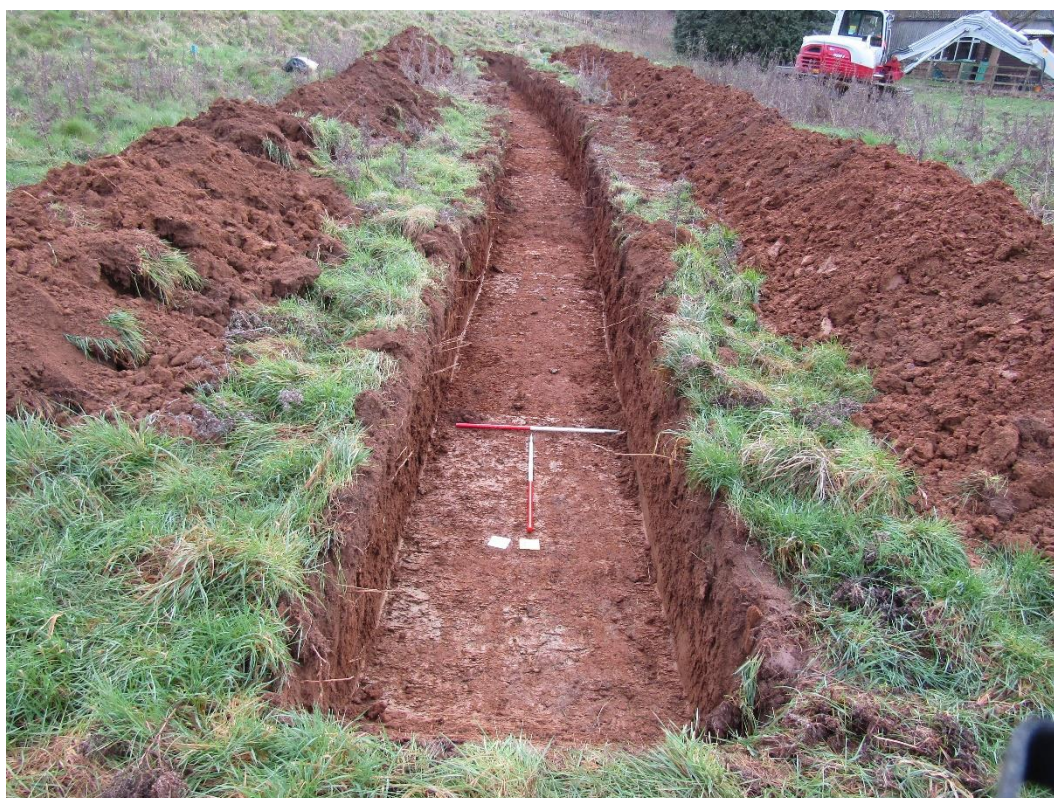
Figure 7: Trench 3. Looking north.

Trench 3 was located to target the footprints of plots three and four and was oriented northwest-southeast on the same alignment as Trench 1. At ground level approximately half way along the length of the trench a bank was visible at ground level. Upon excavation it was shown to be unremarkable in section and is likely the remains of a probable headland or field boundary associated with the ridge and furrow remains present in the northern portion of the development site. A modern land drain was identified running east-west within this trench. Natural

substratum was only reached at the north end in this trench due to the presence of a thick colluvial soil or possibly redeposition deposits from the railway. The base of the trench was excavated up to a depth of 1.10m in the centre of the trench in an attempt to locate the natural substratum however due to the depths excavation was stopped in order to maintain a safe working environment.

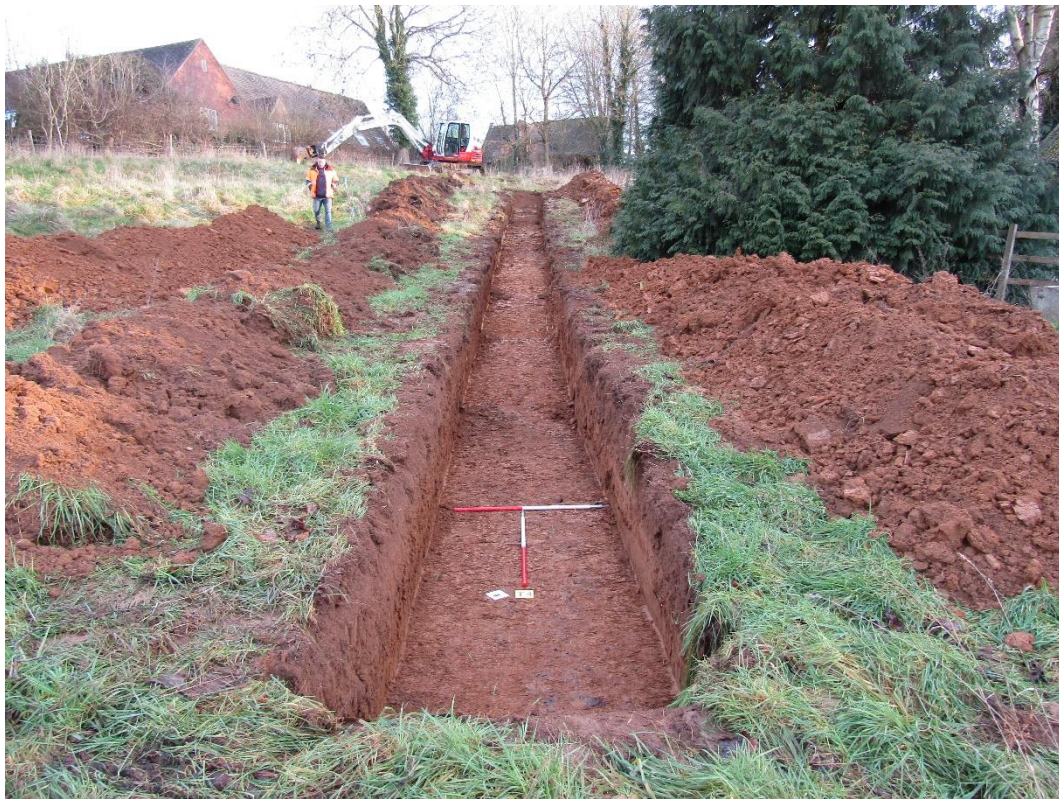
Figure 8: Trench 4. Looking south.

Trench 4 is the southernmost trench in the development site, oriented west-east and positioned to target and possible disturbance from plot five and the access road serving plots five, four and three. The bank visible at surface level that was investigated by Trench 3 was also recorded by this trench, with identical results. A field drain and an old geotechnical pit were identified

within this trench, and as was the case in Trench 3, the natural substratum was not reached due to the presence of a thick colluvial/redeposited soil as in Trench 3. No features of archaeological interest were identified in this trench.
