**47-49 High Street,
Ketton, Rutland:
Historic Building Survey**

ULAS Report No 2010-065
©2010

Planning & Listed Building Applications: LBA/2007/0815

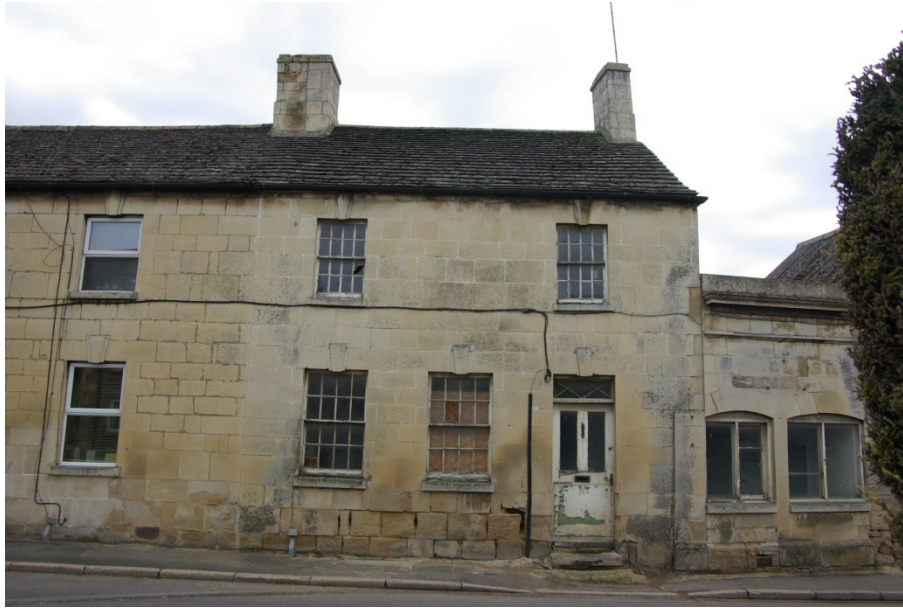
The principal element of number 47 is a twin-bay range fronting High Street (A). It is a two-storied range and the walls are ashlar with Collyweston stone slate on the front roof and Welsh Slate on the rear and gable stacks. The entrance, up two heavily weathered, original-looking steps is a half glazed four panelled door on the right of the elevation, above which there is a rectangular fanlight with glazing bars in a lozenge design. This simple glazing pattern probably dates from the late 18th century. At first floor level there is a pair of small 16 pane sash windows, the pair of windows are the same design, but larger. The concealed sash boxes suggest a late 18th-century date, which is the accepted date for the building itself; it is likely, therefore, that these windows are original. Above both the windows and the door there are double keystones.

There is a straight joint between number 47 and number 45, to the east, suggesting the two are not contemporary. There is also a straight joint between number 47 and the single storey extension to the west. The lower courses are heavily weathered. The rear (southern wall) is coursed rubble.

Figure 2 Number 47, Principal Elevation (Looking South).

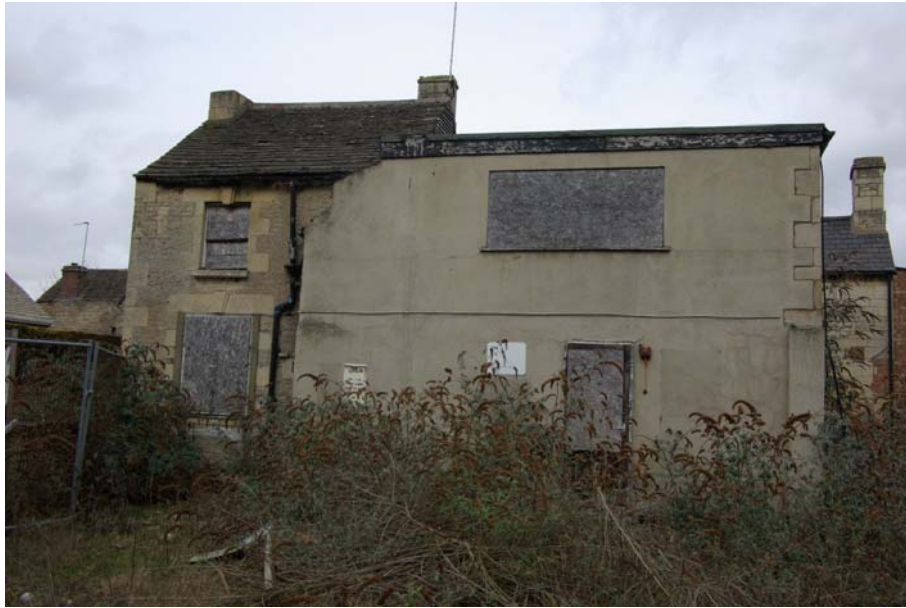
The principal element of number 49 is what appears originally to have been a twin-bay building, at right angles to High Street, fronting to the west. Visually the building is rather more complicated; the principal elevation appears to consist of two separate phases. The northern end (X) is roughly squared limestone blocks laid to courses with ashlar quoins on the northern corner and the windows. Above both windows there are double key stones and a small arrowslit-type opening carved from a single piece of stone to the south of the ground floor window. The southern end (Y) of the elevation juts out from the line of the northern part of the elevation by approximately 500mm and is rendered with quoins visible on the southern corner. The size of the first floor window suggests a 20th-century date. The interface between X and Y is a straight joint with the north facing elevation of Y being the same roughly squared limestone blocks laid to courses as X. There are also the very limited remains of a

Figure 3 Number 49, Principal Elevation (Looking East).

pitched roof, with Collyweston stone slates. It is possible, therefore, that this projection is the remains of another building, originally at right angles to X.

To the north, X has a pitched roof and gable stack, probably reduced in height and capped and is clad with Collyweston stone slates on the front and corrugated asbestos cement sheets on the rear. Y has a flat roof of mineral felt. The southernmost gable of X is clad in weatherboard; the lack of a stone-built gable again suggests the two are not contemporary.

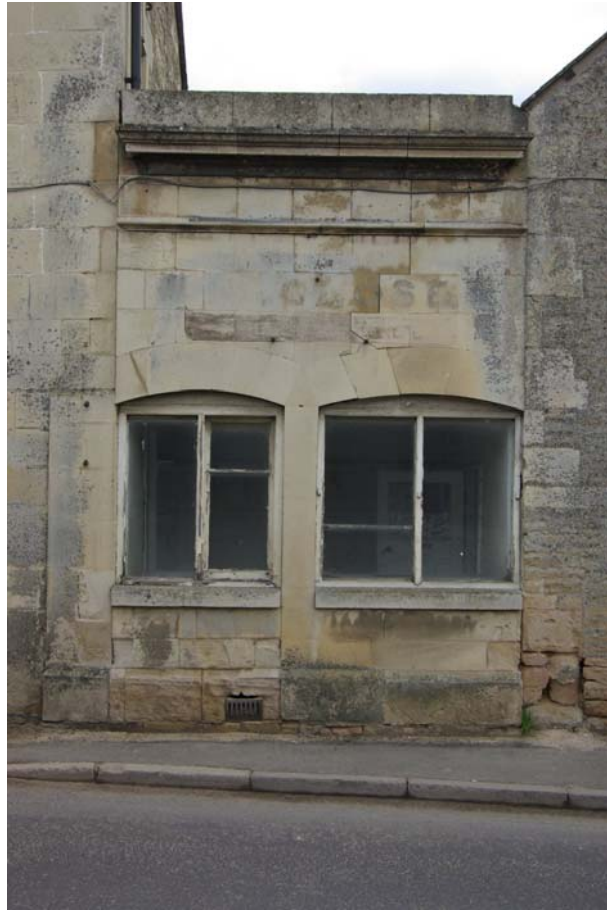
Between number 47 and 49 on the High Street frontage there is a later single-storied passage room. The frontage is ashlar with a plinth and attractive flat-arched heads over the windows, the windows themselves are modern replacements. The easternmost window was originally a doorway and is slightly narrower. At height there is a parapet and a continuous label mould. There is the outline of lettering above the windows, spelling “GLOSE”, the remainder is illegible.

Figure 4 Principal Elevation of Passage Room Between 47 & 49 (Looking South).

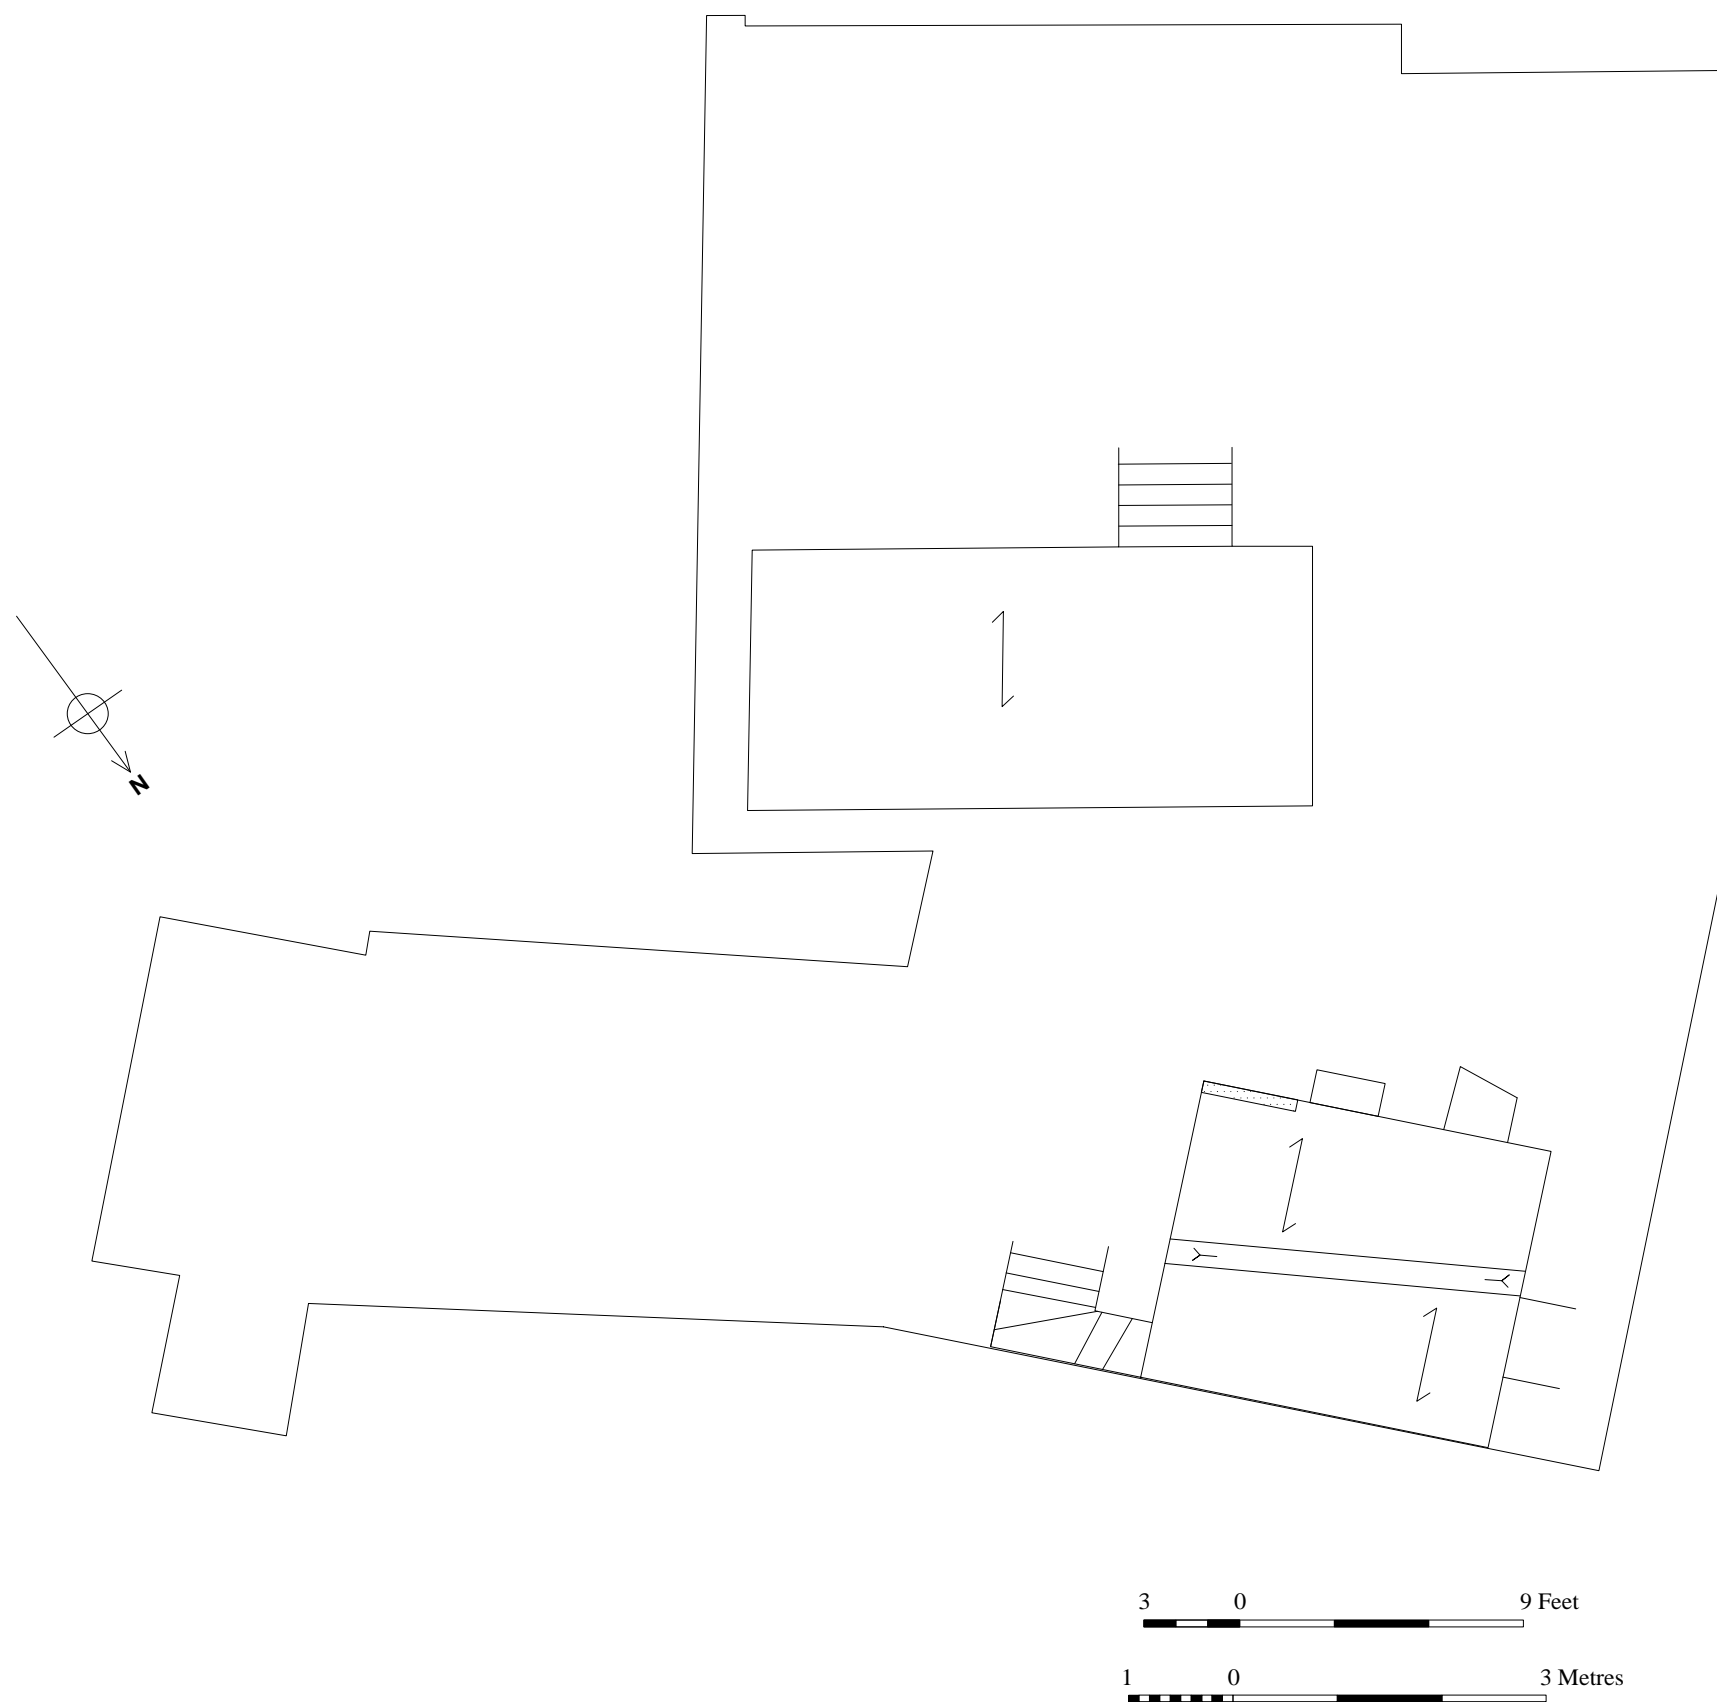
Beneath A there is a cellar constructed from roughly squared limestone blocks laid to courses (*Figure 7*). This has a timber ceiling supported on a chamfered axial beam. There is a blocked skylight recess on the front (northern) wall and on the west wall, a chute (also blocked) and a niche of unknown purpose. The floor was obscured during the visit.

Figure 7 Cellar Plan

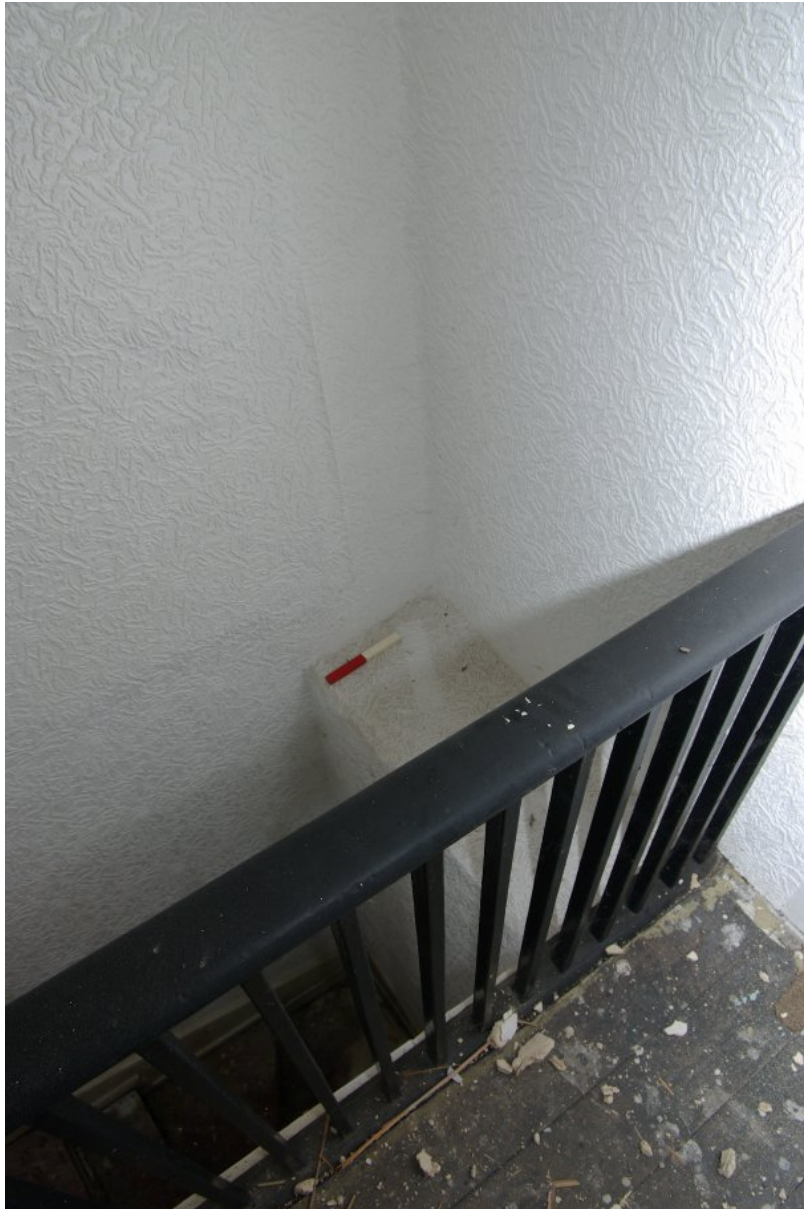
The partition wall between A and B, at first floor level at least is plaster and reed, set atop the stone built wall, the full width of which can be clearly seen within the stairwell (*Figure 6*). This change in wall width between ground and first floors may suggest that this part of the building was originally single storey, but was later raised and the staircase built. From the landing area into the rear wing (B) there is a step down of approximately 300mm. B was originally a single room with a chimney breast on the southern gable and an original window opening on the west wall. A modern partition has been added towards the south of the room and an opening inserted to the right of the chimney breast providing access to C.

Figure 8 Change in Wall Thickness Between Ground & First Floor, No 47.

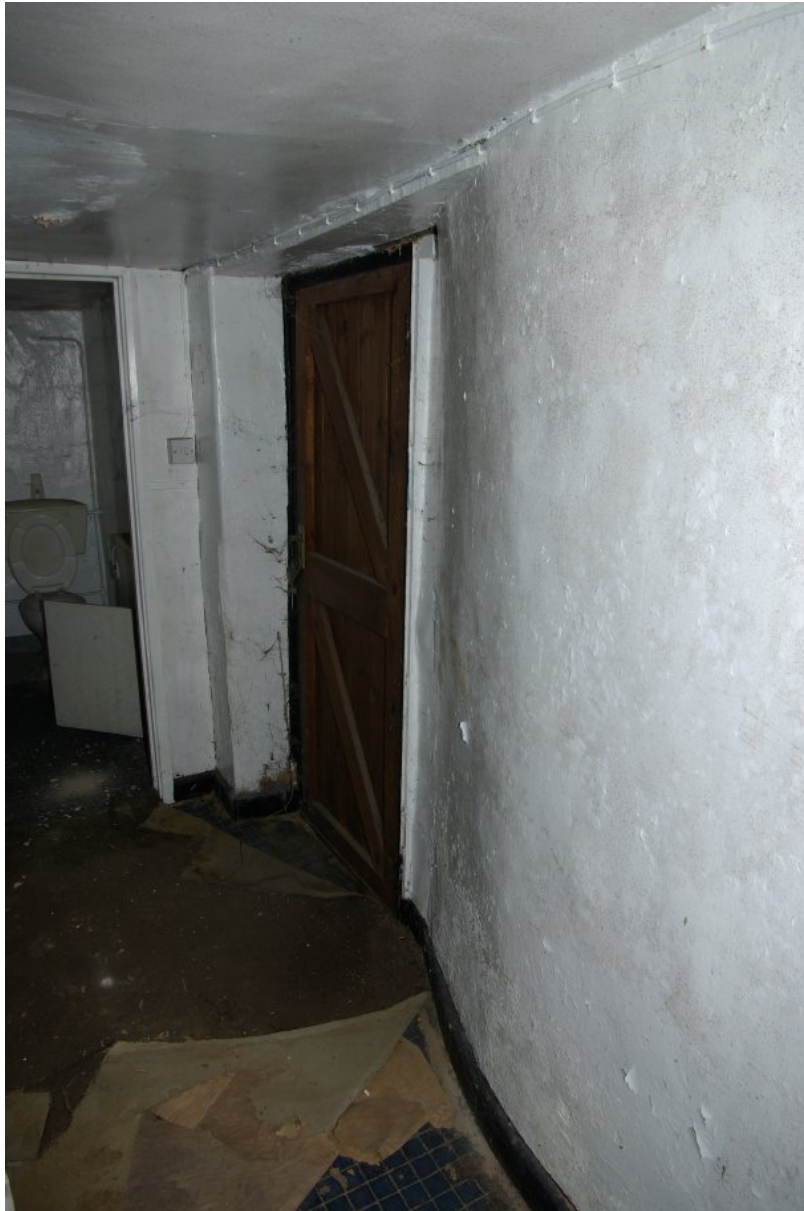
Figure 9 Unusual Wall Angle 47 B.

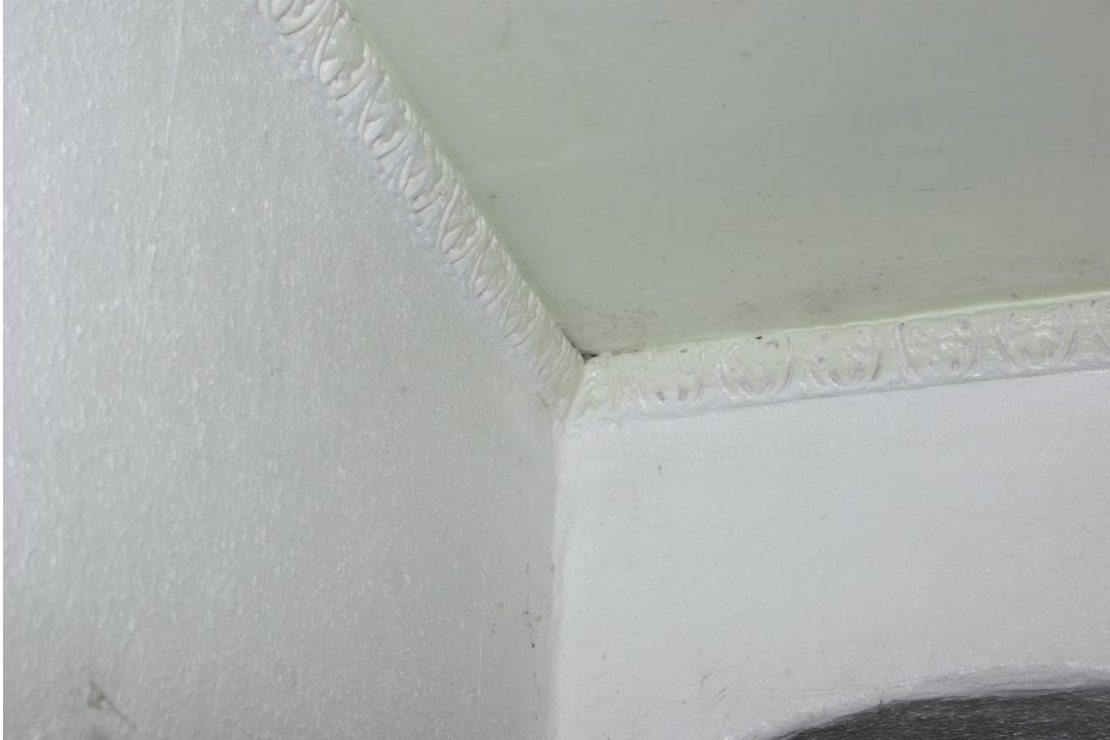
Internally there is a hallway with access to a domestic room, probably originally the living room to the east and an inserted door, within an alcove leading to the western extension, between which there is a considerable difference in floor levels of approximately 500mm. At the southern end of the hallway there is a recessed cupboard within another alcove, confirming there is a partially concealed chimney breast still in position; the fireplace is completely concealed. The presence of this chimney breast suggests the partition wall is a later insertion and the room was originally full width. Interestingly there is a plaster cornice within both the inner and outer hallway which must have been put up at the same time as the partition wall, which suggests the house was increasing in status. Both cornices have considerable paint cover virtually obscuring the pattern; it is clear, however that there are two separate patterns and both appear to be a floral design.

Figure 10 Hallway Cornice, No 47.

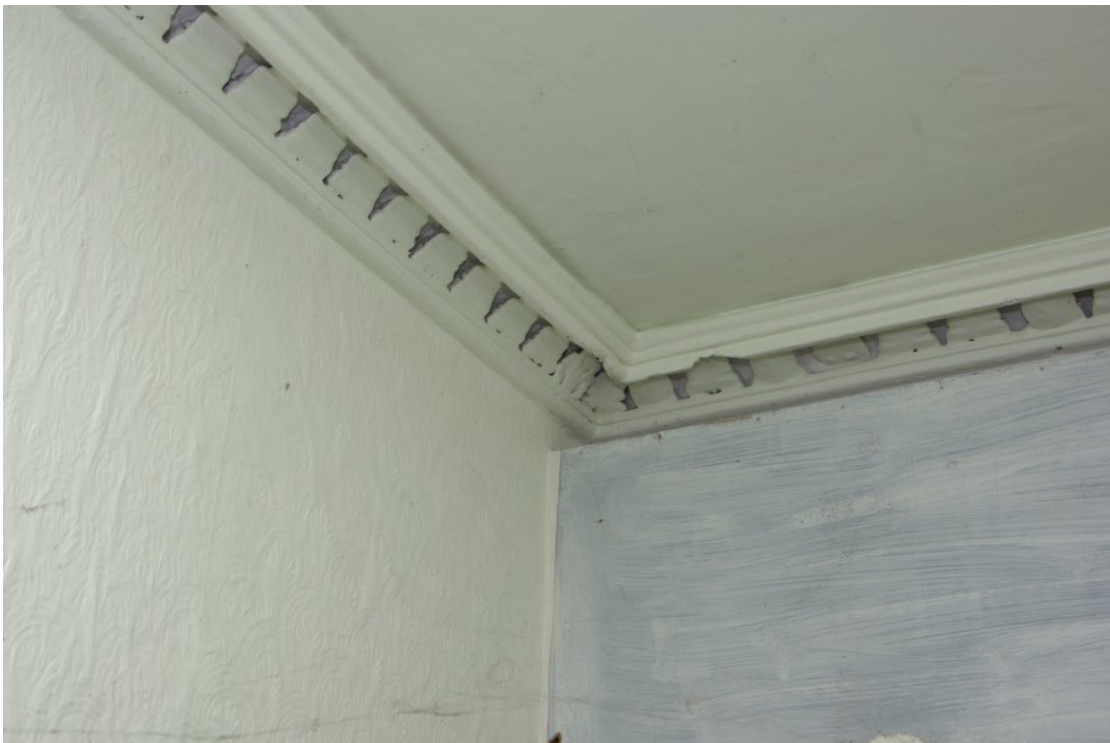
Figure 11 Outer Hallway Cornice, No 47.

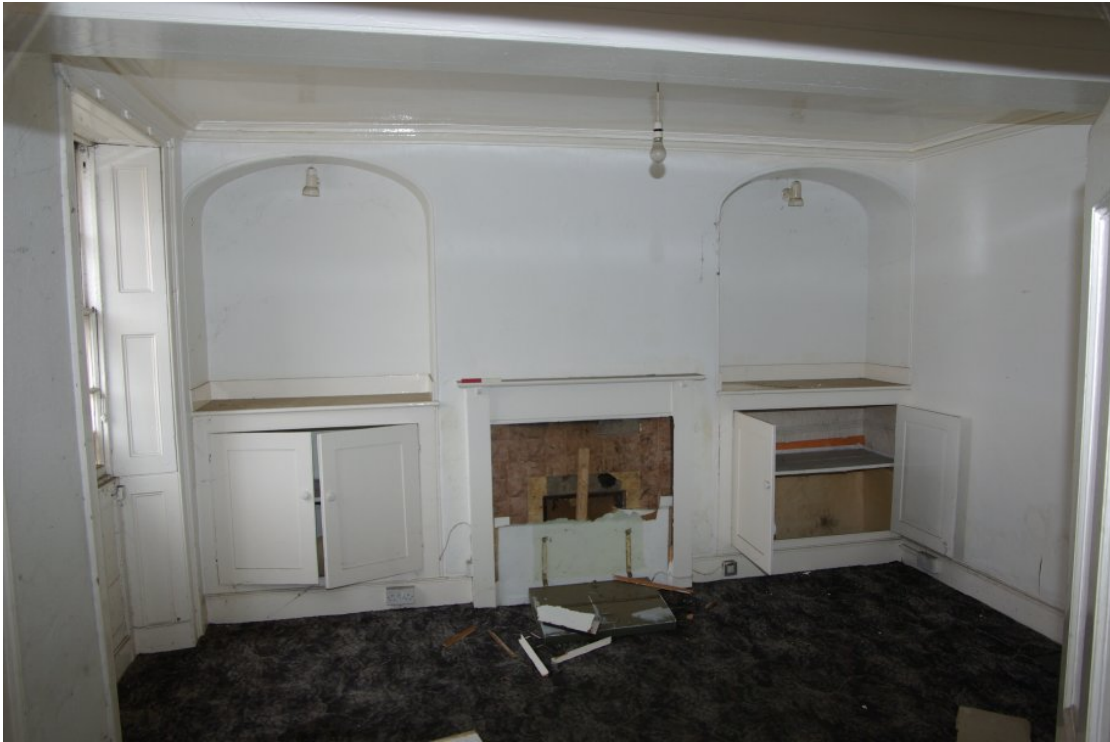
The domestic room to the east appears largely unaltered with the exception of modern decoration. On the easternmost wall there is a chimney breast, each side of which are arched alcoves with cupboards below. There are Victorian shutters on the windows along with Victorian plaster cornice and a Victorian four-panelled door from the hallway. There is an axial beam, slightly off centre, which has been under-boarded. It appears that this room was extensively re-modelled during the later 19th century.

Figure 12 Alcove Cupboards, No 47.

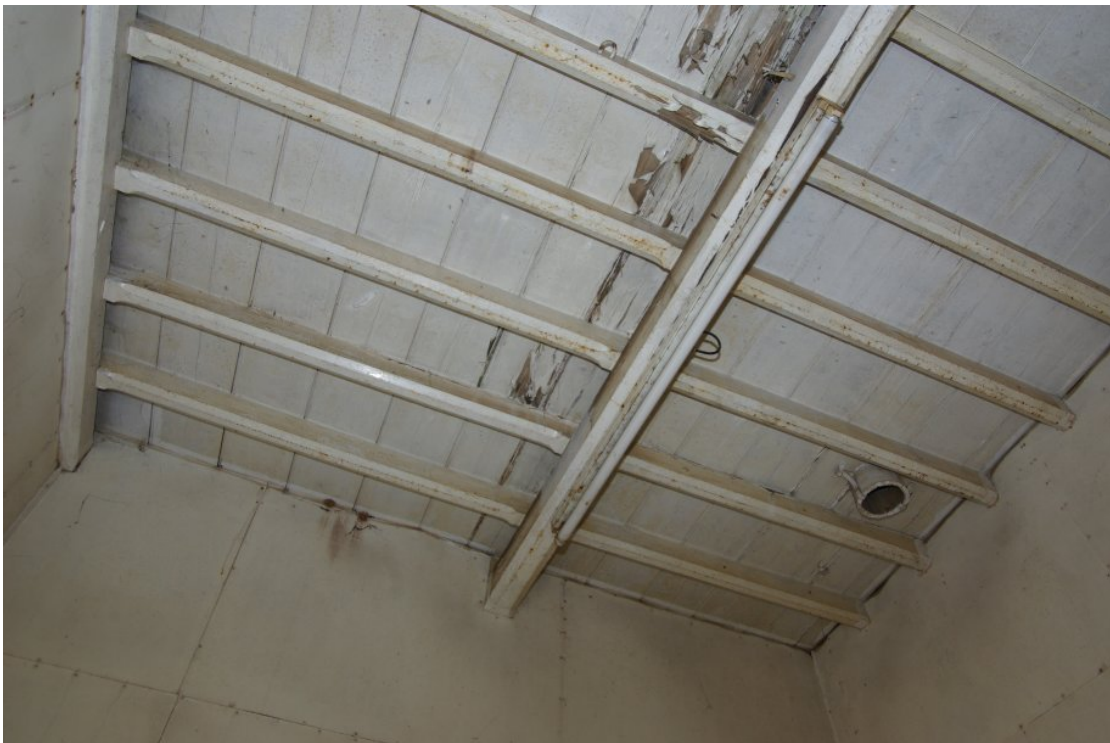
The roof construction is interesting; there is a chamfered axial beam supporting exposed chamfered joists with run-out stops at each end and above the axial beam. There is a second chamfered beam partially concealed within the northern wall. In all, a very attractive and somewhat over the top roof design. Externally the roof is lead covered.

Figure 13 Roof Structure of Passage Room, No 47 & 49.

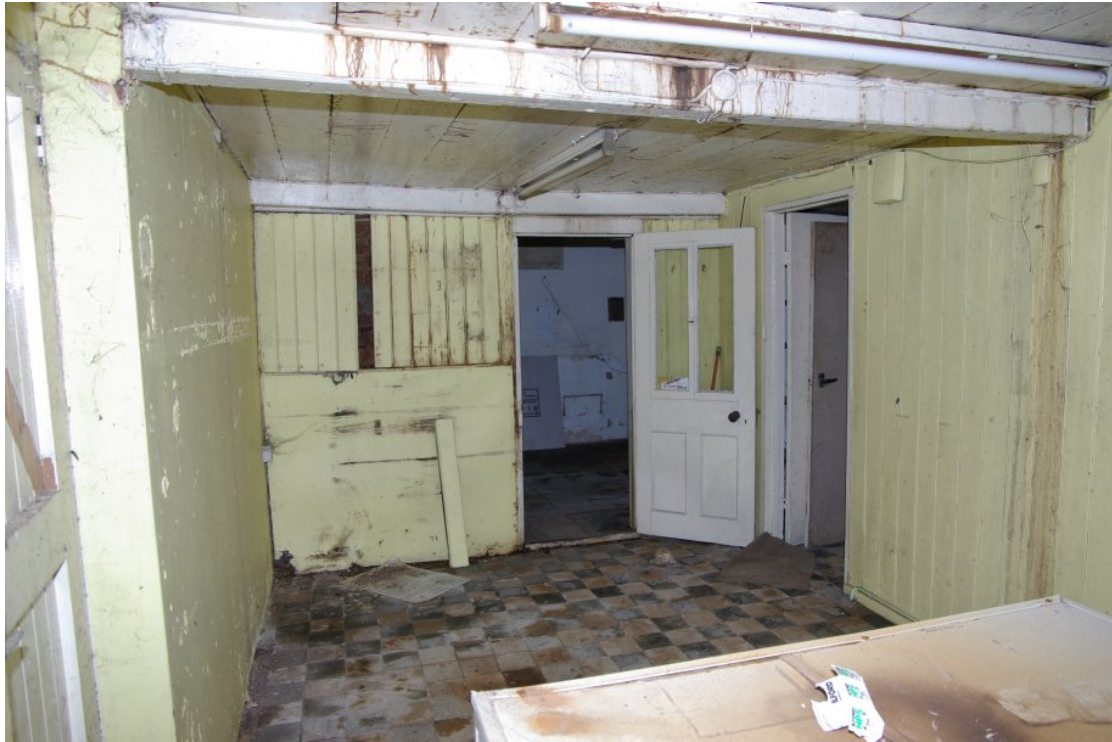
Access to Y is via a door on the western elevation. There is little of architectural or historical interest remaining, given that this part of the building was, until recently used as retail space, evidence for this can be seen in the counter in the south-

Figure 14 General View, Ground Floor No 49.

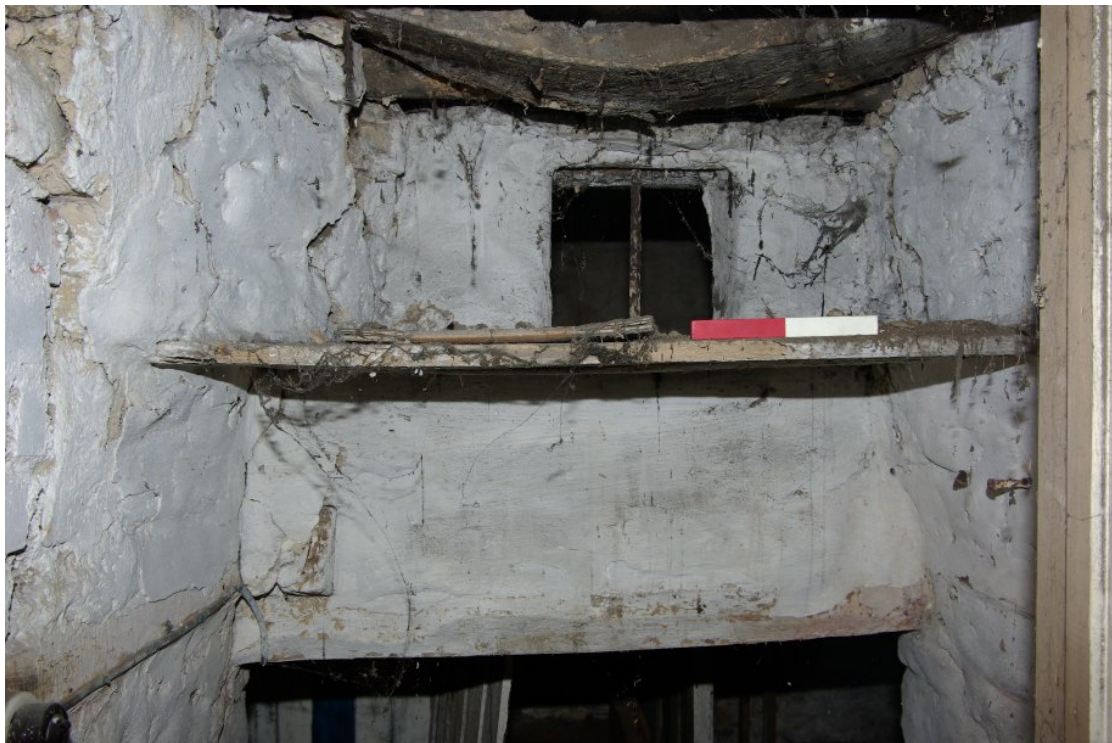
On the eastern wall, there are stairs rising to first floor and 6 stone built steps leading down to a semi basement area, Z, above which there is an unusual arrow slit-like opening above. There is a confusion of levels within Z; there is an opening on the eastern wall which is partially blocked by the existing ceiling. On the southern wall there is a door over a metre above the current ground level. The wall between Y and Z is 970mm wide, approximately twice the width of the other walls. It is likely, therefore that this wall is earlier and was retained and added to when Y was built. A brick skin was also added to the west face, probably when the staircase was built.

Figure 15 Arrow Slit Opening Above Cellar Access, No 49.
