**An archaeological evaluation on Land Adjacent to 7 Ashby Road,
Gaddesby, Leicestershire. NGR: SK 689 128**

**ULAS Report No 2020-056
©2020**

Site Name: Land Adjacent to 7 Ashby Road, Gaddesby, Leicestershire

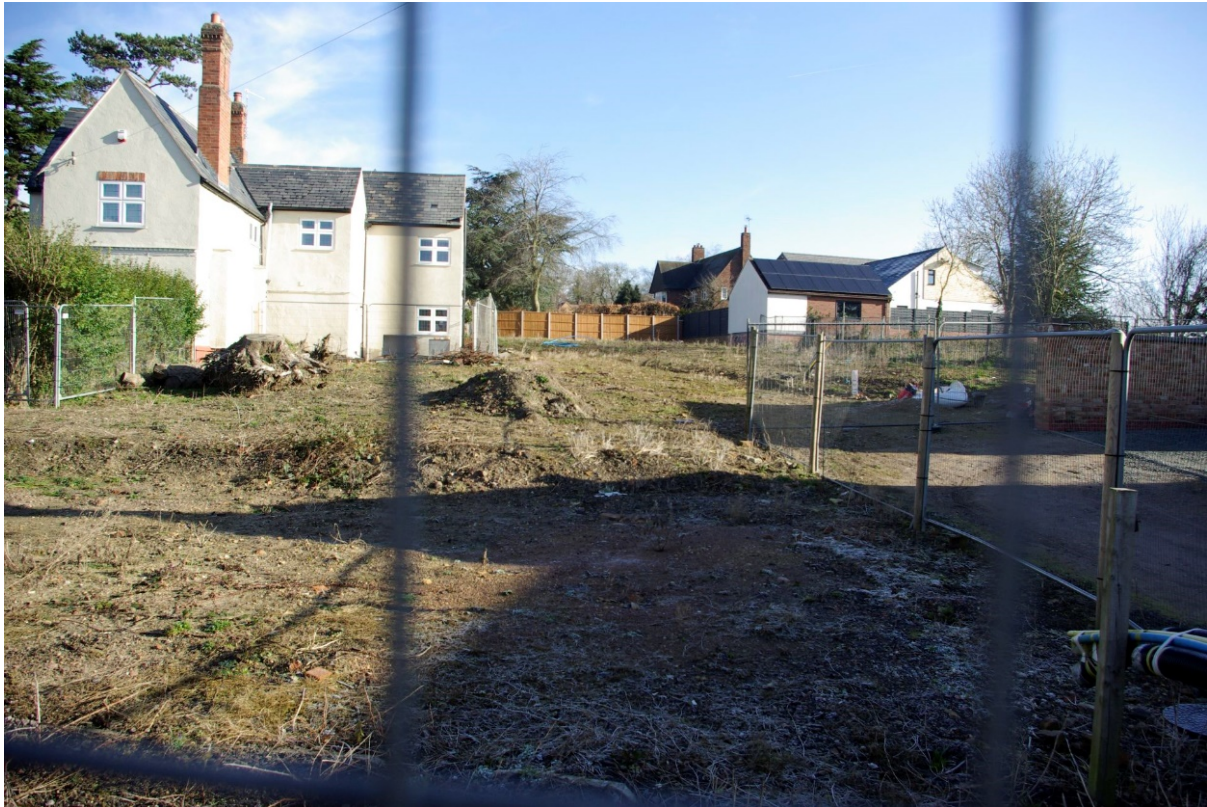
At the time of the report all vegetation had been cleared from the site leaving an open space with only a modern fence forming the northern boundary (Fig. 3). A house and garden wall form part of the north-eastern corner boundary with the remainder having Heras fencing to

Figure 3 General view of site from Ashby Road
Looking north-east

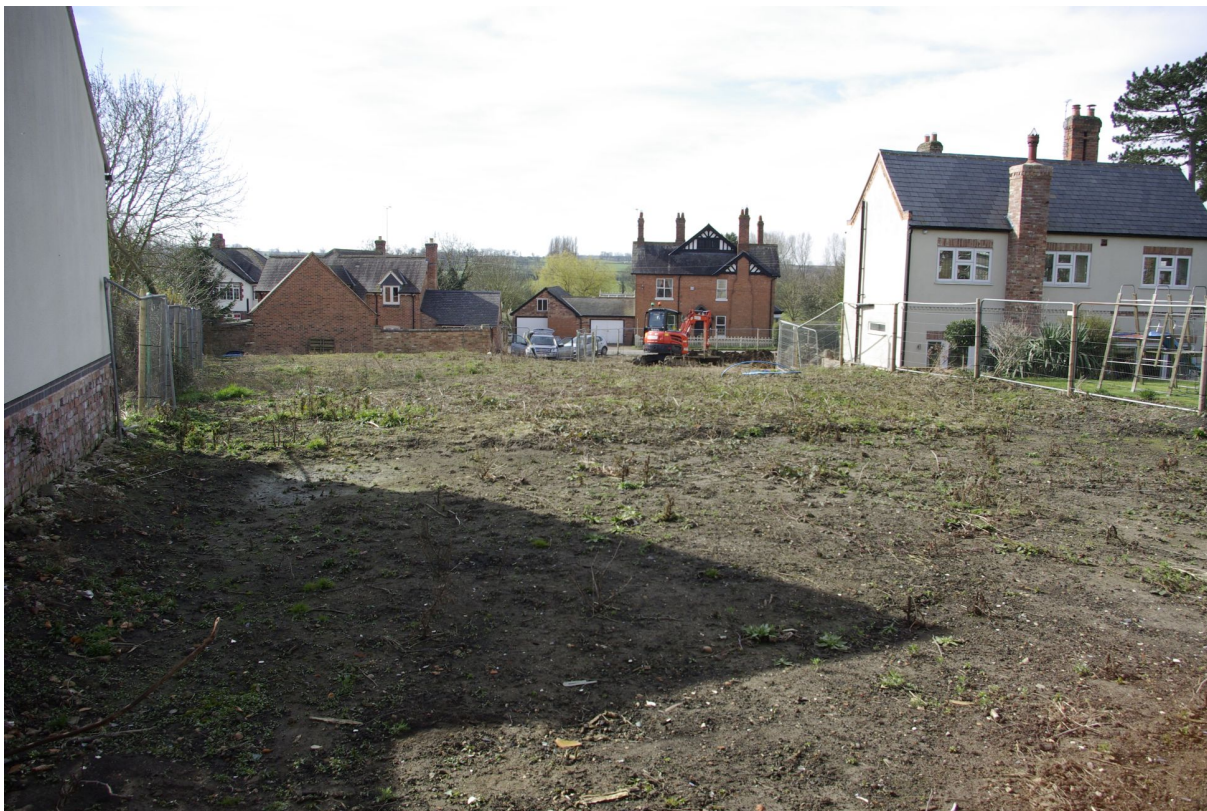
Figure 4 General view of site from north end
Looking south-west towards Ashby Road

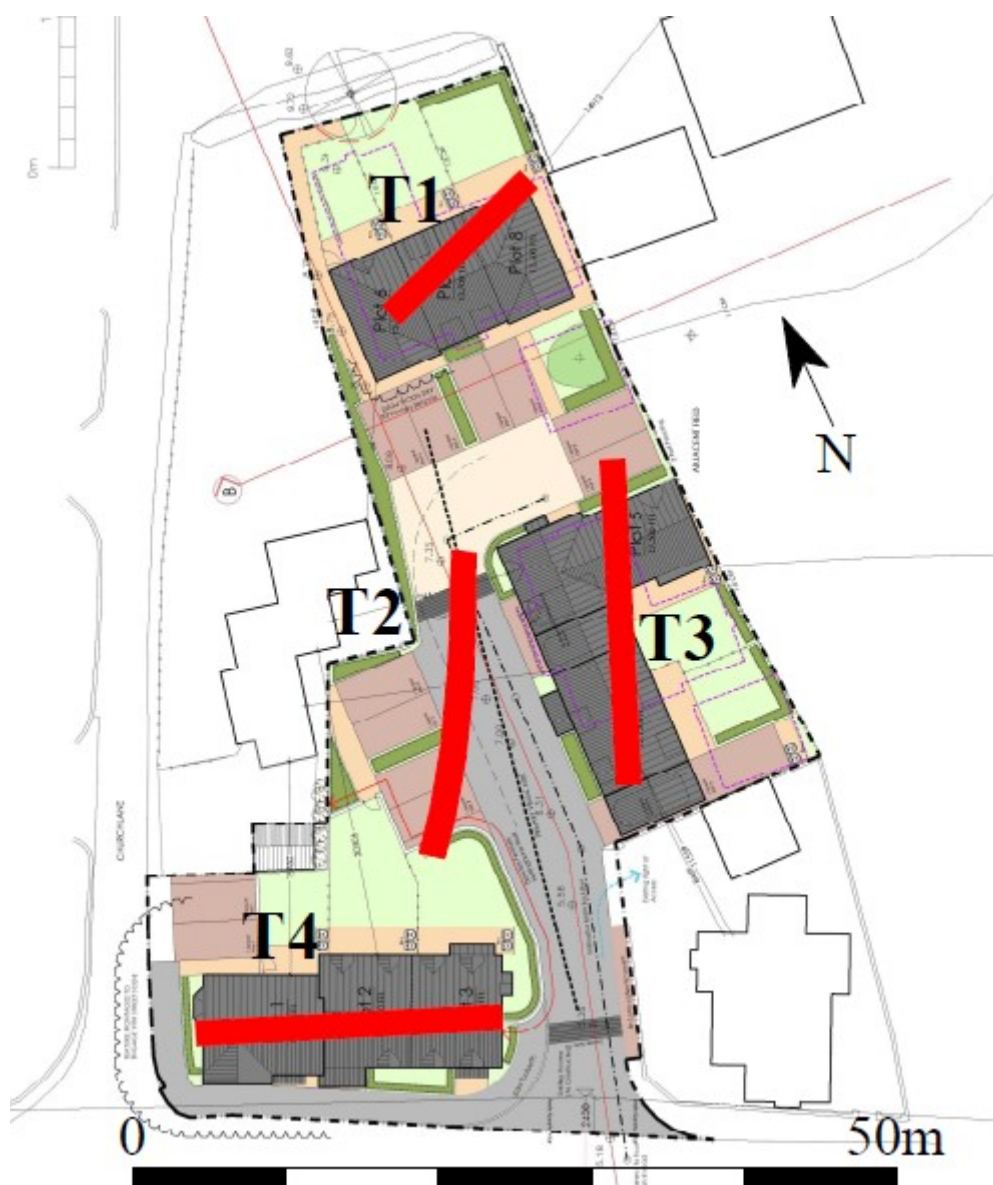
Figure 7 Location of evaluation trenches

Three trenches were placed in order to target the three blocks of proposed housing and a fourth trench was placed along the line of the service road (Fig. 7). All of the trenches were intended to be 20m in length although site constraints and the presence of existing services meant that this length had to be modified during the evaluation (Table 1).

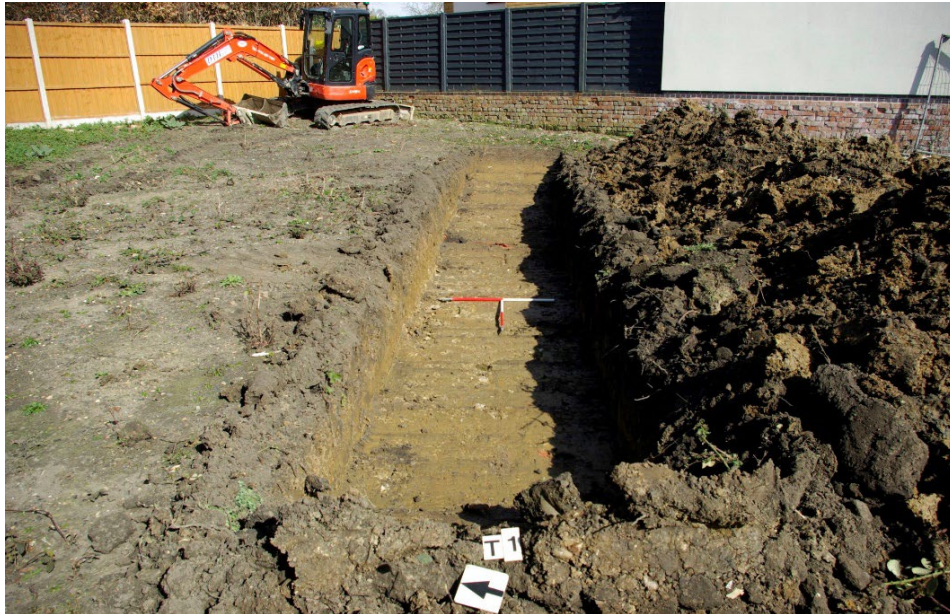
Trench 01 was placed at the northern end of the site to run along the line of the proposed houses. The narrow width of the site at this point meant that the trench had to be angled slightly in order to give the excavator room to manoeuvre. Prior to the evaluation much of the silty sandy topsoil had been removed leaving only a thin layer between 0.08m and 0.20m thick. This however did not appear to have affected the sandy clay subsoil which had a thickness of between 0.30m and 0.48m. Removal of both layers revealed the natural substratum which consisted of a mid-yellow brown sandy clay (Figs 8 and 9).

No archaeological features or deposits were observed in this trench. A circular section land drain was seen following the slope of the land down to the south. The depth of the natural substratum was slightly lower at this point which may possibly suggest the remnant of a plough furrow although there was no evidence of this in the overlying layers.

Figure 8 Trench 01
Looking north-east. 1m scales. Note land drain just beyond scales

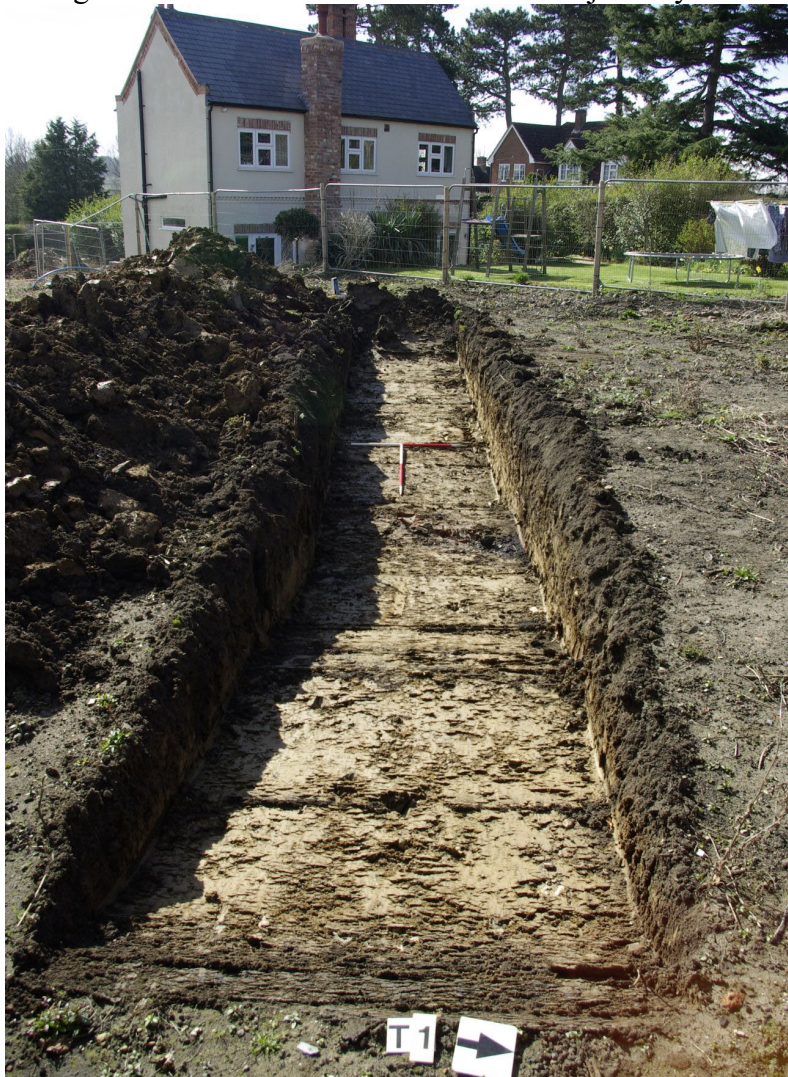
Figure 9 Trench 01
Looking south-west. 1m scales. Land drain running across the trench this side of scales

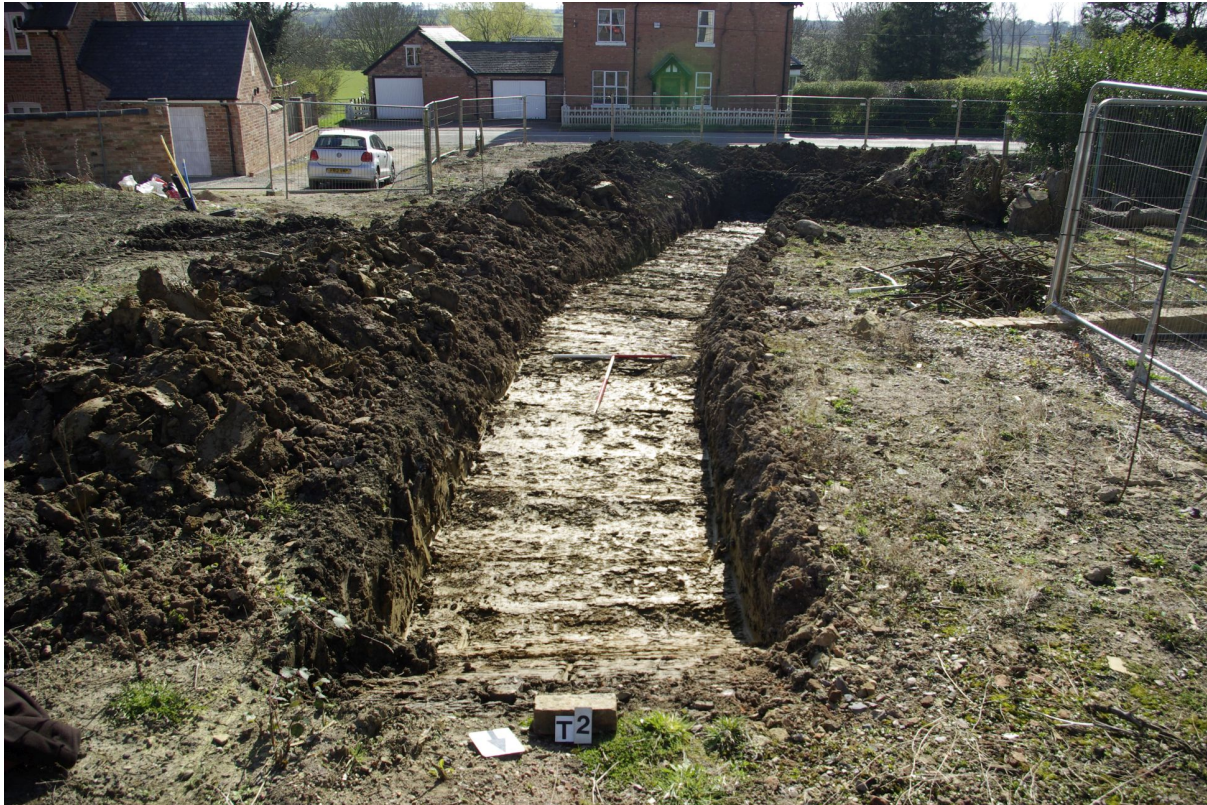
Figure 10 Trench 02

The east wing of the adjacent property on Church Lane, which is shown on all available maps has been demolished leaving only the brick foundation wall at ground level. It is not clear when this demolition took place. The foundations extended into the development site and, as with the service pipes, were thought likely to have disturbed any surviving archaeology. The rest of the house appeared to be of 19th century date with later additions and the brick foundations were of a similar date, therefore Trench 02 was moved slightly in order to avoid them.

Looking south towards Ashby Road. 1m scales. Note foundation wall of demolished wing of adjacent house running under the fencing on the right of the picture

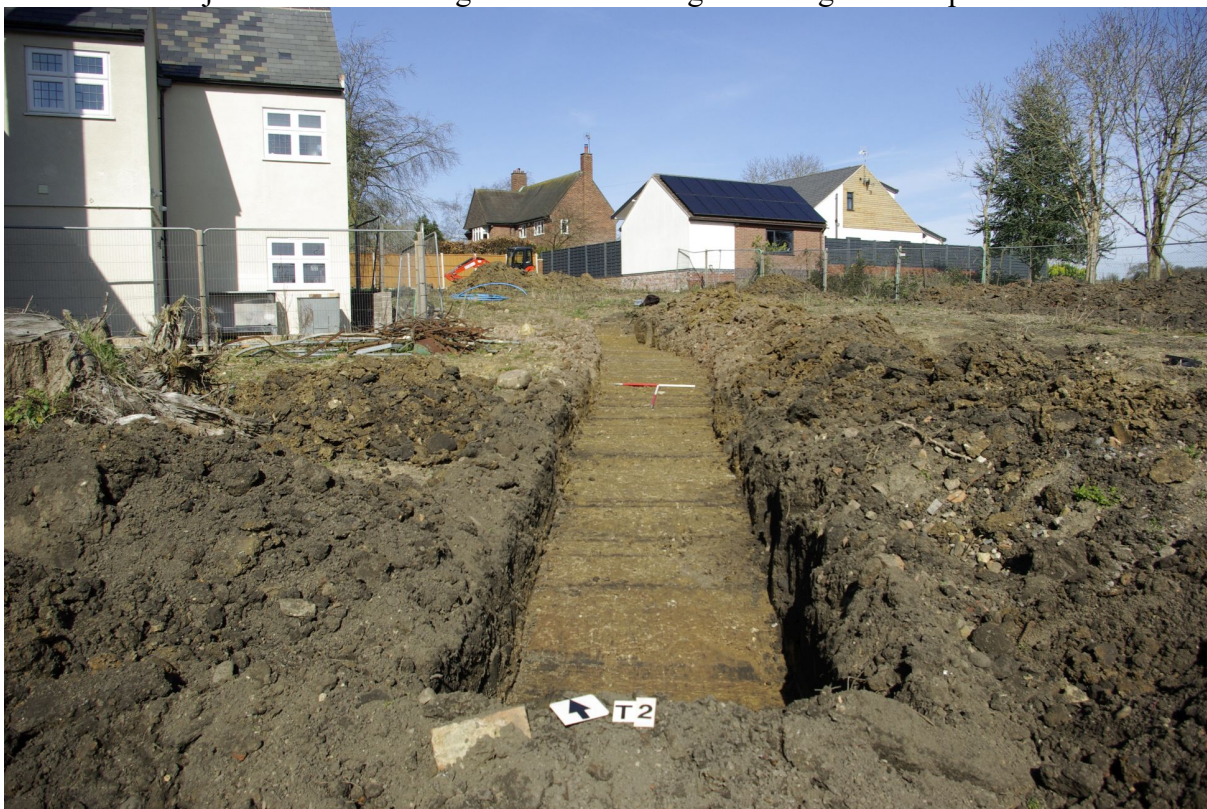
Figure 11 Trench 02

No archaeological features or deposits were observed in this trench. The natural substratum appeared to have been truncated for the final 4m of the southern end of the trench which corresponded with the lack of subsoil. It would appear that this area had undergone some form of landscaping, possibly during the creation of the garage forecourt area or during the demolition of the structures formerly on site. No land drains or evidence of ridge and furrow was observed.

Looking north-east. 1m scales. Note how the depth of natural increases at the southern end of the trench

Trench 02 was slightly more disturbed than Trench 01 and was also negative. The drop in the level of the natural at the southern end might indicate the edge of the heavily disturbed area seen in Trench 04. The lack of any subsoil in this part of the trench also points to a degree of disturbance which is likely to have damaged any surviving deposits.

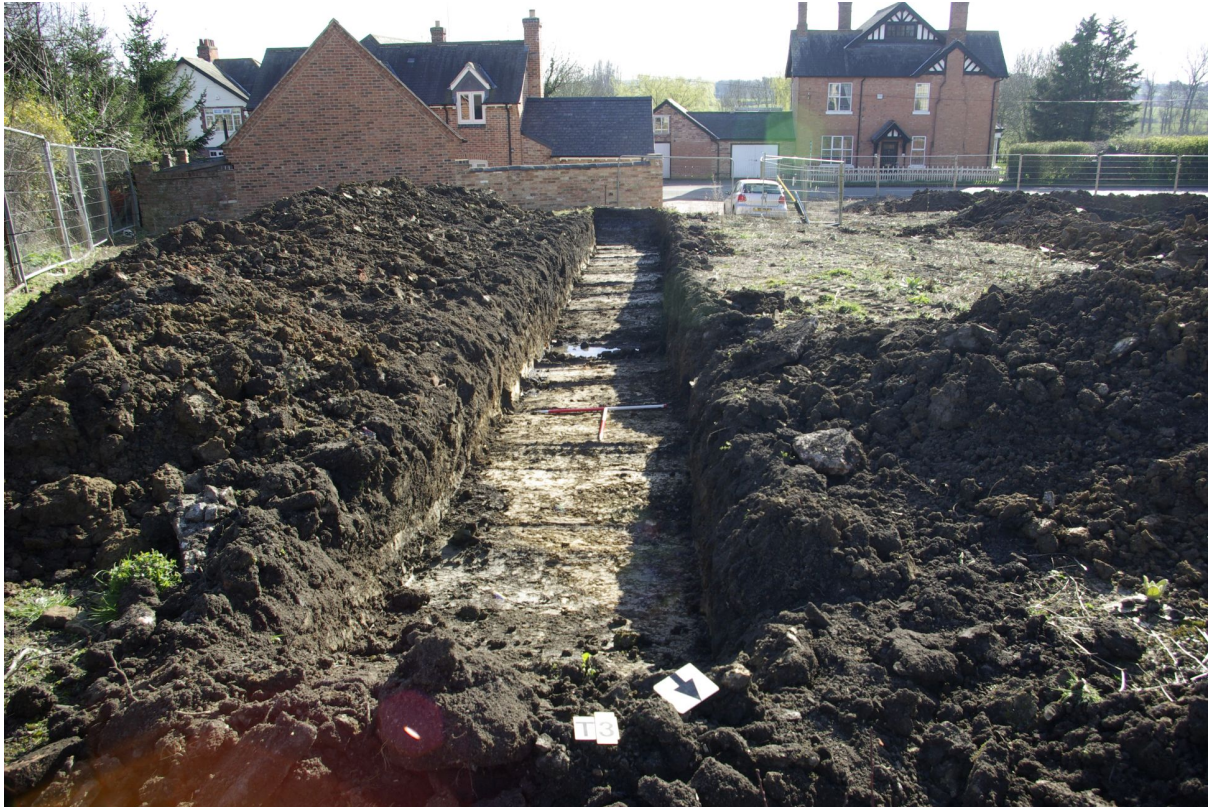
Figure 13 Trench 03
Looking south. 1m scales. Heavily disturbed area just beyond the scales

The high level of disturbance in Trench 03 appears to have been caused by the earlier buildings shown in this part of the site on the Ordnance Survey maps. The number and style of bricks found within the overburden indicates that the buildings were likely to be later 19th century brick-built structures. Map evidence and the quantity of modern debris within the overburden indicates that they were probably demolished in the later 20th century.

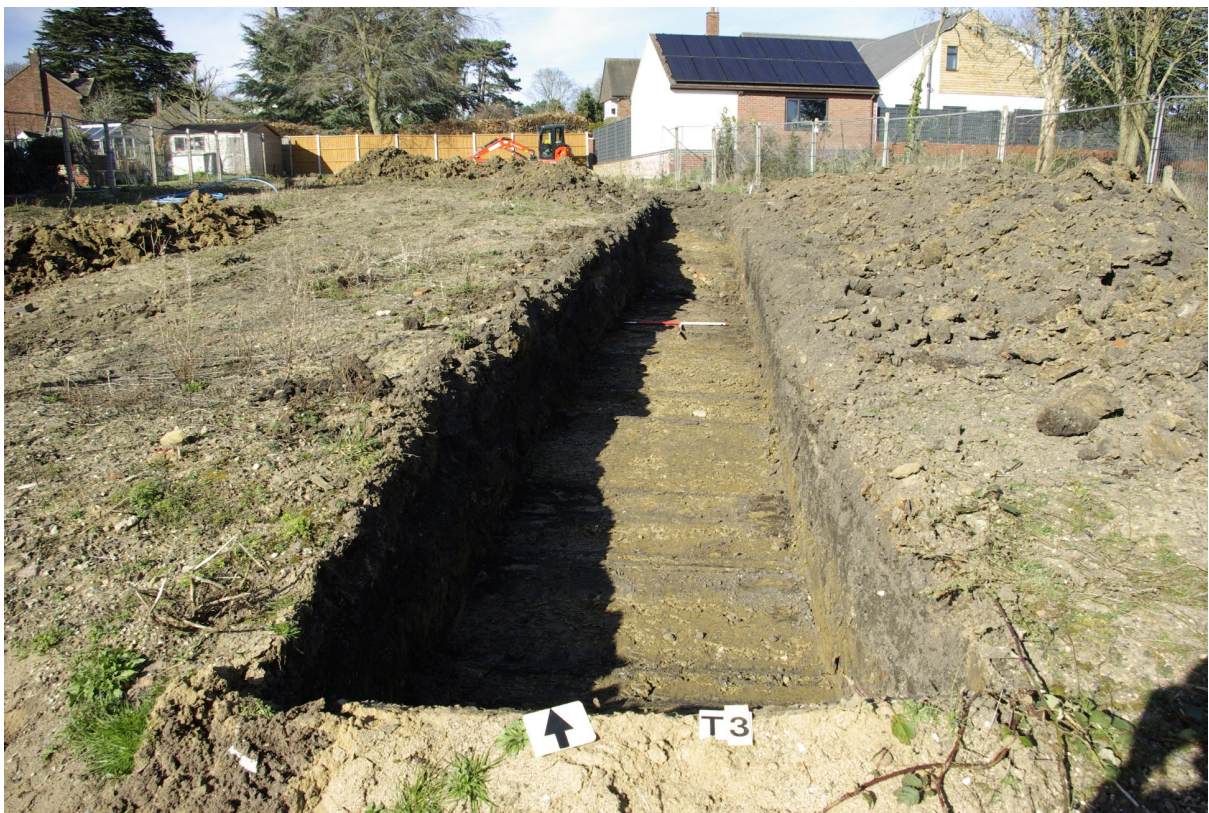
Figure 14 Trench 03
Looking north. 1m scales

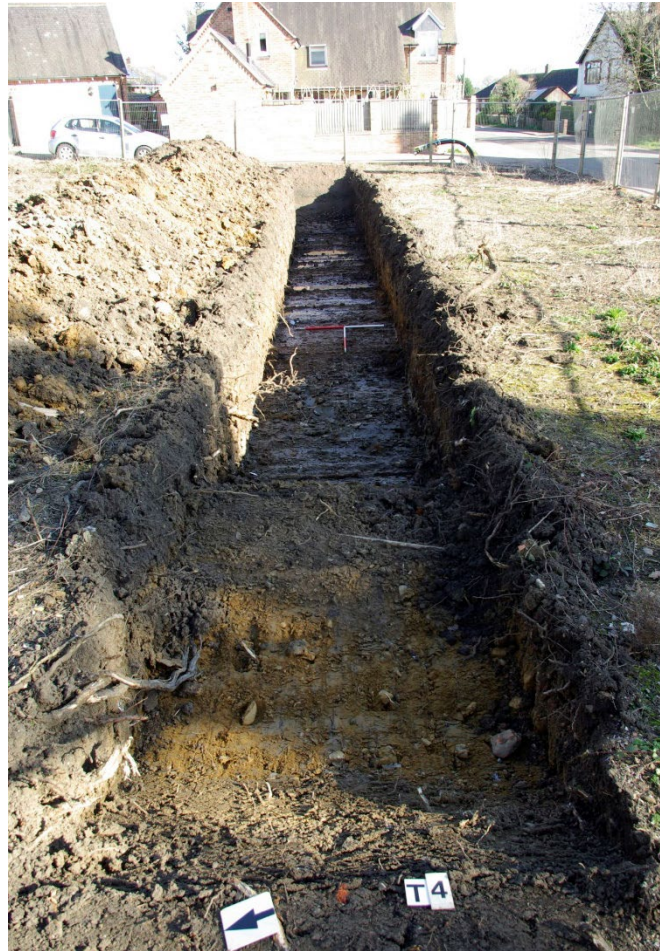
As with Trench 03 the overburden appeared to be extremely disturbed all of the way down to the natural substratum with no evidence of any subsoil. For the first 5m of the western end of the trench the upper 0.3m to 0.5m of sandy silt overburden was full of tree roots. Beneath the roots was an area of sandy gravel containing a water pipe. The pipe appeared to lead from a stopcock in the road towards the adjacent house on Church Lane and was left intact (Fig. 15). Eastwards, beyond the root disturbance the overburden consisted of a mixed sandy silt with areas of brick rubble, ashy patches and stones. A spark plug was found within this material at around 0.7m below present ground level. The undisturbed natural substratum consisted of a yellow brown sandy clay which was slightly darker than that seen in the other trenches. The darker hue may be due to a certain amount of staining from the overburden which appeared to be slightly oily in places.

No evidence of any underground petrol tanks was seen during the excavation of this trench. The owner indicated that these were slightly further north than the location of Trench 04 although it is possible that their installation and, later, removal has caused a significant amount of disturbance to a wider area. The top of undisturbed natural was significantly deeper than in the other trenches which may suggest that the ground has been truncated in this part of the site.

Figure 15 Trench 04
Looking east. 1m scales. Ashby Road on right. Water pipe in foreground

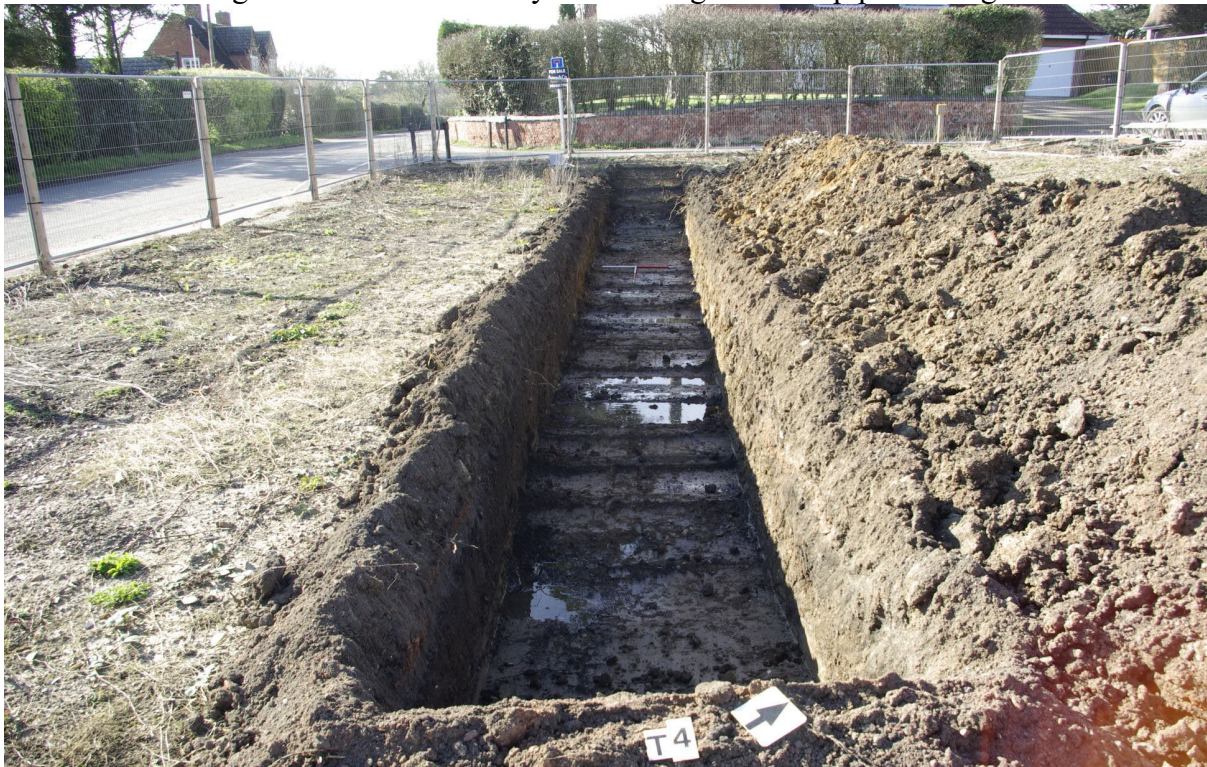
Figure 16 Trench 04
Looking west. 1m scales. Ashby Road on left, Church Lane at far end of trench

Prior to the evaluation Trench 04 offered the greatest potential for evidence of buildings fronting onto Ashby Road. Unfortunately, the level of disturbance caused by the former garage appears to have removed any potential archaeological features which may have survived. The number of tree roots towards the western end of the trench also appears to have added to the disturbance.
