**A photographic historic building survey at  
Saltersford Farm,  
Measham Road, Acresford  
Swadlincote,  
Leicestershire, DE12 8AH  
NGR: SK 30963 12466**

**ULAS Report Number:** 2021-040

## **A photographic historic building survey at Saltersford Farm, Measham Road, Acresford, Swadlincote, Leicestershire (SK 30963 12466)**

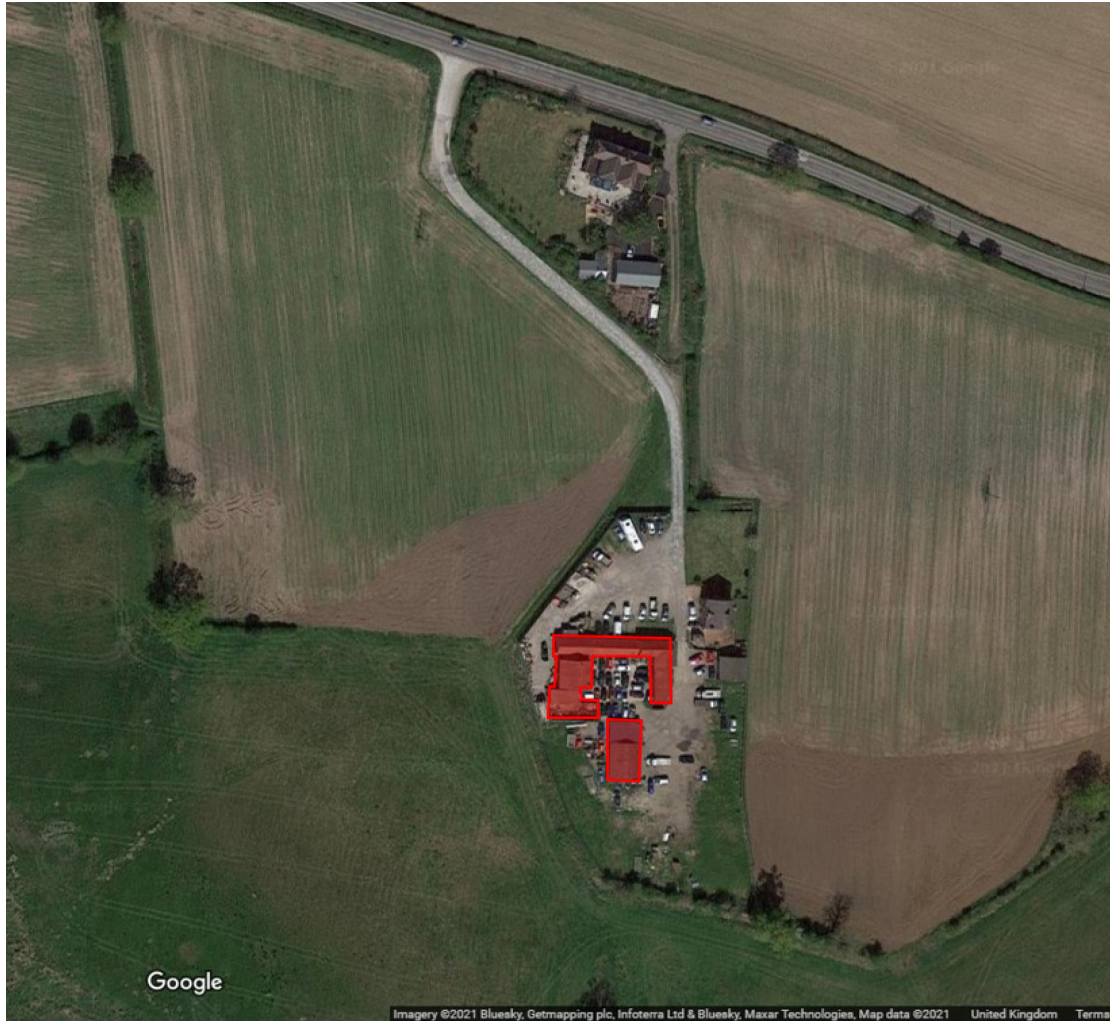
Figure 3 Aerial view of site

Buildings to recorded highlighted. Imagery ©2021 Bluesky, Getmapping plc, Infoterra Ltd & Bluesky, Maxar Technologies. Map Data ©2021

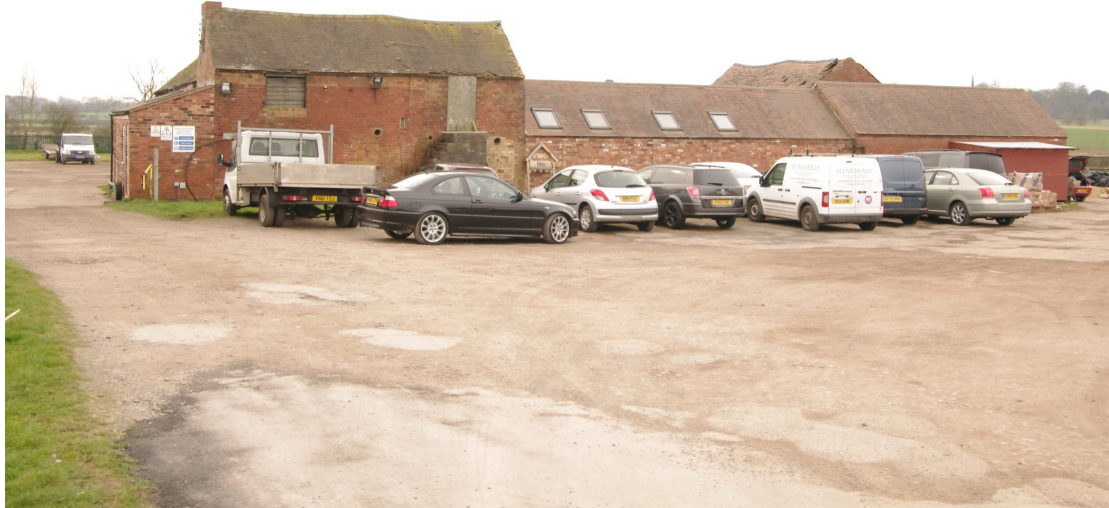
Figure 7 Saltersford Farm seen from the north  
Looking south-west. The two storey barn on the left is the oldest element

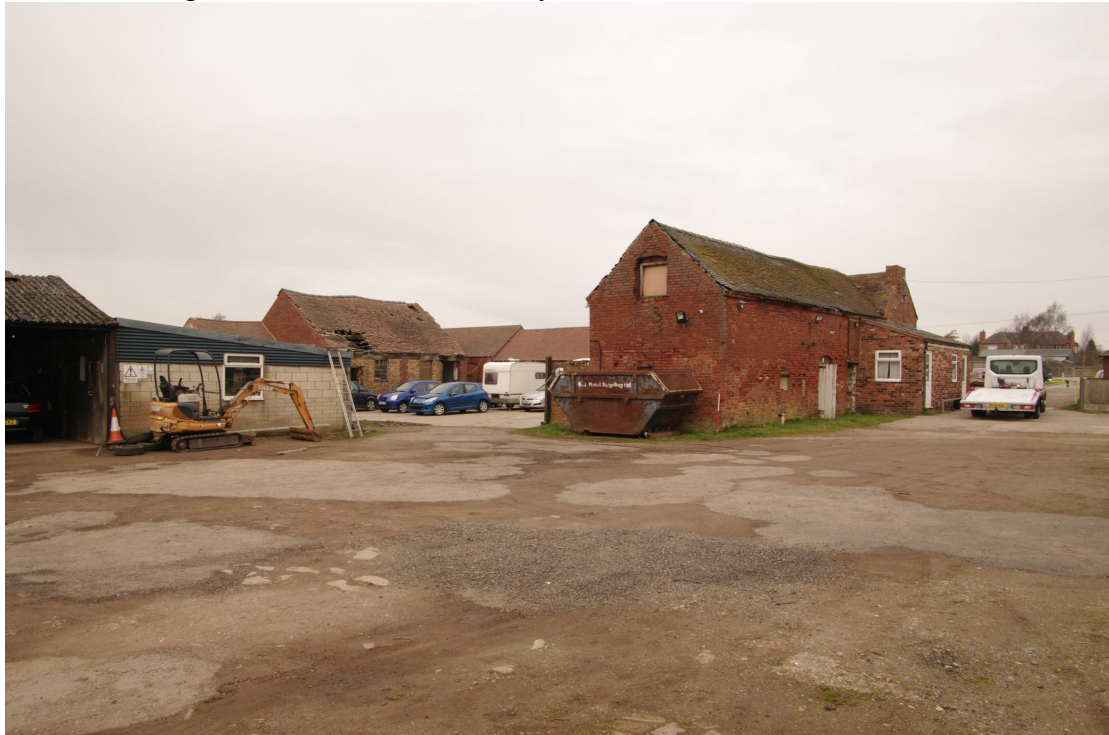
Figure 8 Saltersford Farm seen from the south-east  
Looking north-west towards the yard. Barn 4 on far left

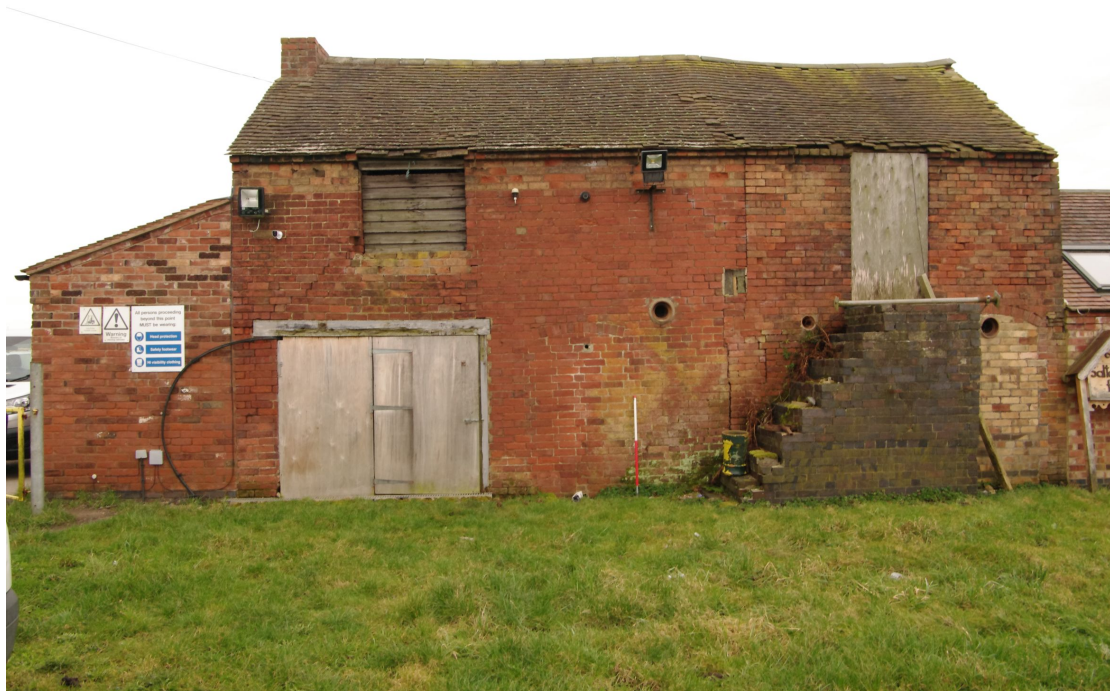
Figure 11 North facing elevation of two storey former house  
Looking south. 1m scale. Note the extension to the right and raised eaves. There is a  
blocked ground floor window to the left of the scale. Lean-to extension on left is  
relatively modern

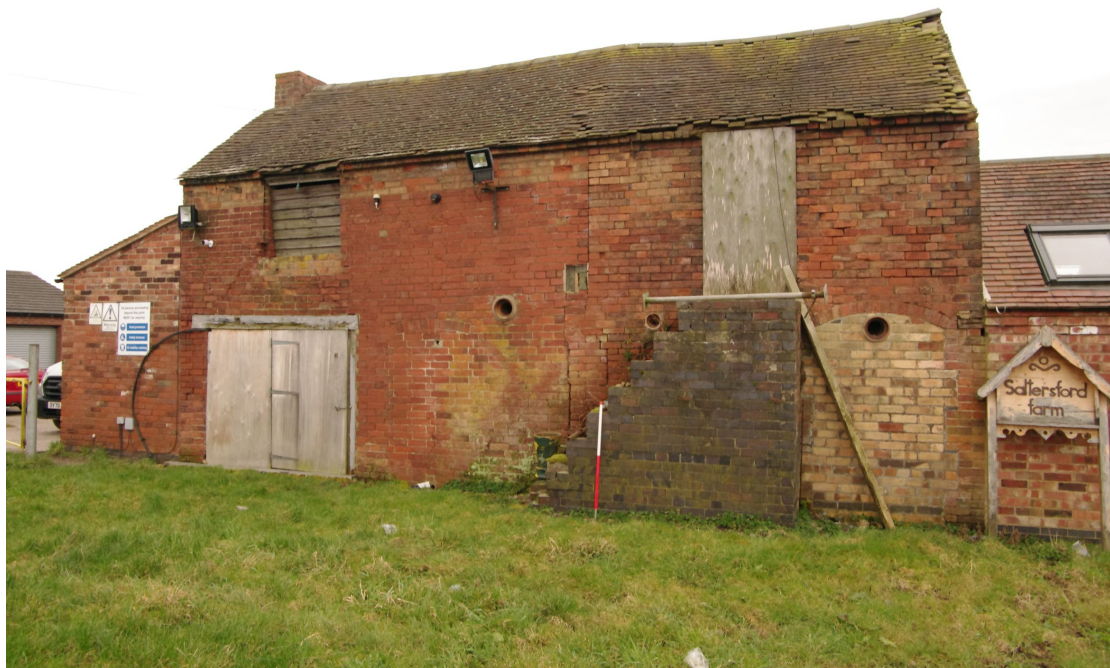
Figure 12 North facing elevation of two storey former house and hayloft  
Looking south-east. The buff-coloured bricks blocking the door to the right can be  
seen elsewhere on the farm

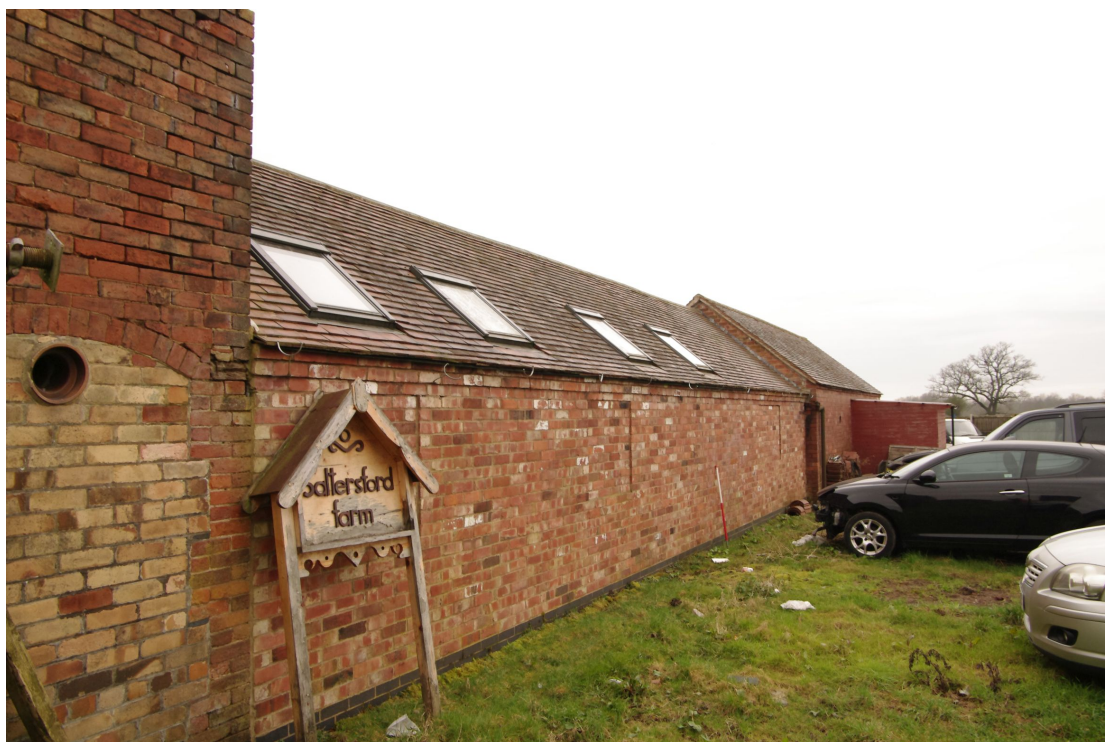
Figure 13 Single storey range of north facing barns (Barn 2)  
Looking south-west. 1m scale. The wall has been rebuilt and now has a blue-brick damp-proof course. The roof has also been re-covered and repaired

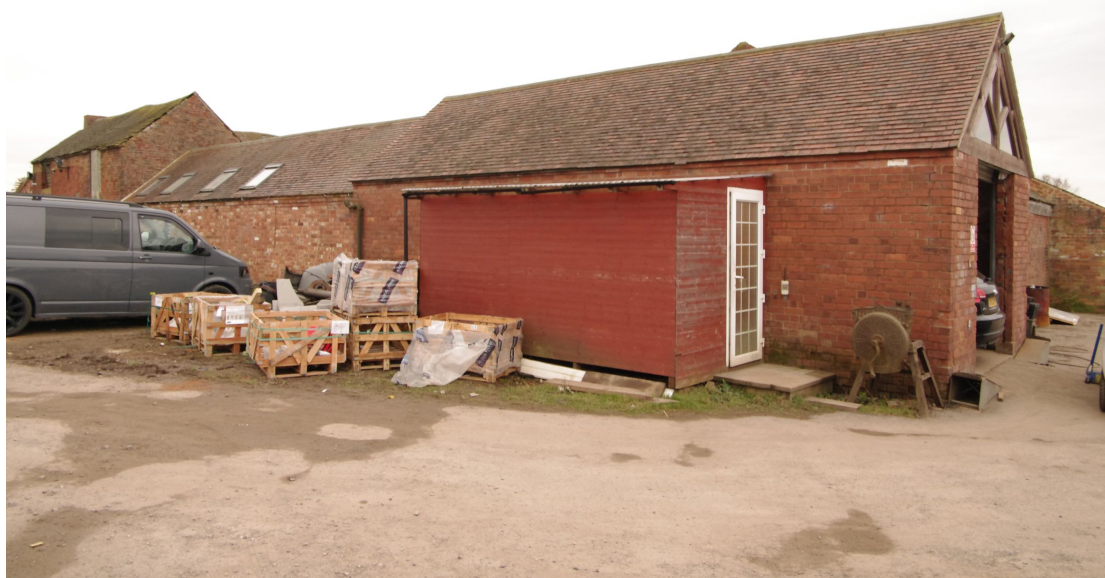
Figure 14 Western end of north facing Barn 2 range  
Looking south-east. The roof is new as is some of the brickwork

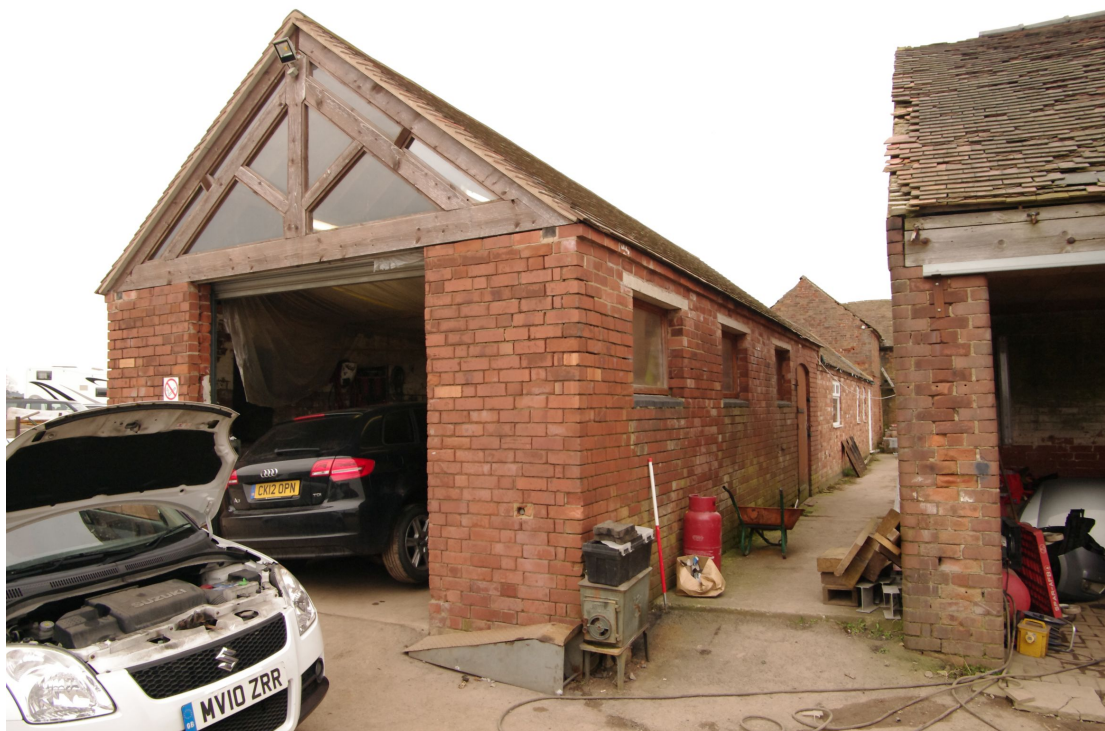
Figure 15 West facing gable end of Barn 2 range  
Looking north-east. 1m scale. The internal details of this single storey range are modern. Note concrete lintels. The edge of Barn 3 is on the far right

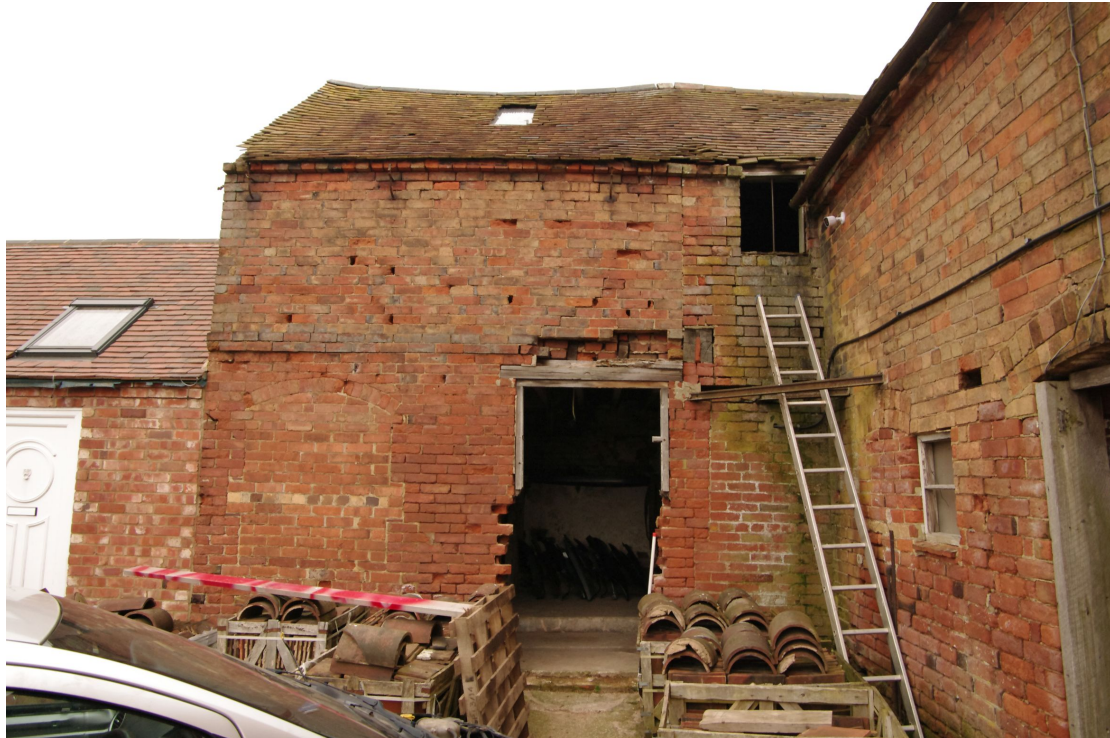
Figure 19 South facing elevation of hayloft  
Looking north. Note the brick joint to the right of the doorway

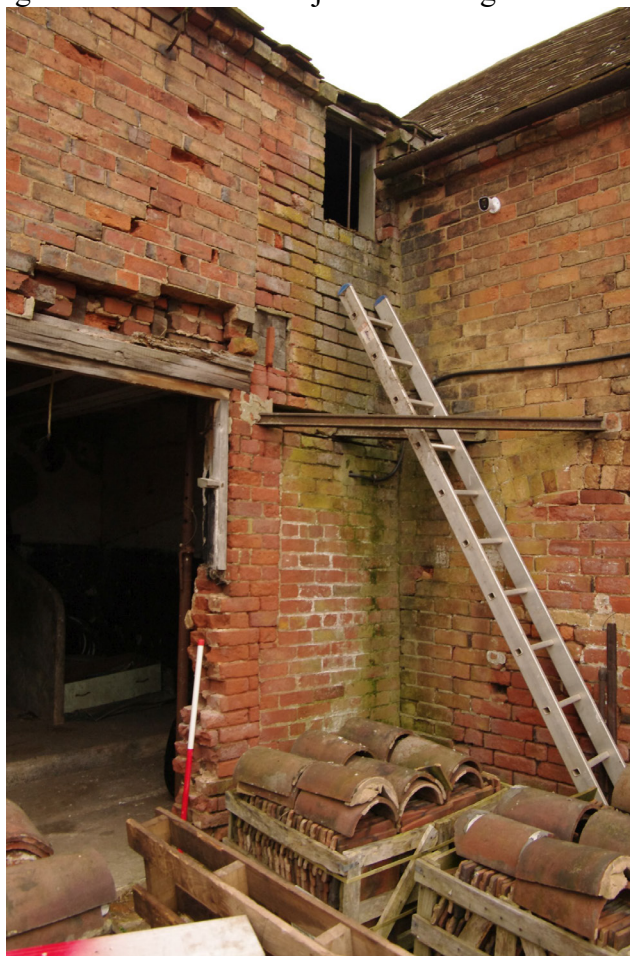
Figure 20 Detail of the joint between the former house and hayloft  
Looking north-east. 1m scale

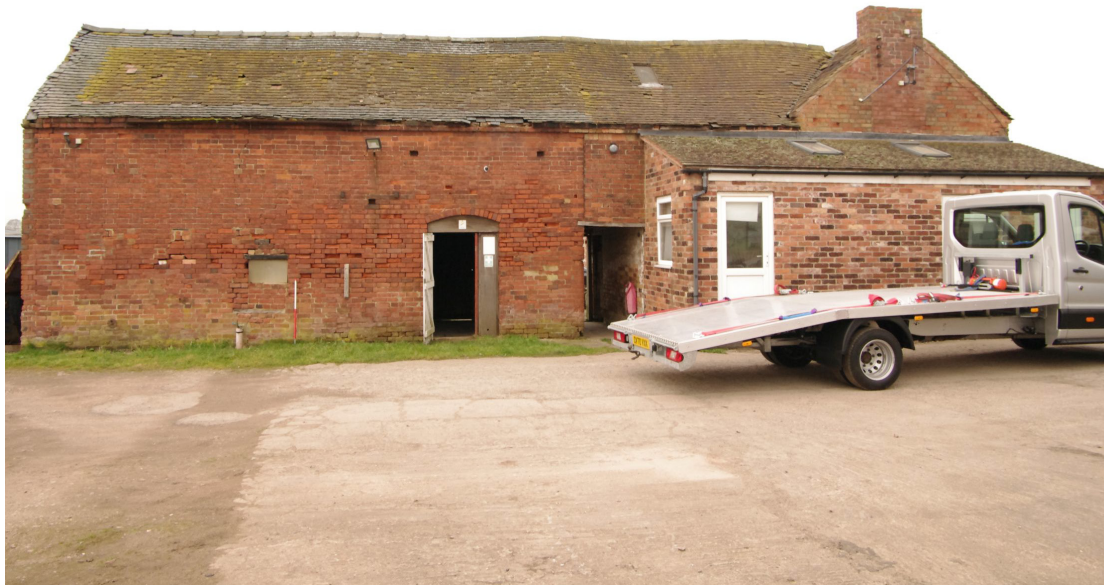
Figure 25 East facing elevation of Barn 1 range  
Looking west. 1m scale. The lean-to structure on the right is relatively modern

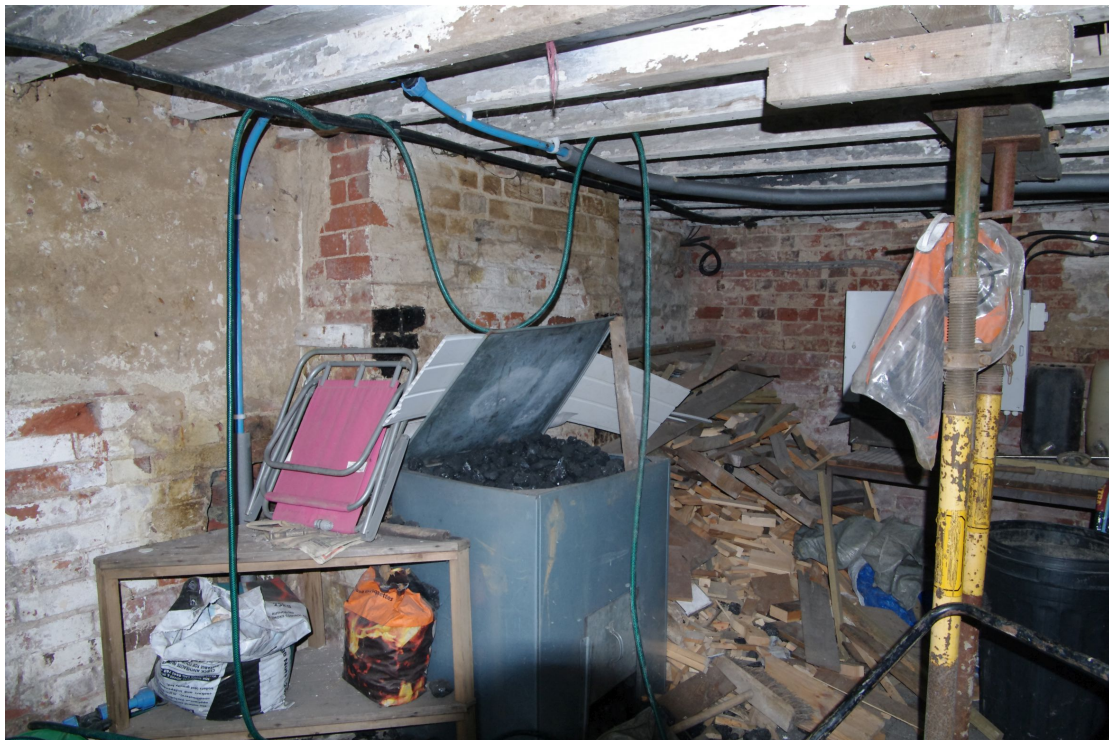
Figure 26 Ground floor room of former house  
Looking south-east. Fire place is behind the coal bunker and wood pile

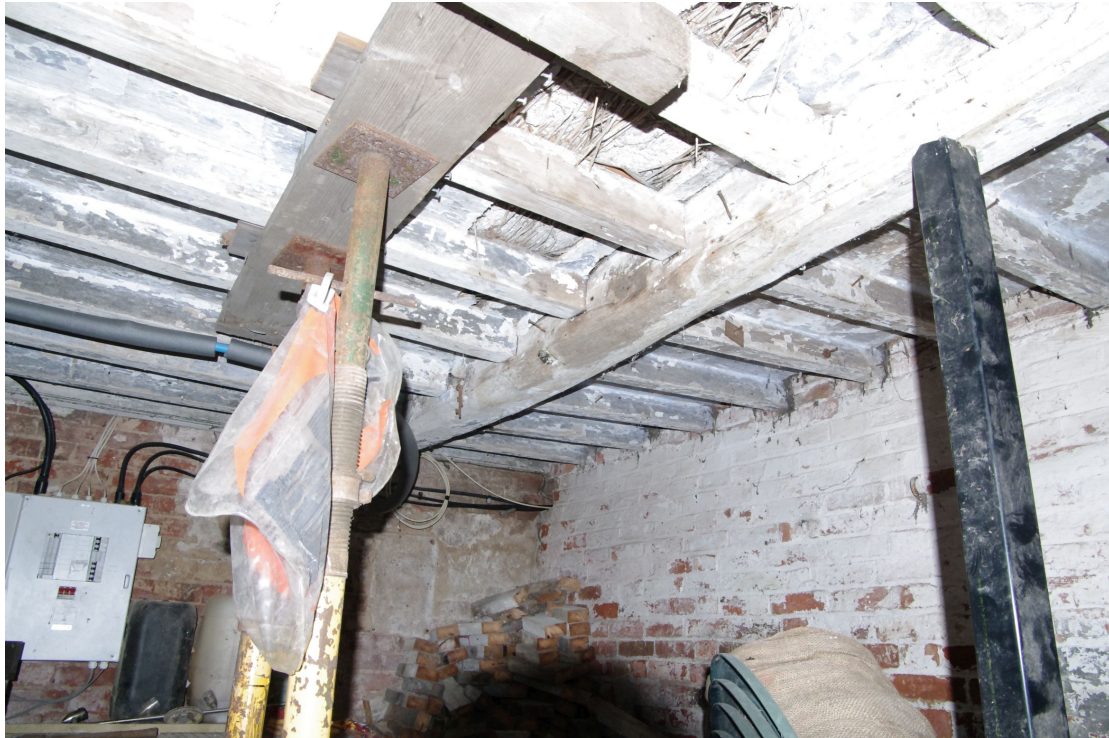
Figure 27 Ground floor room of former house  
Looking south-west. Note straw and plaster ceiling

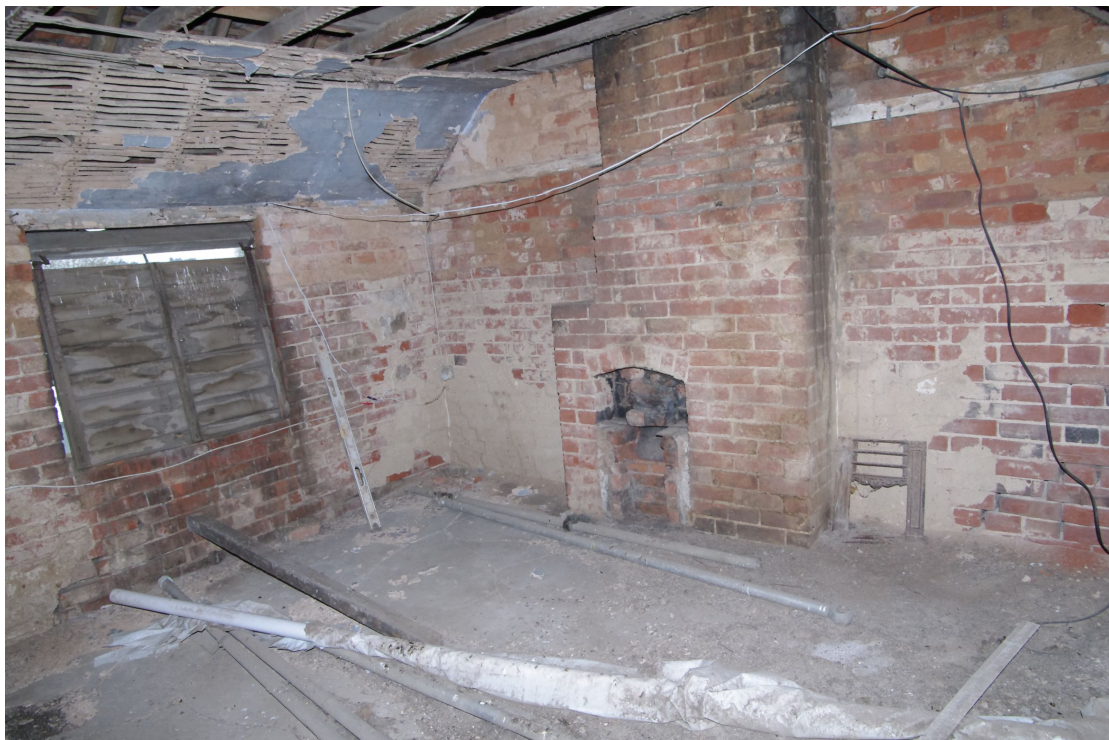
Figure 28 First floor room of former house  
Looking north-east. Note presence of ceiling and plaster floor

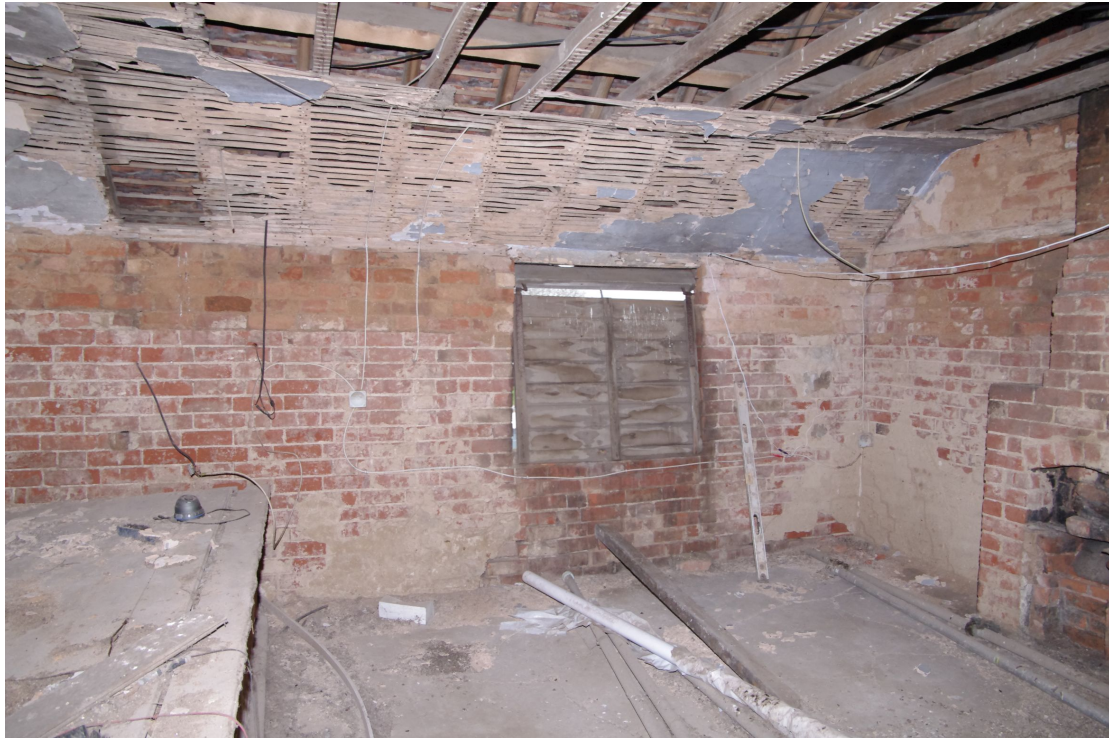
Figure 29 First floor room of former house  
Looking north. Note change in bricks indication raised wall height

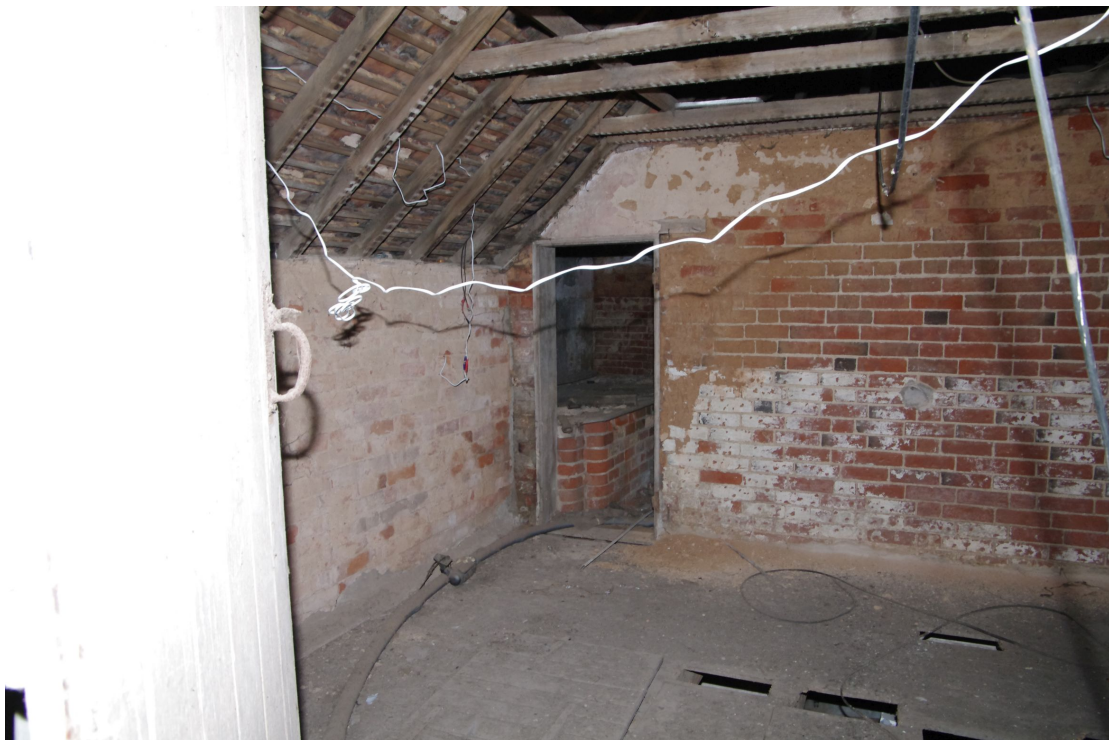
Figure 36 First floor room at north end of Barn 1  
Looking north-west. The doorway leads into the rooms seen in Figs 28 and 29. Note that this room was plastered and had a ceiling and may have been part of the former house

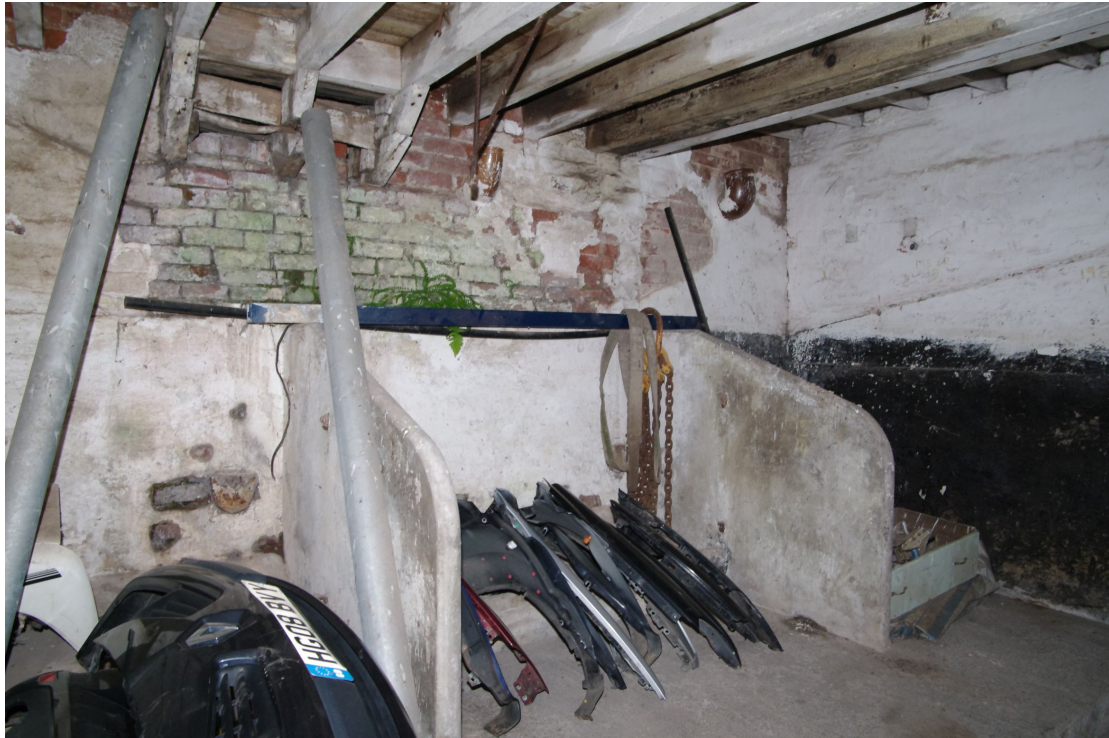
Figure 37 Ground floor of extended hayloft section of Barn 2 range  
Looking north-east. The change in floor joists at the far right may indicate where the former staircase was located

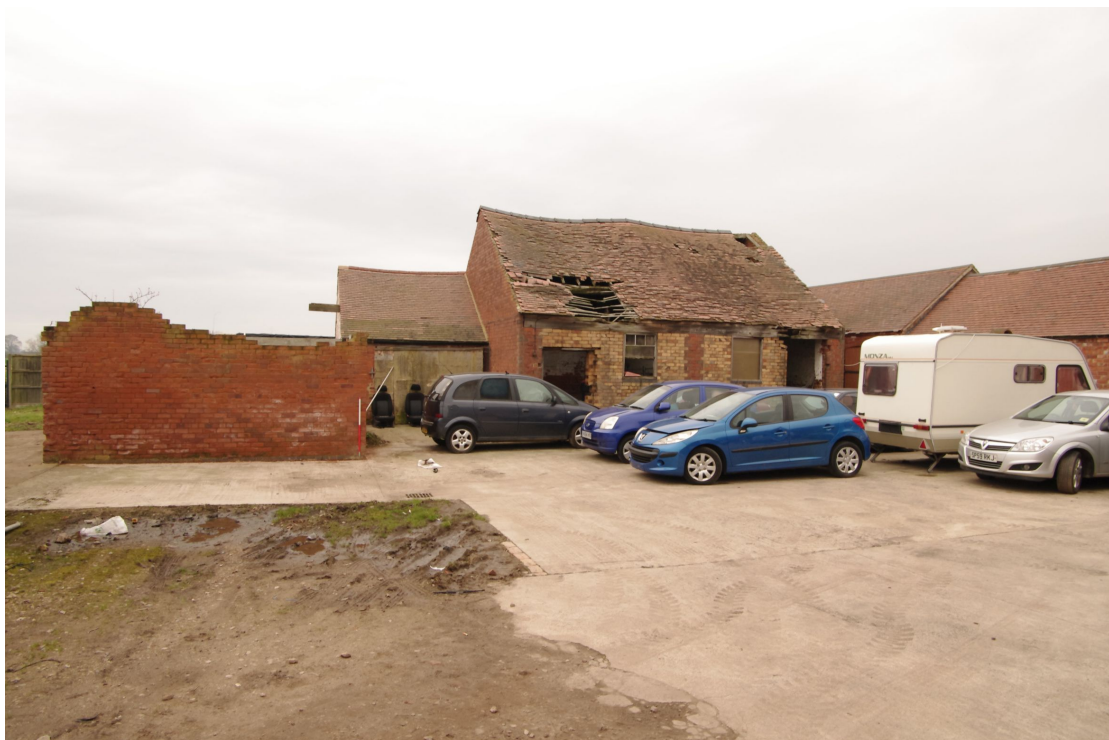
Figure 38 East facing elevation of Barn 3 range  
Looking north-east. The roofless milking parlour is on the left, extension building and cart shed to the right of this. Barn 2 range on right behind the caravan

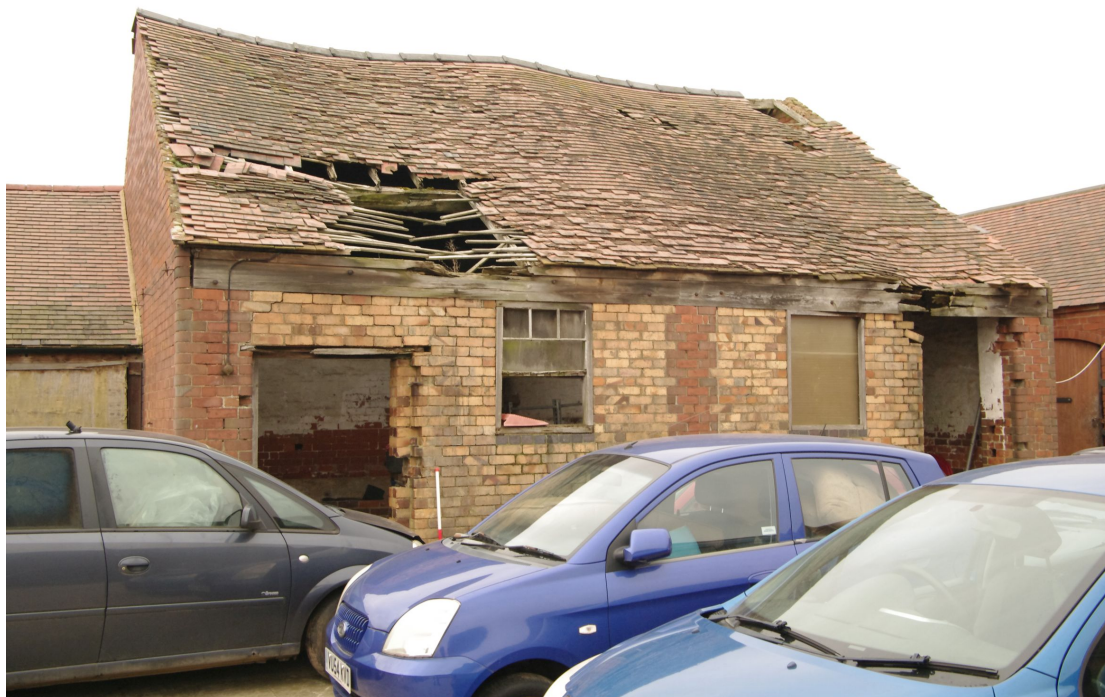
Figure 39 East facing elevation of Barn 3 range  
Looking north-west. 1m scale. The open-fronted cart shed building with a central red-brick pillar has been infilled with pale bricks. Note the large timber lintel

The double-sided cart shed, Barn 3, is a late 19th century structure and is not commonly seen in Leicestershire. It may have been an experimental building as it would appear that the east facing open front, which looks across the yard, was filled in to hold animals quite early on in its life. Barn 4 is a modern metal building often seen in farms and built to accommodate the ever increasing size of farm vehicles and equipment.

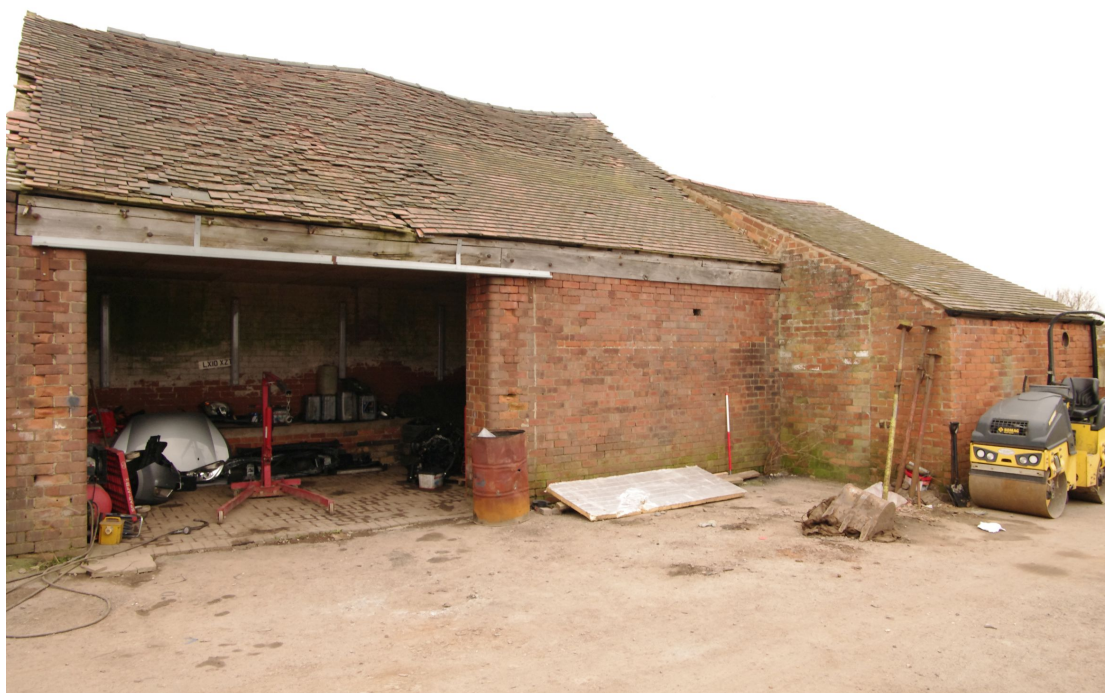
Figure 41 West facing elevation of former cart shed, Barn 3 range  
Looking south-east. 1m scale. The lower wide building to the right is later than the  
cart shed

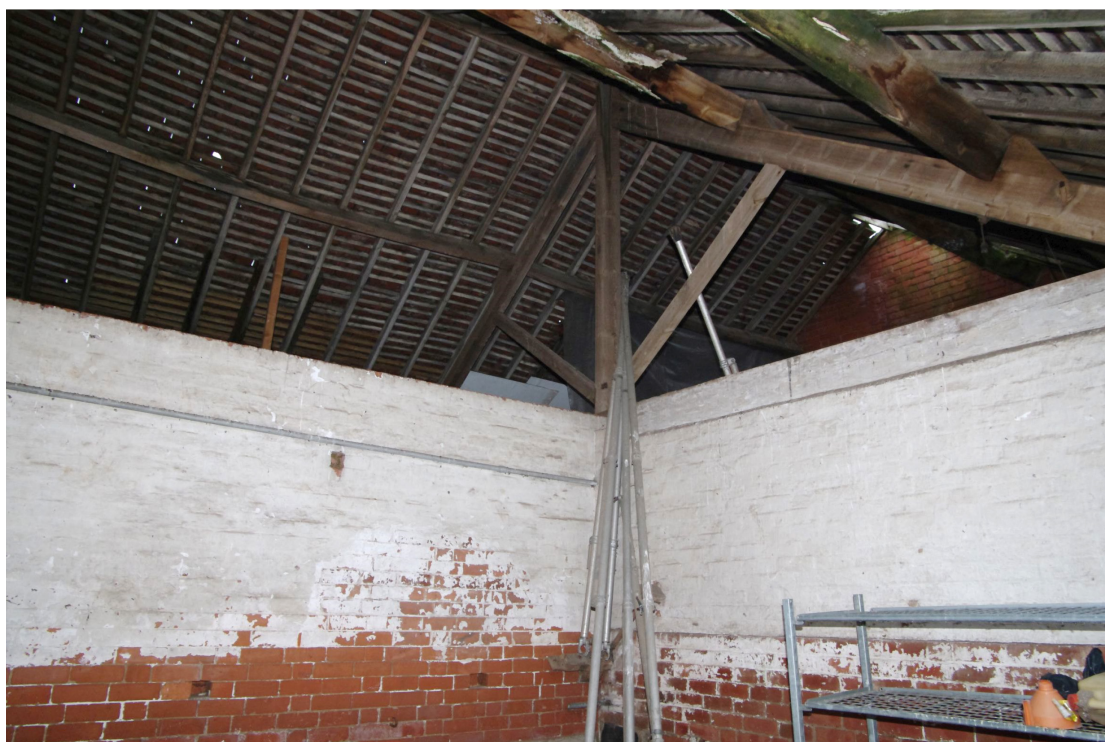
Figure 42 Inside Barn 3 range, the former cart shed  
Looking north-west in the south-eastern room. Internal brick walls, which are  
original, sub-divide the space into three

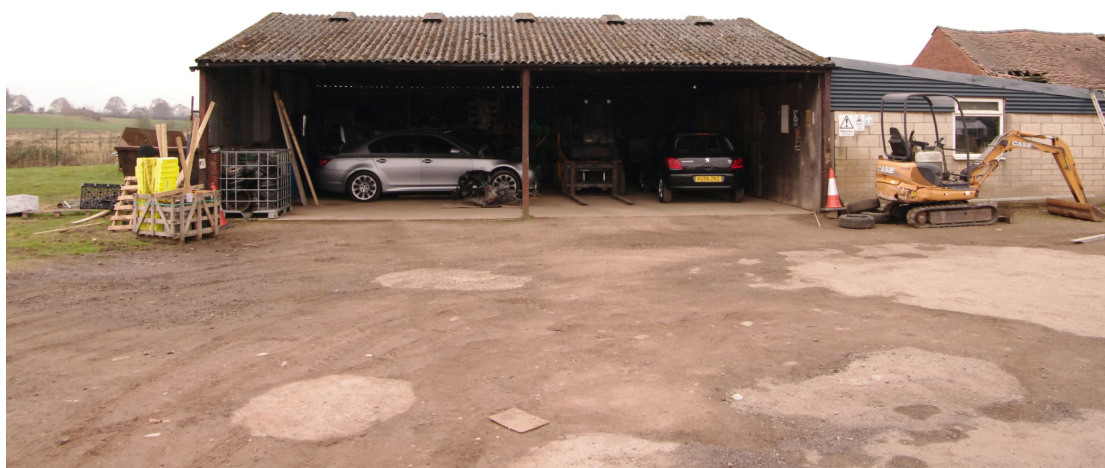
Figure 48 Metal-clad and framed Barn 4  
Looking west
