**Archaeological Attendance and
Recording during Groundworks on land
at Home Farm, Hall Lane, Osbaston,
Leicestershire,
CV13 0DR**

NGR: SK 42573 04417

ULAS Report No. 2020-011
©2020

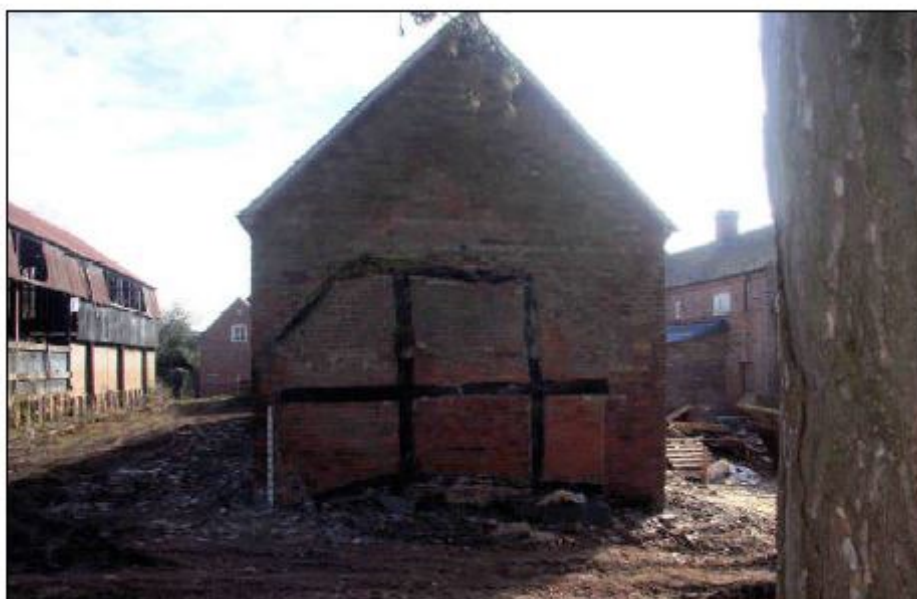
An Historic Buildings Appraisal undertaken in 2010 (Bradwell 2010) prior to the renovation of the Home Farm complex, traced the development of the buildings from the earliest Ordnance Survey and Tithe Map through to the present day. There appeared to be a considerable expansion of the farm in the first half of the 19th century, attributed to the purchase of neighbouring Osbaston Hall by Thomas Cope in 1827 (White 1846). The last building to be added was a large, steel framed, Dutch barn visible in both the photograph prior to the renovations in 2010 (Fig.4) and the 1958 Ordnance Survey Map (Fig. 5).

Figure 4: Home Farm renovations in 2010, looking east, Dutch barn to north (Bradwell 2010).

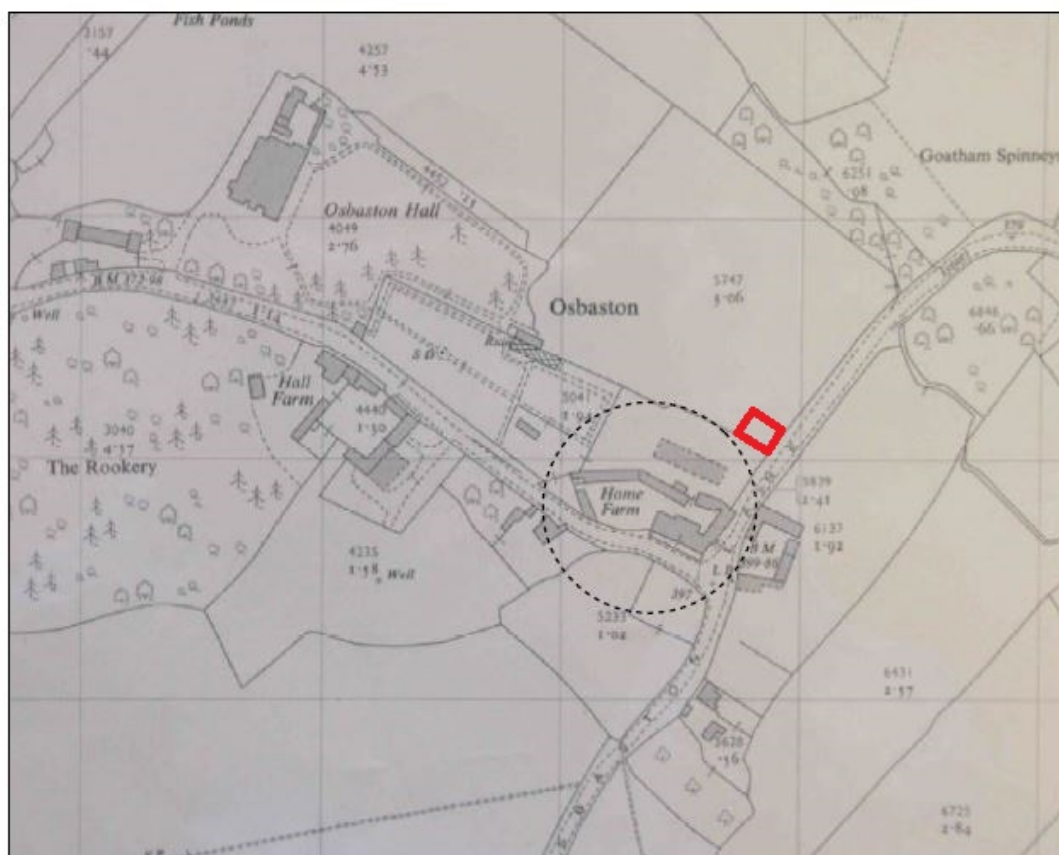
Figure 5: The 1958 Ordnance Survey Map taken from Bradwell (2010) showing the field boundaries and Dutch barn to the north of the main complex.

Notably, in proximity to the development area and in recent times, the Dutch barn has been removed and the field boundaries have changed. The area of the barn is now landscaped and terraced and the development area lies inside the field boundary to the north.

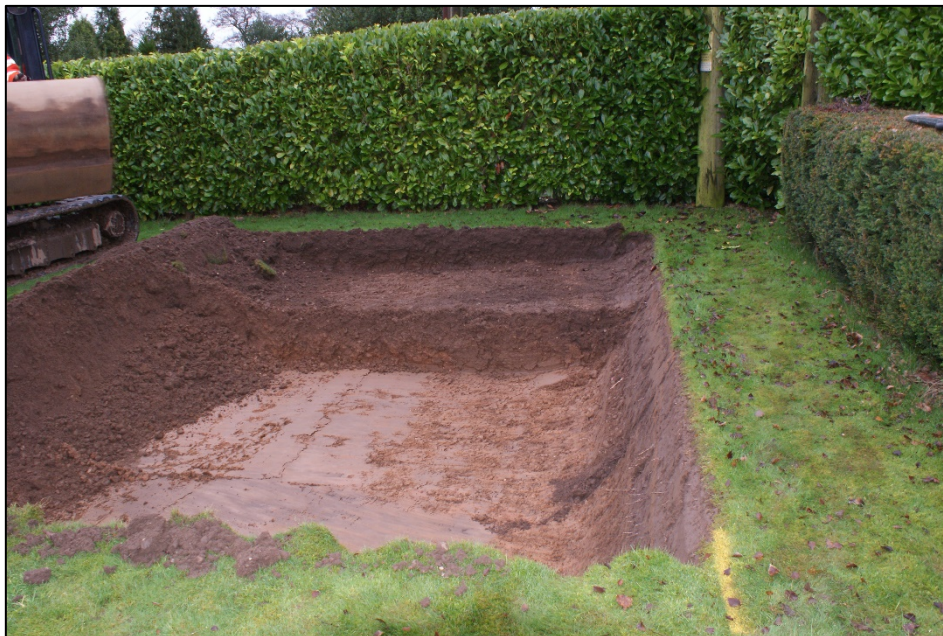
The ground for the pool house was being prepared to hold a concrete slab. The ground topography slopes towards the north and varying depths of excavation were required to obtain a flat surface. Final depths of excavation were 0.25m in the north western corner and 0.70m in the south western corner. Undisturbed natural geology was revealed at the southern end (Fig.7), whilst only a small depth of topsoil was removed from the northern end. A dump of modern material including brick waste was visible in the north-east corner, either simply a dump of waste or used to level the area (Fig. 8). No other features were noted in this area. The final platform dimensions were 13.7m x 5.2m.

Figure 7: Northern end of pool house excavation, looking east.

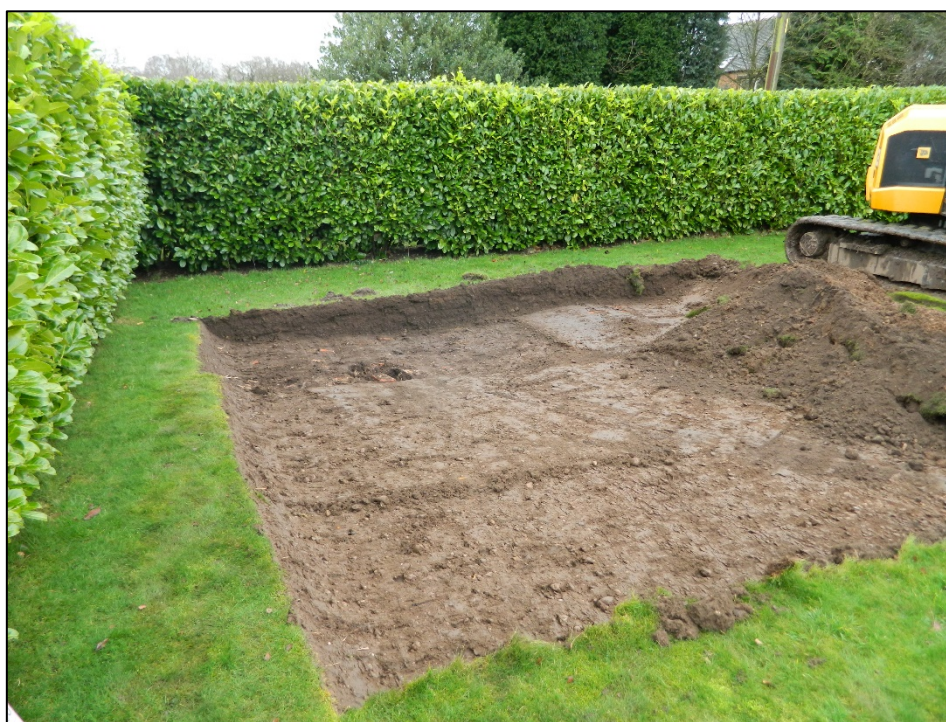
Figure 8: Southern end of pool house excavation, looking east.

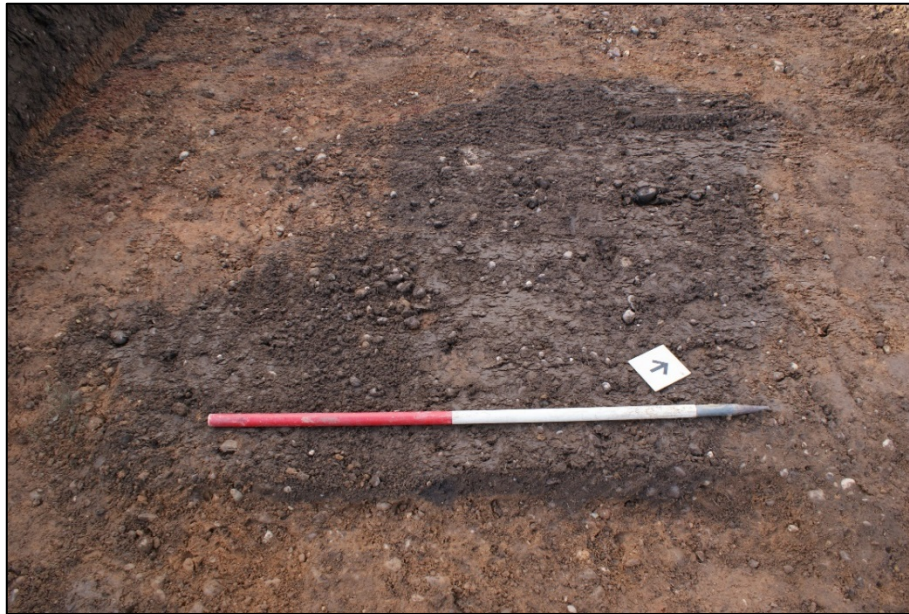
An area joining the pool house and pool was also stripped for ease of access and the preparation of ground for service trenches. This and excavation of the footprint of the pool were observed and the total dimensions of this length were 15.0m x 4.75m. A shallow feature (Fig. 9) was observed and cross sectioned. The feature was amorphous in plan and reached a maximum depth of 0.07m. No dateable finds were recovered, but

the presence of modern brick fragments suggested that it may also relate to recent landscaping. On completion of the groundworks, the area was planned and photographed (Figs 10- 11).

Figure 9: Shallow feature containing modern brick fragments

Despite the potential for exposing archaeological features and deposits during this work, the only feature was a shallow irregular pit containing modern brick. No other archaeological deposits were observed. The results suggests an amount of landscaping in this area during the evolution of the farm buildings and their surroundings.

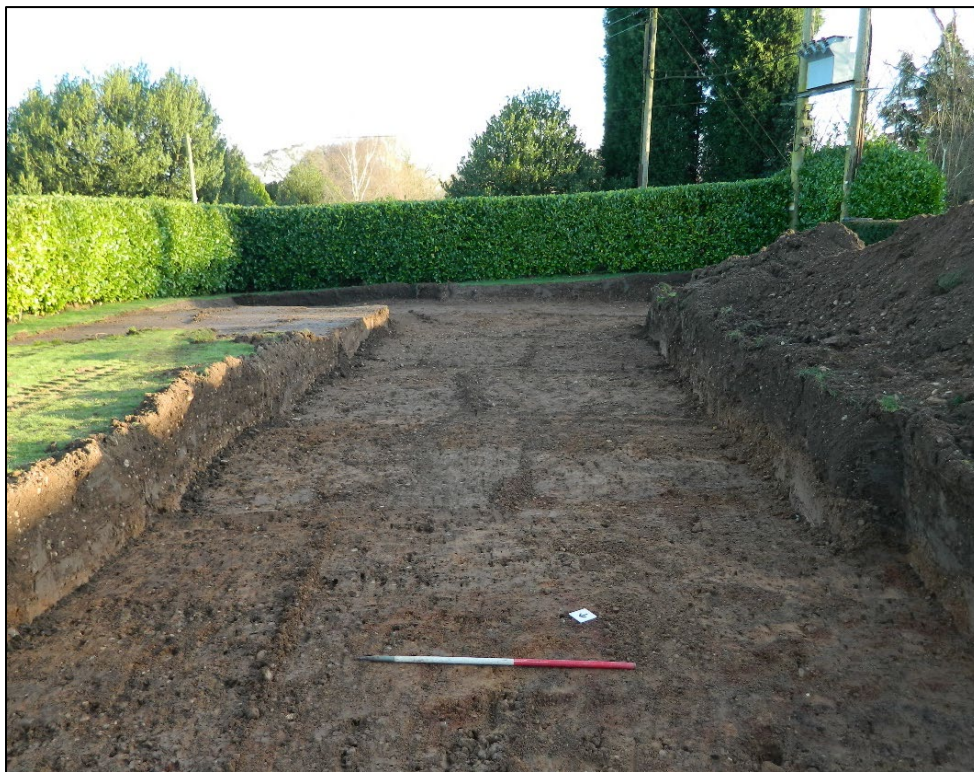
Figure 11: Completed excavations looking east.
