**An Archaeological Standing Building Survey and
Watching Brief at the King William Bridge,
Sheepwash Lane, Anstey, Leicestershire.**

For: Leicester City Council

**An Archaeological Standing Building Survey and Watching Brief at the King
William Bridge, Sheepwash Lane, Anstey, Leicestershire
(SK 5564 0895).**

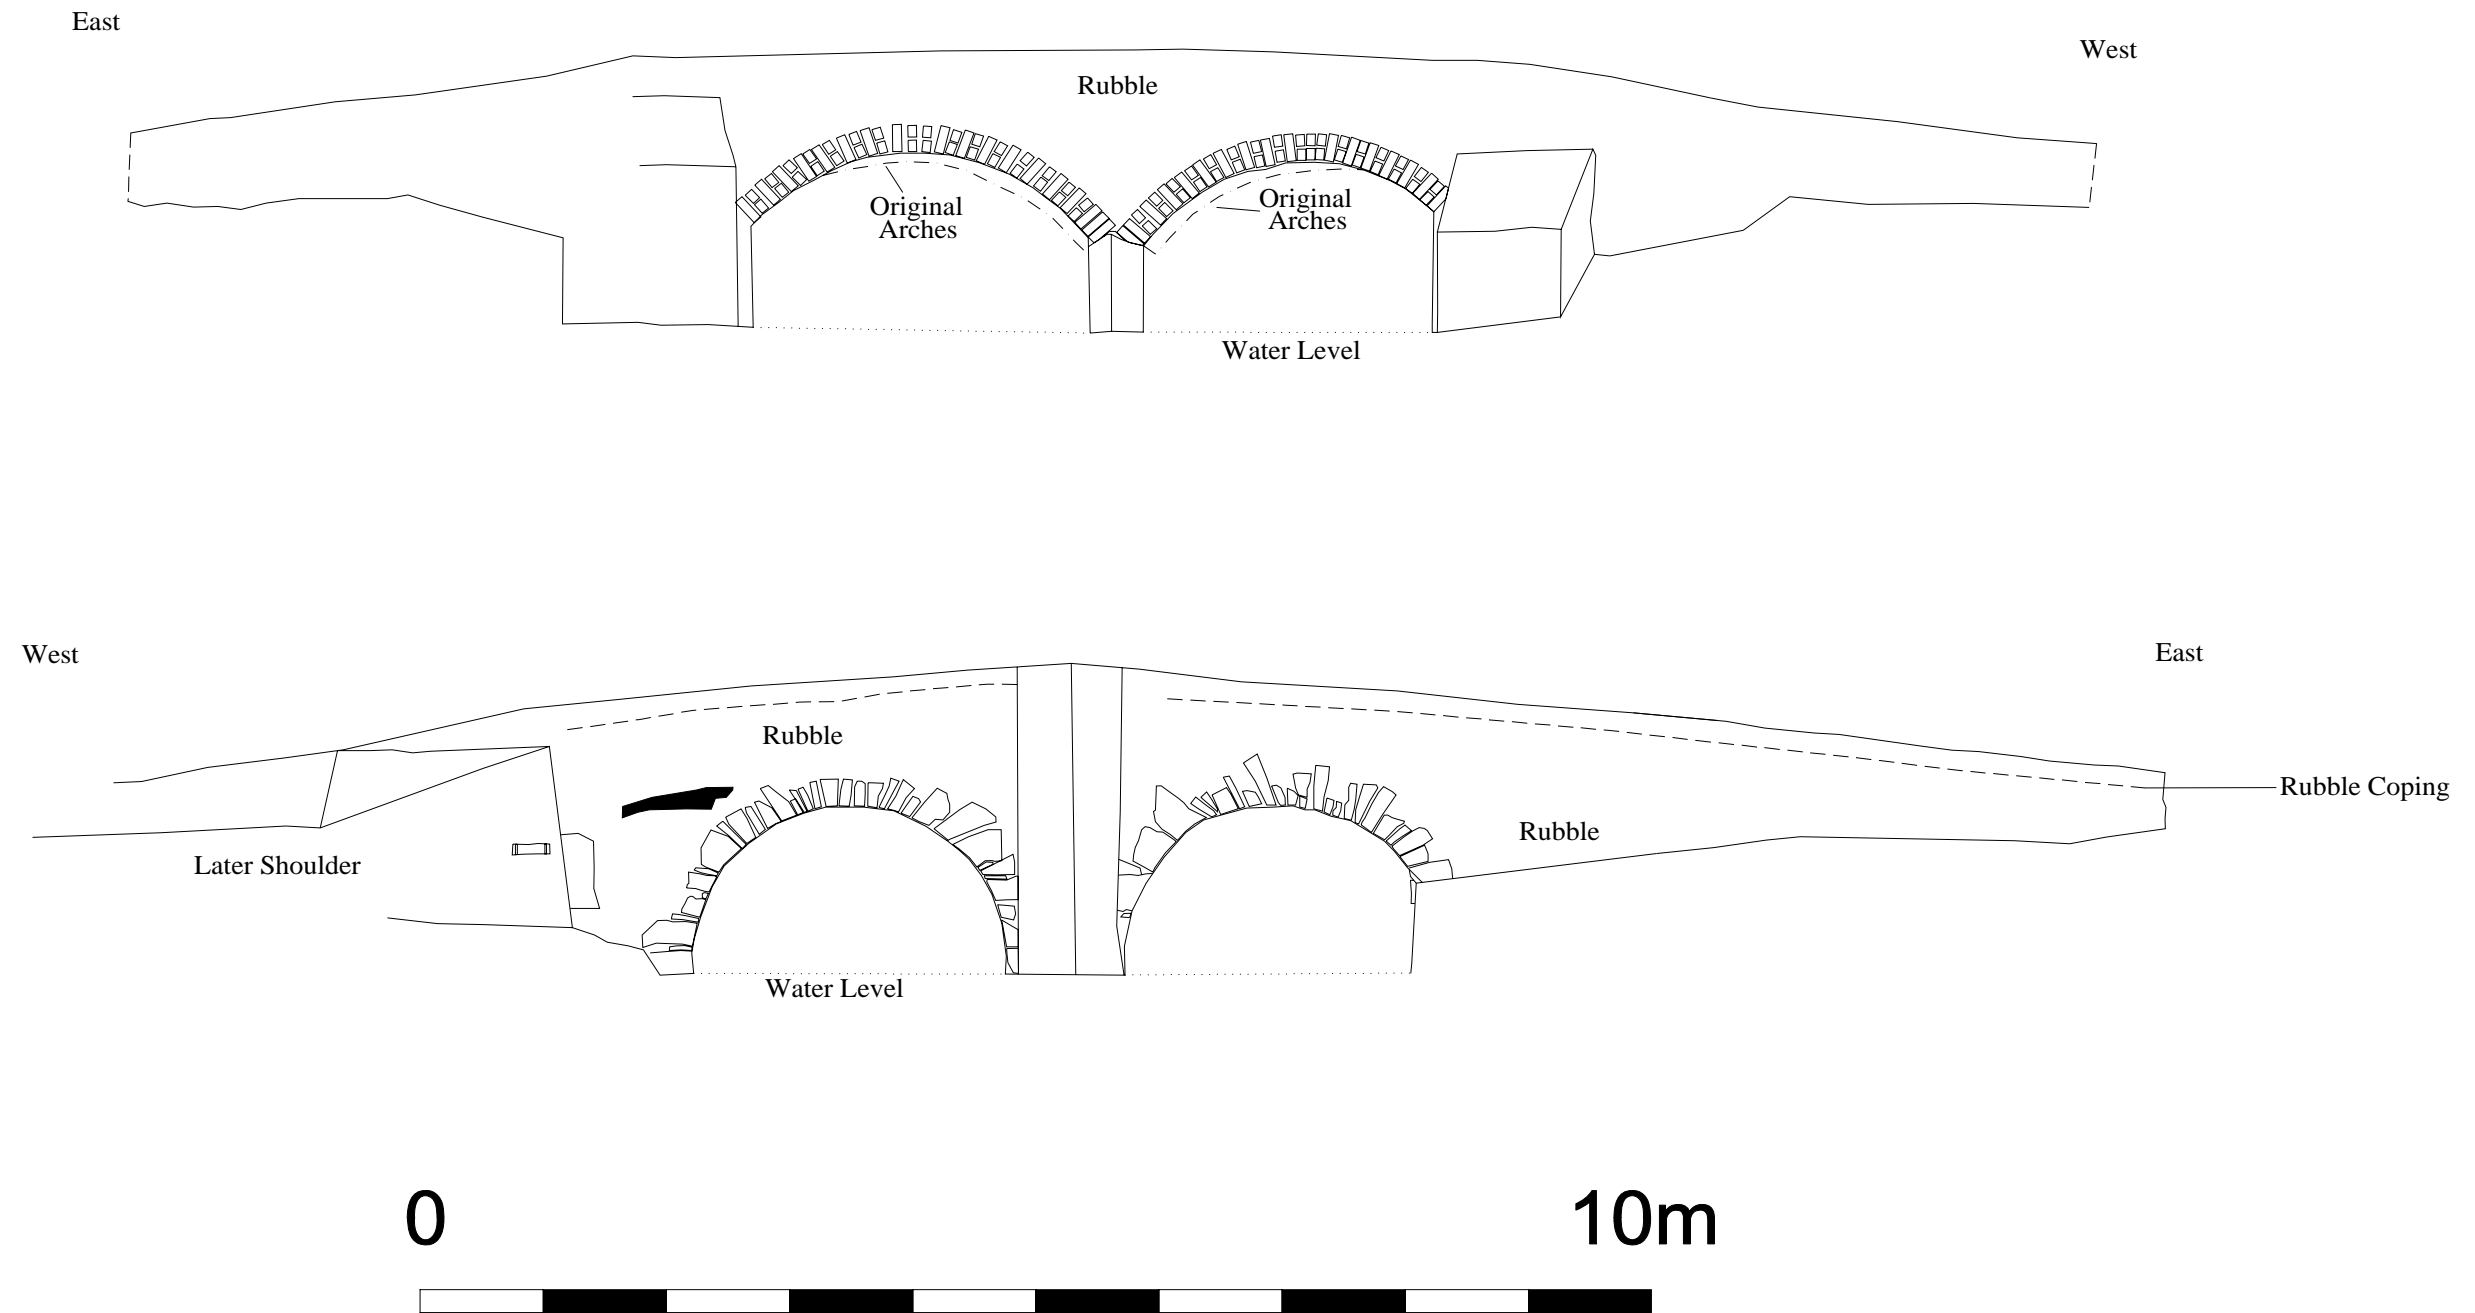
Figure 2 Parapet Elevations

King Williams Bridge consists of a small rubble-built pack-horse bridge with two rounded arches and a full height pointed cut water on the upstream, southern face and a small buttress near the water level on the northern face. The western parapet approaches are splayed out, more so the southern parapet with the addition of a more recent stone-built shoulder to counteract the erosion on the bend in the brook.

A closer examination of the structure confirms the rubble construction, most of which are medium to large angular granite blocks. There are occasional patches of roughly coursed slate blocks concentrated on the south facing parapet at deck level and within the cut water towards the current water level (*Figure 5*). There is also very occasional use of cobbles within the structure, almost certainly recent inserts during repair. There has been extensive and poorly carried re-pointing with cement mortar, but there are limited areas of earlier lime mortar pointing remaining. This cement pointing makes identifying phases virtually impossible.

It is likely, however, that the western shoulder of the southern face is a newer addition, added to re-enforce the bridge. The shoulder contains a great deal more slate than the bridge itself, and it also contains a re-used unusually moulded brick. There is also a large projecting stone at approximately deck height which may suggest that the parapet above this point has been rebuilt. The arches are, like the rest of the bridge 'rough' in appearance, with the voussoirs only roughly shaped or possibly not shaped at all and only selected because of their shape; there is no clearly identifiable keystone only a series of stones within the crown acting in unison as a keystone.

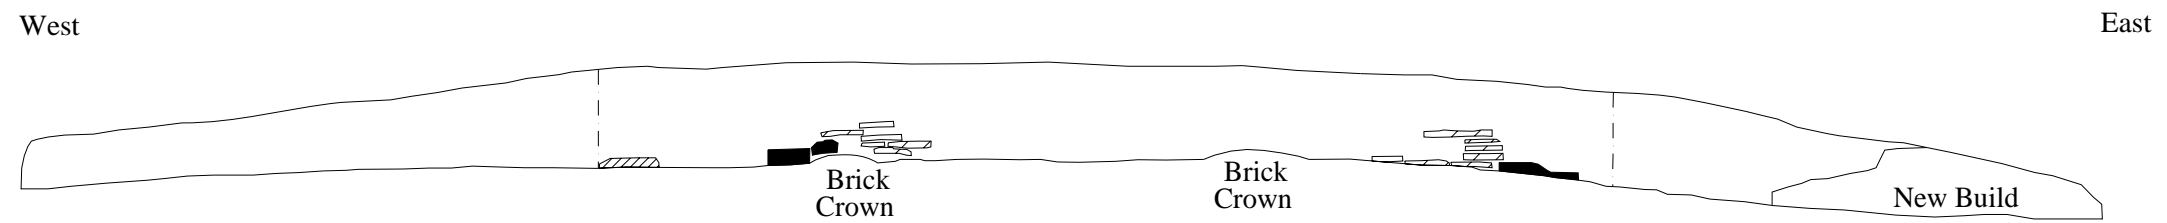
Figure 4 Internal Parapet Elevations.

Initial work consisted of raking out recent cement pointing on the internal parapets. It was hoped that the removal of the accumulated cement mortar may reveal evidence of phased building or repairs. Unfortunately, no such evidence was observed, which was not surprising due to the rubble construction employed.

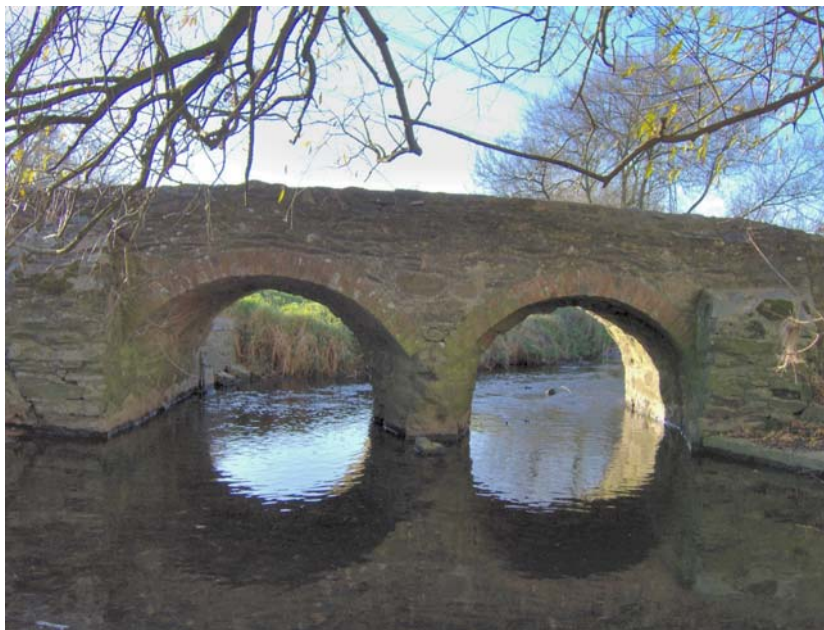
Figure 6 North Facing Parapet.

It is the northern face (*Figure 6*) which contains the most information, and it is here that the clearest proof of the widening can be seen; the segmental arches are lined with brick as are the intrados. The original arches can also be seen rising from the central pier and the eastern abutment, and it appears the extension is not square to the original bridge. Unlike the opposite face, there appears to be a greater amount of slate used in the construction and again the amount of cement mortar re-pointing makes identifying phases impossible. There are also a number of iron cleats set into mortar near the water level.

Curiously the bricks within the arches are all 9inch by 3inch apparently wire cut red bricks; these dimensions and their appearance does suggest a cautious date of the early to mid nineteenth century (Between 1825 and 1850). The dimensions of the bricks match those established by the Brick Tax in 1803 (effectively limiting the size of green bricks to 10inch by 5inch by 3inch), appearing to confirm an early nineteenth century date. This together with possible indications of the bricks being wire cut suggests a pre-1850 date but certainly post-1803, and not late seventeenth century. The bricks for nearby Bradgate House were made by firing Boulder Clay at a site now flooded by Cropston Reservoir (Loughborough Naturalists Club, 1981); it is possible that the bricks used to widen the bridge also came from this source, although with c. three hundred years difference in date, this is unlikely. Another possibility is that stone was used to widen the bridge in 1696 in what would have undoubtedly been a rushed job and the brick we see in the bridge today is a later repair or rebuild. A list of expenditure on the County's bridges between 1779 and 1830 (Chalkin 1999) does not record any expenditure on the bridge, but if the bridge was still in private ownership at this time there is no certainty that a record of the works would have been made or indeed survive. Further examination of City & County Council Records did not provide any additional information, the only recorded works being minor repairs carried out in the early 1990s (N Lad, pers.comm.).

A physical examination of the bridge carried out during this building survey, however, does confirm the bridge has been widened by the addition of brick built arches on the downstream side. As previously stated the bricks used are undoubtedly early nineteenth century in date. The Enclosure Award (1761-62) resulted in the creation of a "double" road as a boundary between two different landowners, Daniel Glover downstream (to the north) and Mary Heard upstream (to the south), and the width of this double road can still be seen today. It is possible that this wider road led to an increase in traffic, necessitating the widening of the bridge in the early nineteenth century. There was a brickworks in operation in nearby Glenfield supplying bricks for the construction of the Glenfield Tunnel on the Leicester & Swannington Railway in 1831, and it is possible that these works continued in operation after the completion of the tunnel supplying bricks to local markets.

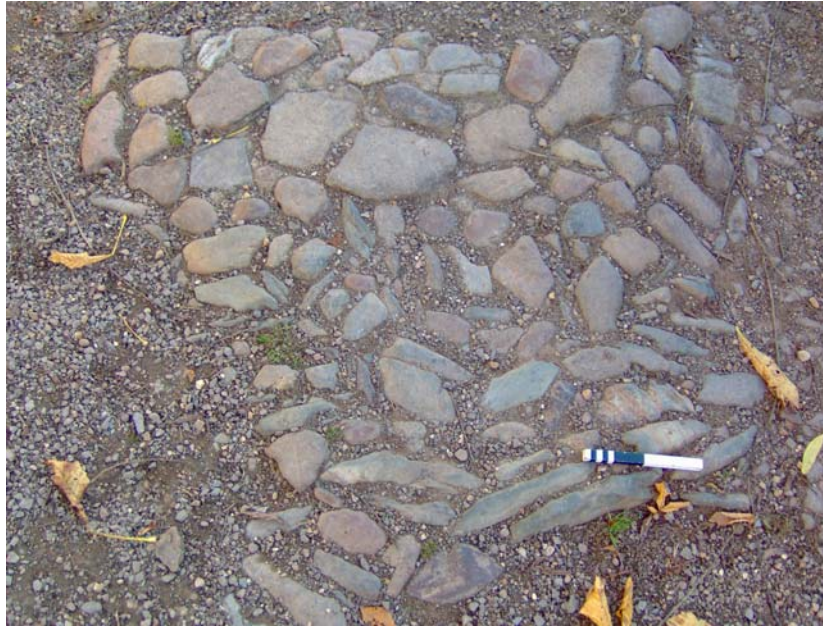
Figure 7 Early Cobbled Surface.

It is the precarious condition of the deck which necessitated the proposed phase of works and as expected the deck is in a poor state of repair. The crowns of the brick arches can be seen as well as the core, the original surfacing has long since disintegrated. There are however two patches of cobbled surface (*Figure 7*); it is unlikely that these are the original cobbles, but if they are not original they most likely mirror an earlier surface. Such cobbles are normally bedded in clay, although there was no evidence of the clay on the bridge, however given the condition of the deck any clay would have been washed away. There is, however, possible evidence of tyre ruts, which are likely to be early in date and caused by cart wheels. There are also a number of projecting stones on the parapets which may suggest the original deck level.

The deck, as expected, was in a poor state of repair; it is possible, however, that the patches of cobbles are, if not original, then very early and it was suggested that the resurfacing should attempt to copy this as much as possible.

It was decided to leave the two patches of early cobbled surface *in-situ* as they were below the formation level of the new surface.
